REPORT NAEC-92-129

WEAR PARTICLE ANALYSIS OF GREASE SAMPLES

Technical Report  
Contract NAVY N68335-76-C-2281

Prepared by: *E. Roderic Bowen*  
J. R. Bowen/E. Roderic Bowen  
Foxboro Analytical Division  
The Foxboro Company

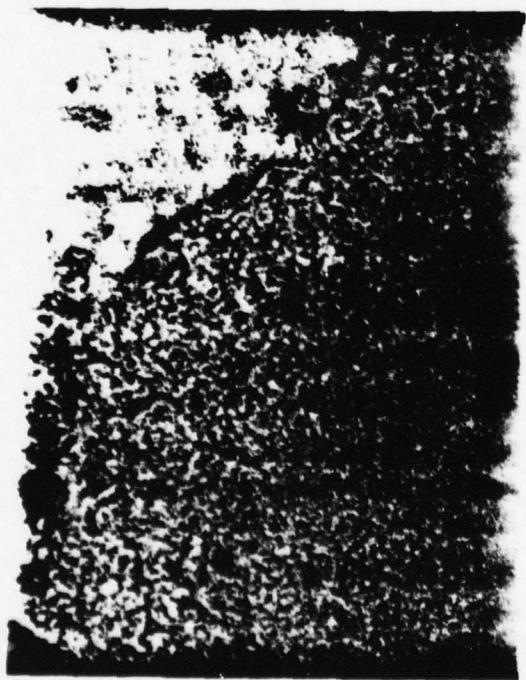
Photo No. F1428-4 Magnification: 100X

Bichromatic light photo of same material in Photo F1428-3 above. Shows chiefly amorphous nature of undissolved grease.

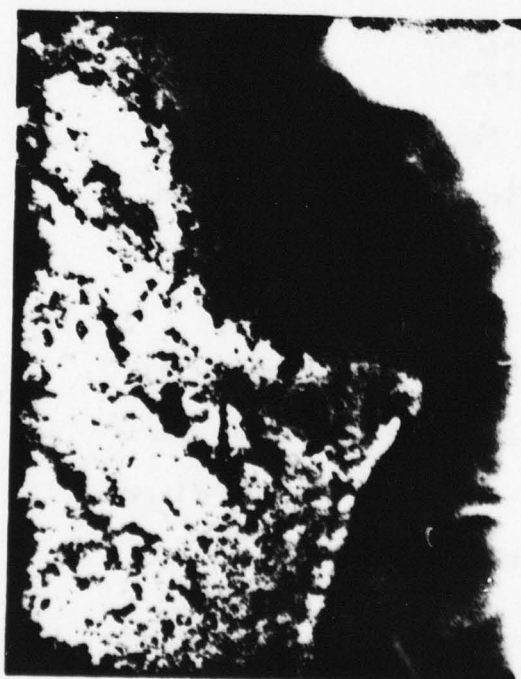
Photo No. F1428-6 Magnification: 100X

Another view down the Ferrogram of  
material thought to be lithium soap  
apparently swollen by Solvent #1.

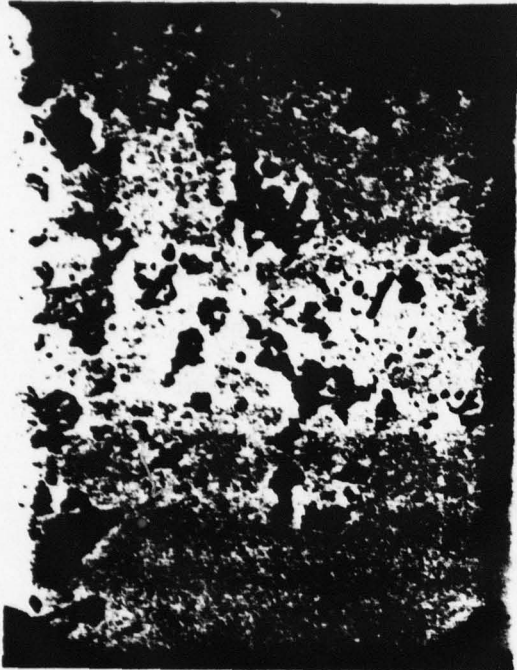
Photo No. F1437-7 Magnification: 100X

Sample dissolved in grease Solvent #3, (high aliphatic content). Good solvation. No grease or soap evident. Some thin non-metallic particulate matter present.

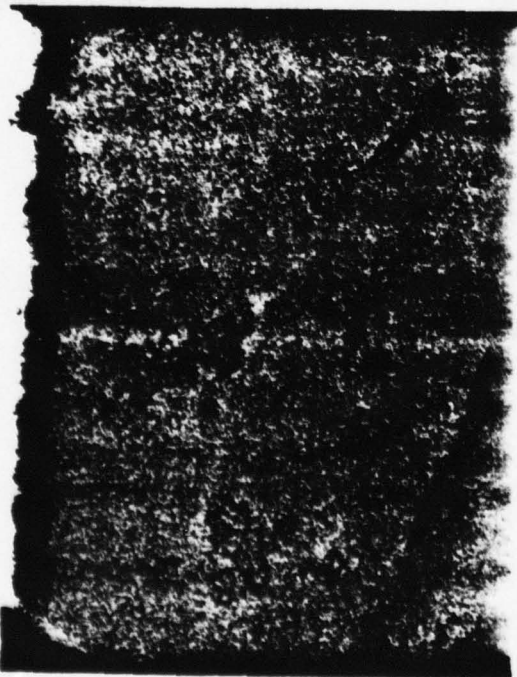
Photo No. F1437-8 Magnification: 100X

Another view of same Ferrogram. Emphasizes good solvency power of Solvent #3 vs. Solvent #1 (Photos -1 to -6).

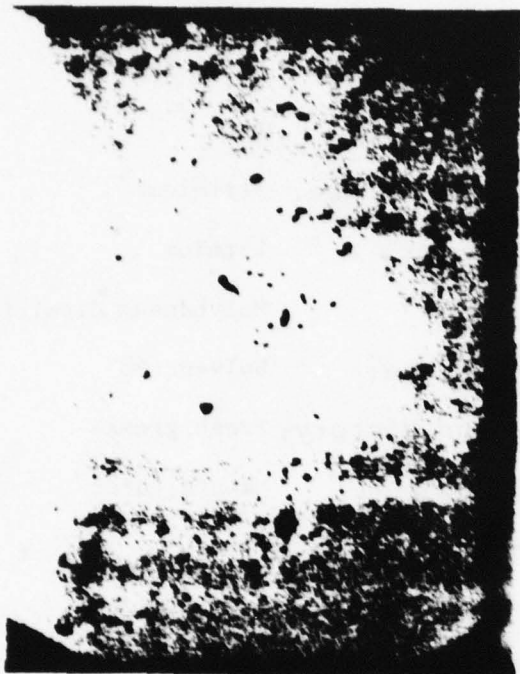
Photo No. F1439-11 Magnification: 100X

Grease dissolved well. Small amount of non-metallic particulate matter present (silica).

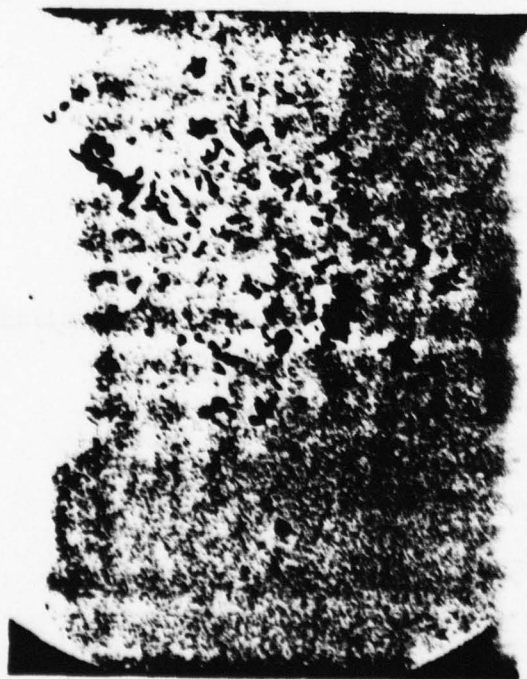
Photo No. F1439-12 Magnification: 400X

Higher magnification photo of F1439 in bichromatic light shows the fine silica particles.

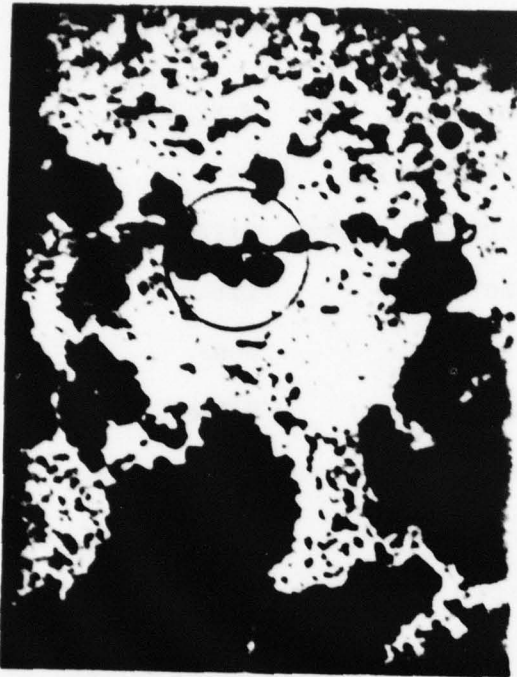
Photo No. F1442-13 Magnification: 100X

Remarks: Some metal particles. Most of deposit is a high concentration of soap materials used in this type of grease. The used silicone greases show an entirely different deposit and these agglomerates disappear under heat and pressure.

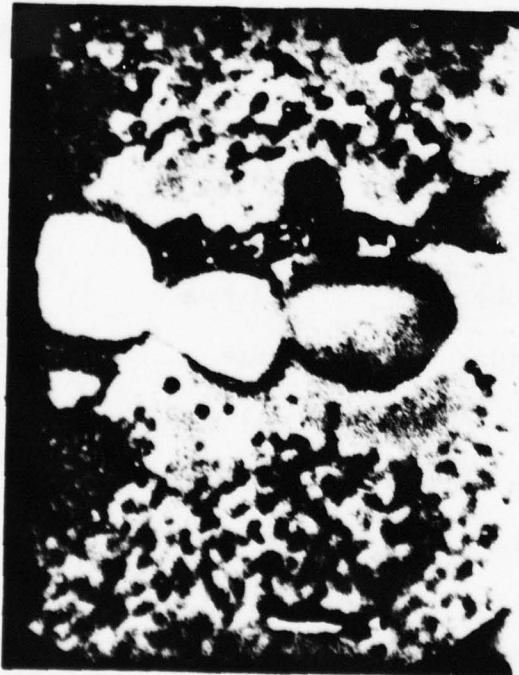
Photo No. F1442-14 Magnification: 400X

An enlarged view of Photo F1442-13 above.

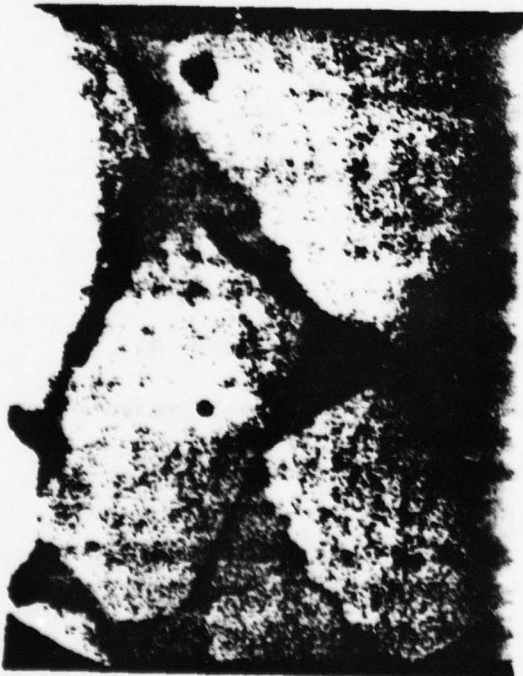
Photo No. F1442-16 Magnification: 400X

Magnified (400X) view of polarized light Photo F1442-15 circled above. No evidence of such structures in used silicone greases. See Photos F1491-36 and F1491-37.

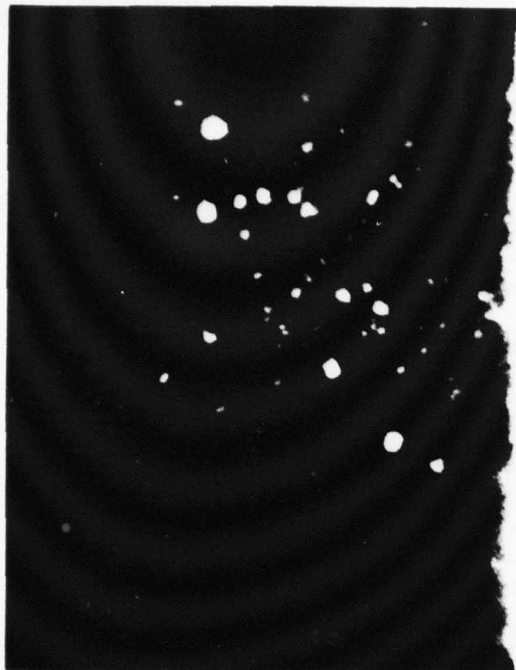
Photo No. F1442-17 Magnification: 100X

This sample diluted 5:1 with Solvent #3.  
Large soap particles much reduced in size  
compared to original sample shown in  
Photos F1442-13 to -16.

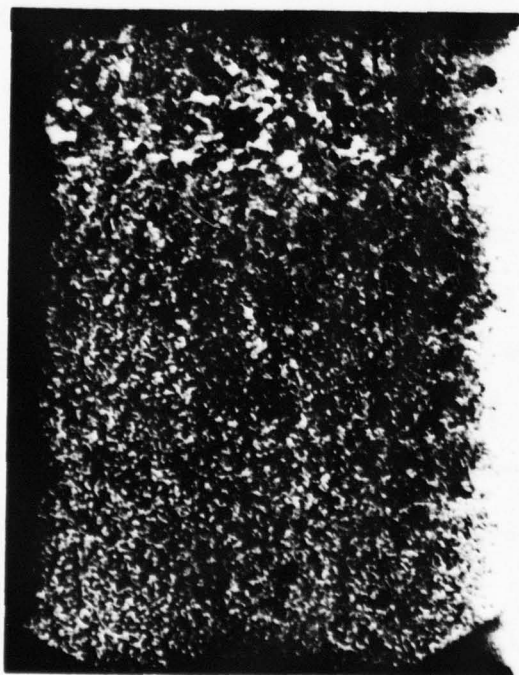
Photo No. F1442-18 Magnification: 400X

Enlarged view (400X) in bichromatic light  
of diluted (5:1) fresh silicone grease  
sample shows how particles are dispersed.

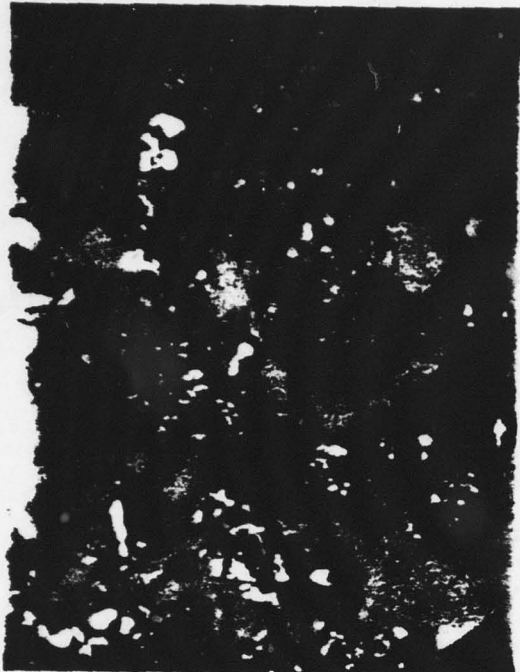
Photo No. F1444-23 Magnification: 400X

Enlarged view (400X) of Photo F1444-22.  
Some particles exceed 50  $\mu$ m.  $MoS_2$   
particles have entirely different  
configuration in used greases.

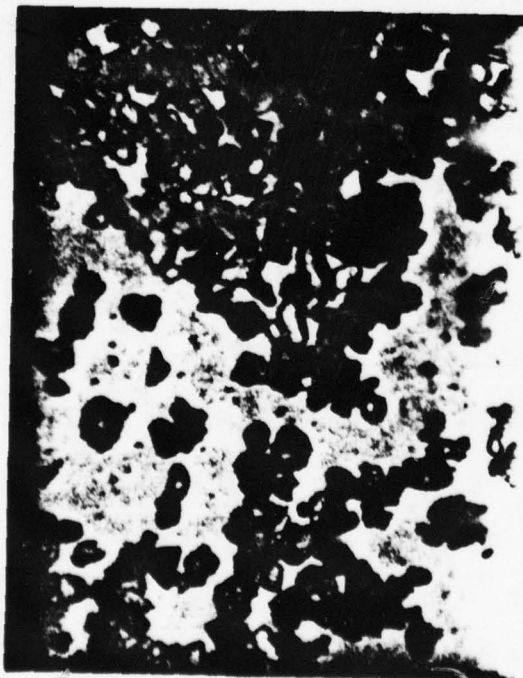
Photo No. F1441-25 Magnification: 400X

Same as Photo F1441-24, but in bichromatic light. Differences between Bentone particles (transparent) and MoS<sub>2</sub> (red).

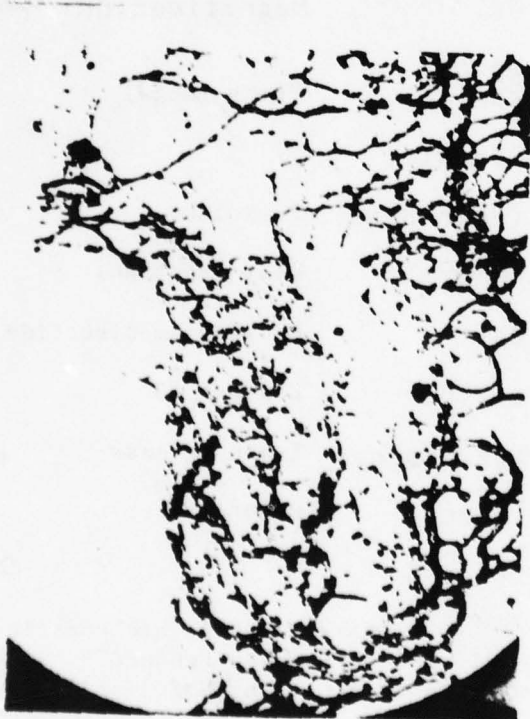
Photo No. F1443-27 Magnification: 400X

Locations A & B (circles) show metallic particles caught in web-like mass. Composition unknown.

Location on Ferrogram: @ 51.5 mm

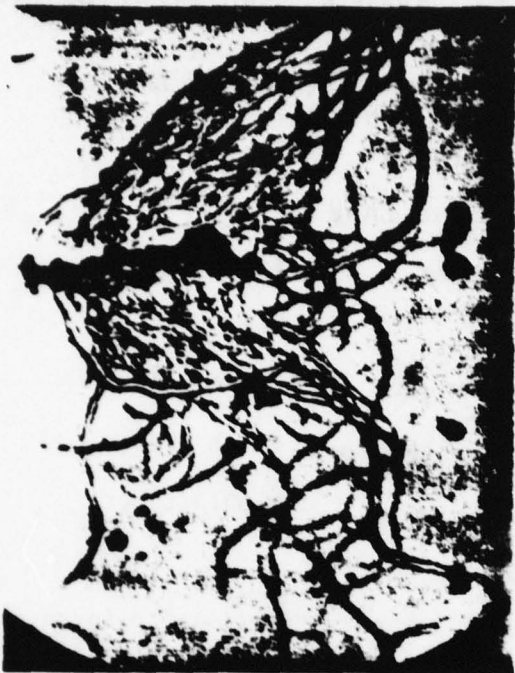
Photo No. F1443-30 Magnification: 400X

Ferrogram F1443 heated to 625<sup>o</sup>F, 90 seconds.  
Organic material fuses and shrinks.  
Blue portion of metal (arrow) indicates  
low carbon steel.

Location on Ferrogram: @ 54.6 mm

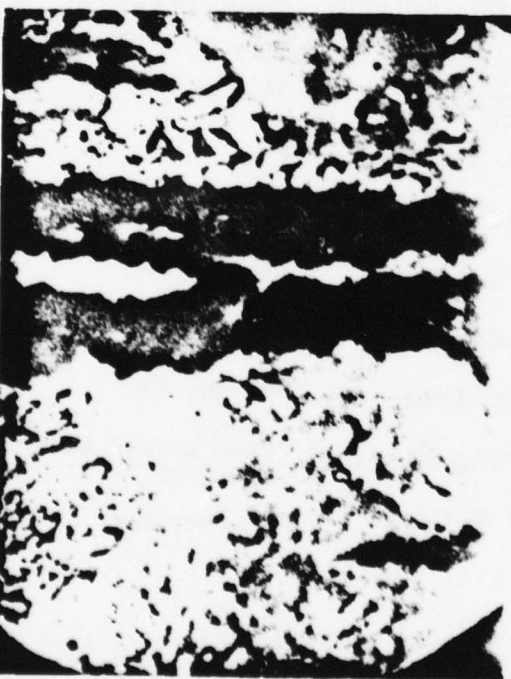
Photo No. F1491-37 Magnification: 400X

Remarks:  
Enlarged view (400X) of entry deposit in  
Bichromatic light. Demonstrates that  
large amount of soap material in used  
silicone grease present low interference  
when observing metal particles micro-  
scopically.

B. FERROGRAPHIC ANALYSIS OF CERTAIN TYPES OF WORKED GREASES. As already shown in Photos Nos. F1491-36 to -39 (appendix B, pages 47(B-19) and 48(B-20)), working of the lithium soap silicone grease #4 reduced the size of the undissolved particulate matter deposited on the Ferrogram, and also eliminated its interference with the interpretation of the Ferrogram. Even in the presence of a background of undissolved grease, wear particles precipitated from the grease can be satisfactorily analyzed by bichromatic microscopy.

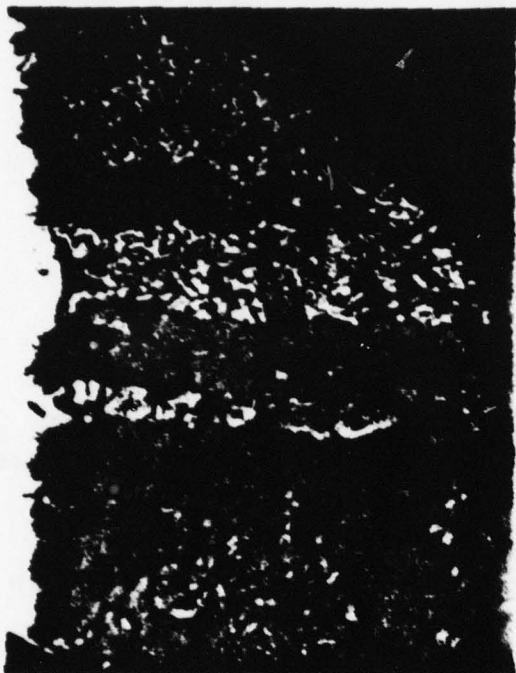
Photo No. F1491-38 Magnification: 400X

Another view in Bichromatic light showing contrast between metallic wear particles and non-metallic debris.

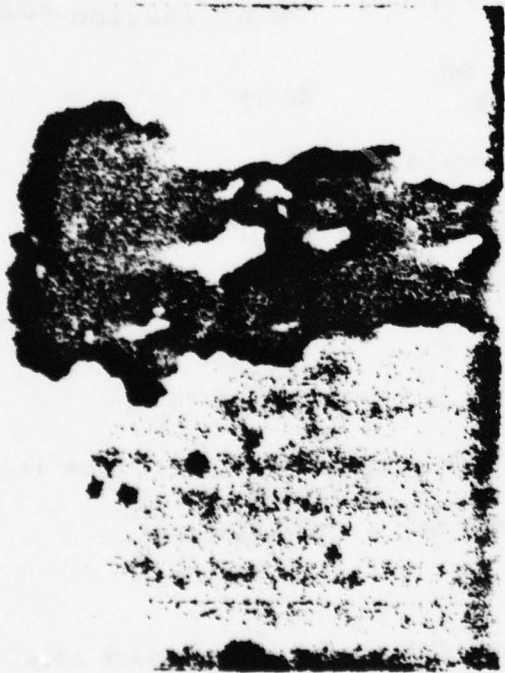
Photo No. F1494-43 Magnification: 400X

General view of entry deposit in Bichromatic light. Very little interference from web-like deposit found in fresh barium greases in viewing metallic wear particles.

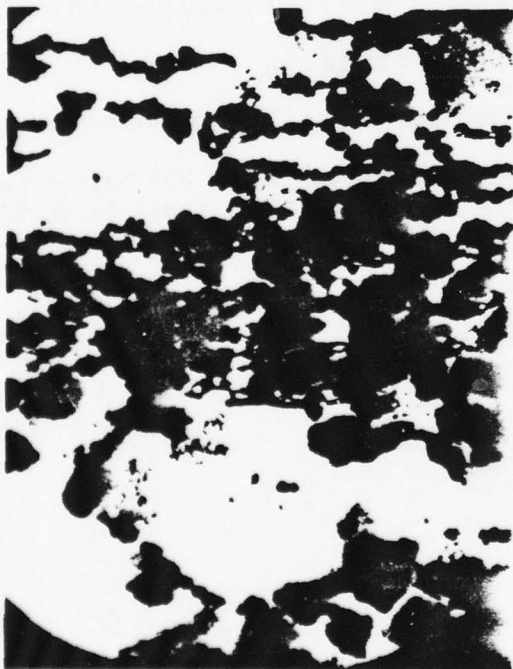
Low wear metal concentration. The primary  
difference to the above reference sample  
is the presence of oxides and compounds  
that may be wear associated or contaminants.  
Bearing appears normal

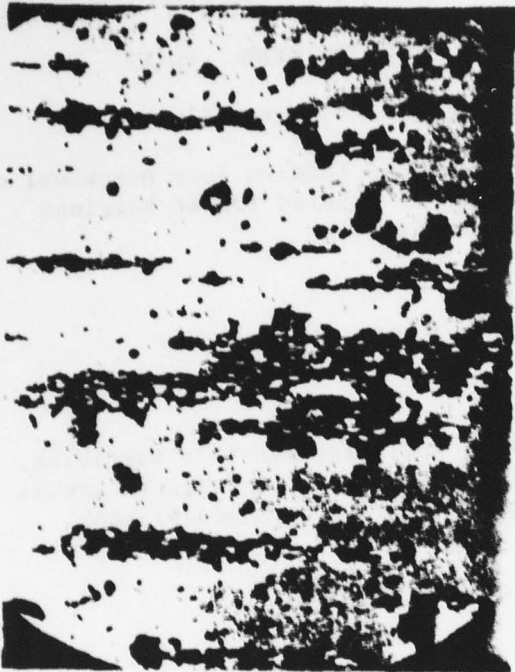
Photo No: F1964-1 Magnification: 400x

Clean Ferrogram in terms of residual grease  
and contaminants. Larger free metal particles  
( $> 10 \mu\text{m}$ ) give appearance of repeated  
passage through rolling contact.

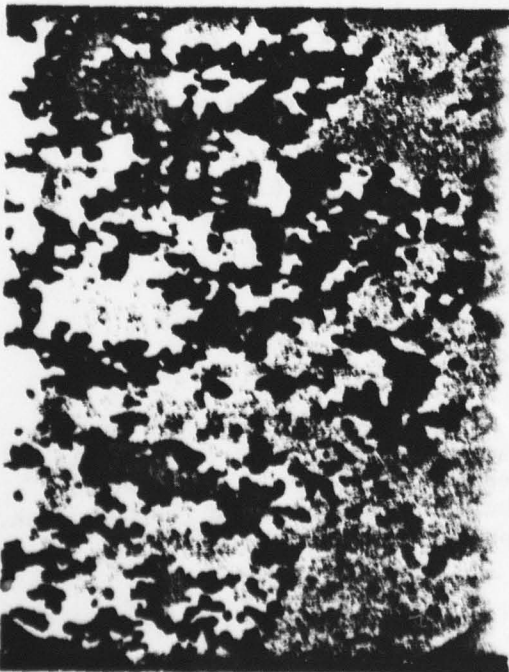
Photo No: F1965-1 Magnification: 400x

Heavily contaminated.

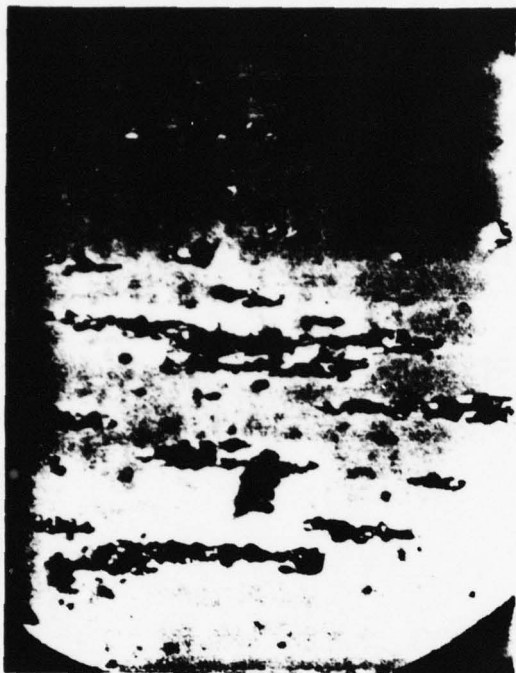
Grease Sample: #13 100:1 dilution

Sample Source: Helicopter.  
Reduction gear for rotor folding.  
Sampled at crack in gear box housing.

Operating History: hours on unit - 1203  
since overhaul - 353

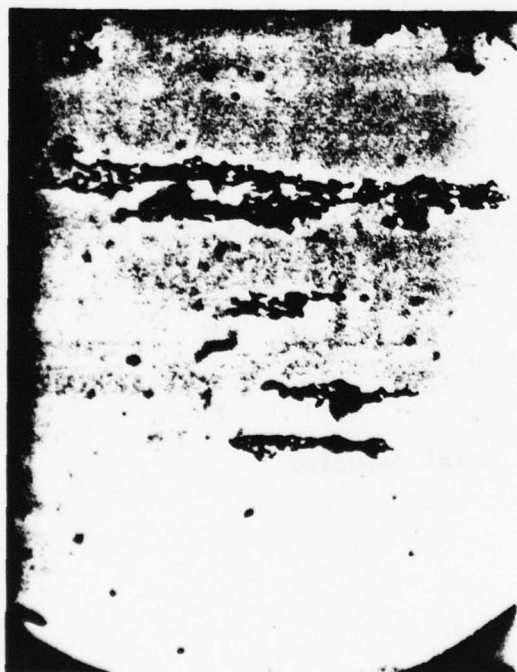
Grease Sample: #14 100:1 dilution

Sample Source: Helicopter  
Reduction gear.  
Sampled at gear teeth (minor gear)

Operating History: hours on unit - 1203  
since overhaul - 353
