"AN INVESTIGATION OF MECHANISMS EFFECTING
ENVIRONMENTAL STRESS CRACKING IN TITANIUM ALLOY"

Work Performed Under The Direction of
Ira J. Graham
(Principal Investigator)

Mechanical Engineering Department
Southern University
Baton Rouge, Louisiana 70813

Contract No. N00019-78-C-0065 *new*

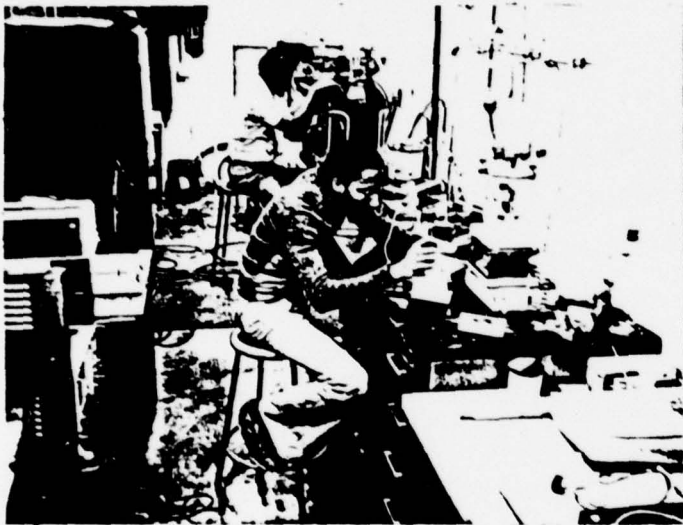
Figure 2. The sustained loaded test specimen can be seen in the closed-loop environment chamber. The nitrogen, methanol, drive line to the AE system, and thermometer were passed through the top cap of the chamber tube. The micrometer traveling microscope follows and measures the crack length.
