Technical Report 78124

**TRIALS OF THE
DOPPLER MICROWAVE LANDING SYSTEM
AT LONDON (GATWICK) AIRPORT,
AUGUST 1977**

SUMMARY

The trials of the Doppler Microwave Landing System (DMLS) at Gatwick formed part of a series conducted at operational airports to collect data for the ICAO evaluation programme.

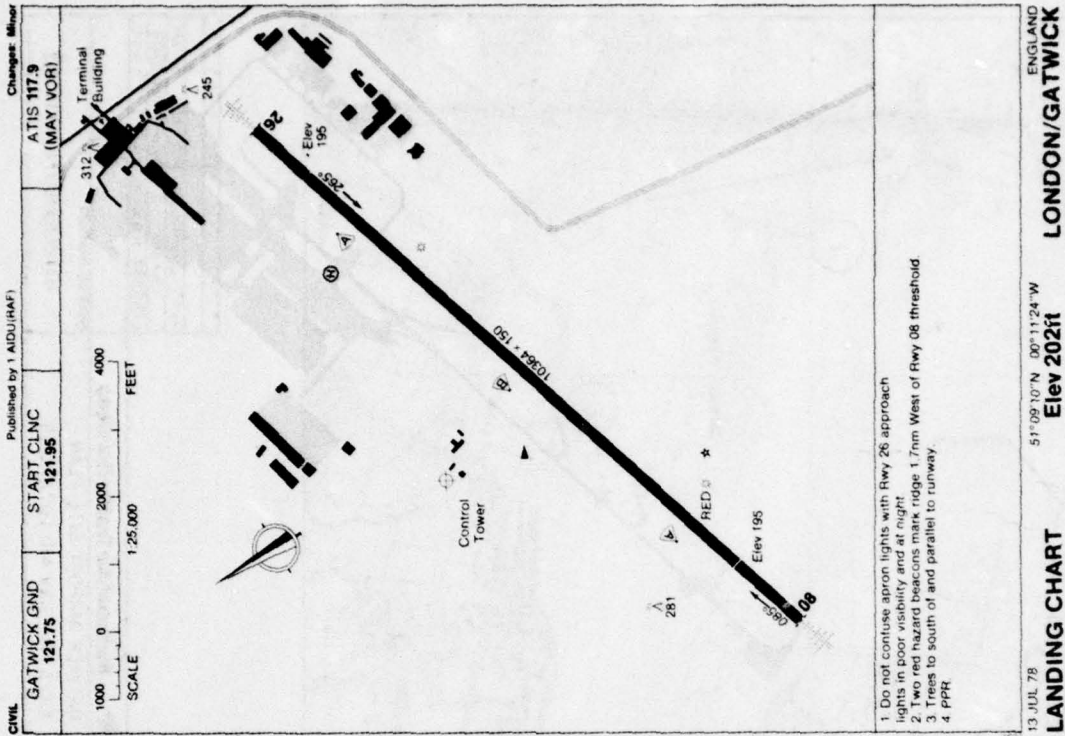
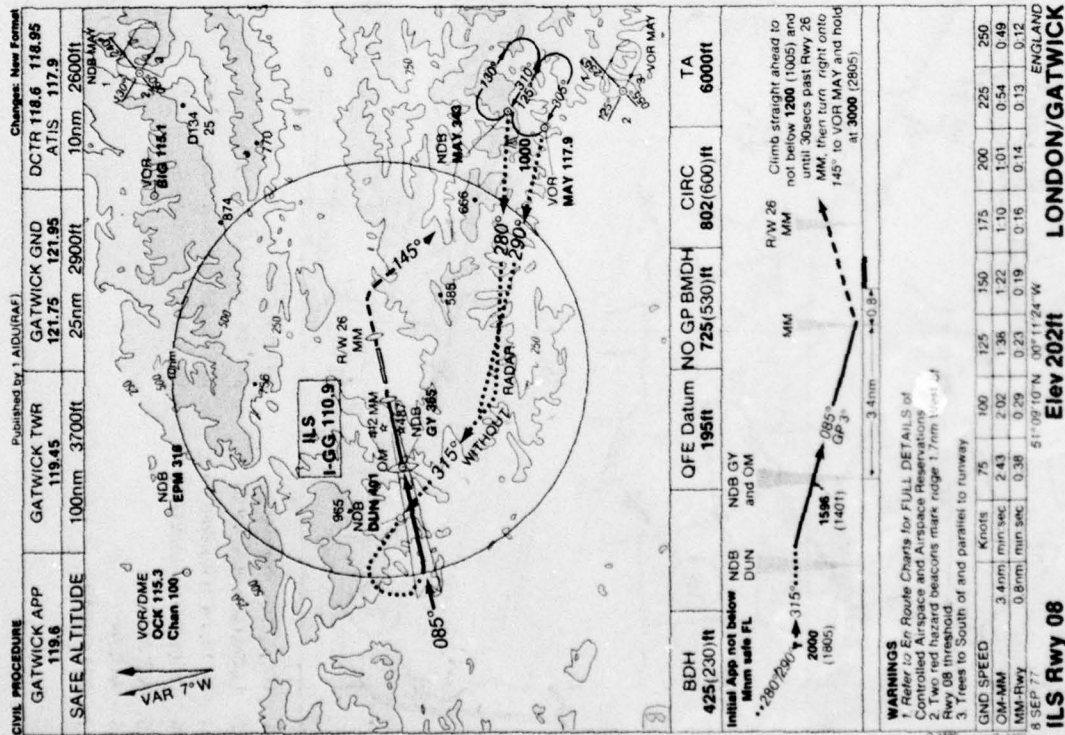
Fig 1 London/Gatwick landing chart

A copy of the Instrument Approach and Landing Chart for London (Gatwick) Runway 08 is shown in Fig 1. A plan of Gatwick Airport identifying the position of the DMLS equipment with respect to runway 08 is shown in Fig 2. This also shows the position relative to the Cat II STAN 37/8 VHF ILS localiser and glide-path systems. Fig 3a&b show the azimuth array in relation to the VHF ILS localiser antenna and Fig 4 gives an overview of the site in relation to the terminal and maintenance hangars.

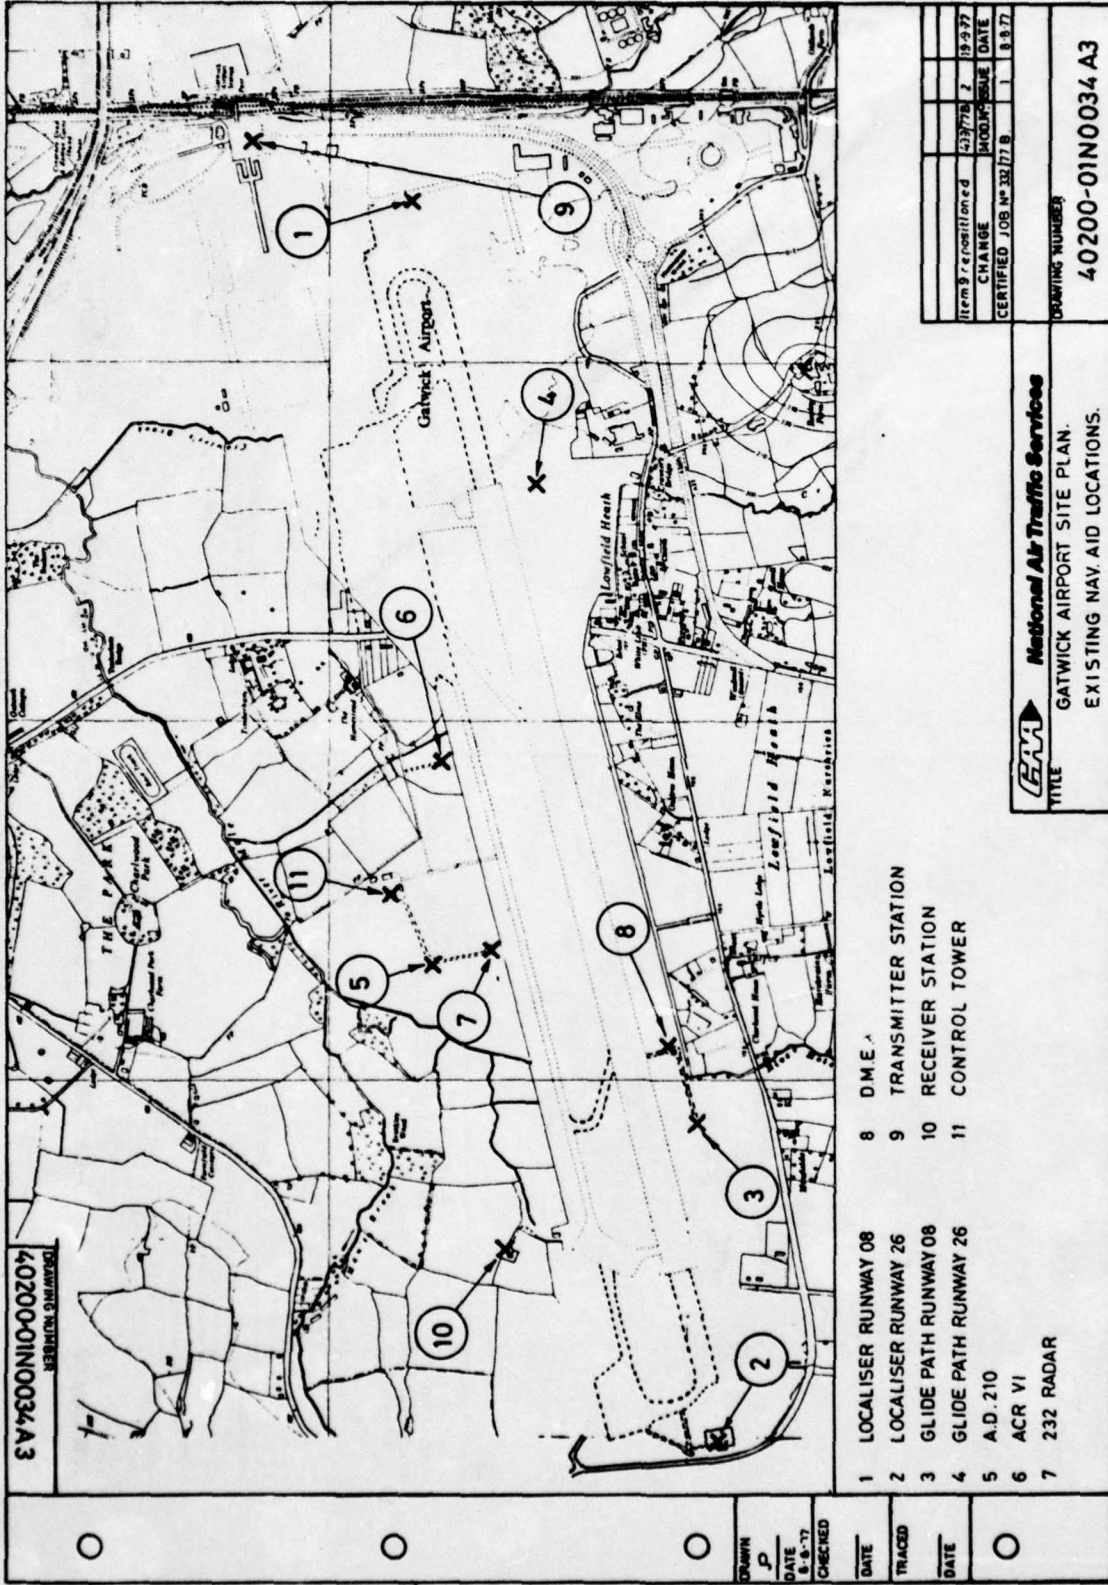
- 1 LOCALISER RUNWAY 08
- 2 LOCALISER RUNWAY 26
- 3 GLIDE PATH RUNWAY 08
- 4 GLIDE PATH RUNWAY 26
- 5 A.D. 210
- 6 ACR VI
- 7 232 RADAR
- 8 D.M.E.
- 9 TRANSMITTER STATION
- 10 RECEIVER STATION
- 11 CONTROL TOWER

Fig 2 Gatwick airport site plan. Existing navigational aid locations

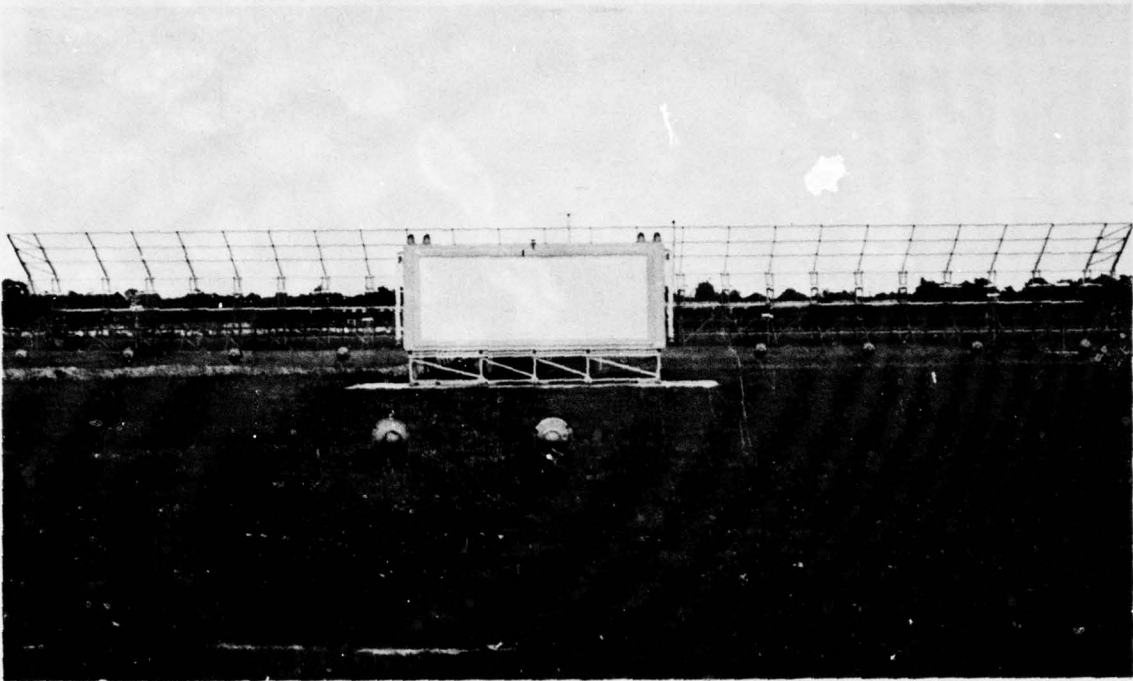
Fig 3a DMLS azimuth antenna sited in front of ILS localiser

In order to provide a satisfactory basis for assessing the compatibility of DMLS with ILS, the DMLS elevation antenna was sited to provide a guidance datum equivalent to the nominal ILS glide path and the DMLS azimuth antenna was sited in front of and close to the ILS localiser array.

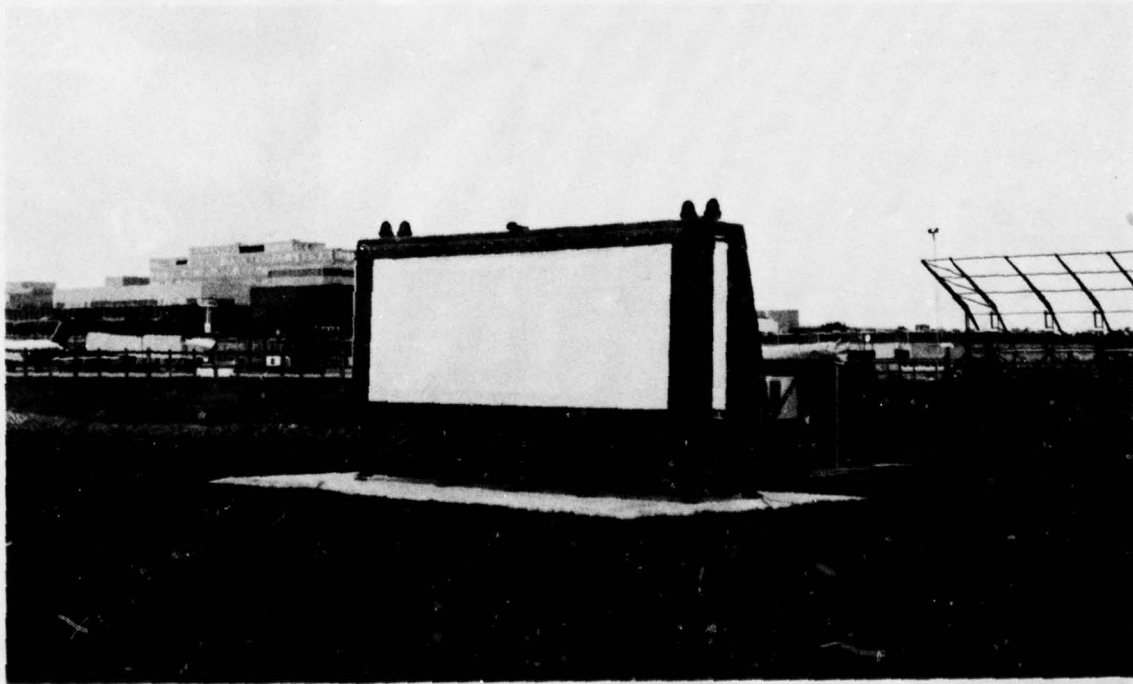
Fig 3b View of DMLS azimuth facility installed 30 metres in front of Category II ILS localiser

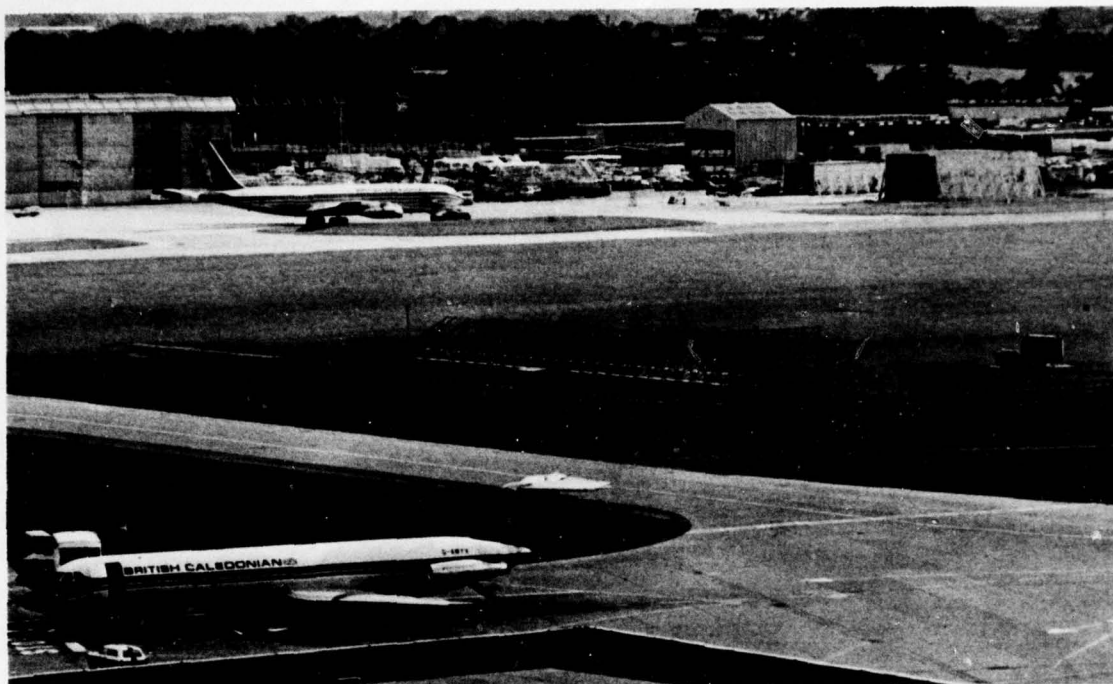
Figs 4&5

Fig 4 Overview of stop end of runway 08 showing Category II ILS and DMLS azimuth facility

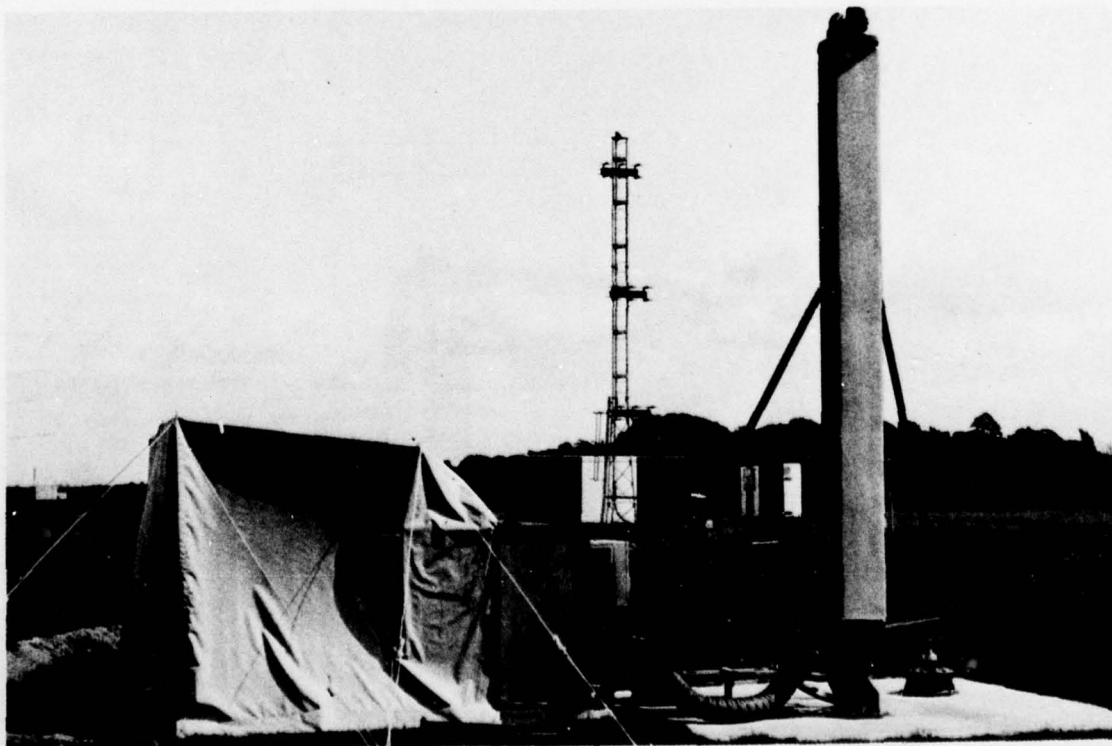
Fig 5 View of DMLS elevation facility installed 55 metres in front of Category II ILS glidepath

Fig 5 shows the DMLS elevation with the STAN 38 glidepath in the background. The DMLS elevation system was sited 55 m (180 ft) in front of the UHF glidepath array in order to give the same threshold crossing height for DMLS and ILS (50 ft nominal). The small profile of the DMLS elevation array minimised disturbance of the VHF/UHF ILS signals; ILS calibration flights after installation of the DMLS confirmed that there was no measurable change in ILS performance.

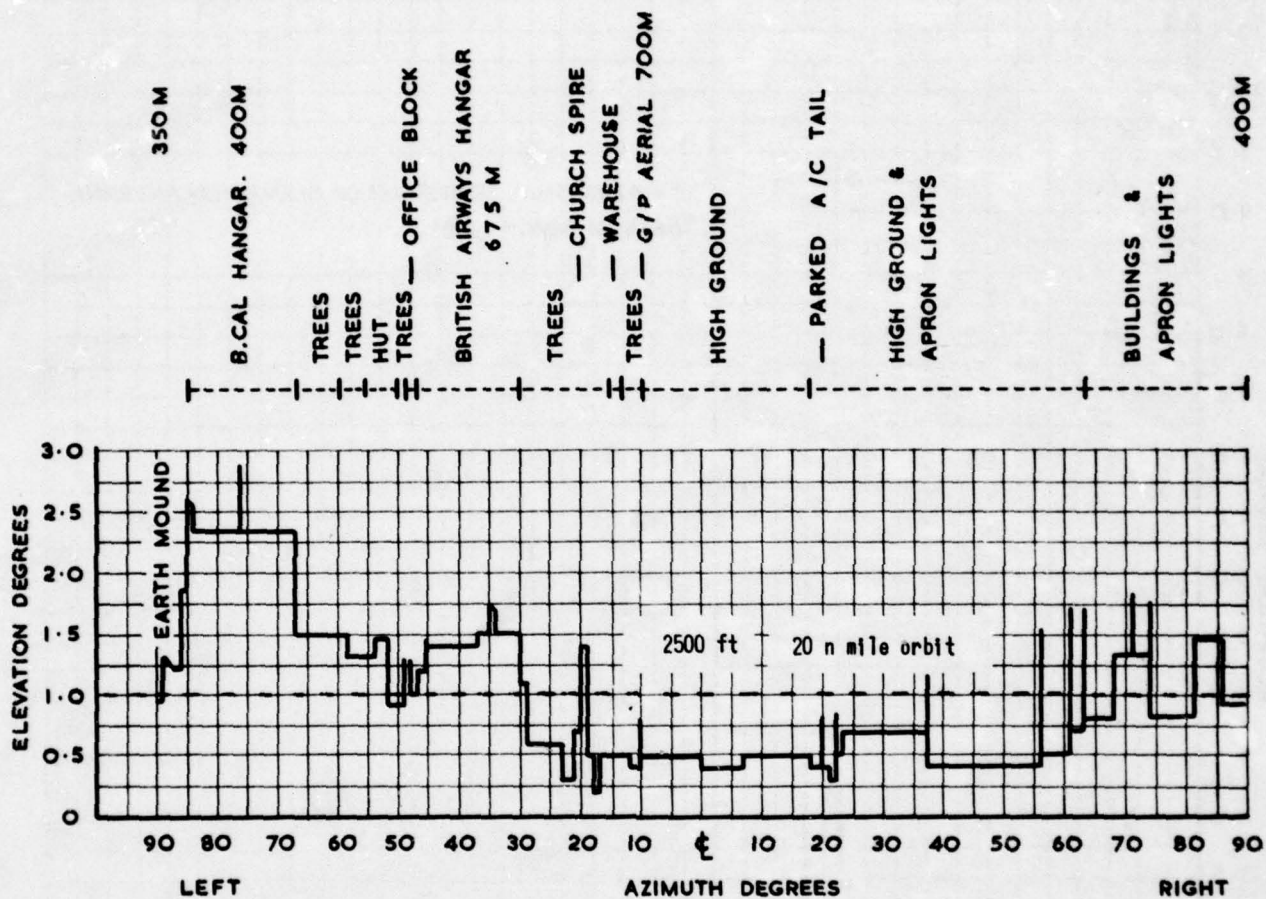
0° = RUNWAY CENTRELINE and AZIMUTHAL BORESIGHT OF AZIMUTH ANTENNA
 Theodolite height = 1.42M

Fig 6a London (Gatwick) Airport, runway 08, DMLS azimuth site — horizon profile

and elevation sites are given in Fig 6a&b. The height profile under the approach path is given in Fig 7.

The loss of signal and flag at 0° is caused by the ground reflected signal nulling the real or wanted signal. The wanted signal was already very small and the receiver could not withstand this apparent small loss in the signal, and lost the function identity code (Fig 25a). The gap at $+20^{\circ}$ is probably due to shadowing by the church spire shown in Fig 6a.

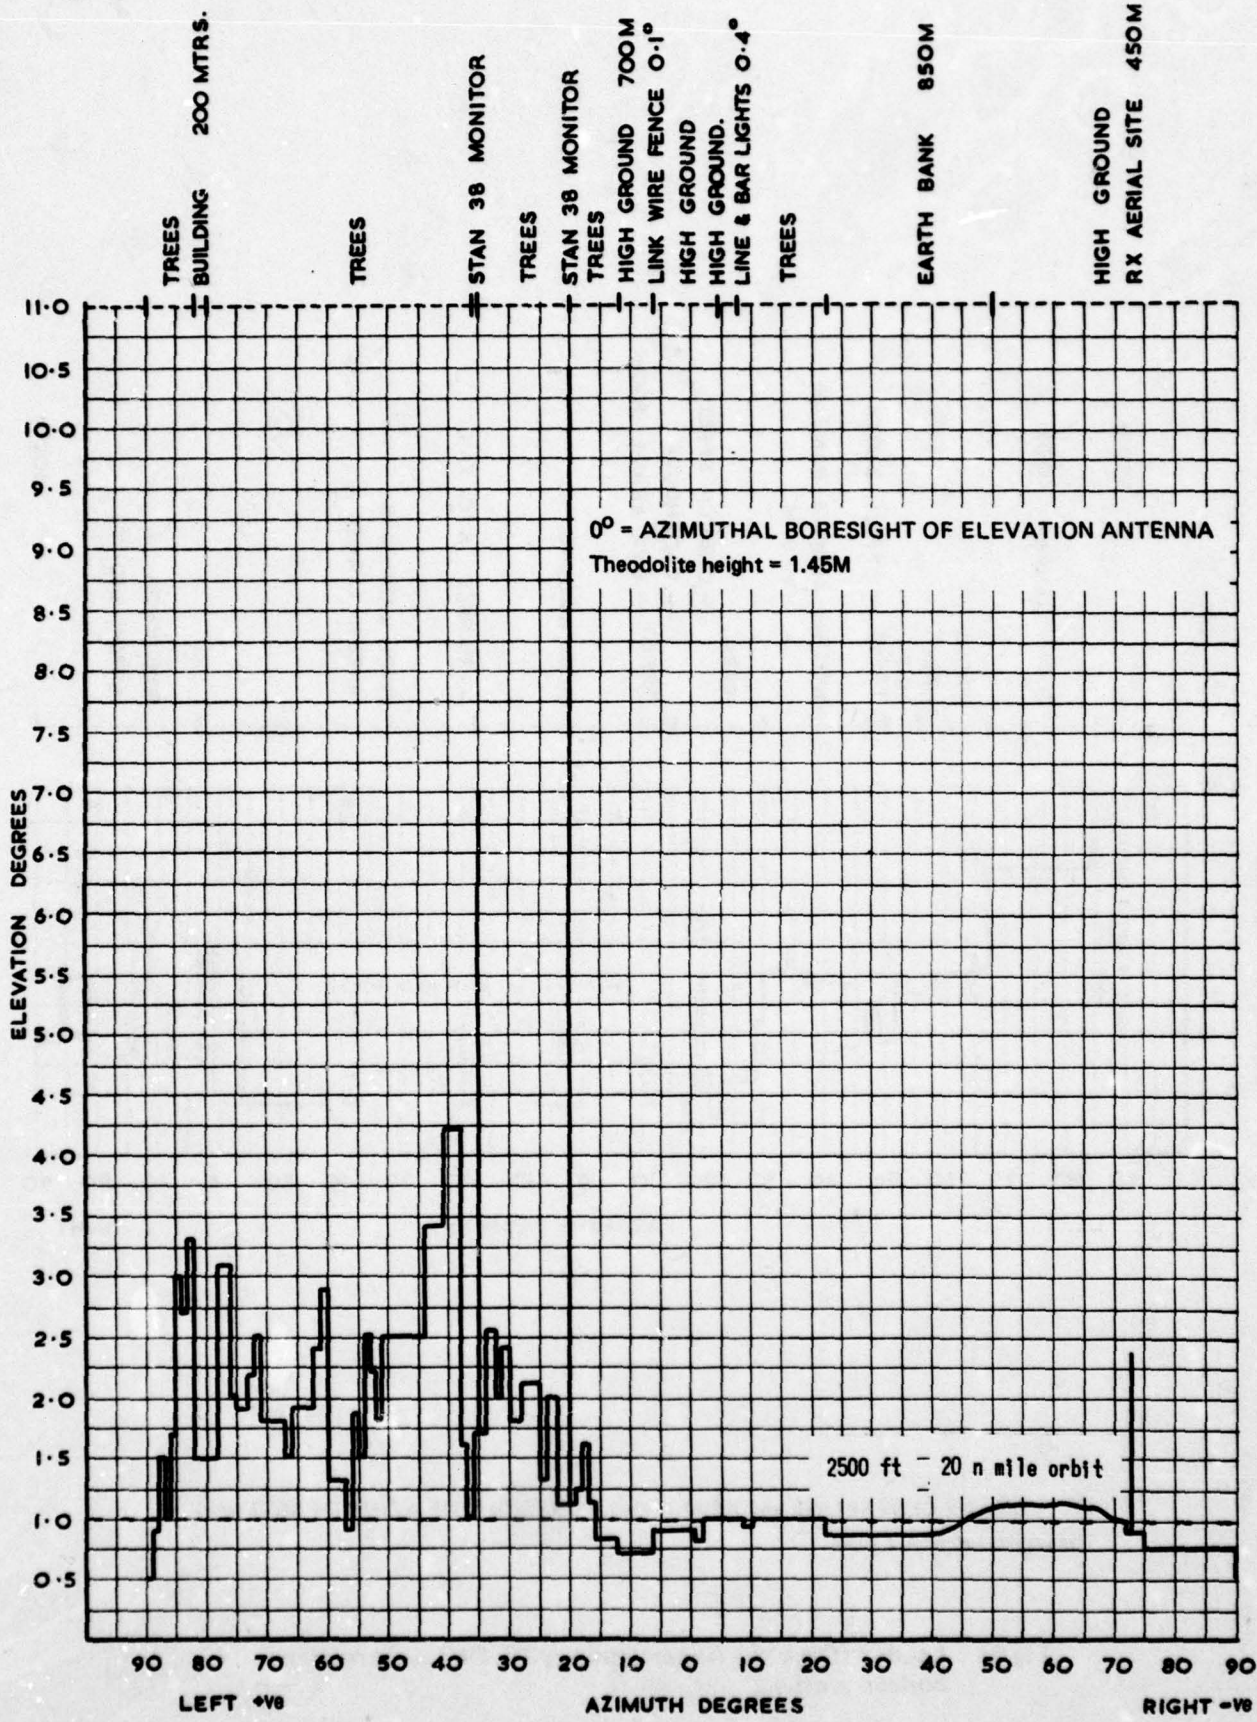
Fig 6b London (Gatwick) Airport, runway 08, DMLS elevation site - horizon profile

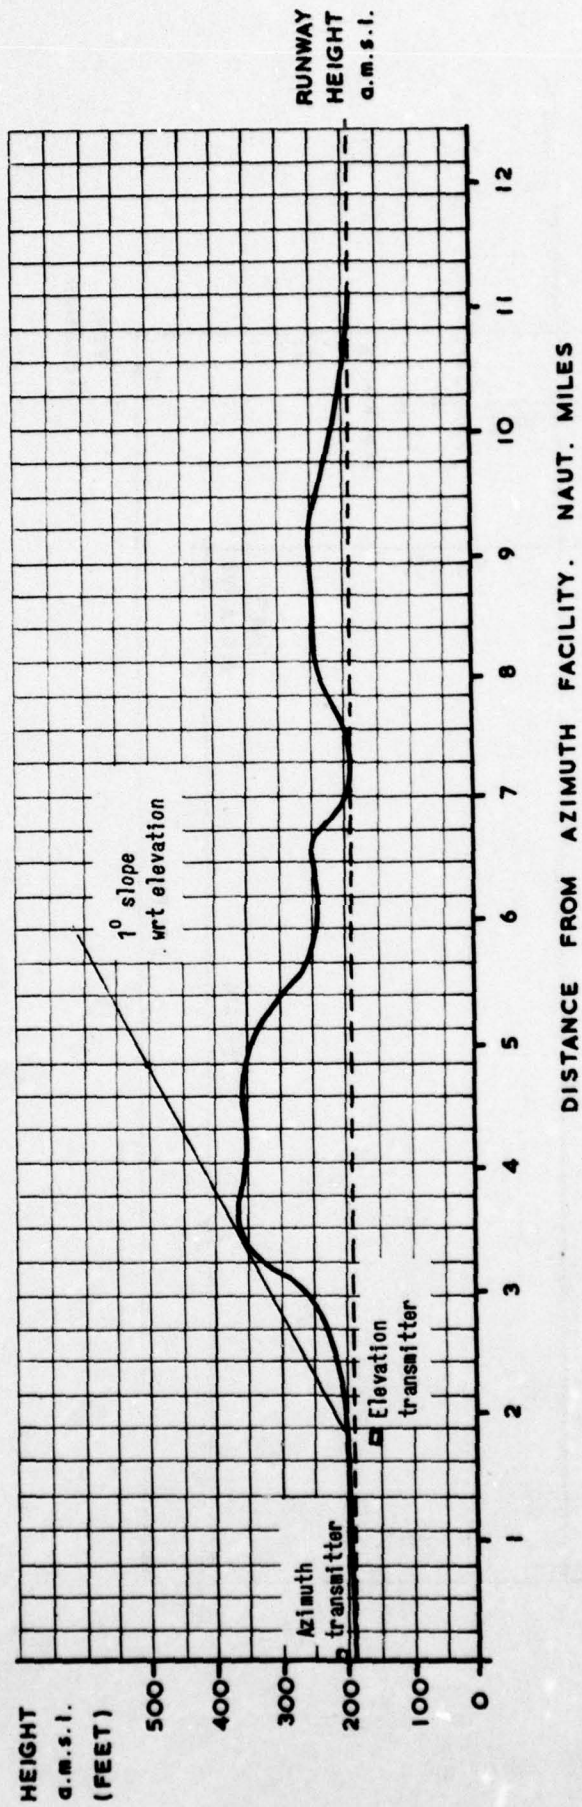
Fig 7 Extended centre line ground profile

exceeded these limits but in particular this run (Fig 17b) showed a higher noise content and long period bends at ranges greater than 1 n mile from threshold, which can be attributed to the rising ground profile on the approach path. This gave rise to ground reflections with small separation angles, 1° or less as shown on Fig 7.

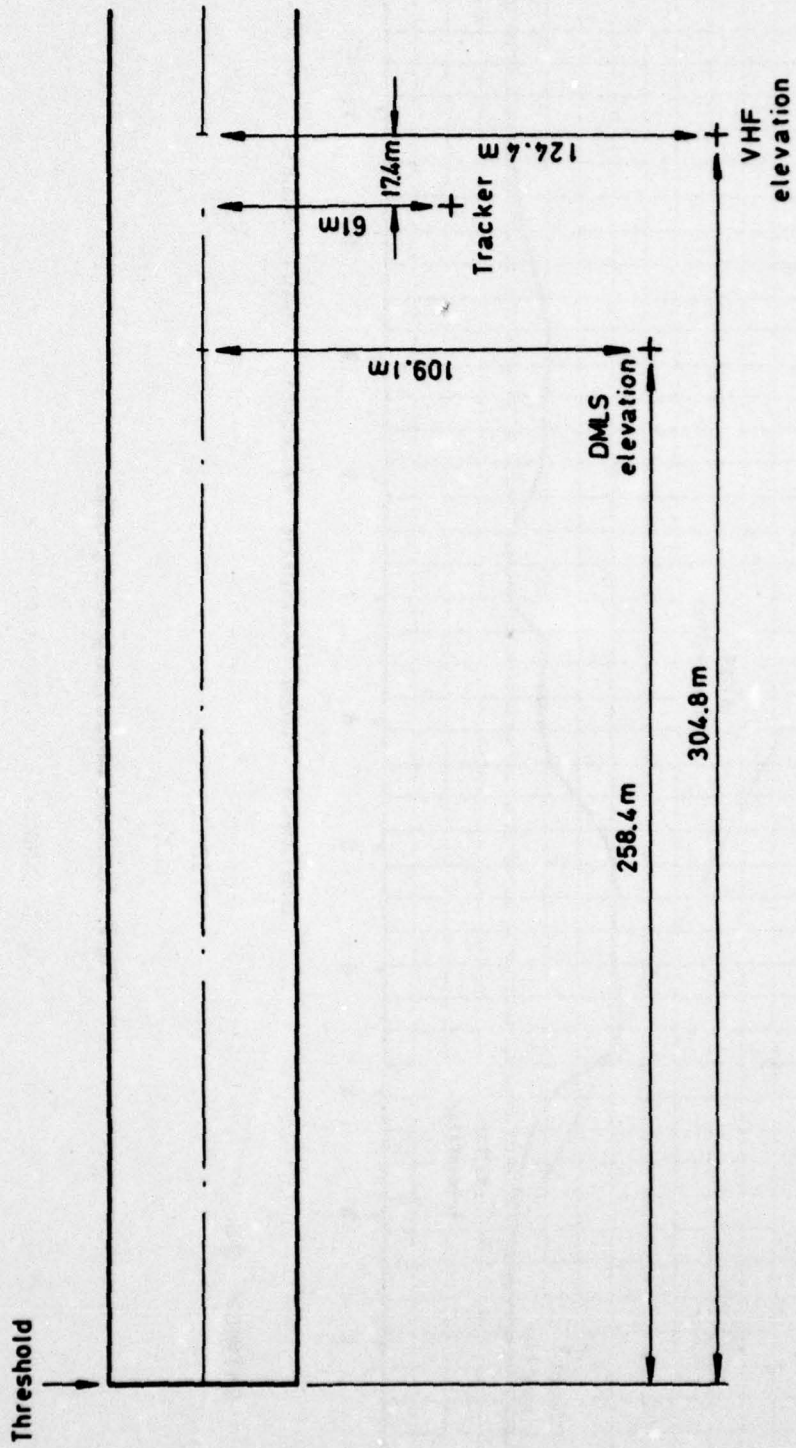
Fig 8a Plan of elevation siting

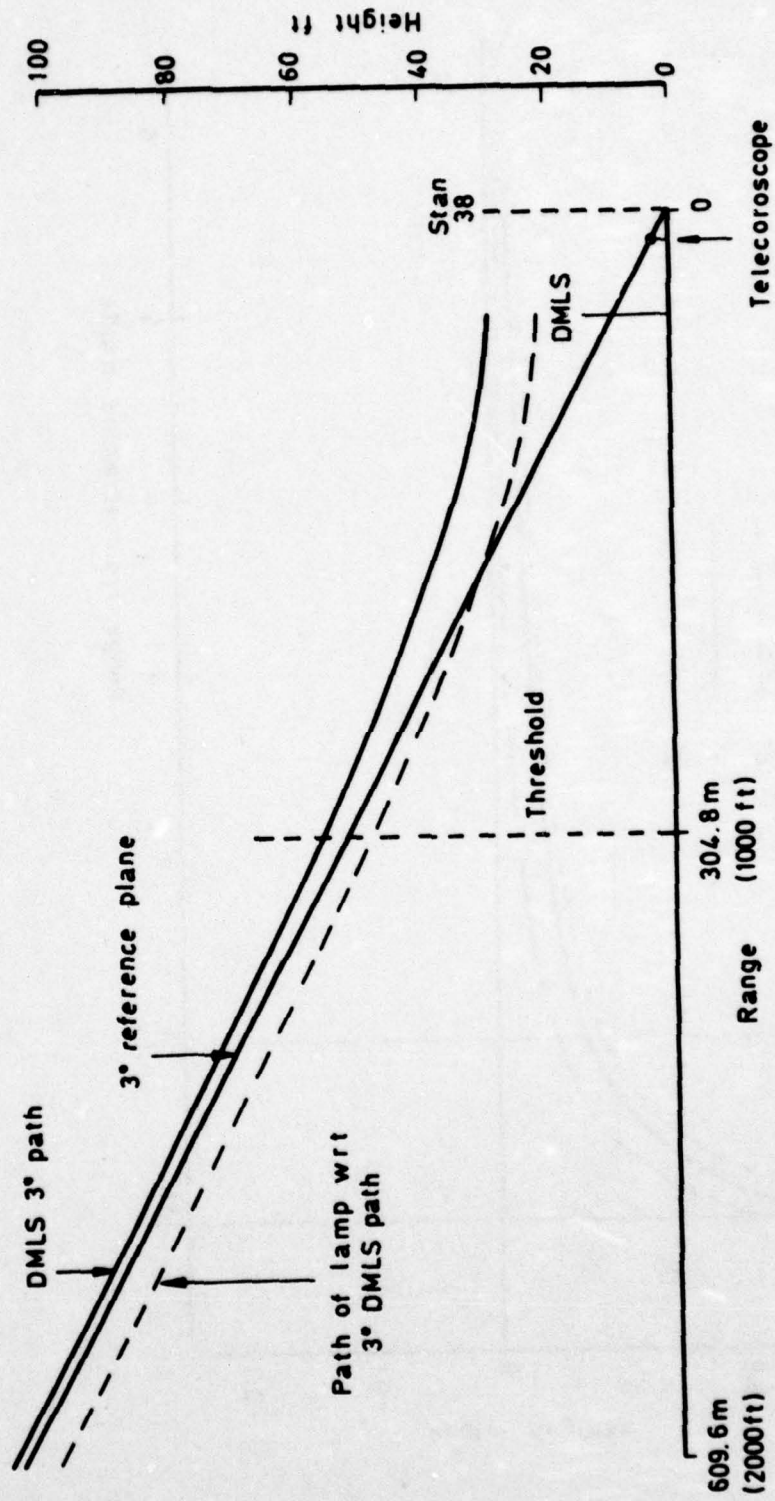
Fig 8b Short range elevation geometry

For elevation tracking the Telecroscope was mounted close to the runway edge (to keep the aircraft within the optical azimuth field of view of $+11^\circ$ at short ranges) and at such a distance from threshold as to put the optical head in the continuation of the 3° glidepath plane. The relative position of the tracker is shown in Fig 8a and the short range geometry relative to the DMLS and ILS systems in the vertical plane containing the runway centreline is shown in Fig 8b, from which the following points should be noted:

The nominal UHF ILS glidepath is taken as a 3° line from the base of the antenna mast. Whilst this is correct for far field matching, the path is distorted at short ranges, but no accurate information on performance within the range of runway threshold is available. It should be recognised that the UHF glidepath has conical geometry like DMLS, but the actual UHF antenna is normally phased to give a near linear path over the runway centreline.

The DMLS antenna was sited so as to put the ILS 3° reference line through the phase centre of the array.

As the Telescopescope has to be near the runway edge to get maximum tracking coverage at short ranges it must be low down and is also sited on the 3° reference line.

Due to the conical symmetry of a phased array and the offset from the runway the DMLS 3° code path, at short range over the runway, is hyperbolic and will lie above the 3° reference line.

On the Andover aircraft, the tracking lamp is situated about 2.29 m below the DMLS antenna and about 2.44 m in front, so that the path described by the lamp is generally below the 3° DMLS reference line until inside threshold.

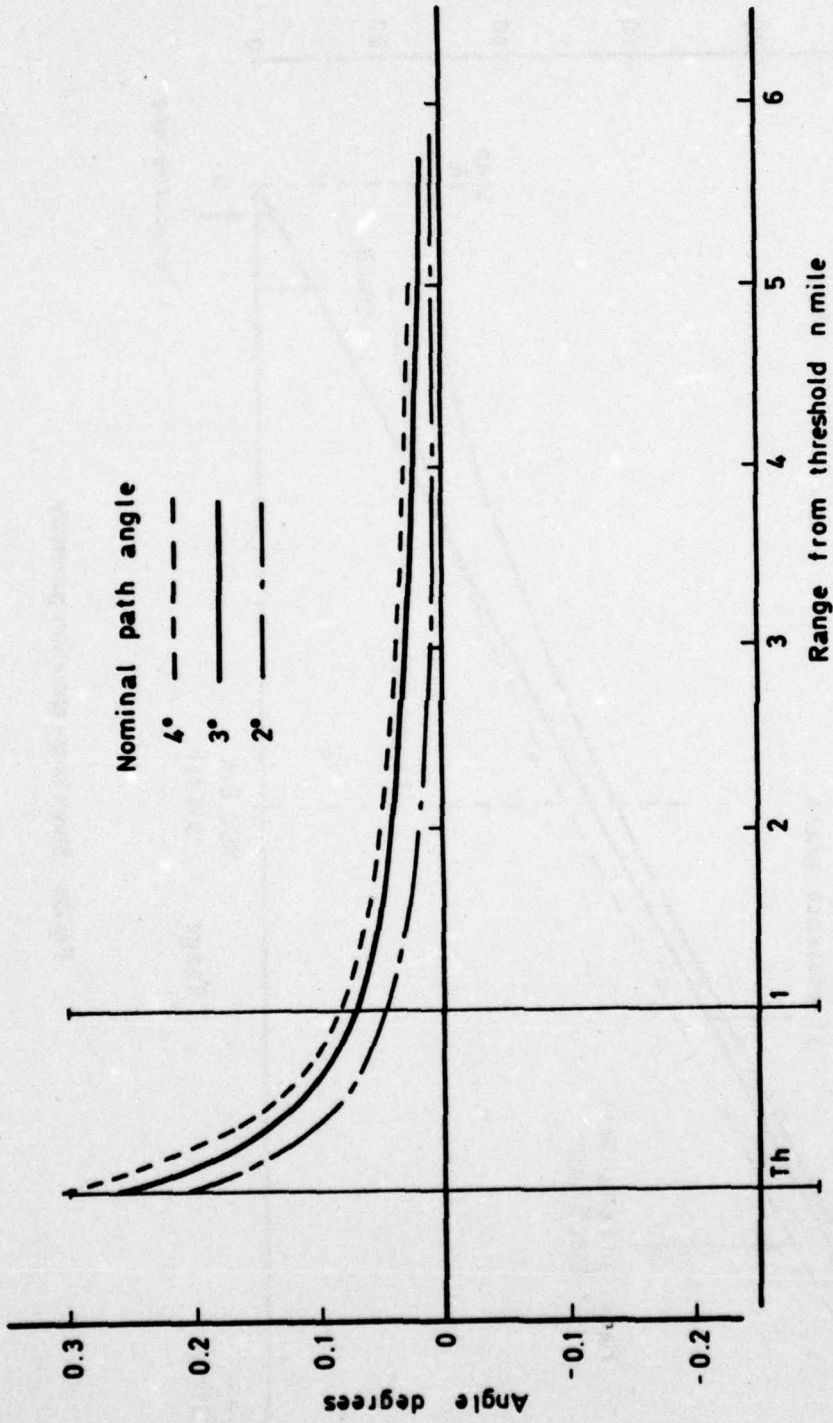
Fig 8c Error curves due to tracker geometry

The net result on a 3° approach is for an increasing positive error to show as the range decreases, which is to some extent compensated by the hyperbolic geometry of MLS at short ranges. The predicted error curves derived from the above geometry are shown in Fig 8c.

These curves are derived using the following formula:

$$\text{predicted error} = \theta_D - \tan^{-1} \left[\frac{\tan \theta_D \sqrt{(\ell + X)^2 + Y^2} + h_p - h_{at}}{(L + X)} \right],$$

- where θ_D = Doppler angle
 X = aircraft range to threshold
 L = distance from tracker to threshold
 ℓ = distance from elevation transmitter to threshold
 Y = distance from elevation transmitter to centreline (offset)
 h_p = height of phase centre of transmitter
 h_{at} = height difference between tracking lamp and MLS aerial added to the height of tracker from ground.

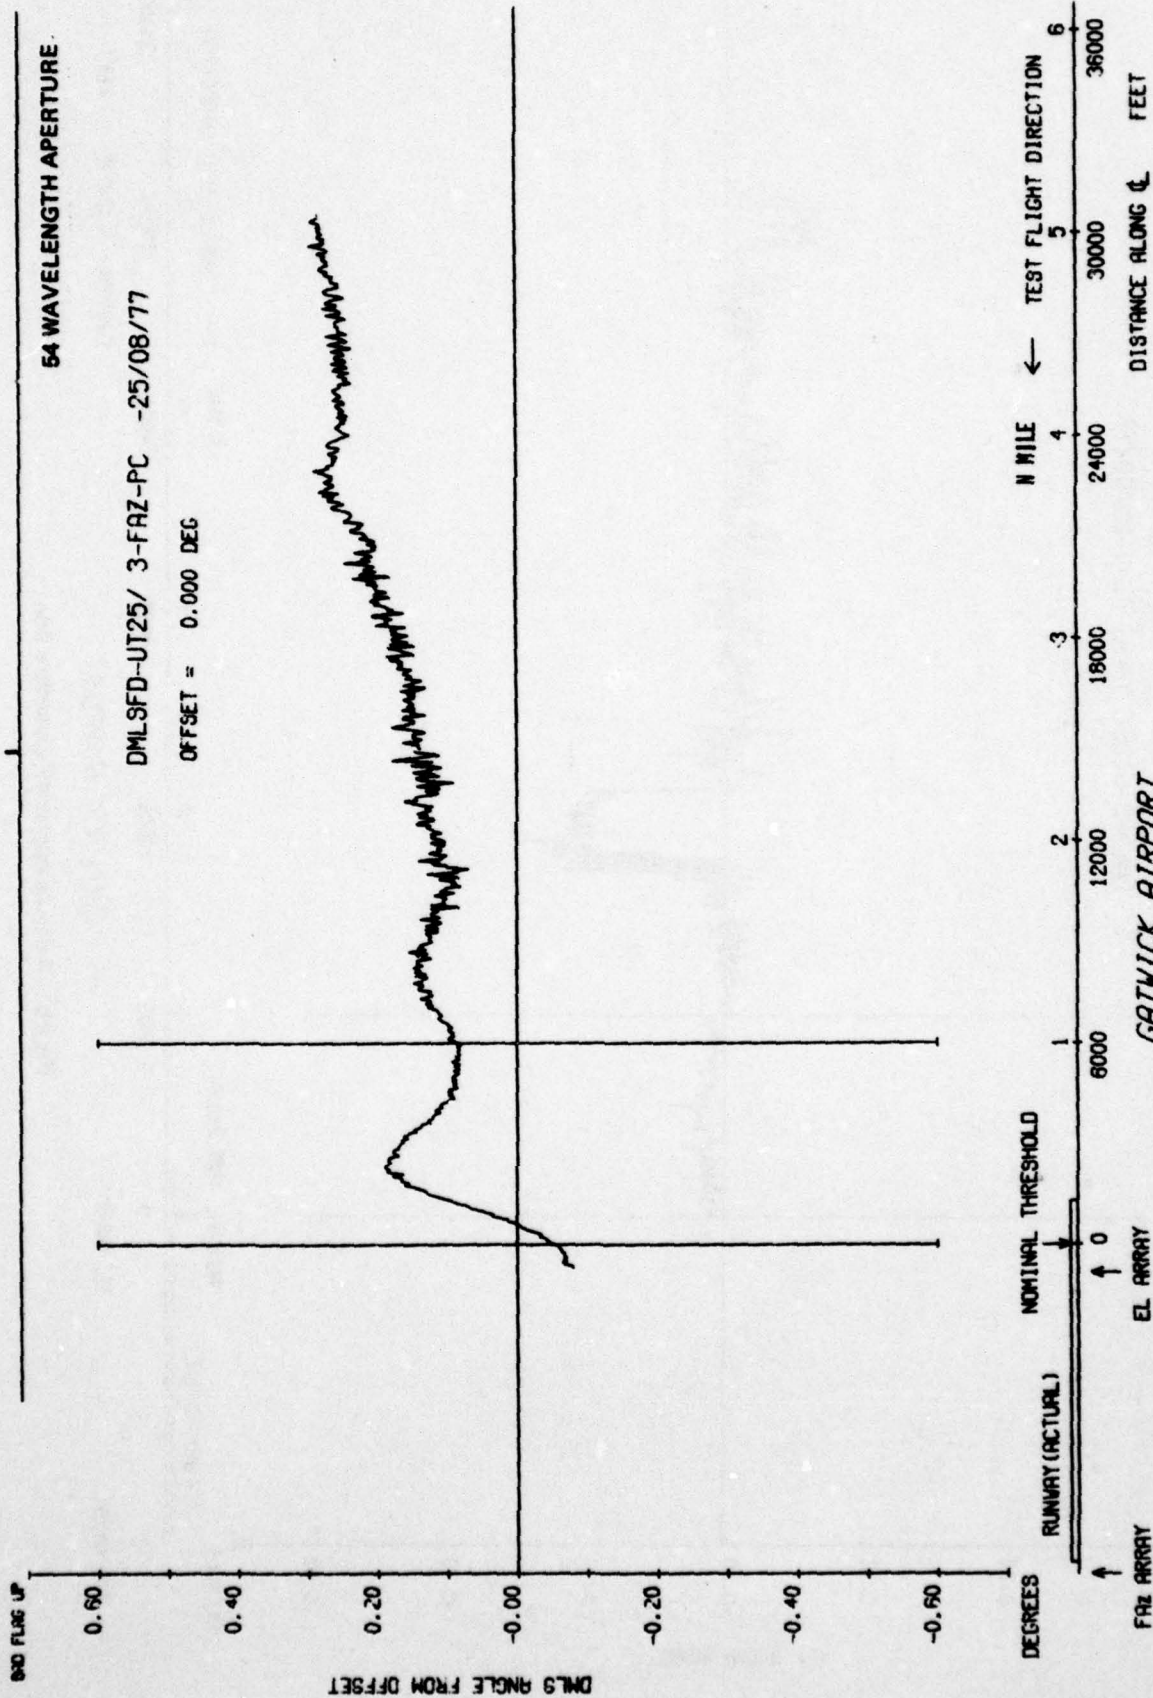
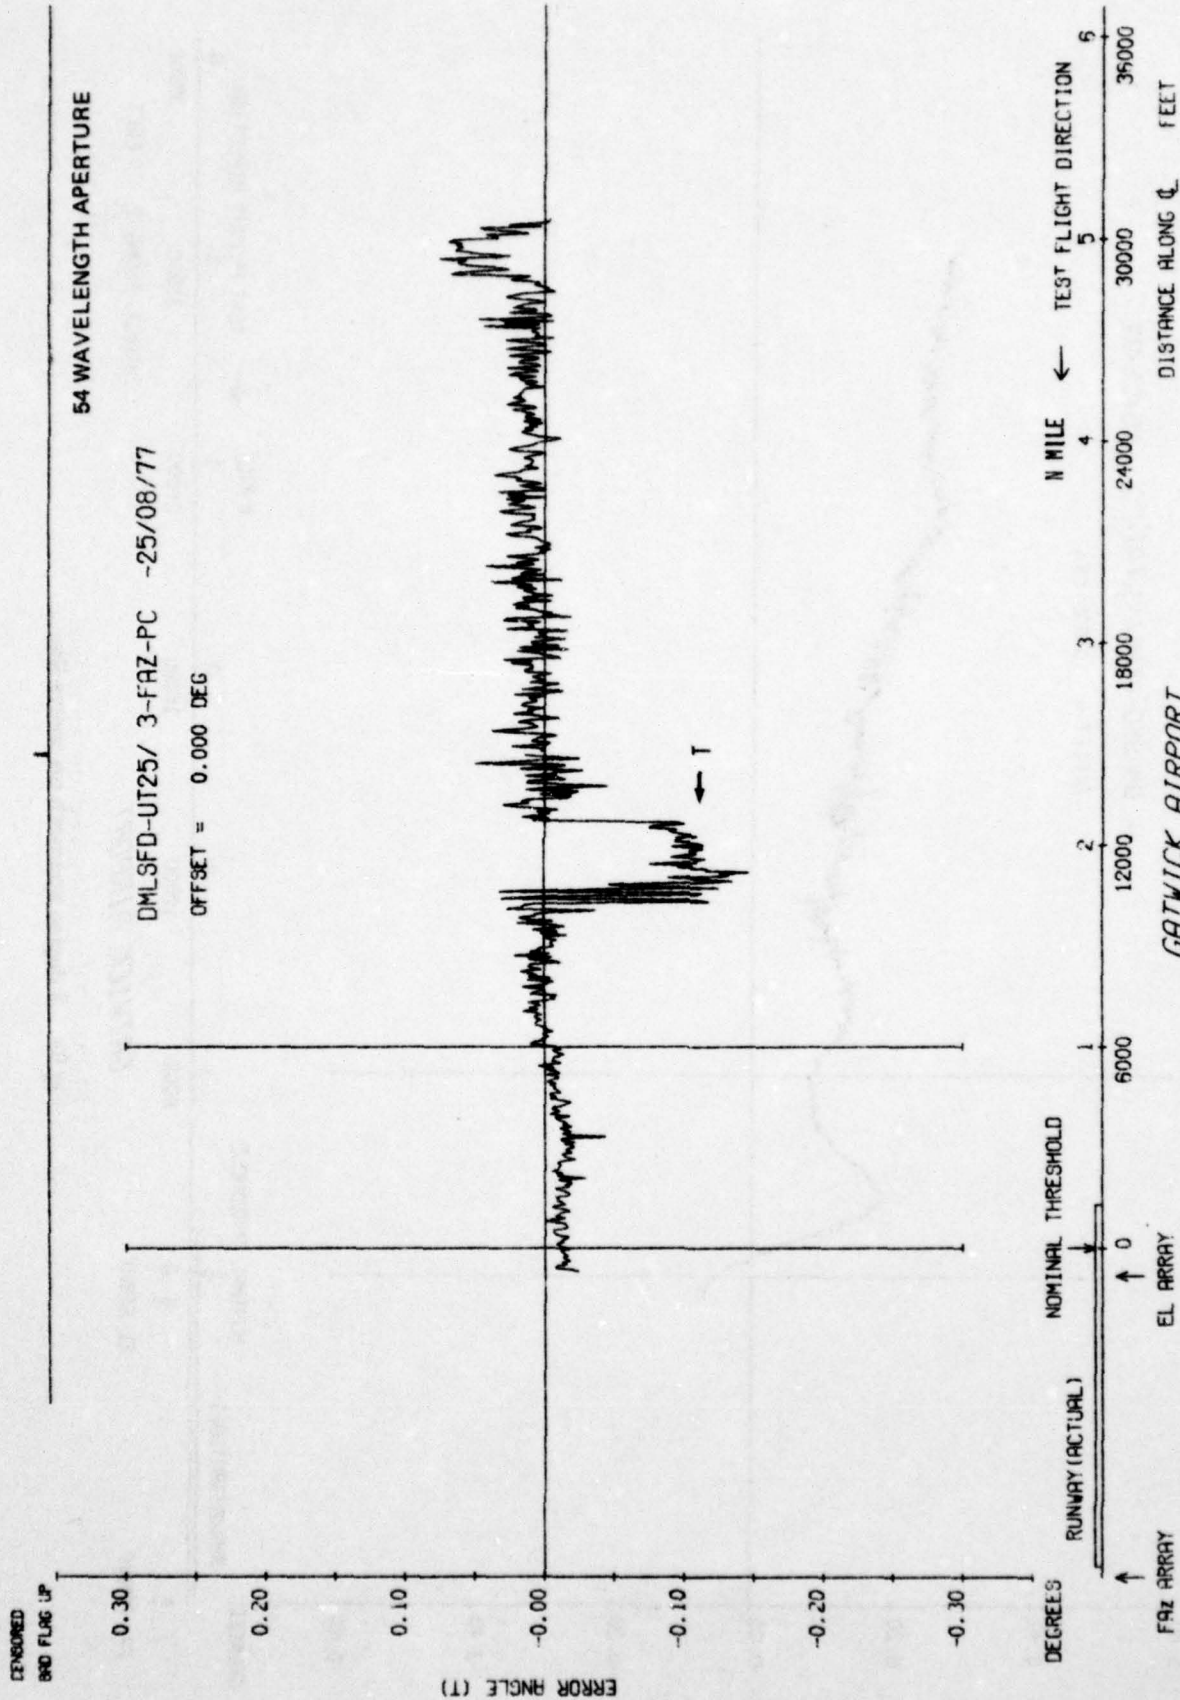
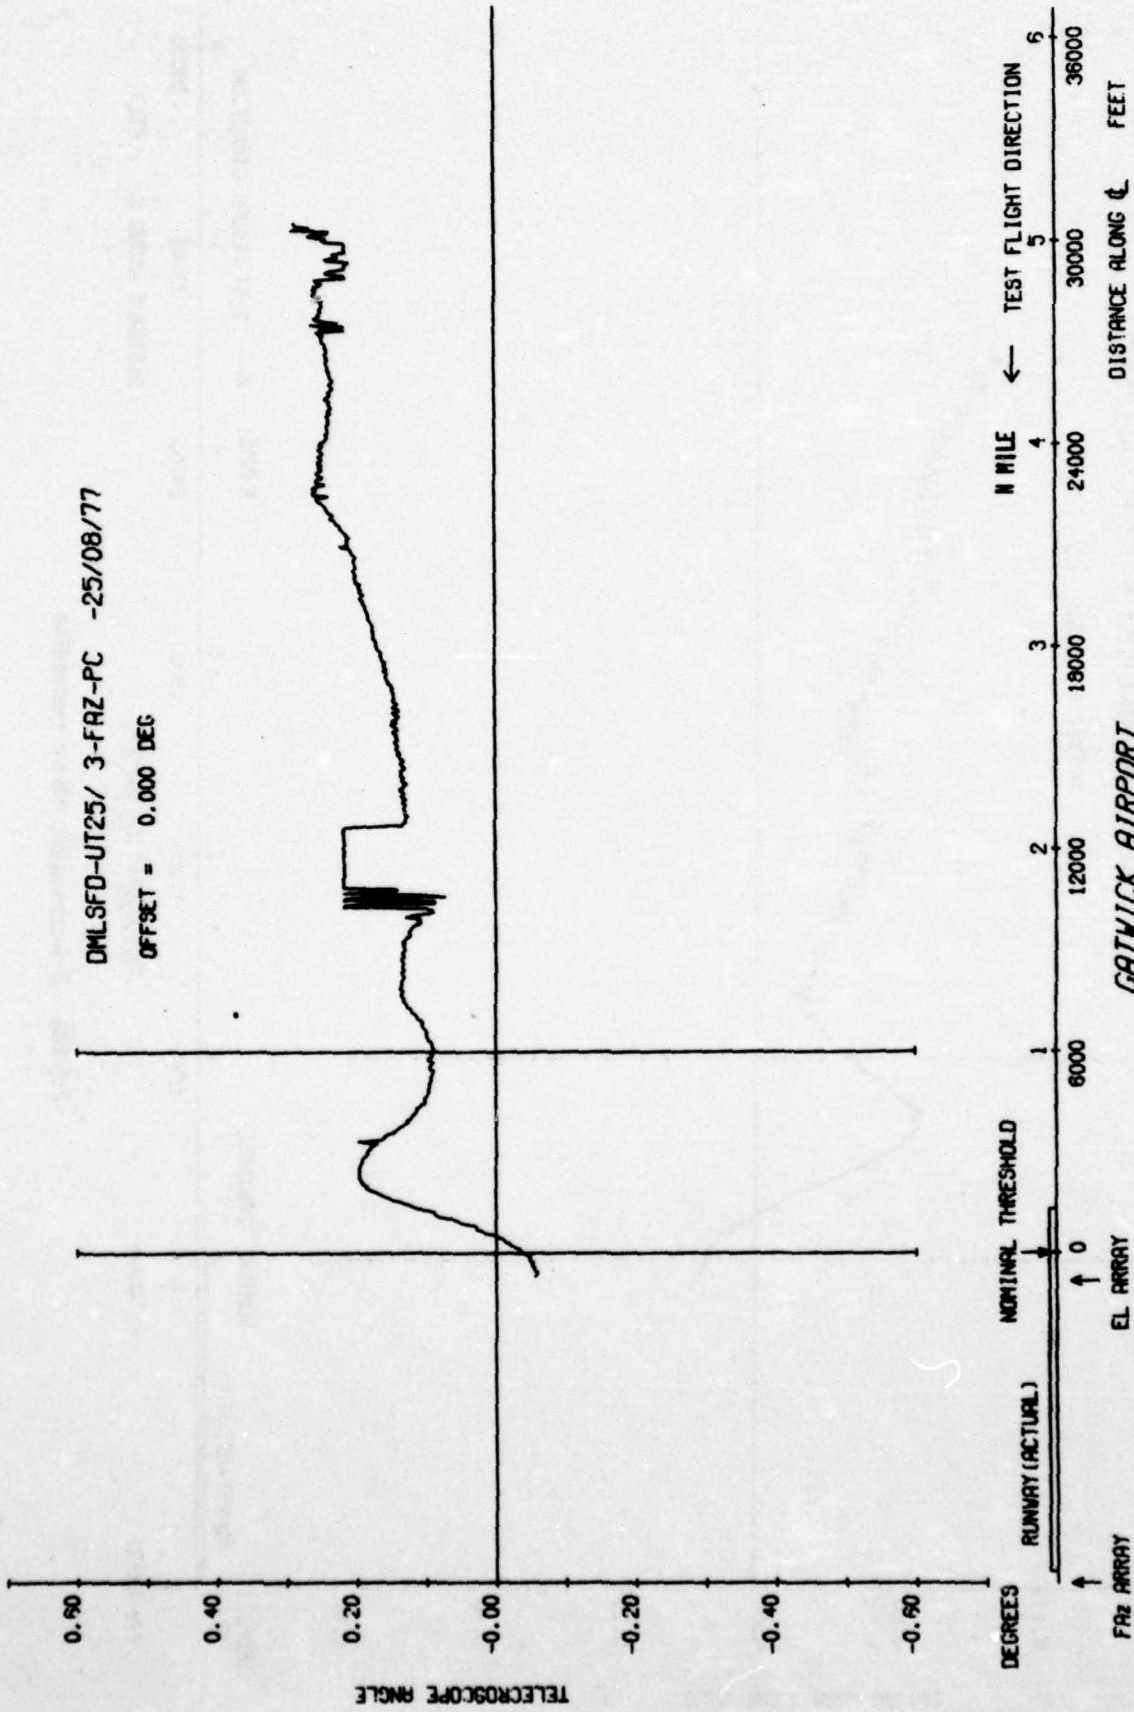
Fig 9a 3 degree approach on centre line

Fig 9b 3 degree approach on centre line

Fig 9c 3 degree approach on centre line

Run 3 (Fig 9a-d). This was the first tracked azimuth run. Both transmitters were in the 54λ mode and the azimuth noise level was approximately 0.02° peak to peak at ranges less than 1 n mile. This increased to a maximum of 0.08° peak to peak at about 2.5 n mile, this is attributed to signals being reflected from the rising ground about 1 n mile from threshold on the extended centreline. The ground has a maximum up slope of 2.8° and subtends a maximum angle of 0.5° to the azimuth transmitter. The Telecroscope tracker suffered from drop-outs due to loss of lock on the aircraft lamp. Where this occurred the error traces were hand censored, Fig 9c shows typical Telecroscope dropouts.
