Technical Report 78124

**TRIALS OF THE
DOPPLER MICROWAVE LANDING SYSTEM
AT LONDON (GATWICK) AIRPORT,
AUGUST 1977**

SUMMARY

The trials of the Doppler Microwave Landing System (DMLS) at Gatwick formed part of a series conducted at operational airports to collect data for the ICAO evaluation programme.

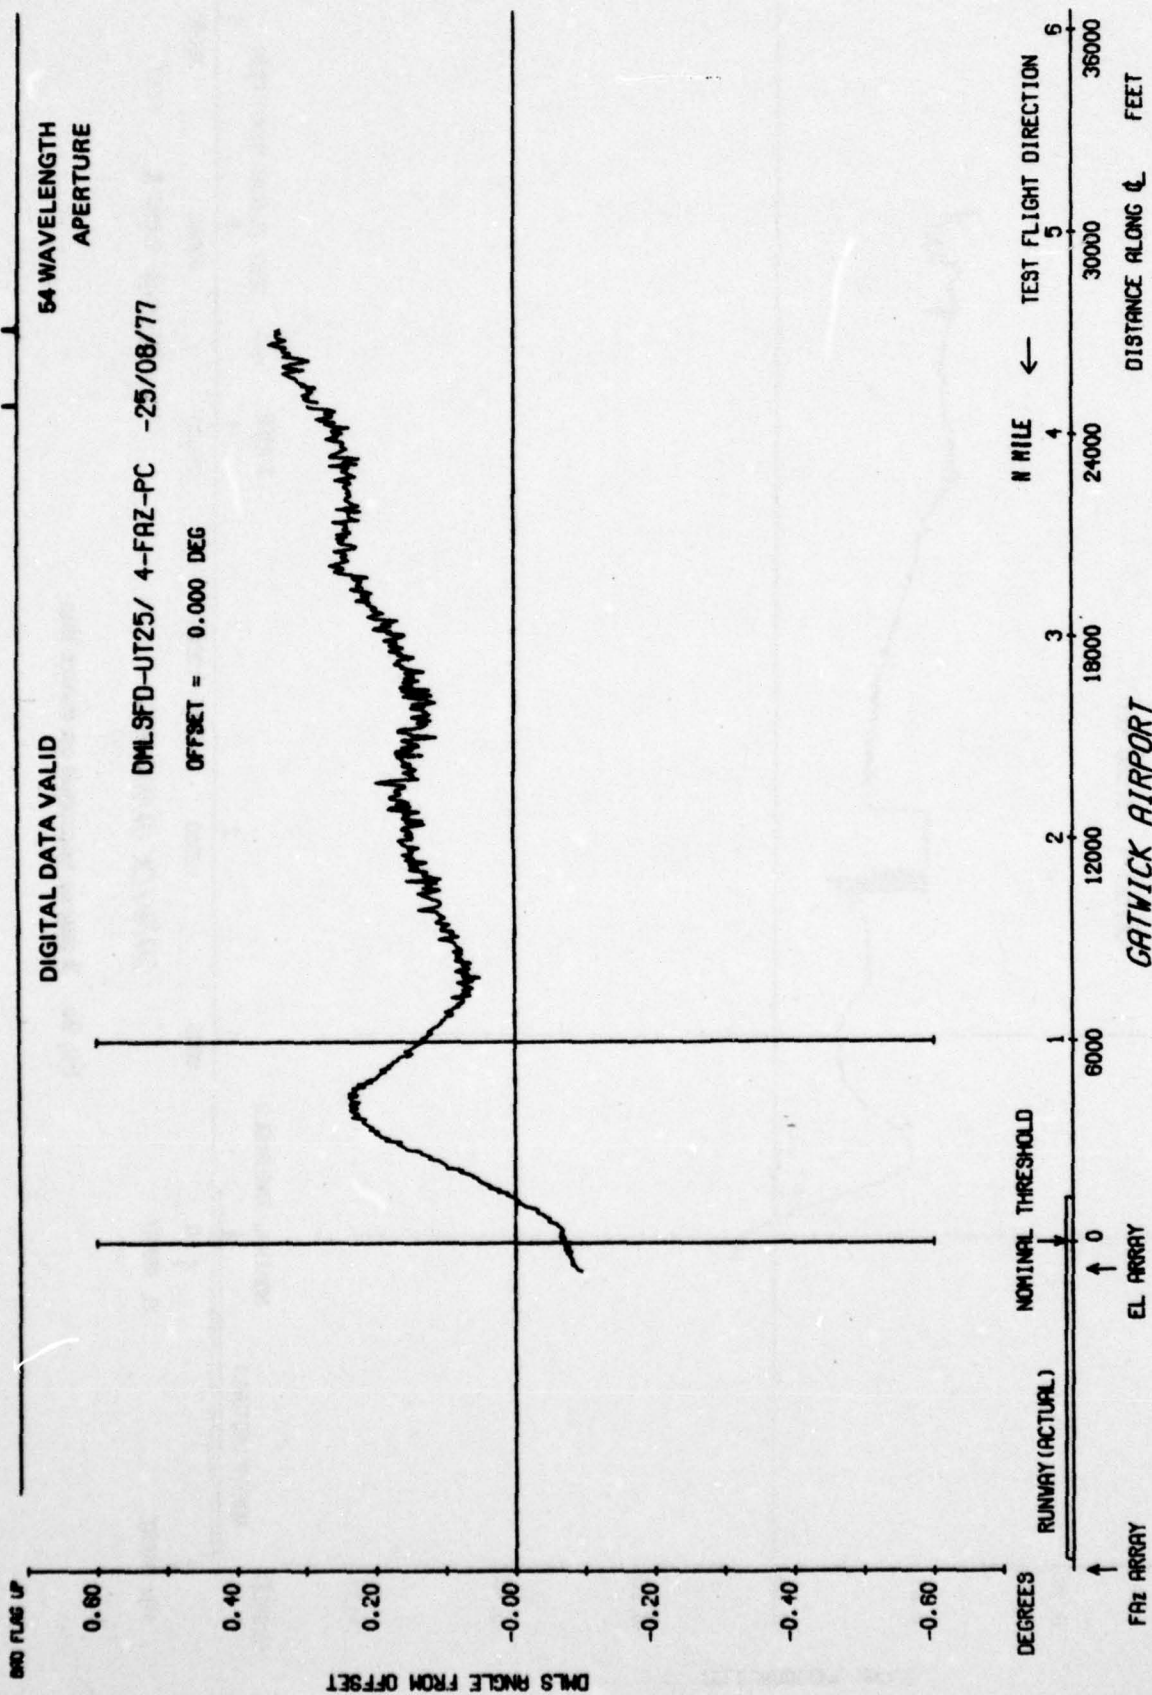
Fig 10a 3 degree approach on centre line

Run 4 (Fig 10a,b). This run, as Run 3, was tracked from 5 n mile and is again quiet at ranges less than 1 n mile, but shows an increase in noise at greater ranges, peaking at about 2.5 n mile. Again the elevation was quiet throughout the run. Both transmitters were in the 54λ mode.

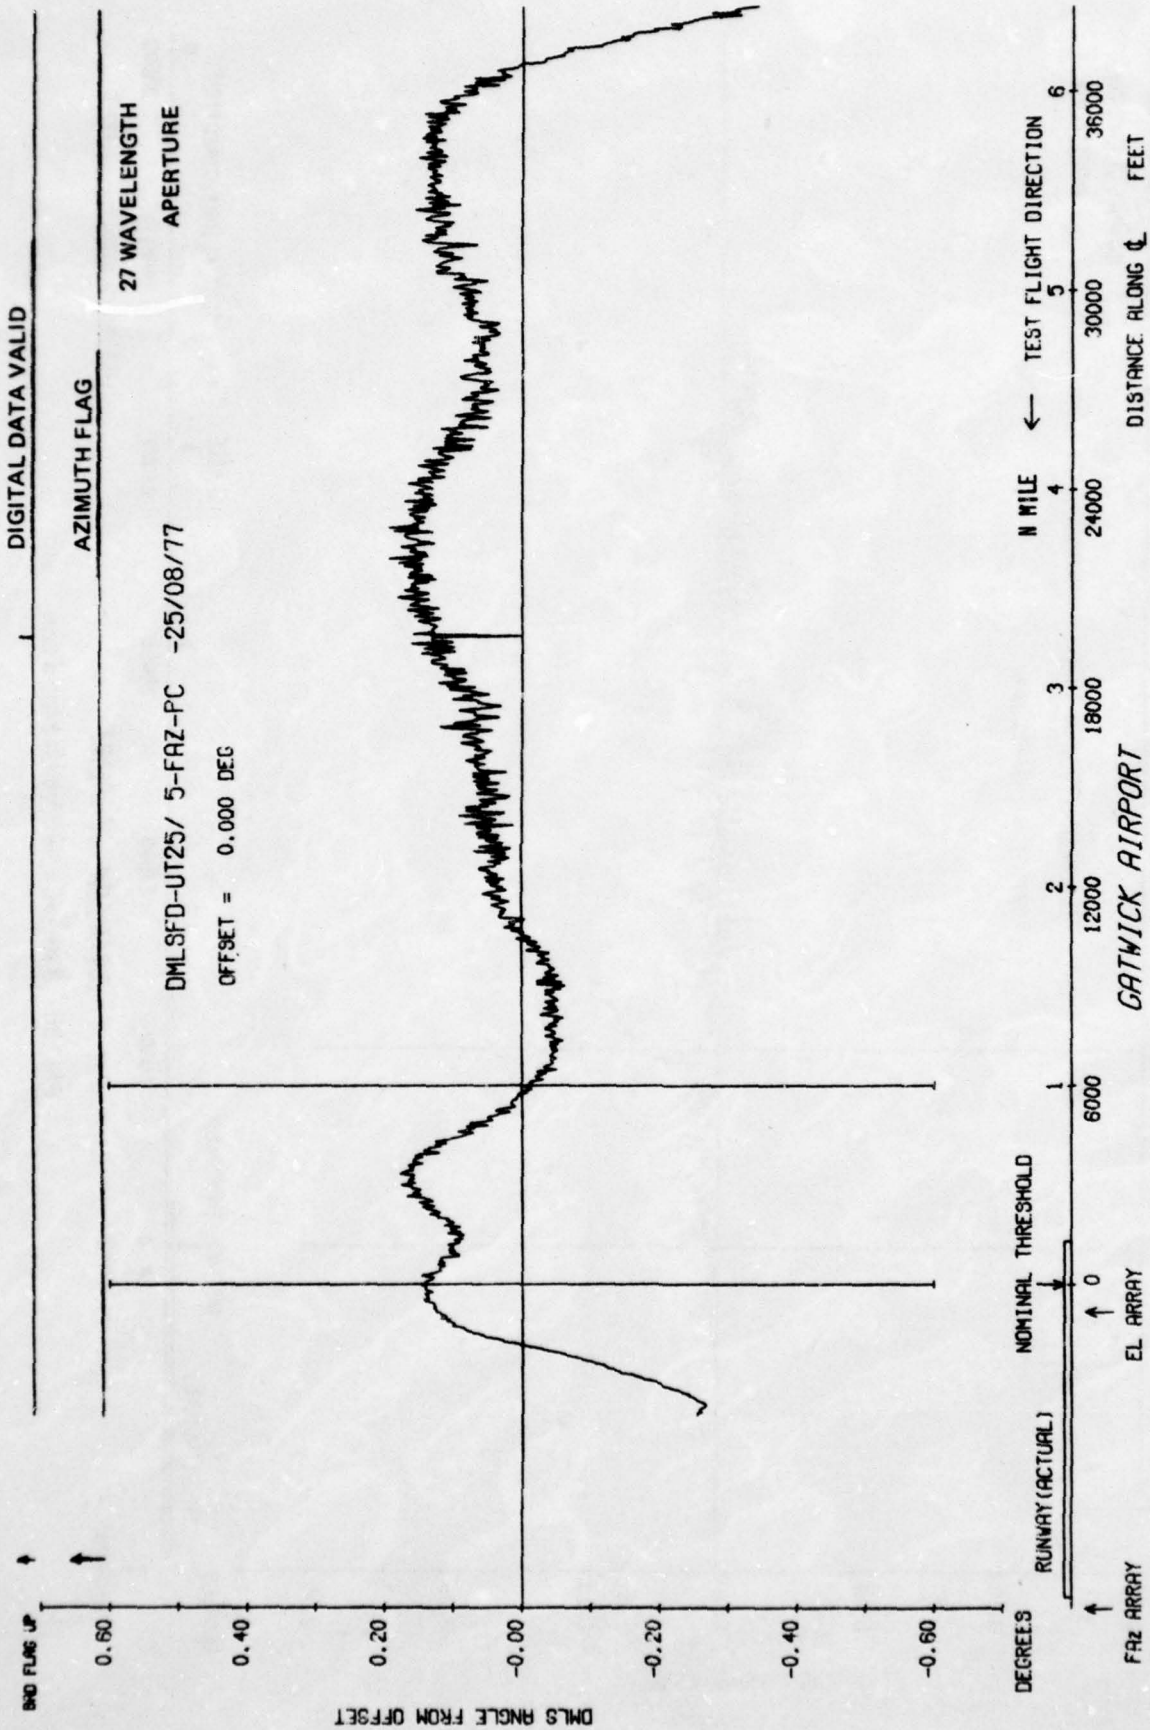
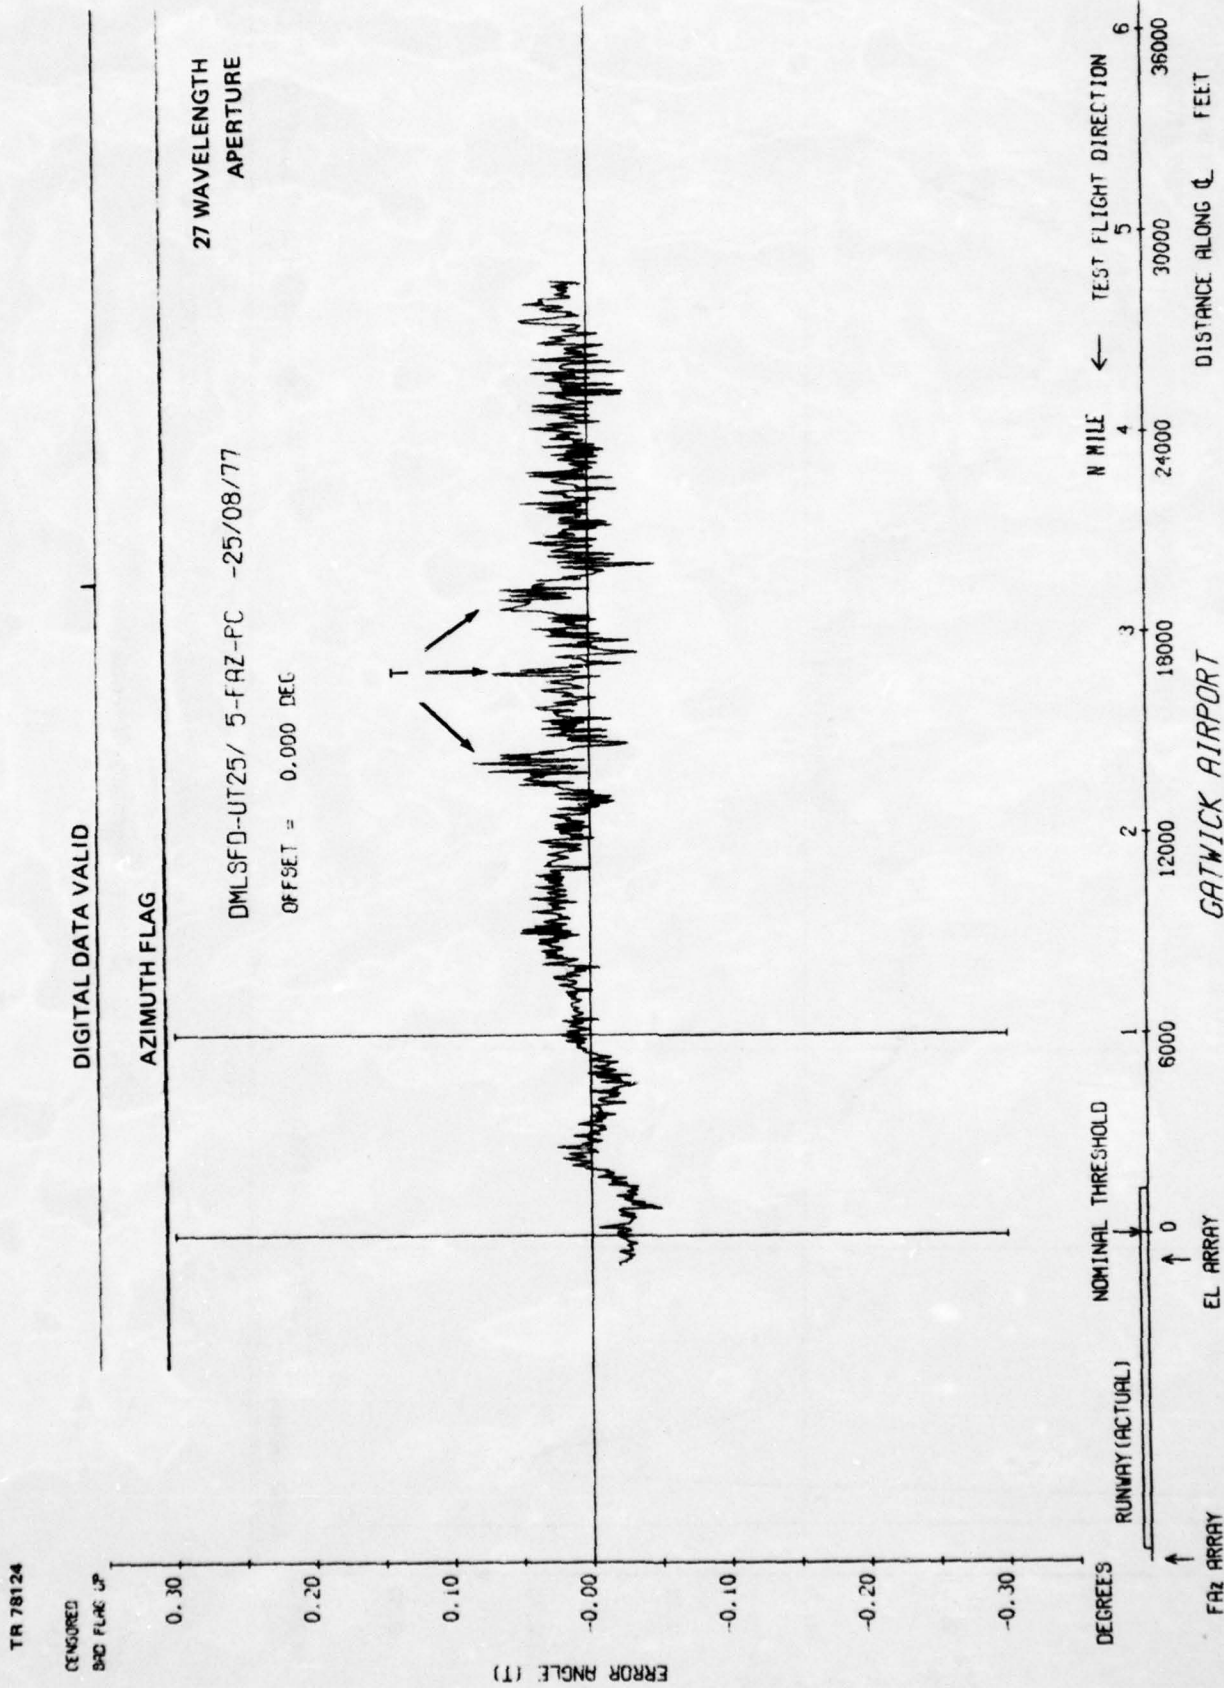
Fig 11a 3 degree approach on centre line

Fig 11b 3 degree approach on centre line

Run 5 (Fig 11a,b). During this run the azimuth was in the 27λ mode, and the noise was slightly greater, but did not increase in proportion to beamwidth. This again reached a peak at 2.5 n mile, but its amplitude is approximately 0.1° peak to peak. The tracker was locked at 5 n mile.

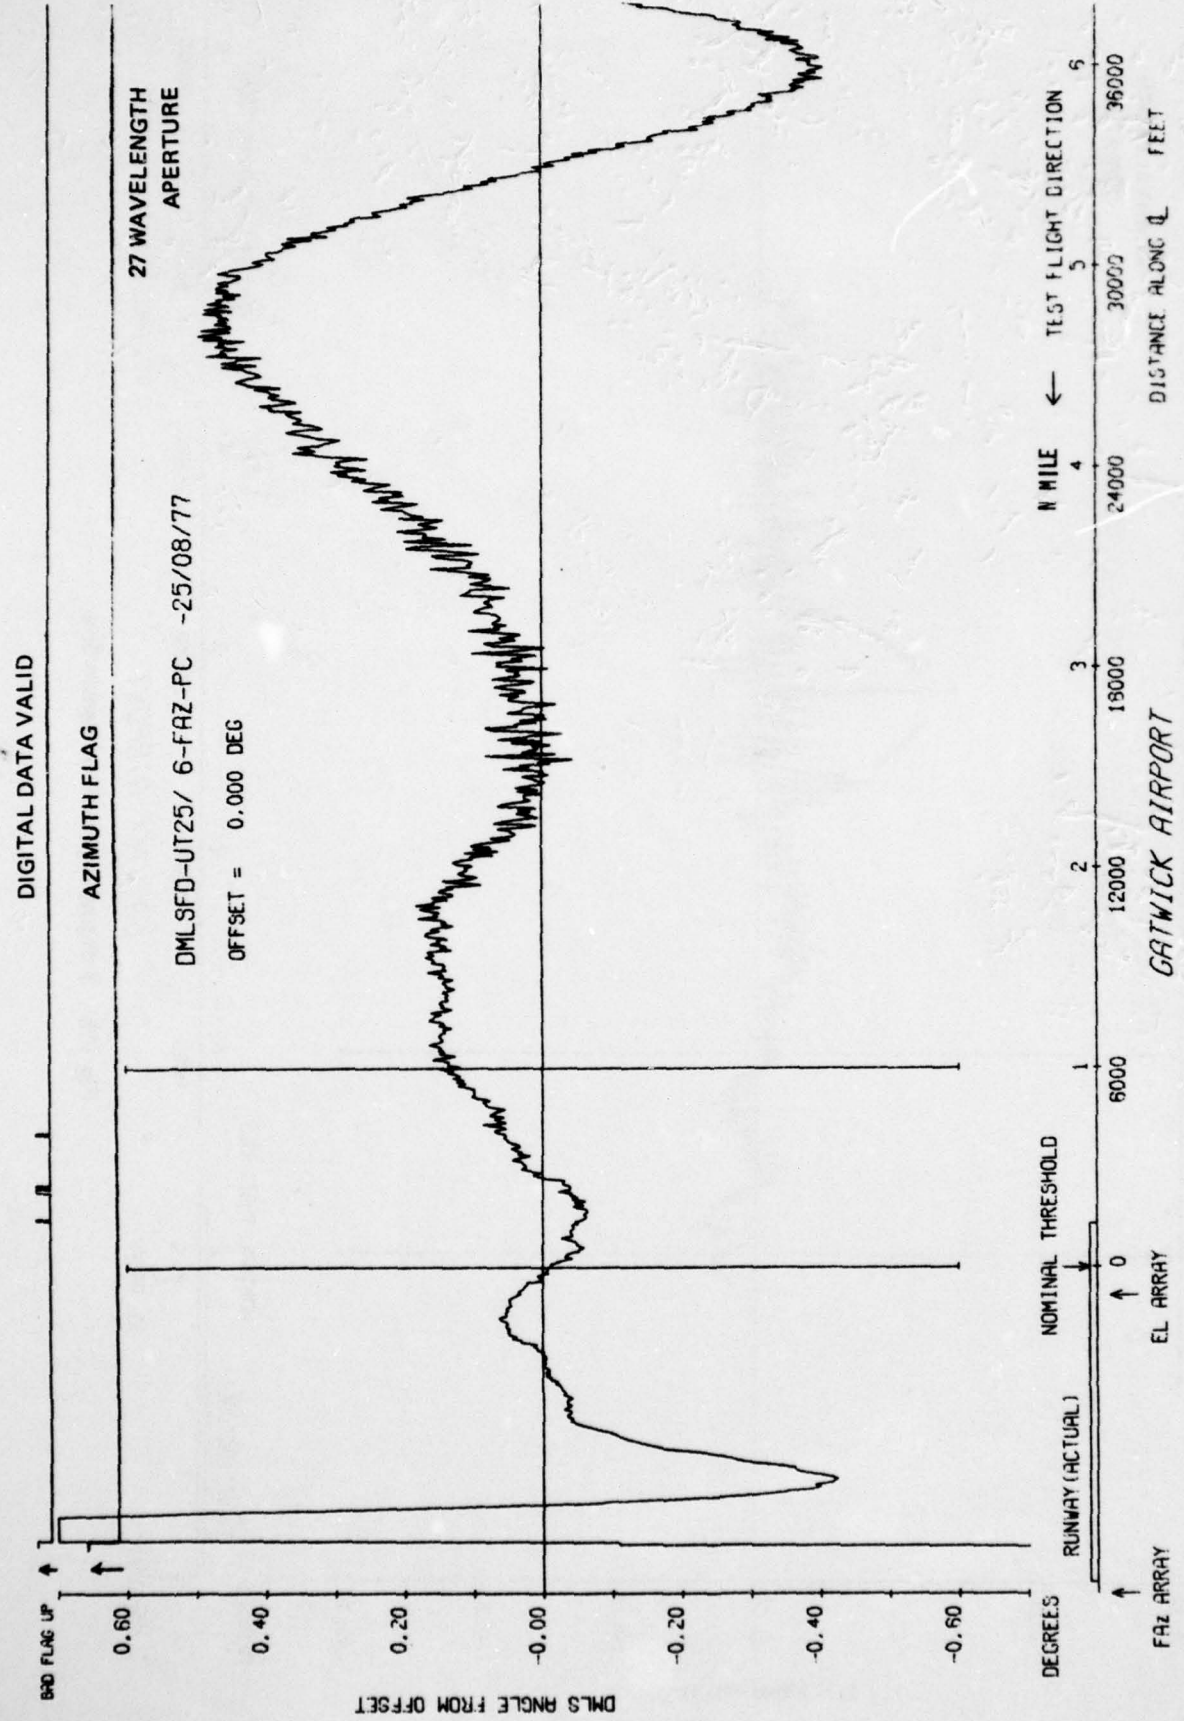
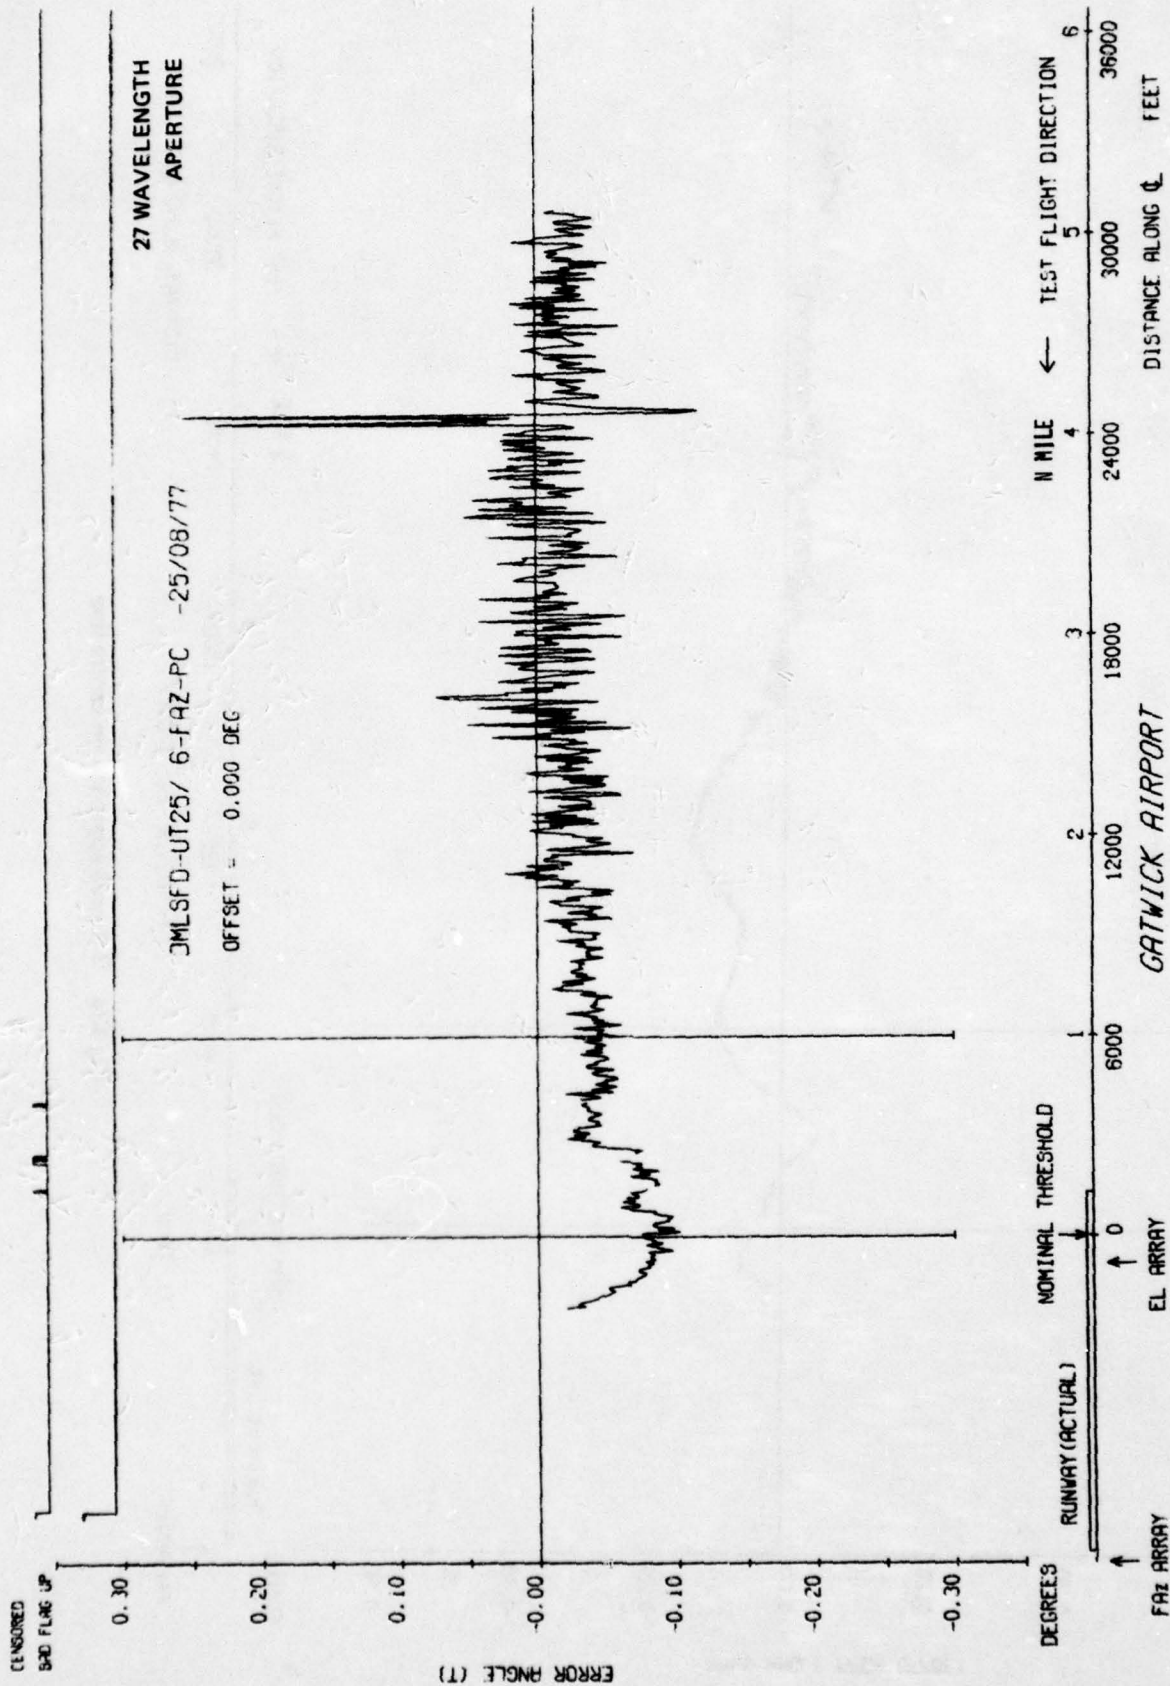
Fig 12a 3 degree approach on centre line

Fig 12b 3 degree approach on centre line

Run 6 (Fig 12a,b). Again the transmitter was in the 27λ mode and the noise level was somewhat greater than previously. At its worst it was about 0.12° peak to peak, generally twice as noisy as the 54λ mode.

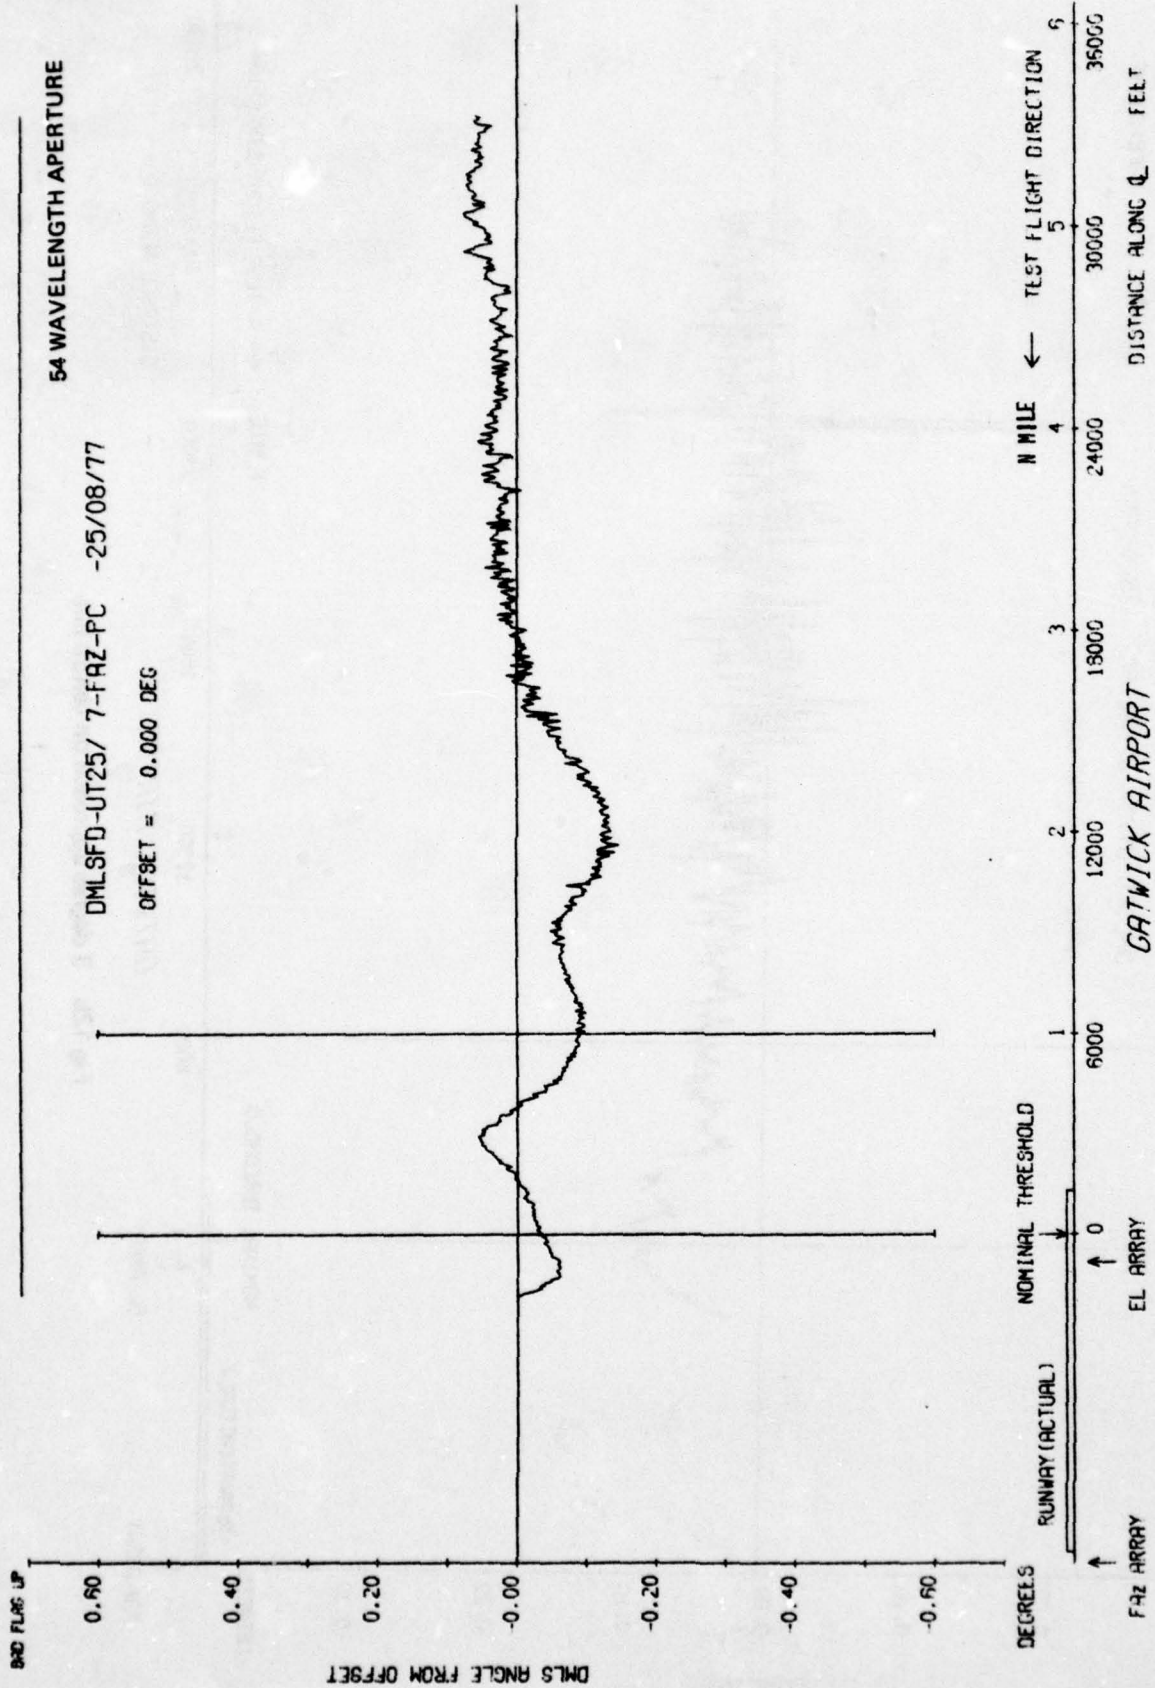
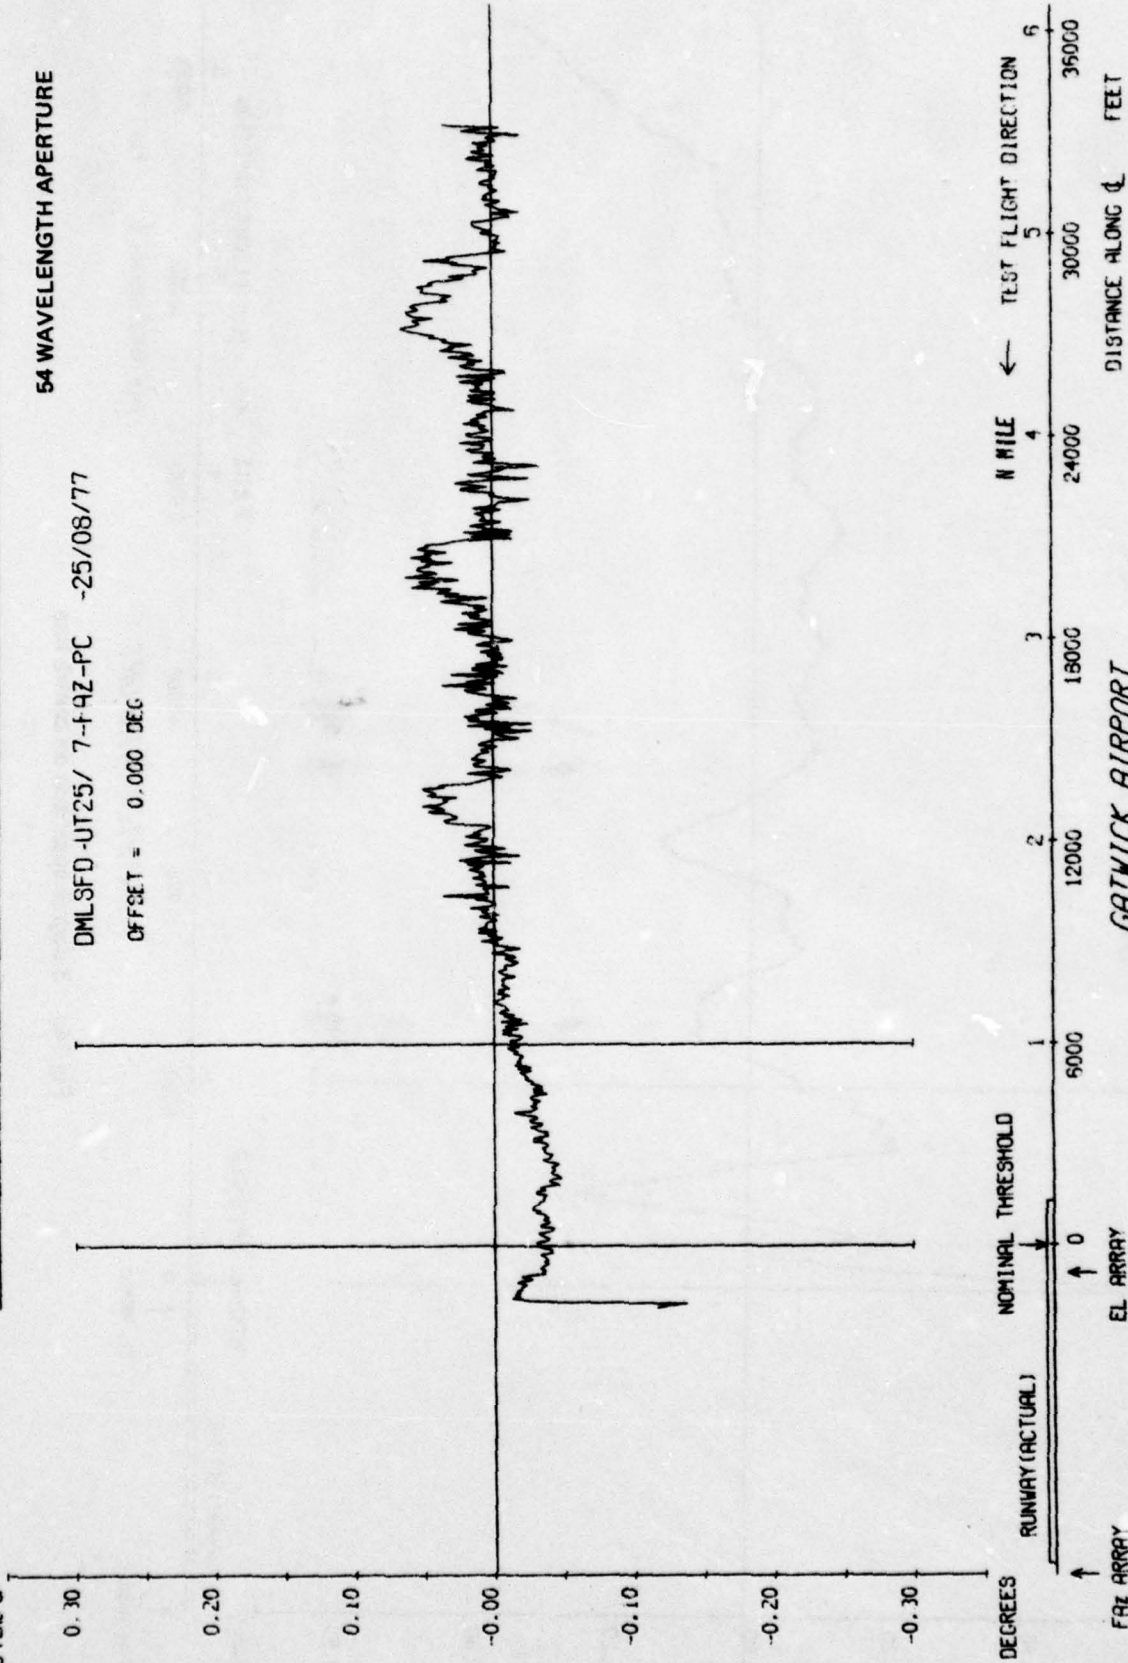
Fig 13a 3 degree approach on centre line

Fig 13b 3 degree approach on centre line

Run 7 (Fig 13a,b). This run was the final tracked azimuth run and the transmitter was operated in its 54λ mode. The results are similar to Run 4 with a tracker lock at 4.8 n mile.

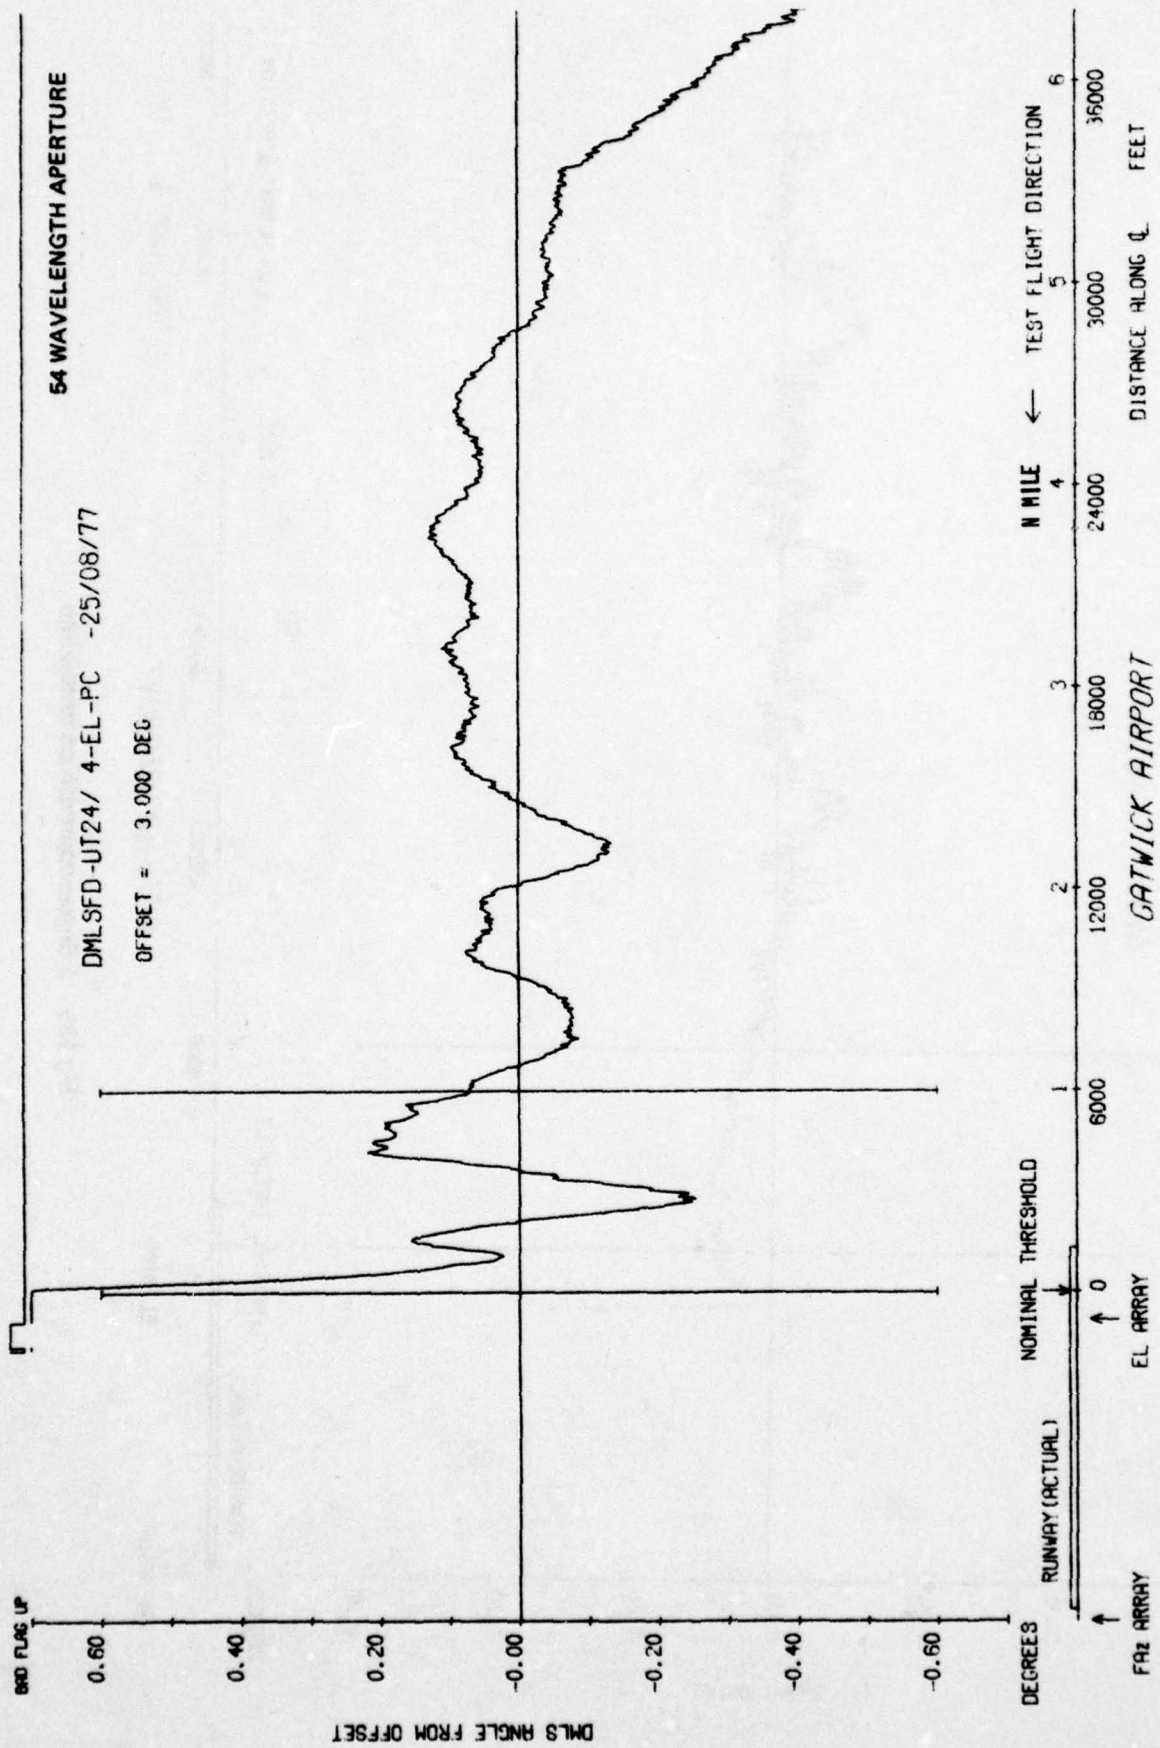
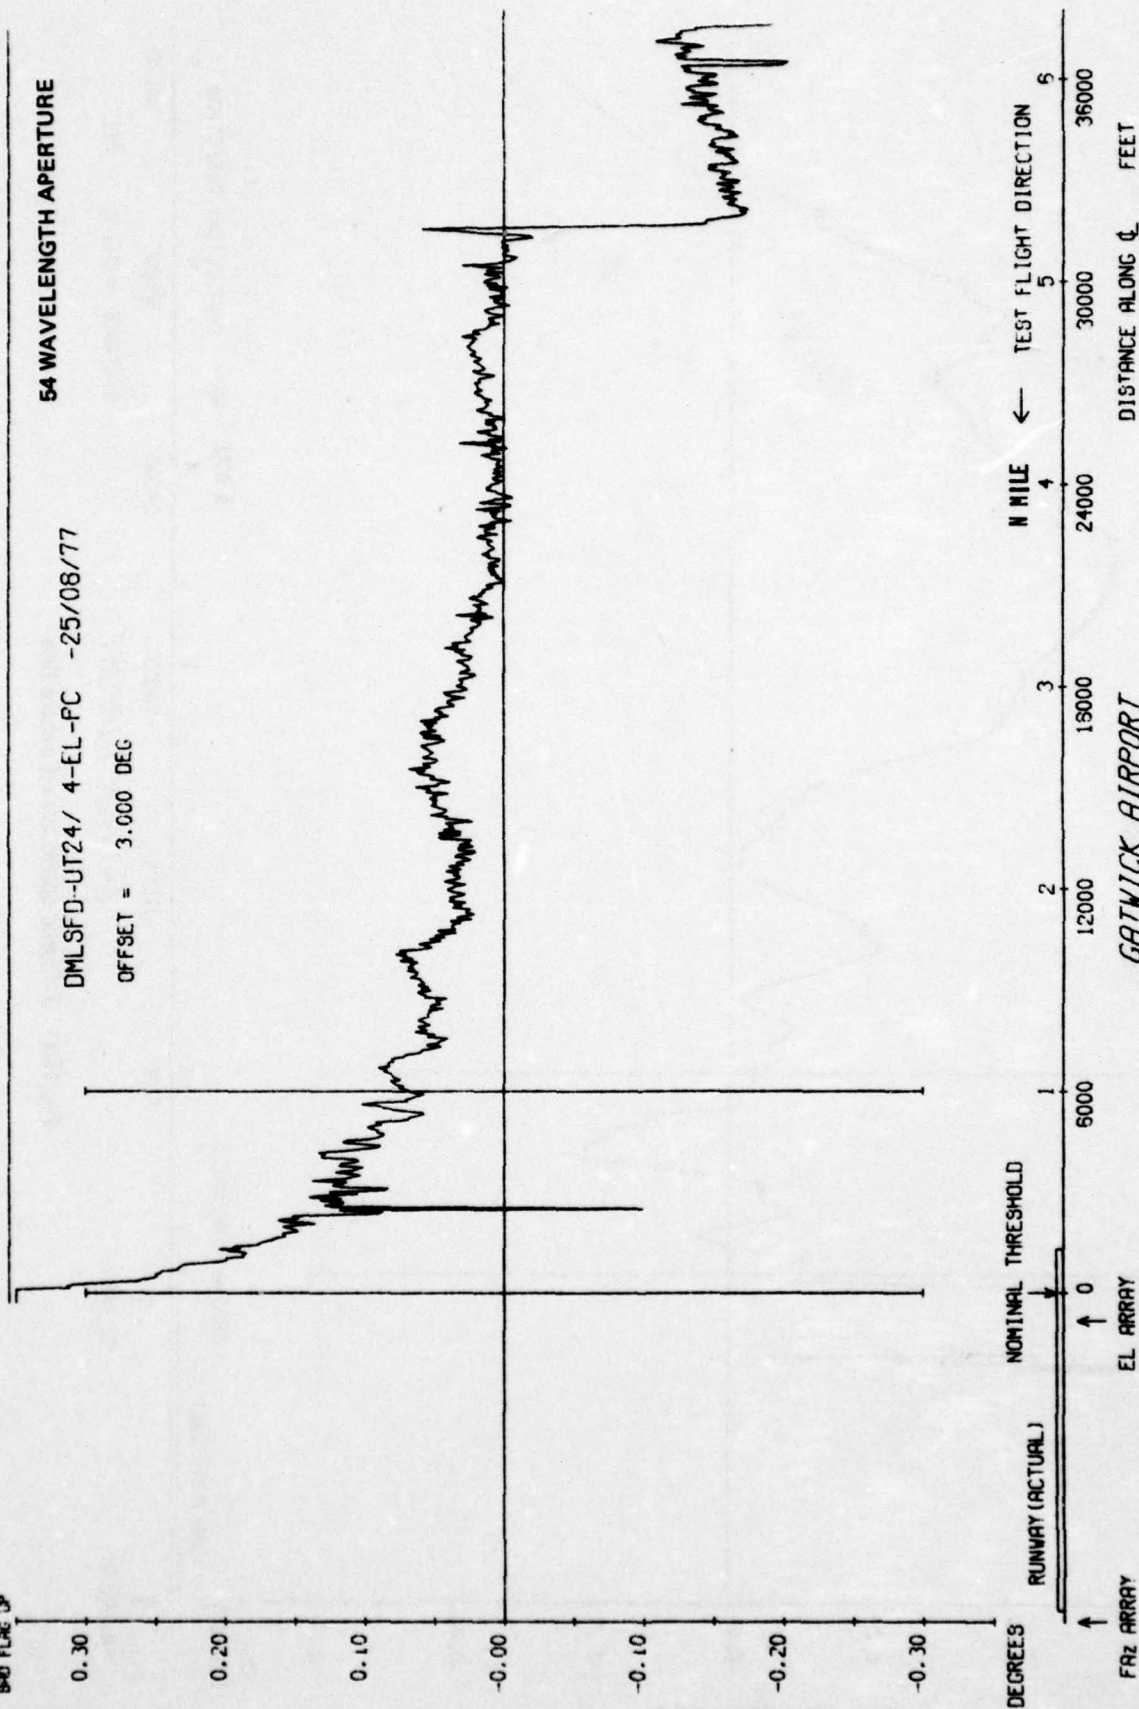
Fig 14a 3 degree approach on centre line

Fig 14b 3 degree approach on centre line

Run 4 (Fig 14a,b). 3° centreline approach. This run was tracked from 5 n mile with a good lock up to the runway threshold. The general noise level on the elevation system was 0.02° peak to peak with an increase to 0.04° peak to peak at 1220 m from threshold. This was due to residual ground reflections.

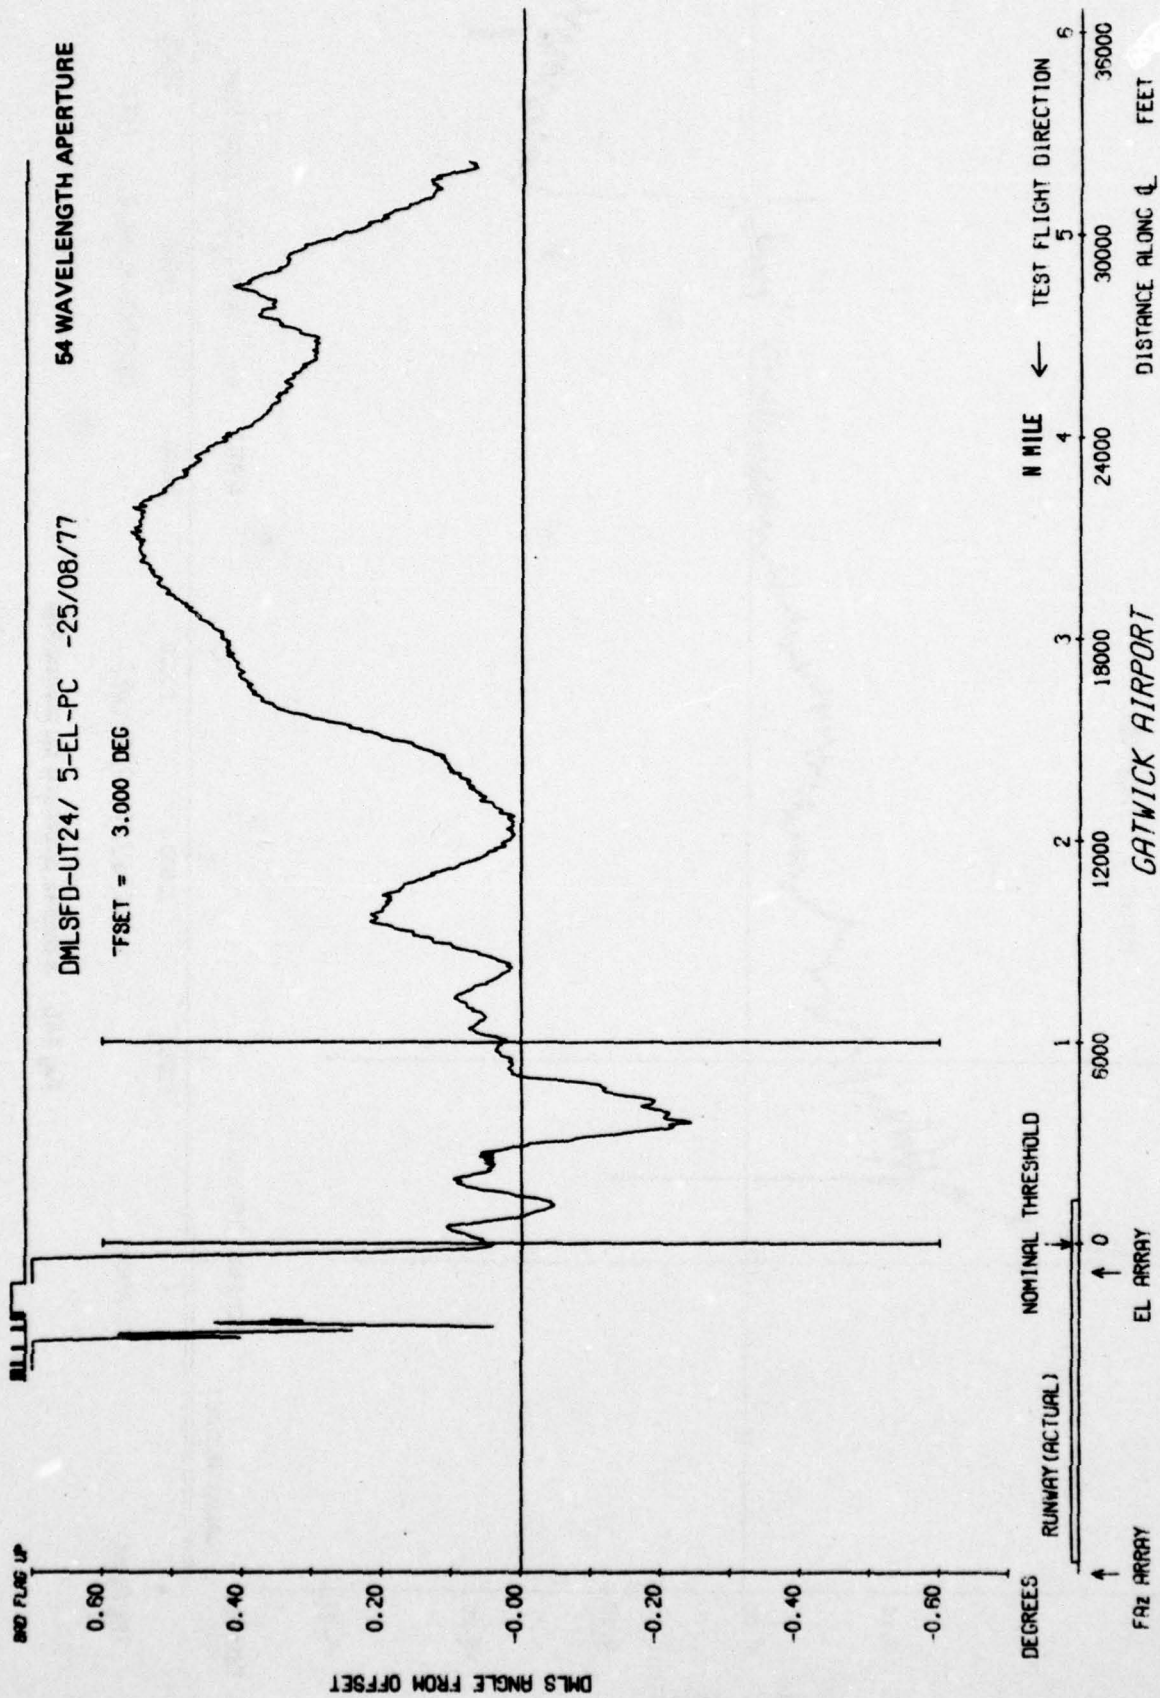
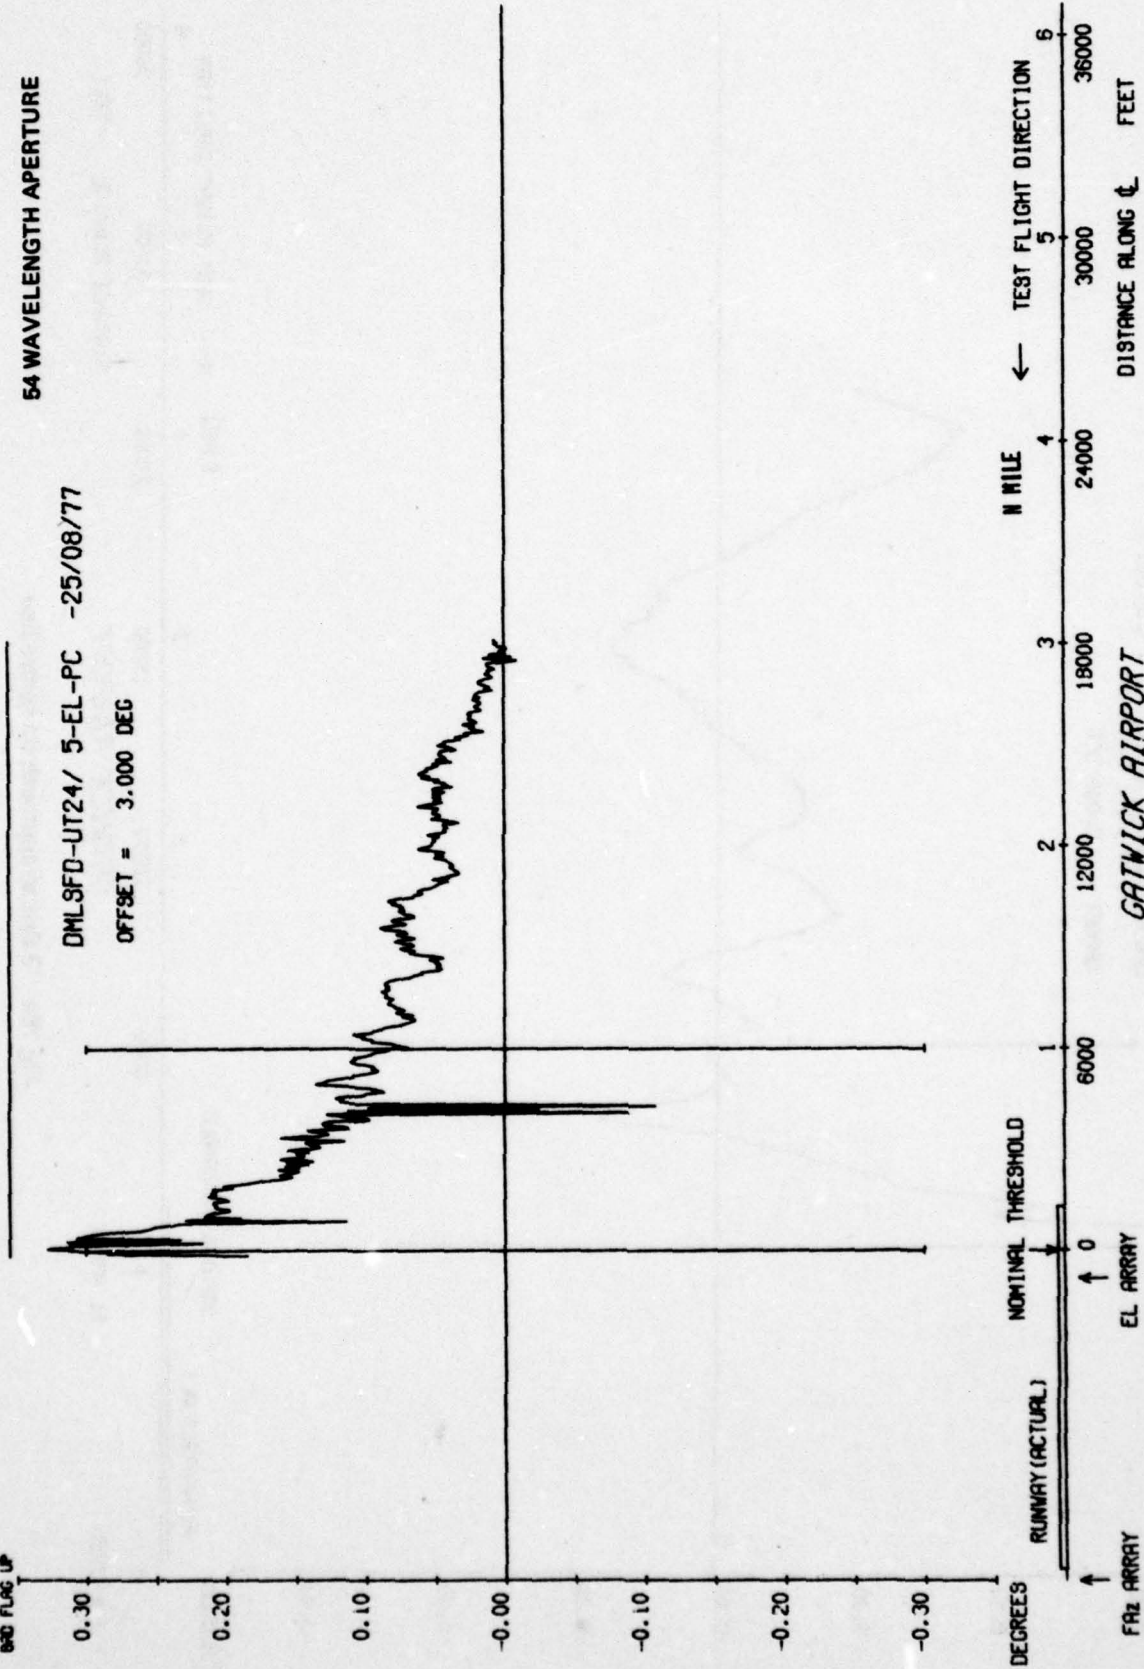
Fig 15a 3 degree approach on centre line

Fig 15b 3 degree approach on centre line

Run 5 (Fig 15a,b). 3° centreline approach. The DMLS performance during this run was similar to Run 4. Both DMLS signals were recorded from 5.5 n mile and the tracker locked at 3 n mile.
