Technical Report 78124

**TRIALS OF THE
DOPPLER MICROWAVE LANDING SYSTEM
AT LONDON (GATWICK) AIRPORT,
AUGUST 1977**

SUMMARY

The trials of the Doppler Microwave Landing System (DMLS) at Gatwick formed part of a series conducted at operational airports to collect data for the ICAO evaluation programme.

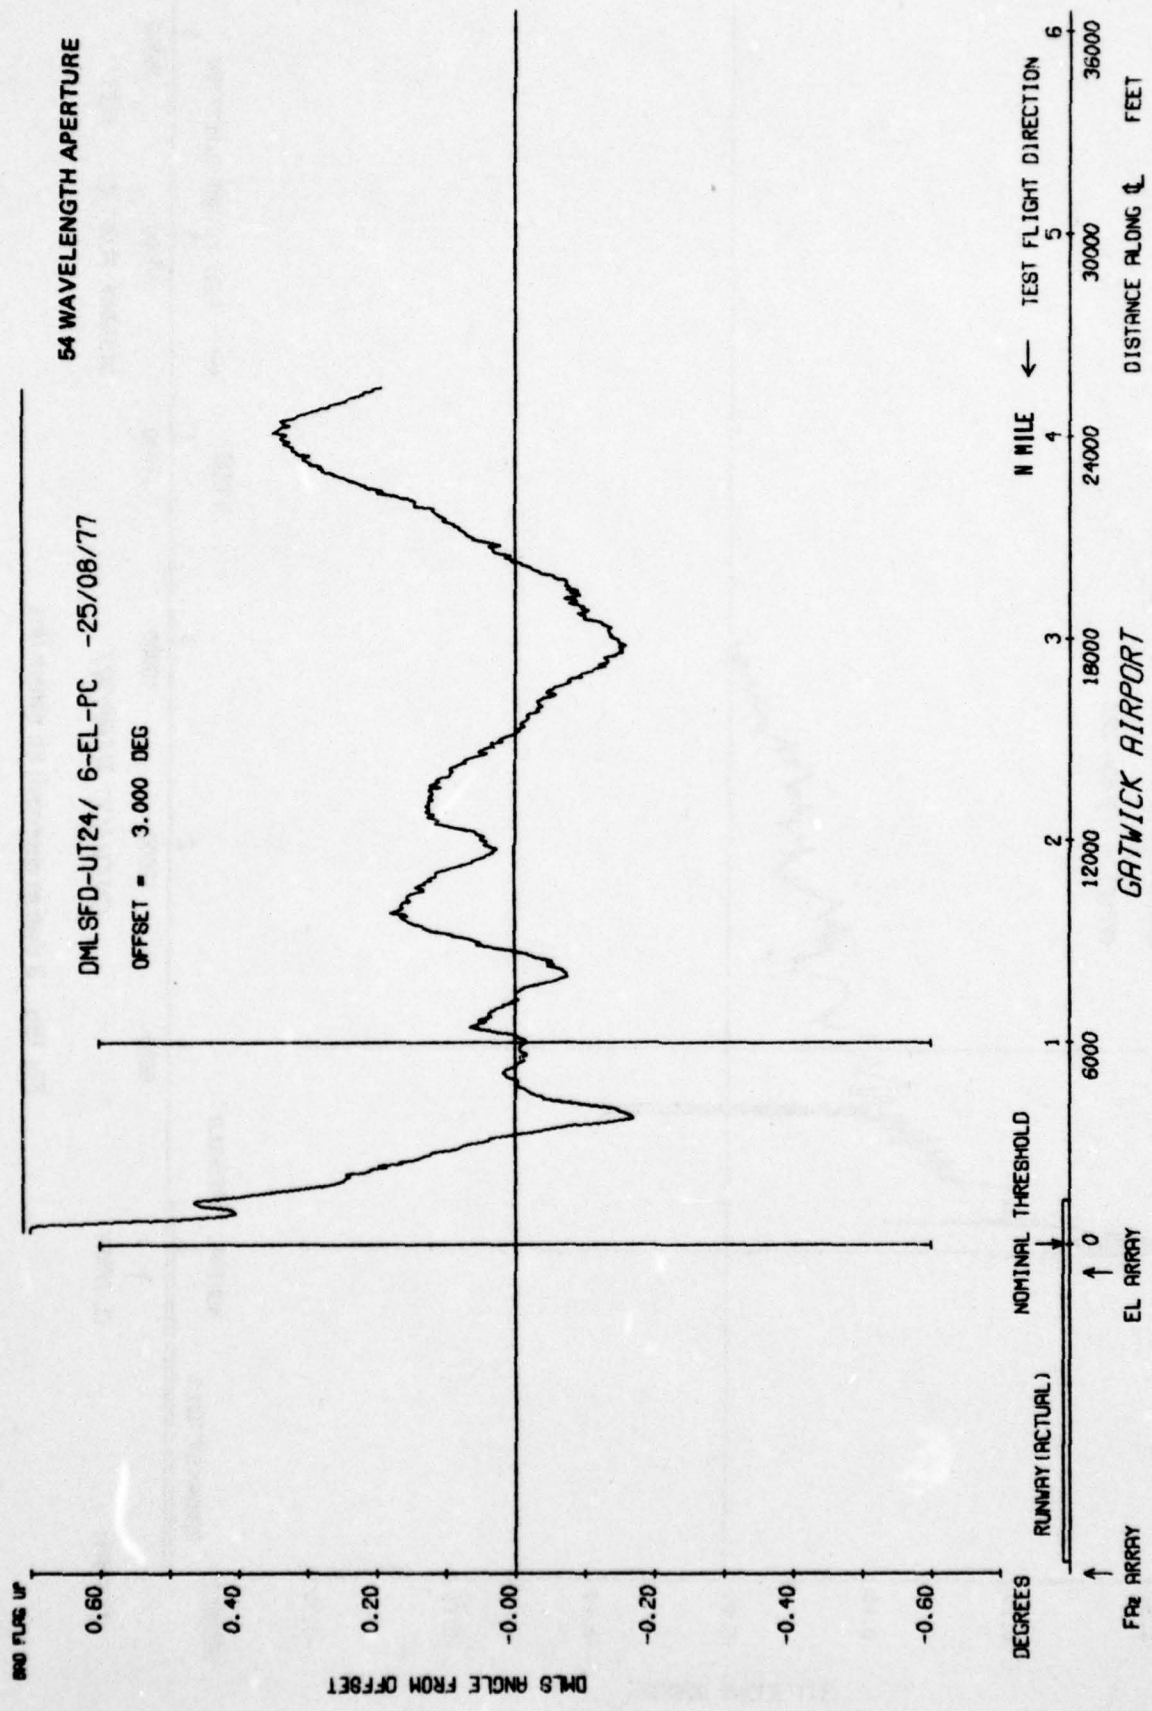
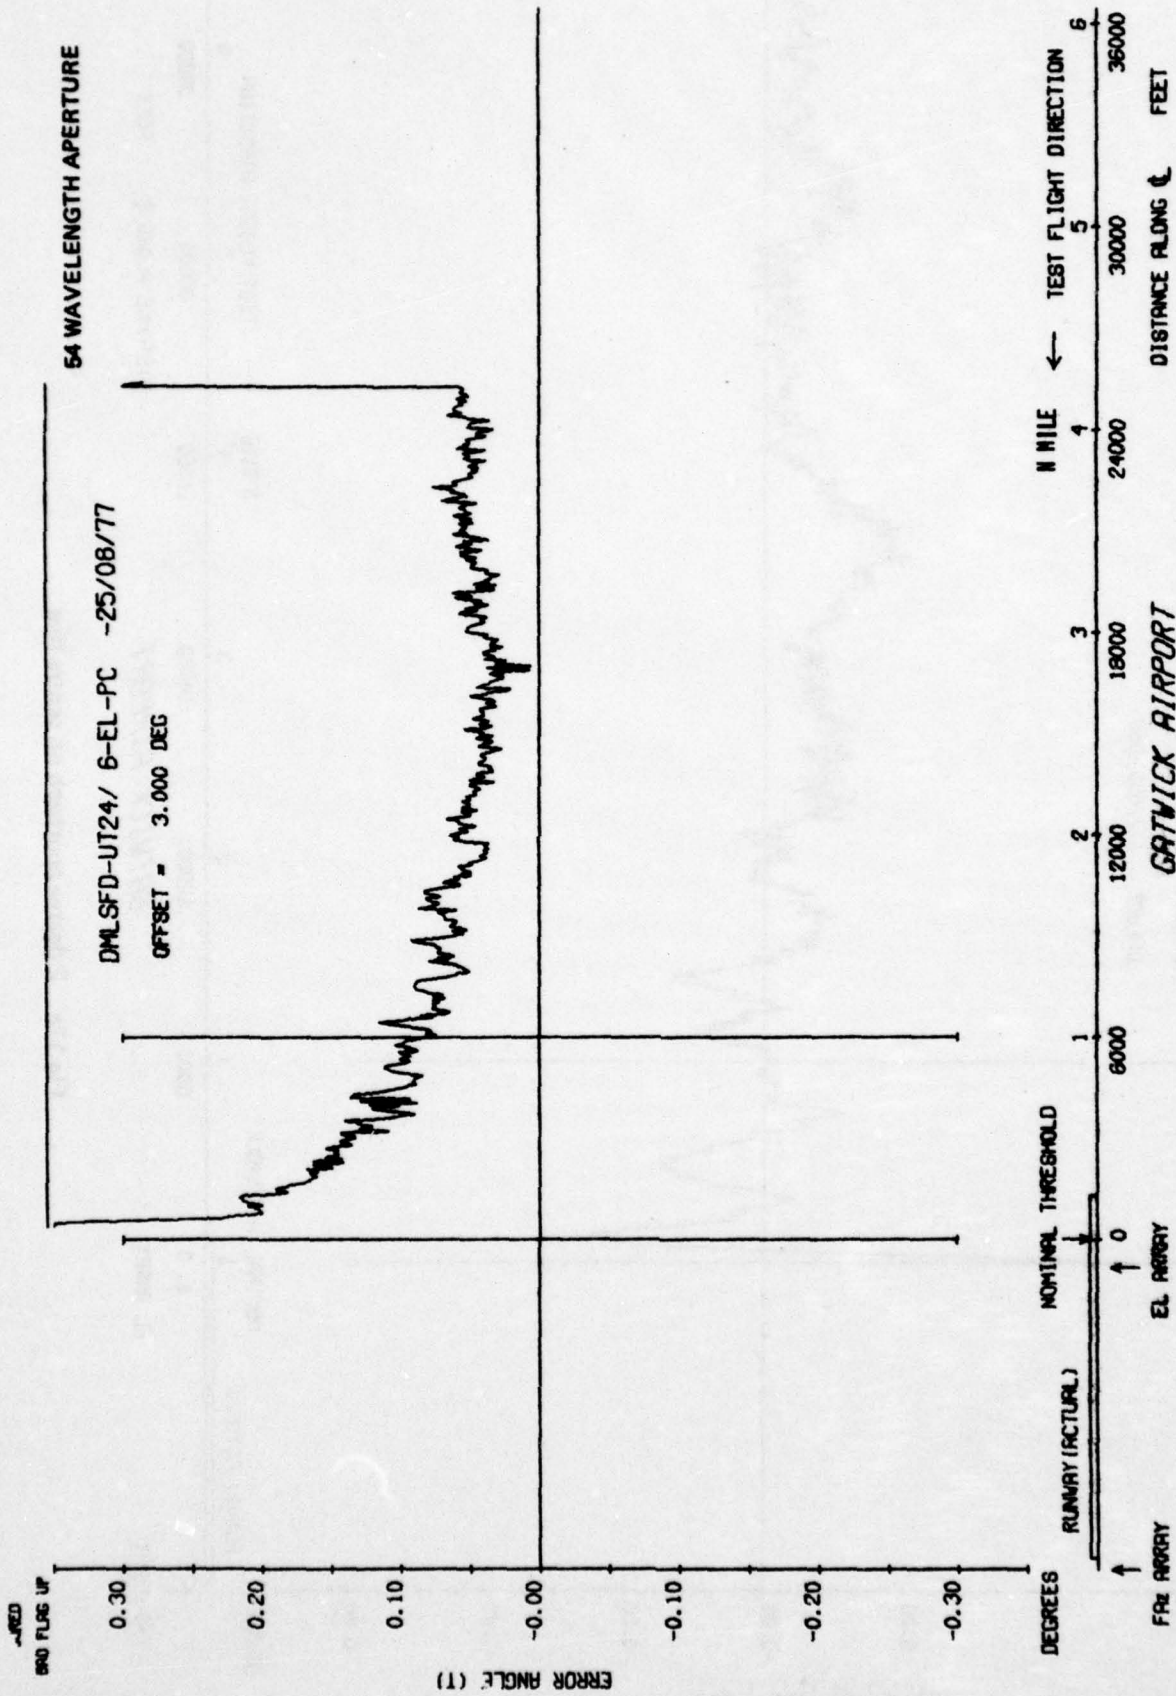
Fig 16a 3 degree approach on centre line

Fig 16b 3 degree approach on centre line

Run 6 (Fig 16a,b). 3° centreline approach. Again, the DMLS performance was similar to Run 4. The aircraft was tracked from 4.3 n mile. There is some evidence of small bends at ranges between threshold and 2 n mile, again this is attributed to reflections from the rising ground profile.

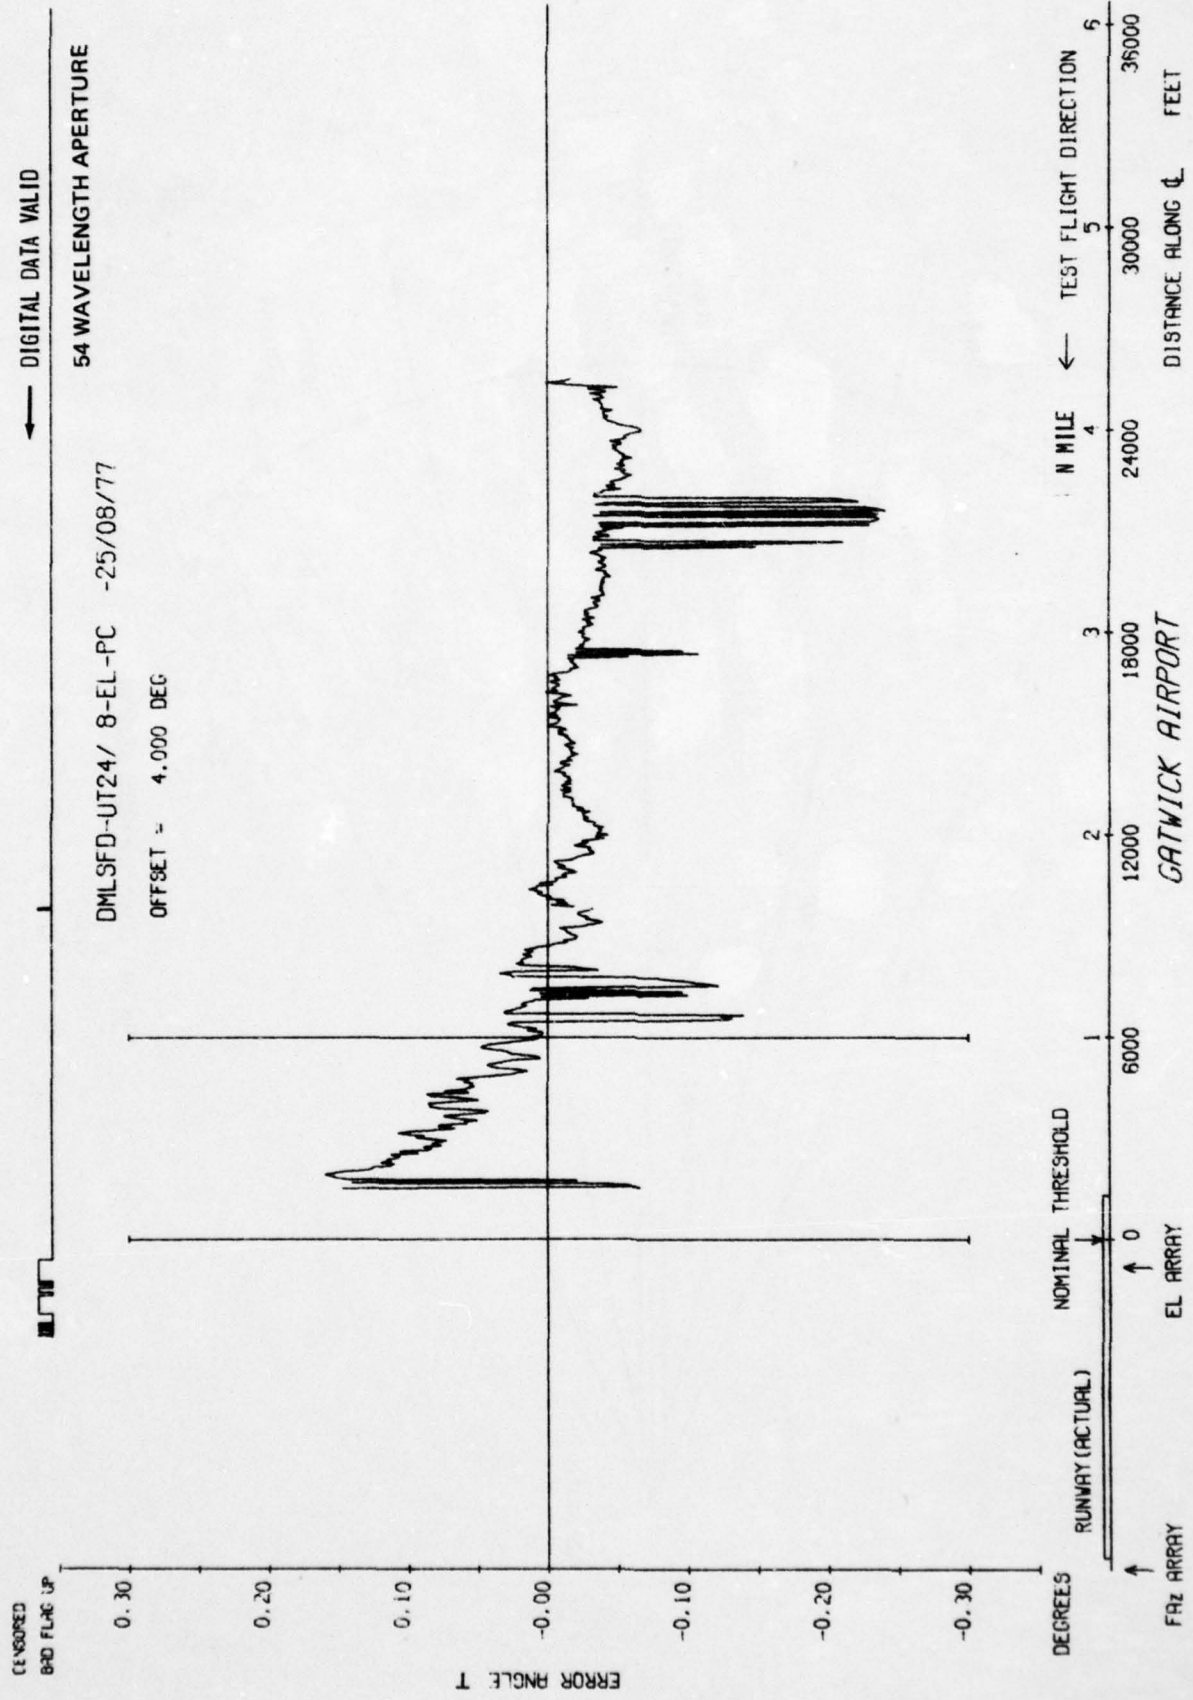
Fig 18b 4 degree approach on centre line

Run 8 (Fig 18a,b). 4° centreline approach. This run was tracked from 4.3 n mile with evidence of tracker dropouts at 3.8 and 1.2 n mile (Fig 18b); both guidance signals were good with low noise levels throughout. There is evidence of small beam bends (0.04° pp) at a range of just over 1 n mile on the UV analogue record.

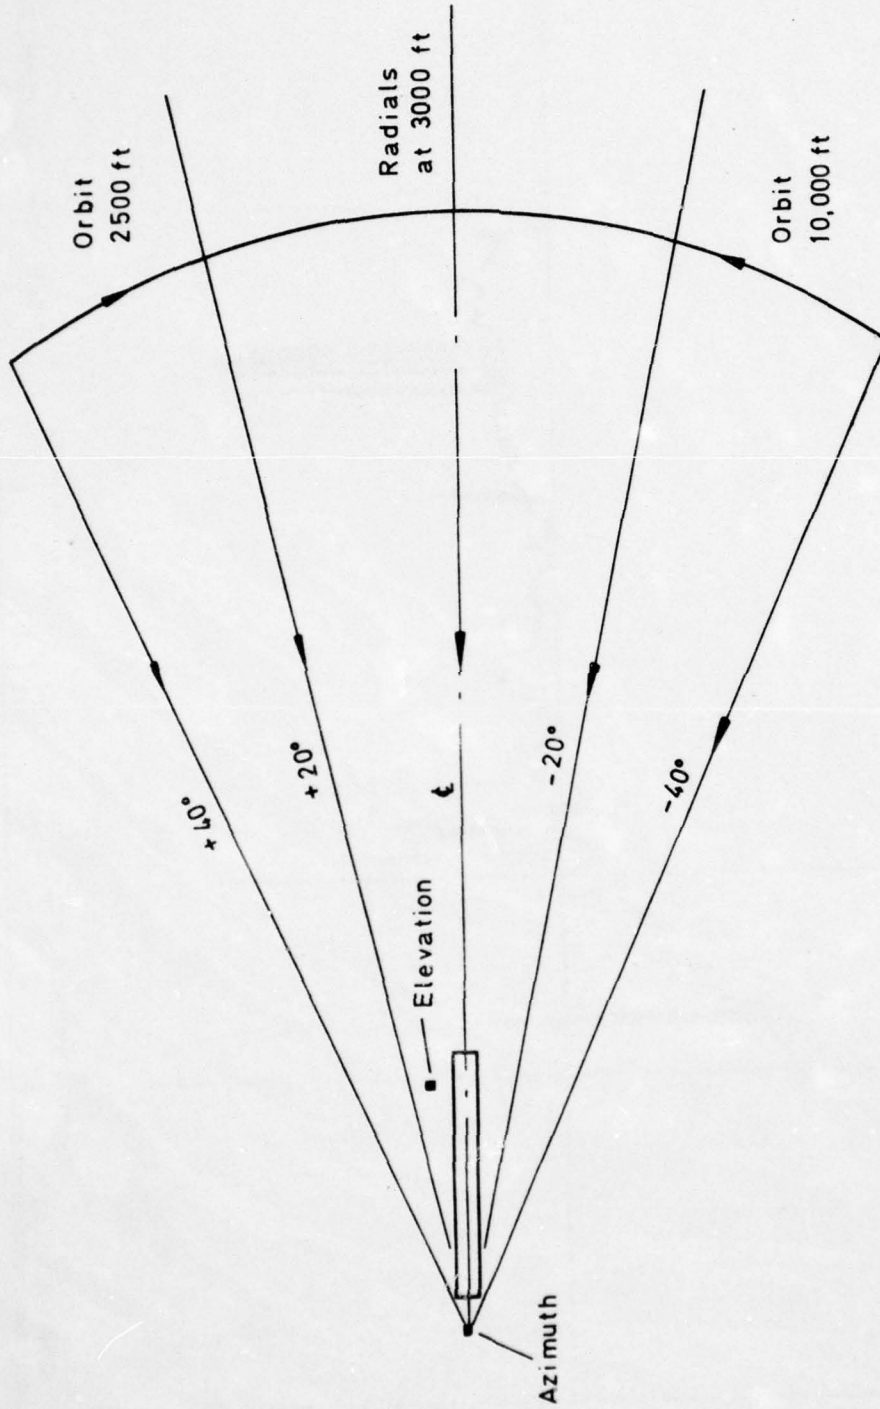
Fig 19 Coverage flight profiles

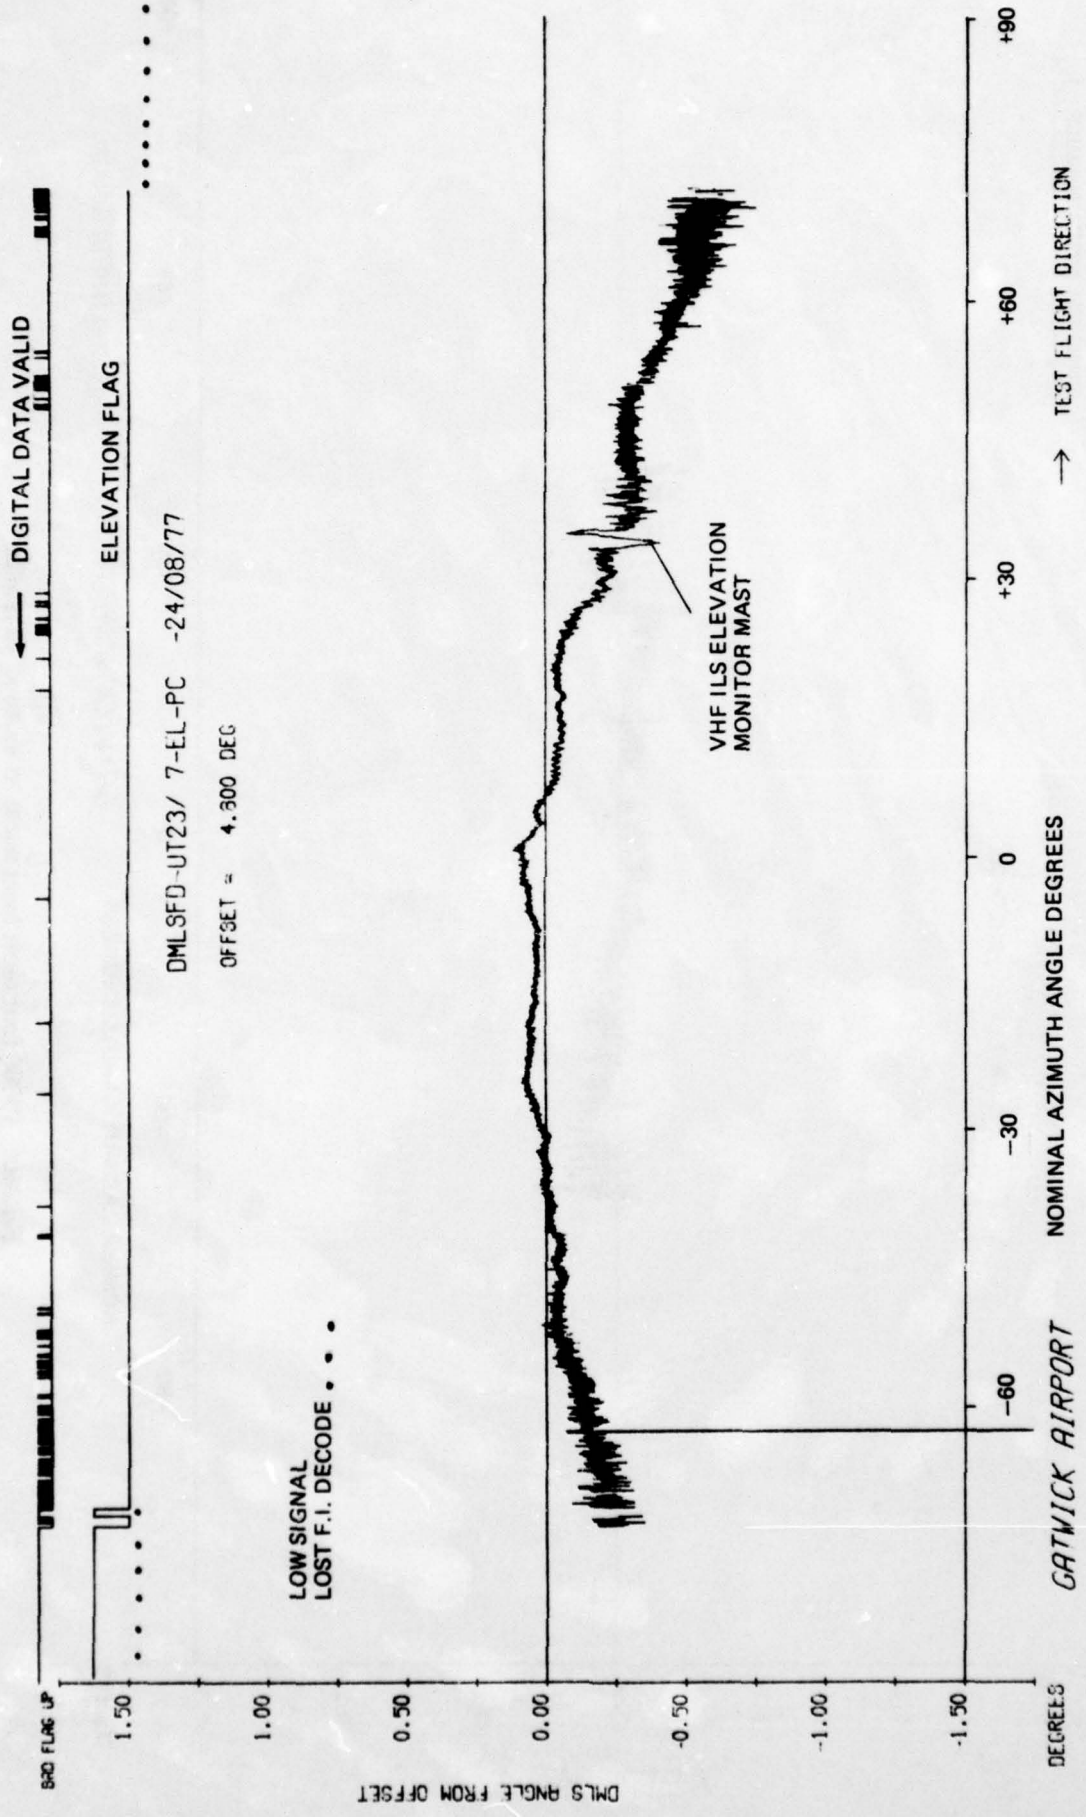
Fig 26c 10000 foot orbit from north to south at 20 n mile

This apparent contradictory situation arises from the nature of the interference generated by a 'thin' vertical pole. If the pole is of sufficient length that it is equally illuminated by all elements of the MLS elevation array relative to the elevation angle of the aircraft, then it appears as a second signal source with the same angle code as the direct signal and introduces little or no error. This condition applies to the monitor mast at $+20^\circ$ azimuth. On the other hand, if the pole is so positioned that illumination by the elements at the top of the MLS array relative to the elevation angle of the aircraft passes over the top of the pole, the second signal source formed by the pole appears as a shortened version of the MLS array. This has the effect of putting a phase discontinuity in the resultant received signal which cycles as a function of the difference in path lengths from the MLS array and the pole to the aircraft, giving rise to the typical error seen in Fig 26c.

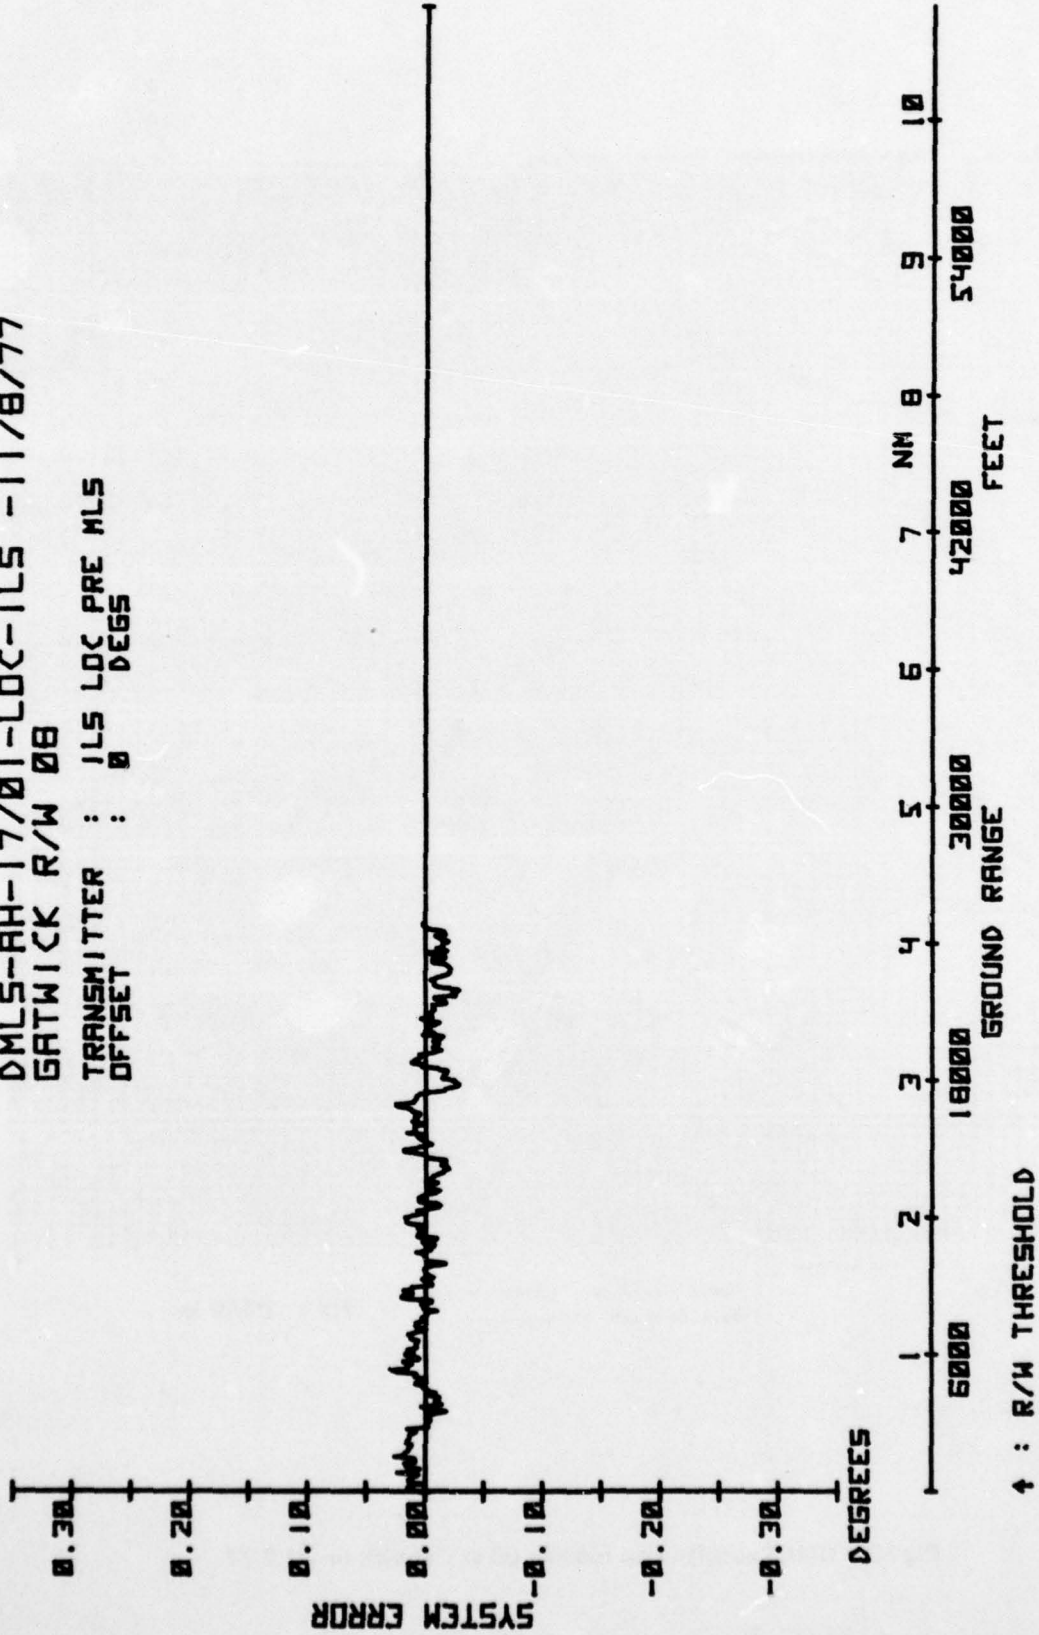
DMLS-AH-17/01-LOC-ILS -11/8/77
GATWICK R/W 08
TRANSMITTER : ILS LOC PRE MLS
OFFSET : 0 DEGS

Fig 36 System error plot for ILS localizer on runway 08 at Gatwick Airport before DMLS installation

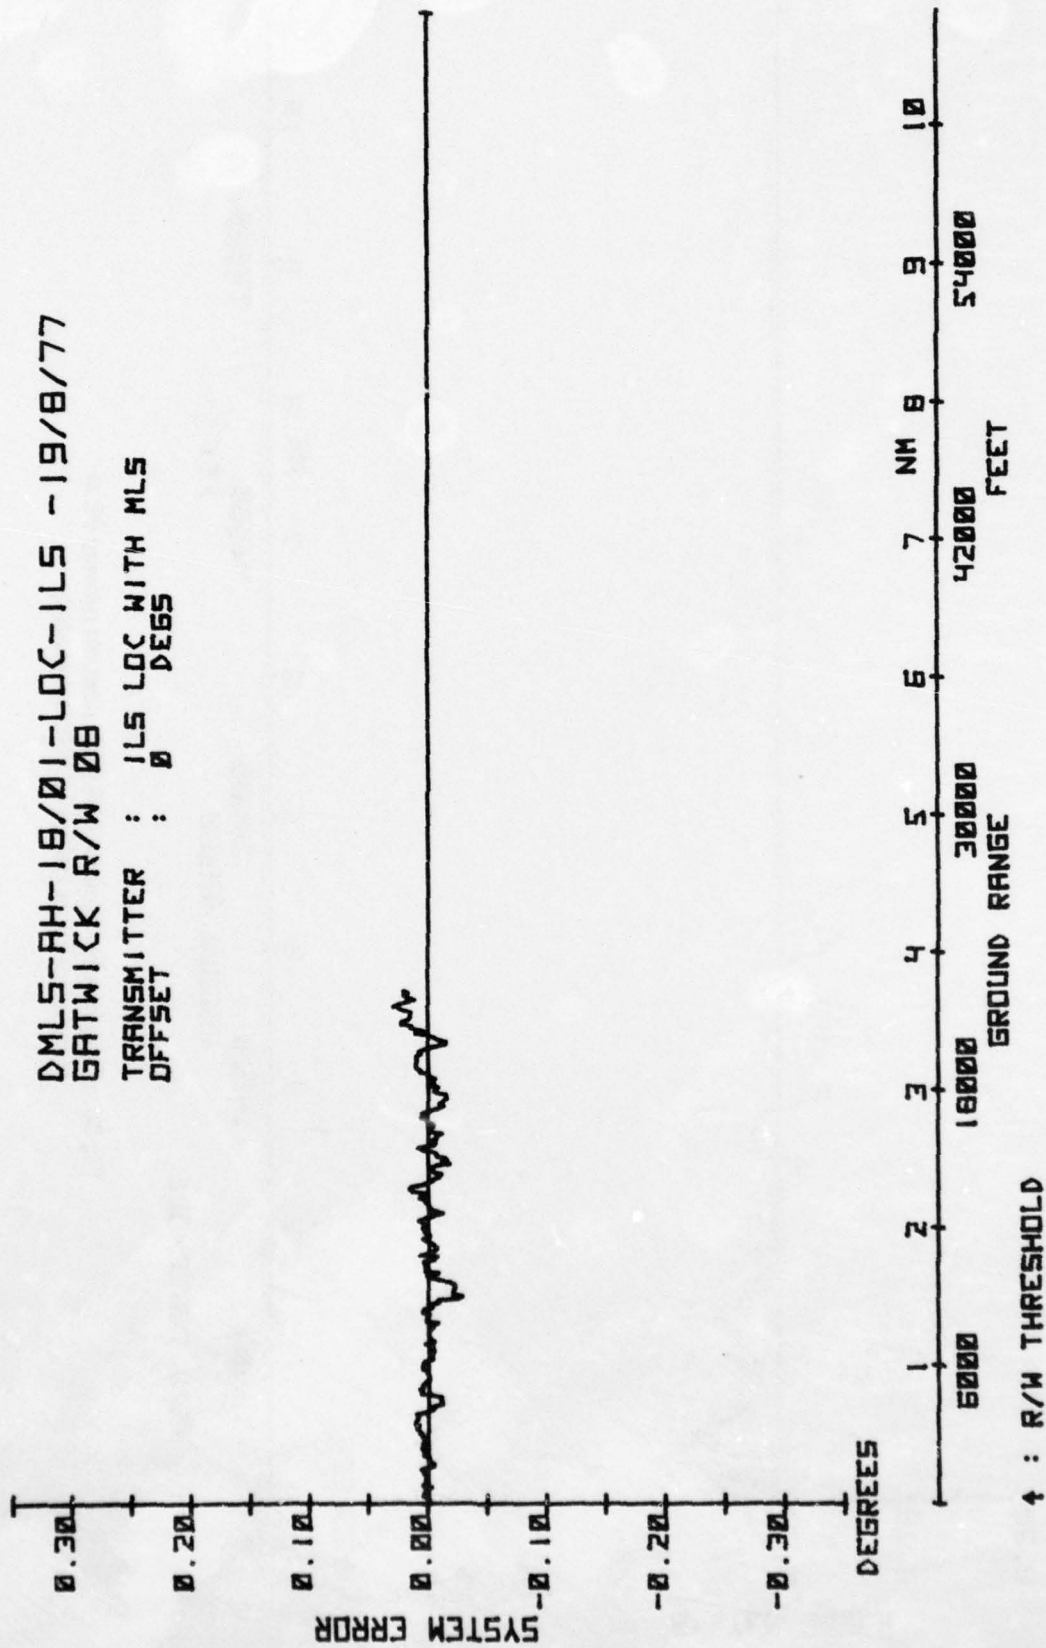
Fig 37 System error plot for ILS localizer on runway 08 at Gatwick Airport after DMLS installation

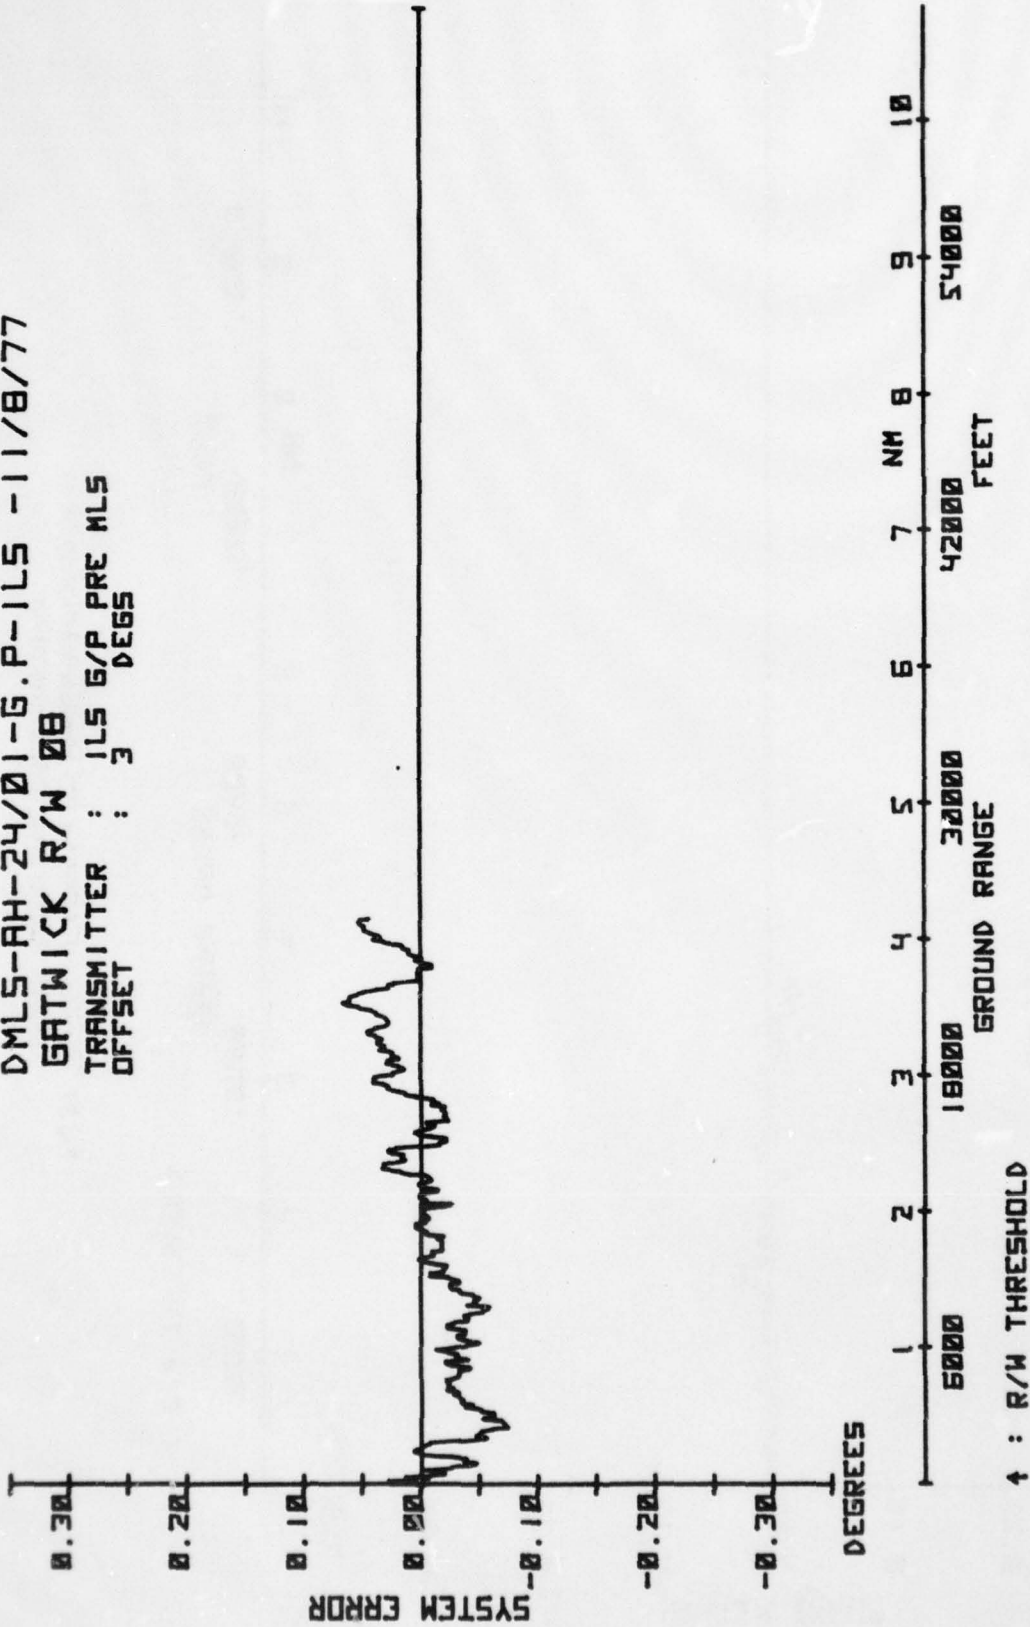
DMLS-AH-24/01-G.P-ILS -11/8/77
GATWICK R/W 08
TRANSMITTER : ILS G/P PRE MLS
OFFSET : 3 DEGS

Fig 38 System error plot for ILS glide path on runway 08 at Gatwick Airport before DMLS installation

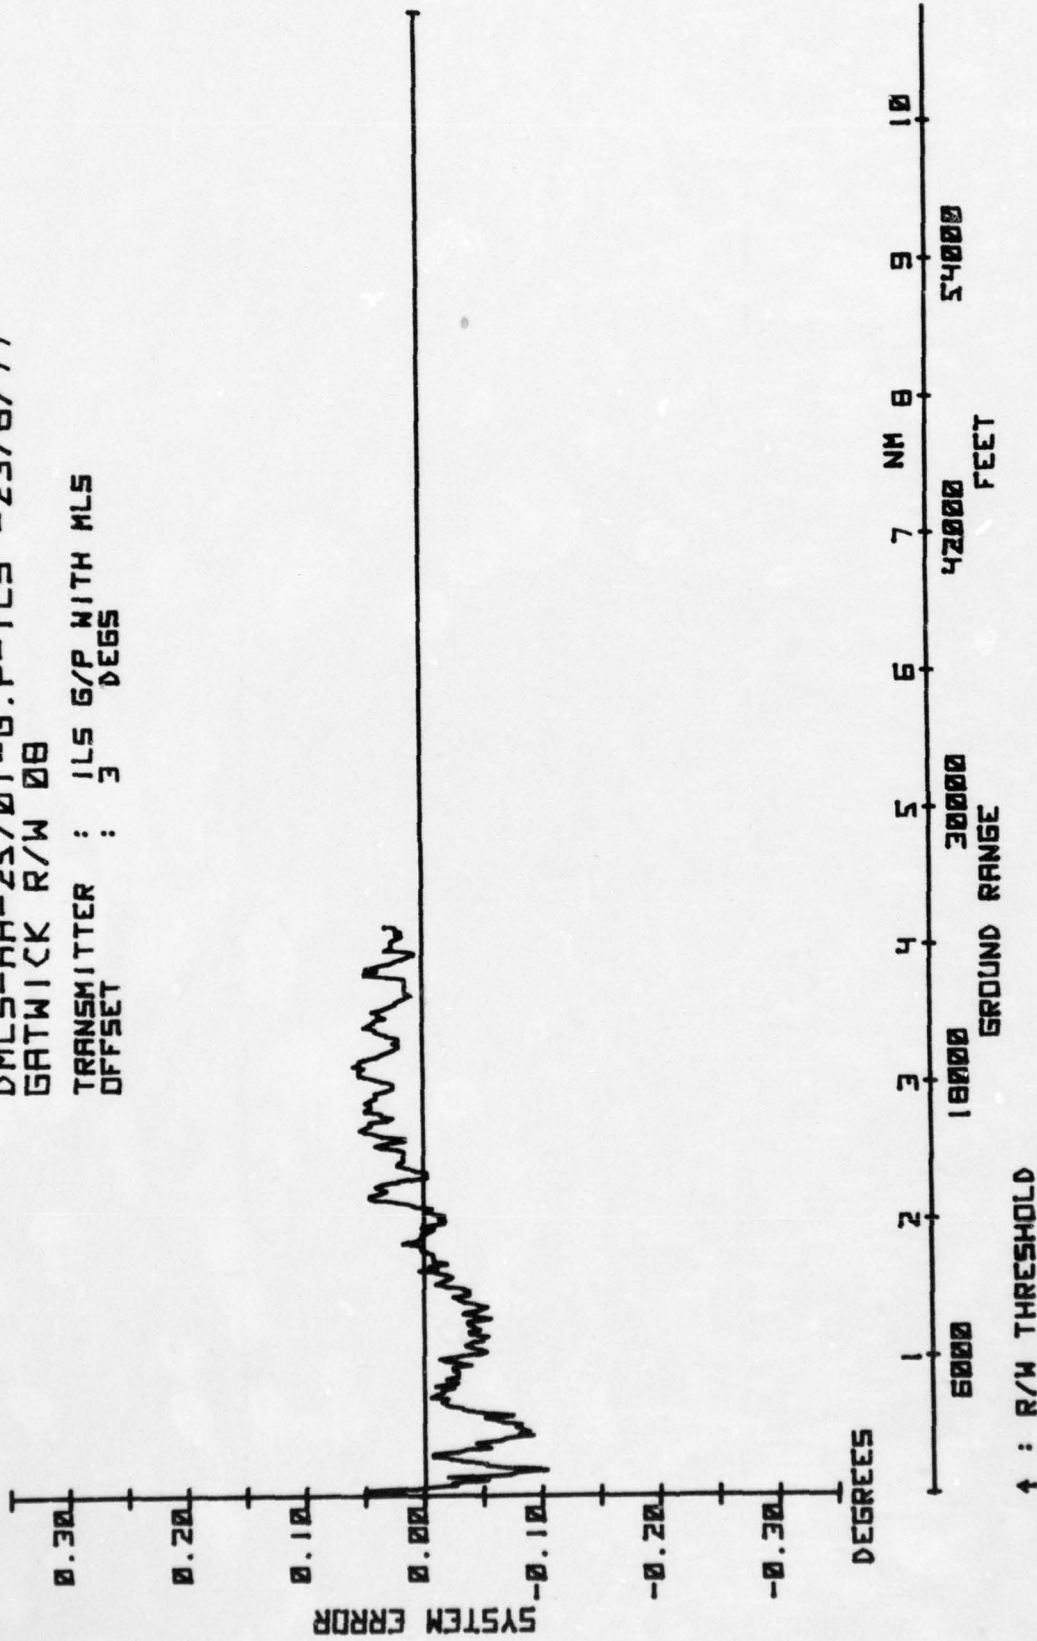
DMLS-AH-25/01-G.P-ILS -23/8/77
 GATWICK R/W 08
 TRANSMITTER : ILS G/P WITH MLS
 OFFSET : 3 DEGS

Fig 39 System error plot for ILS glide path on runway 08 at Gatwick Airport after DMLS installation
