**HIGH SPEED BIRD IMPACT TESTING
OF AIRCRAFT TRANSPARENCIES**

R. H. Magnusson
Douglas Aircraft Company
McDonnell Douglas Corporation
3855 Lakewood Boulevard
Long Beach, California 90846

TECHNICAL REPORT AFFDL-TR-77-98

Final Report Period July 1975-June 1978

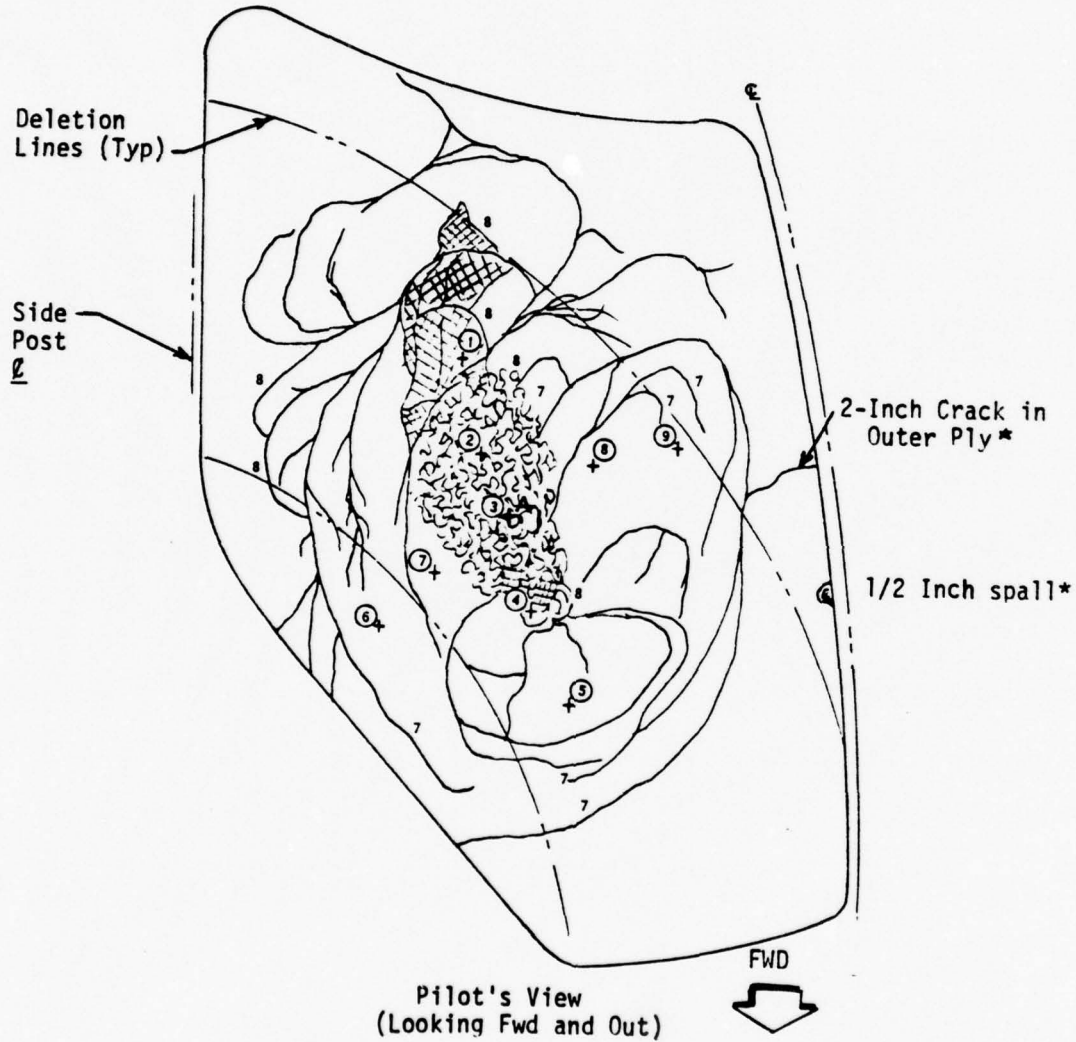
indicates target point
7. * indicates tool damage (pre BM006).

Figure A.2. B-1 windshield test specimen (SWU107) test BM006 to BM008.
