# RELIABILITY OF NONDESTRUCTIVE INSPECTIONS

## FINAL REPORT

December 1978

Prepared by The Lockheed-Georgia Company

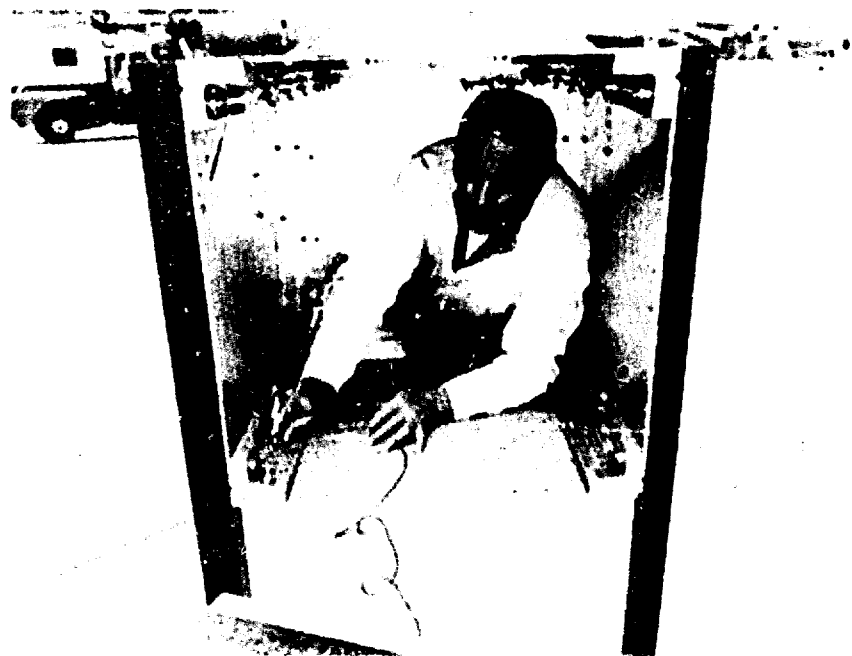
Figure 3-9. Sample Type E - C-5 Wing Spar Cap/Web Test Assembly (Box Beam)

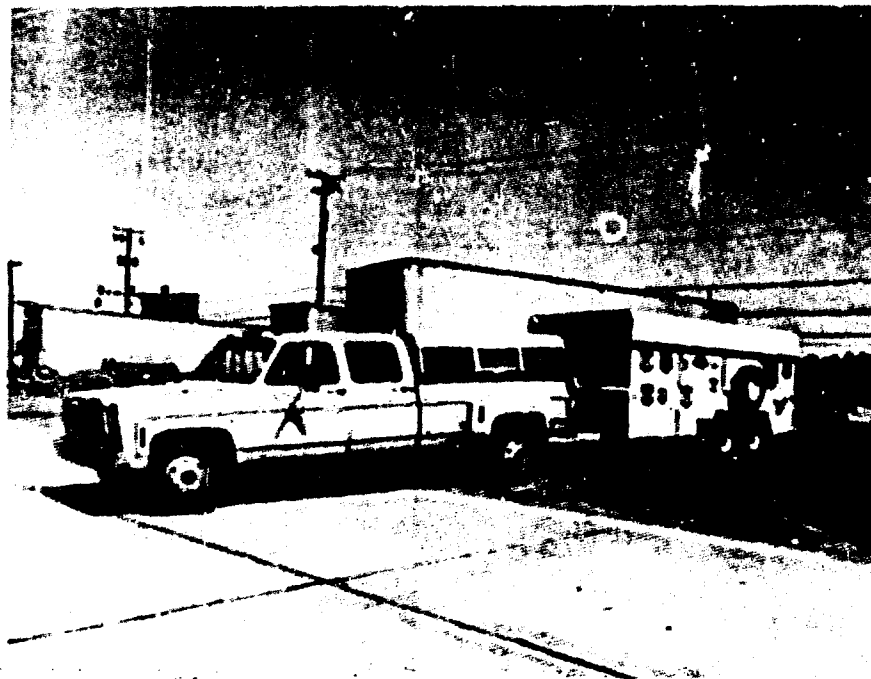
Figure 3-10. Equipment Trailer and Tow Vehicle

The structure samples were transported to the selected Air Force installations in a utility trailer specifically built for this purpose. The trailer also served as an object on which to mount Type B structure to perform radiographic and eddy current NDI. The trailer and tow vehicle are depicted in Figure 3-10. A pickup truck was used for both transportation of the Lockheed engineer (who remained with the program throughout to provide overall coordination and direction) and trailer towing to the various locations.

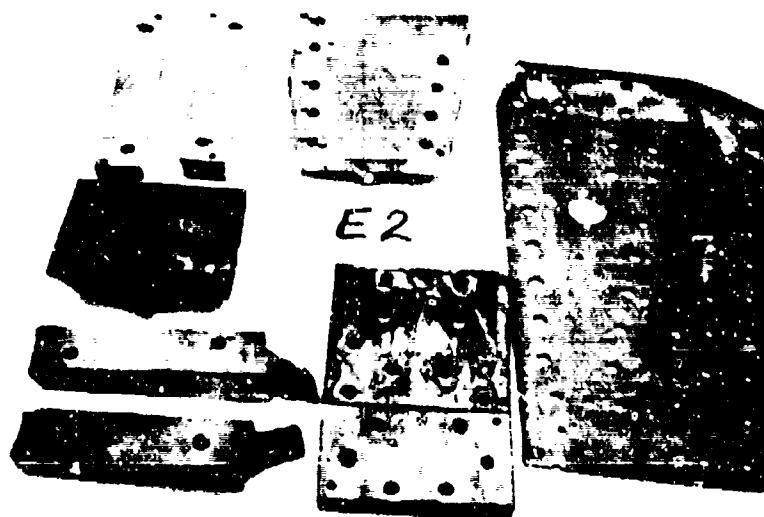
Figure 7-3D, Structure Sample Type 1 - Specimens E1 and E2

Structure samples, Type C, were excluded from teardown because they were machine grown fatigue cracks under closely controlled conditions. The size and shape of those flaws are therefore known with sufficient detail for analyses. Structure Samples A, B, E and F were totally disassembled. The Sample A portion was cut from the intact wing box, rivets sheared off at the buck tail and skins removed from stringers in three pieces. Sample B was treated in the same manner but no initial cutting was required due to their size. Sample D required no disassembly and Sample E breakdown was achieved by unbolting the cracked fittings from the dummy cover plates. Sample F sections were cut from the total box beam and separated into spar caps, webs and web stiffeners. Paint was removed from all structure samples with Turco 5212 paint stripper. After stripping, the samples were cleaned in an alkaline solution, water rinsed, dipped in an acid neutralizing bath, water flushed and oven dried. Photos of the samples after the clean and acid dip operations are presented in Figures 7-3A - 7-3E.
