**RESULTS OF THE FIRST FIVE
"DATA YEARS" OF EXTREME
STRESS SCRATCH GAUGE DATA
COLLECTED ABOARD
SEA-LAND'S SL-7's**

16. Abstract This report covers the installation of Extreme Stress Gauges mounted on each of SEA-LAND's SL-7's. Data collected from each ship over a five-year period is presented in histogram form.				13. Type of Report and Period Covered 9 FINAL REPORT 1972-1978

"Reduction of SL-7 Scratch-Gauge Data"

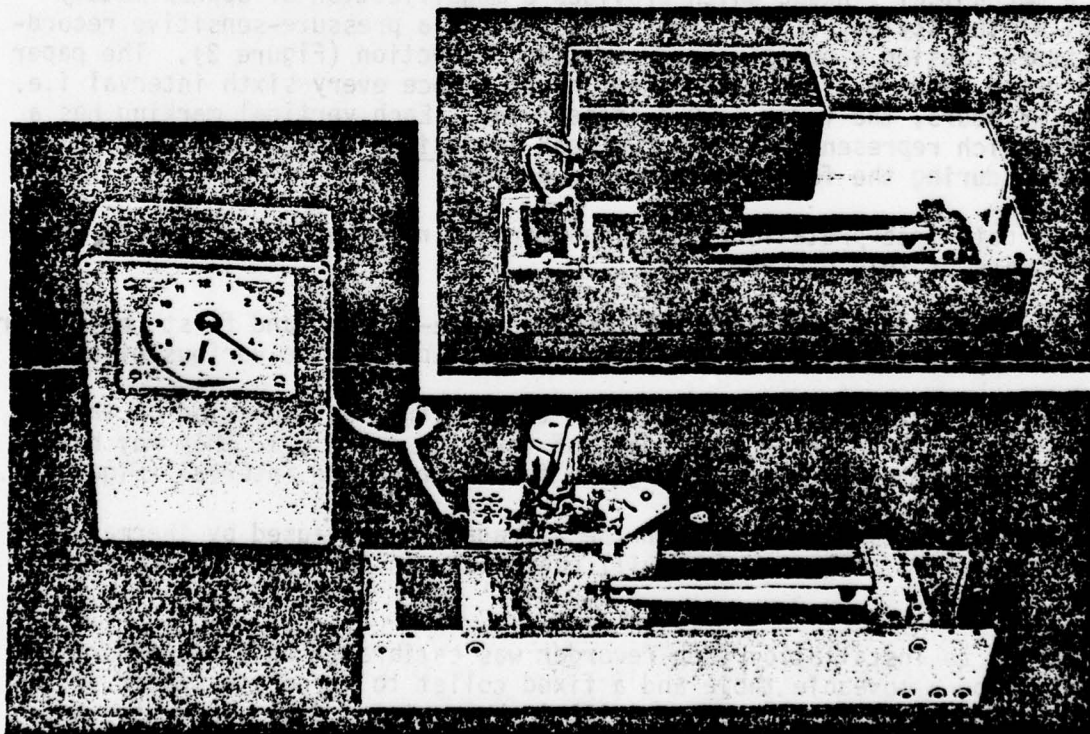
FIGURE 1

N.C.R.E. -maximum reading STRAIN GAUGE RECORDER

The analysis of wave-induced stresses imposed on the steel hull of a surface vessel involves the use of data relating to maximum bending moments applied to the hull girder. In the course of such analysis, scientific staff of the Naval Construction Research Establishment, Dunfermline, Scotland, adopted a method of recording maximum strain variations during specified time intervals by means of a maximum-reading strain gauge incorporating a strip chart.

Prototype quantities of the NCRE designed recorder were produced within the Establishment, subsequently evaluated and used as highly successful data acquisition instruments in the arduous environments experienced by Royal Navy warships at sea. To meet a demand for further models, it was decided by NCRE to permit a strain instrumentation company to manufacture the device commercially. Elcomatic Limited of Glasgow was chosen, and the NCRE recorder now is available as a standard Elcomatic product.

Basically, the N.C.R.E. gauge consists of gauge points 10 inches apart and a mechanical linkage which provides a magnification of approximately 100:1 at the stylus. The stylus moves against a pressure-sensitive recording paper causing a positive and negative deflection (Figure 3). The paper is indexed about 0.1 inch every four hours. Once every sixth interval i.e. every 24 hours, the index is 0.4 inches wide. Each vertical marking has a length which represents the maximum peak to maximum trough stress which has occurred during the four-hour sampling period.

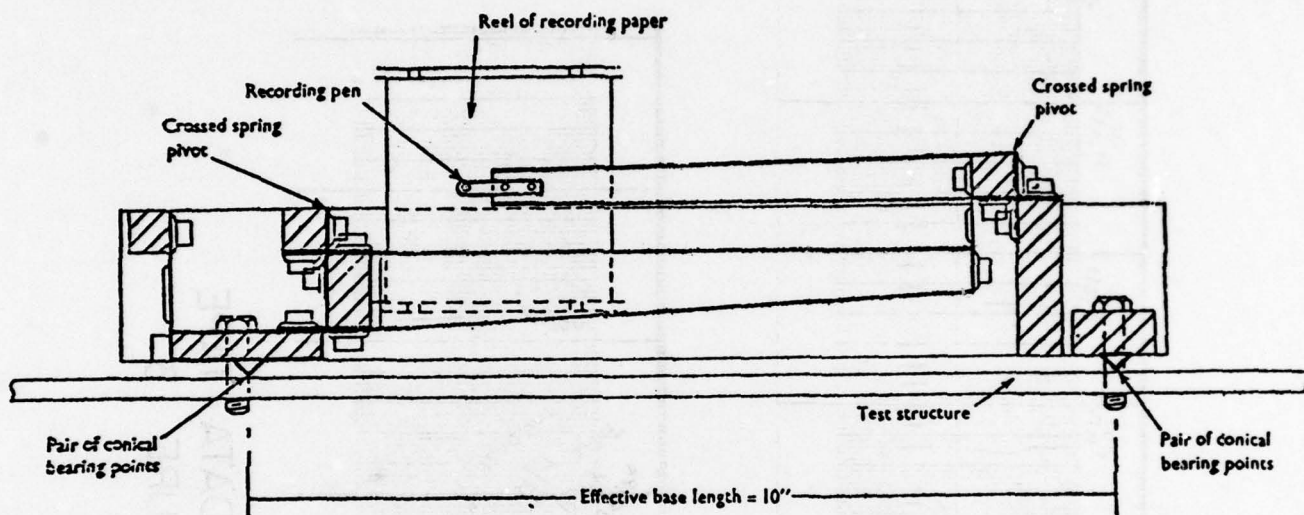
FIGURE 2

Gauge Action :

As shown in the sectional diagram below, the lever system is actuated by distortion of the structure under test and requires no external power supply. The instrument is bolted in position, bearing against the test surface on two sets of hardened conical studs. Any change in separation of bearing points is magnified by the lever system which drives the recording pen across the stationary reel of carbon-backed paper. Time related maximum strain records are obtained by forward movement of recording paper programmed by a precision battery-rewound clock and powered by a small motor also battery powered.

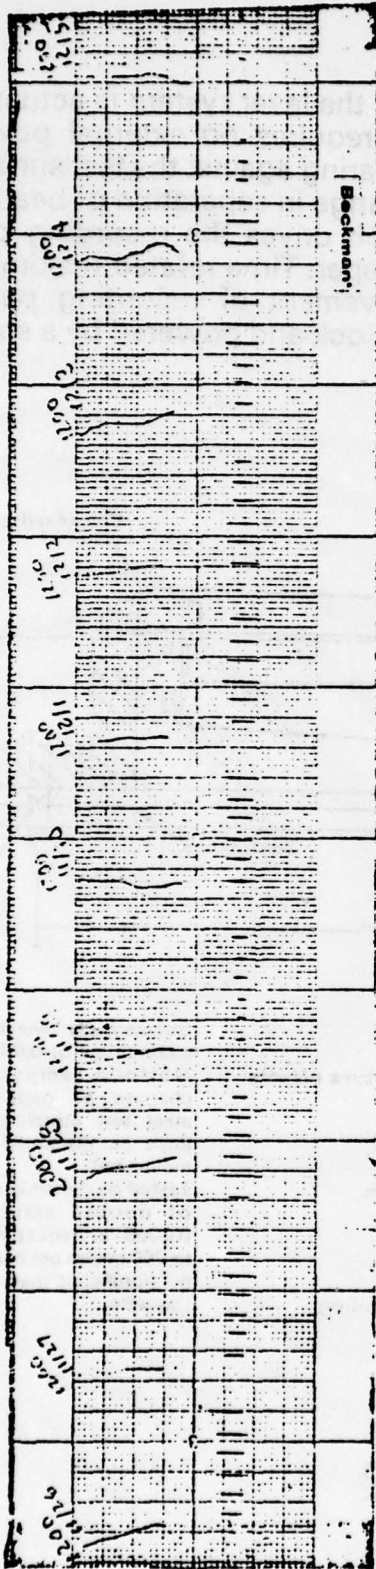
SAMPLE DATA TAPE
 FIGURE 3

SEALAND McLEAN
 VOYAGE #5
 PORT SIDE

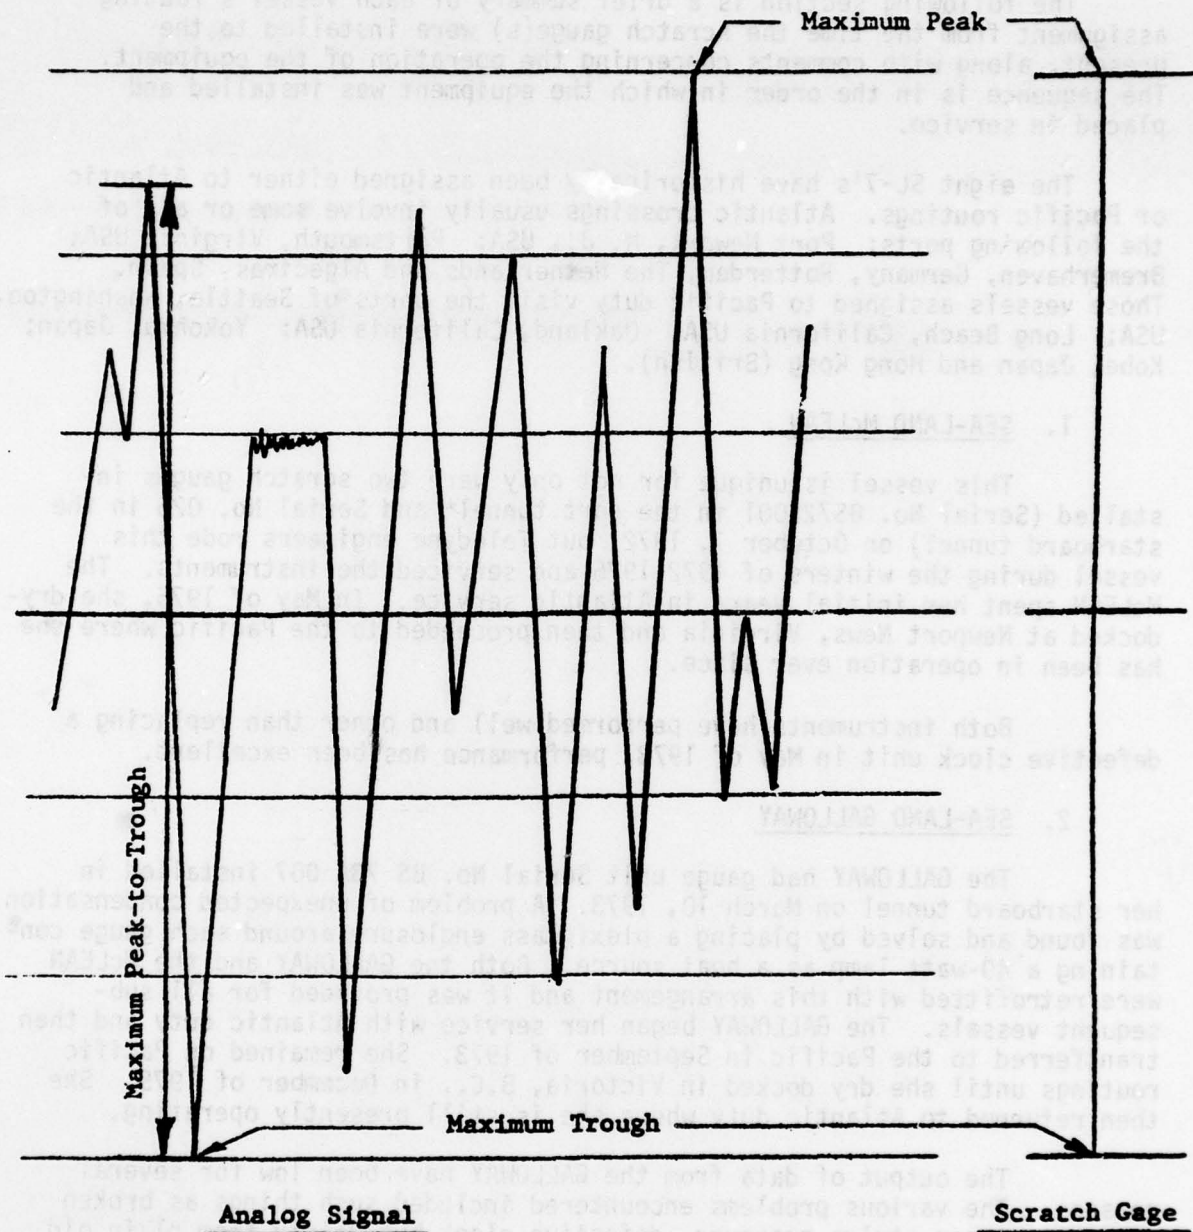
FIGURE 4

ILLUSTRATED EXAMPLE OF THE COMPARISON
OF AN ANOLOG SIGNAL WITH THE SCRATCH GAGE

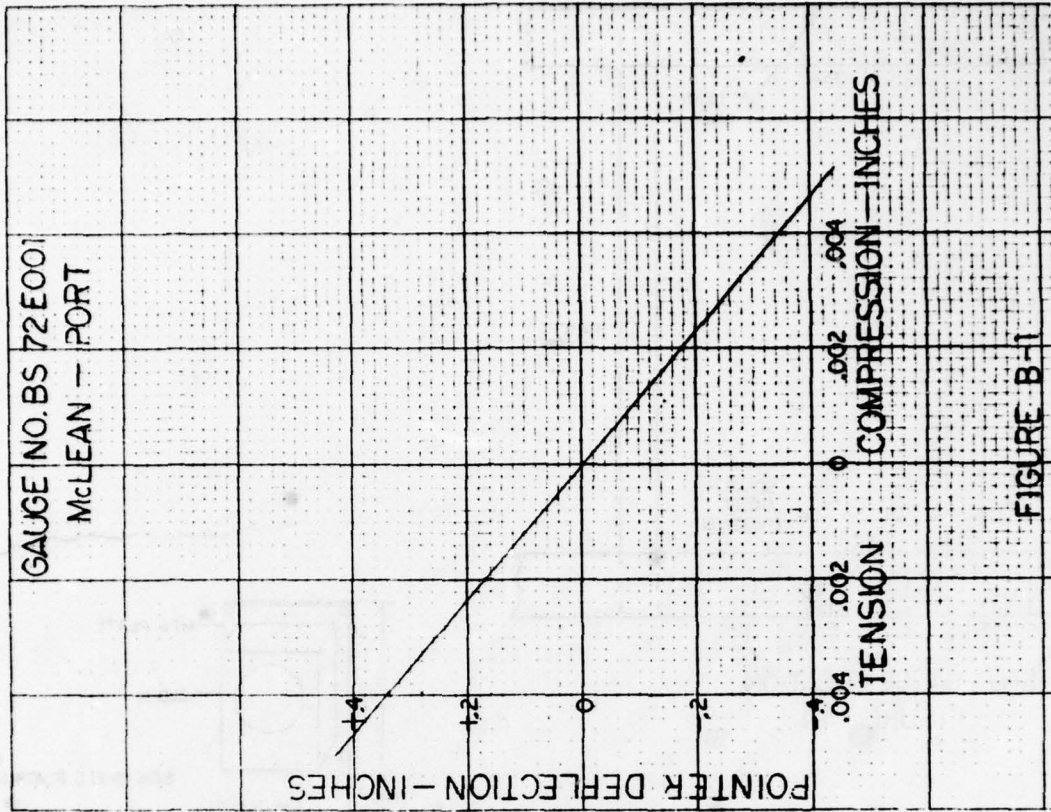
FIGURE B-1

GAUGE SERIAL NO. BS 72E 001 McLEAN
 STBD TUNNEL FR 186 1/4

INDICATOR	DEFLECTION		POINTER DEFLECTION (IN)
	Compression (in)	Tension (in)	
0.0		0.0	0.0
0.002			0.176
0.004			0.350
0.006			0.540
0.008			0.688
0.009			0.768
0.0	0.0		0.00
	0.002		0.172
	0.004		0.338
	0.006		0.536
	0.008		0.692
	0.01		0.85

Prior to installation, each recorder was calibrated on a Bridgeport Miller using a moveable table and a fixed collet to generate strain. The table was moved in increments of 0.001 inches using a dial indicator to measure the motion in both tension and compression. A calibration table and plot for each recorder is provided in Appendix B of this document.

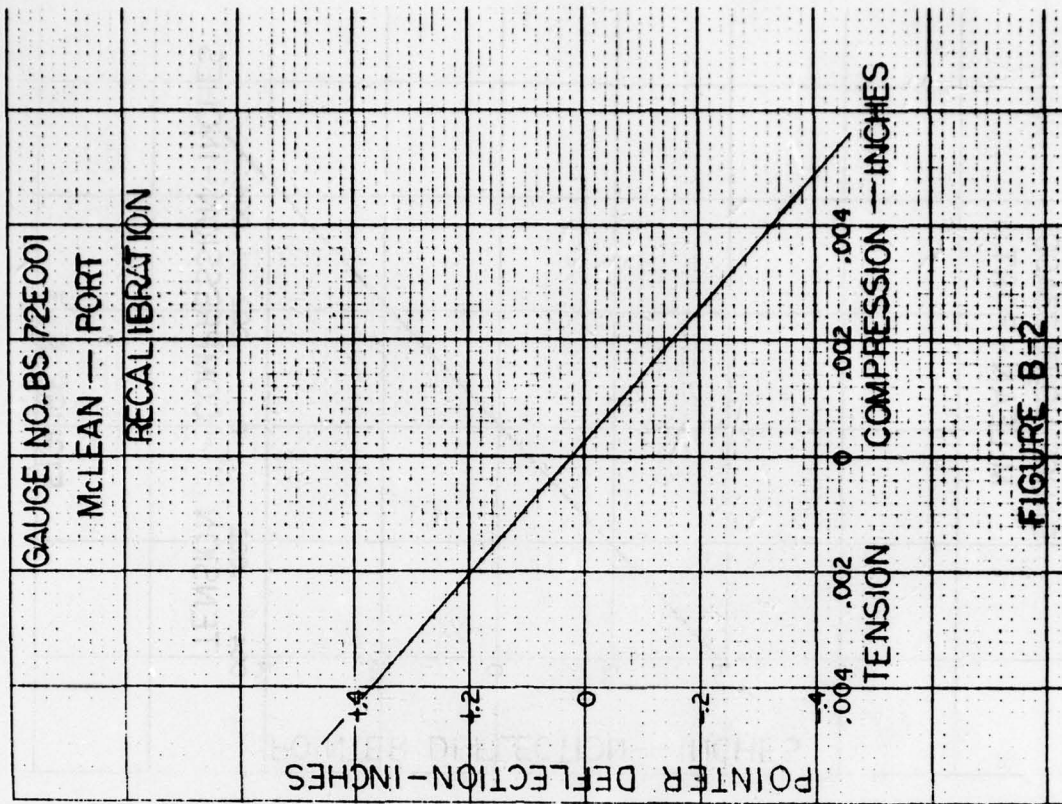
TABLE B-2
 STRAIN GAUGE RECORDER CALIBRATION DATA
 GAUGE SERIAL NO. BS 72E 001
 RECALIBRATION 11/26/75
 OF McLEAN PORT GAUGE

INDICATOR Compression (inch)	DEFLECTION Tension (inch)	POINTER DEFLECTION (IN)
0.0	0.0	0.0
0.002		0.15
0.004		0.33
0.006		0.53
0.008		0.72
0.100		0.91
	0.0	0.0
	0.002	0.2
	0.004	0.37
	0.006	0.57
	0.008	0.76
	0.010	0.95

*In order to ascertain if the calibration curve for an installed unit had shifted with time, the McLEAN port tunnel gauge, Serial No. BS 72E 001 was removed on October 18, 1975 and replaced with the spare unit. Serial No. BS 73E 001. The removed unit was returned to TES and recalibrated. See Appendix B for the results of this test.

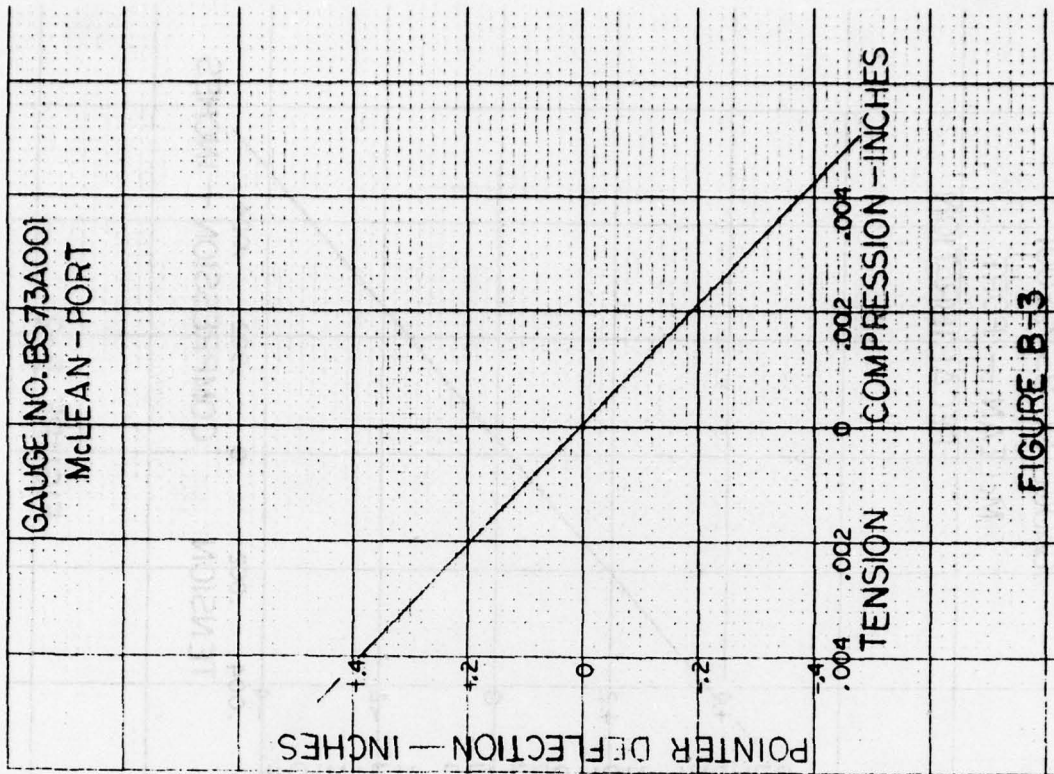
TABLE B-3

STRAIN GAUGE RECORDER CALIBRATION DATA

GAUGE SERIAL NO. BS 73A 001
(SPARE UNIT INSTALLED AS
McLEAN PORT 10/18/75)

INDICATOR Compression (in)	DEFLECTION		POINTER DEFLECTION (in)
	Tension (in)	Compression (in)	
0.0	0.0		0.0
0.001			0.100
0.002			0.20
0.003			0.28
0.004			0.37
0.005			0.47
0.006			0.55
0.007			0.68
	0.0		0.0
	0.001		0.10
	0.002		0.20
	0.003		0.30
	0.004		0.38
	0.005		0.49
	0.006		0.58

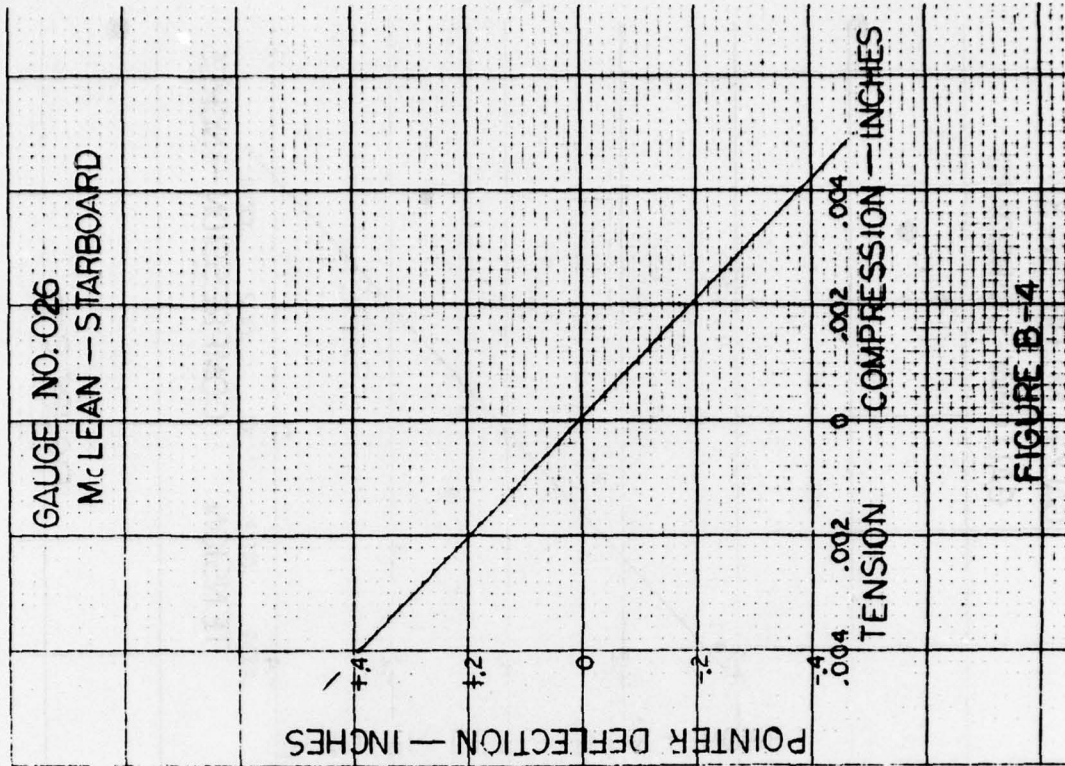
TABLE B-4
 STRAIN GAUGE RECORDER CALIBRATION DATA
 GAUGE SERIAL NO. 026 McLEAN
 STARBOARD TUNNEL FR 186 1/4

INDICATOR Compression (in)	DEFLECTION Tension (in)	POINTER DEFLECTION (in)
0.0	0.0	0.0
0.002		0.170
0.004		0.378
0.006		0.558
0.008		0.716
0.0	0.0	0.0
	0.002	0.198
	0.004	0.388
	0.006	0.560
	0.008	0.712
	0.01	0.874
0.0	0.0	0.0

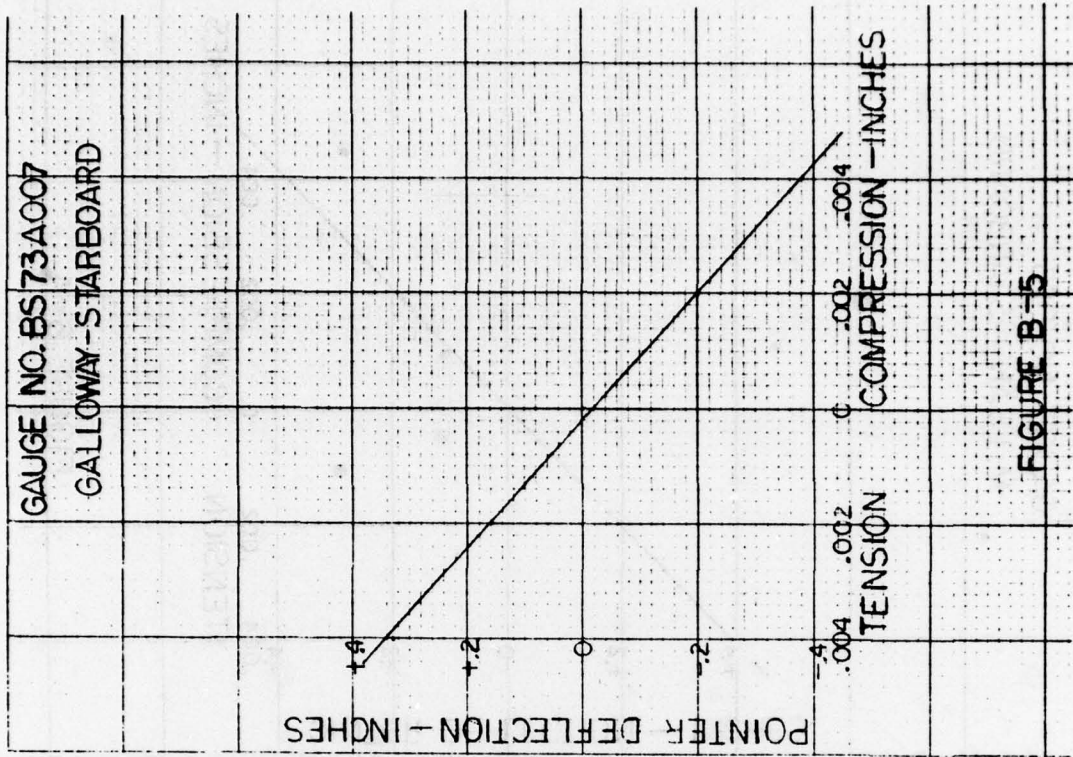
TABLE B-5
 STRAIN GAUGE RECORDER CALIBRATION DATA
 GAUGE SERIAL NO. BS 73A 007 GALLOWAY
 STBD TUNNEL FR 186 1/4

INDICATOR Compression (in)	DEFLECTION Tension (in)	POINTER DEFLECTION (IN)
0.0	0.0	0.0
.002		0.2
.004		0.38
.005		0.48
.006		0.51
.005		0.48
.004		0.39
.003		0.30
.002		0.16
.001		0.072
0.0	0	0
	.001	.12
	.002	.16
	.003	.28
	.004	.33
	.005	.45
	.006	.53
	0.0	0

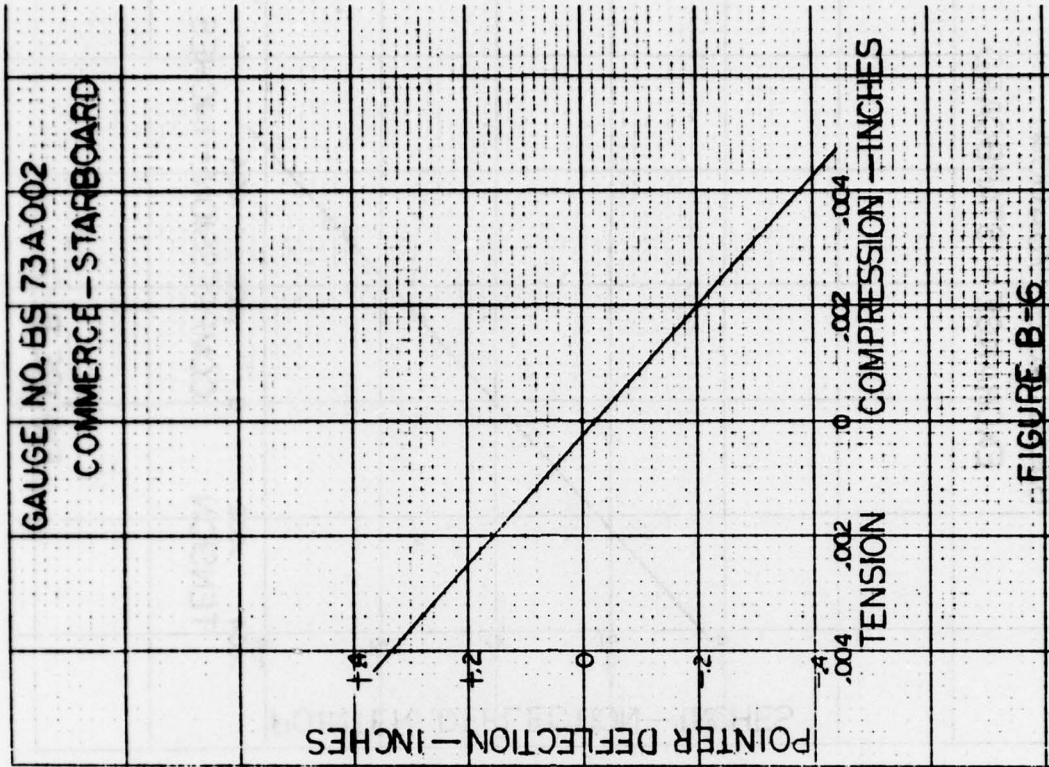
FIGURE B-6

TABLE B-6
 STRAIN GAUGE RECORDER CALIBRATION
 DATA GAUGE NO. BS 73A 002
 SEA-LAND COMMERCE STBD
 TUNNEL FR 186 1/4

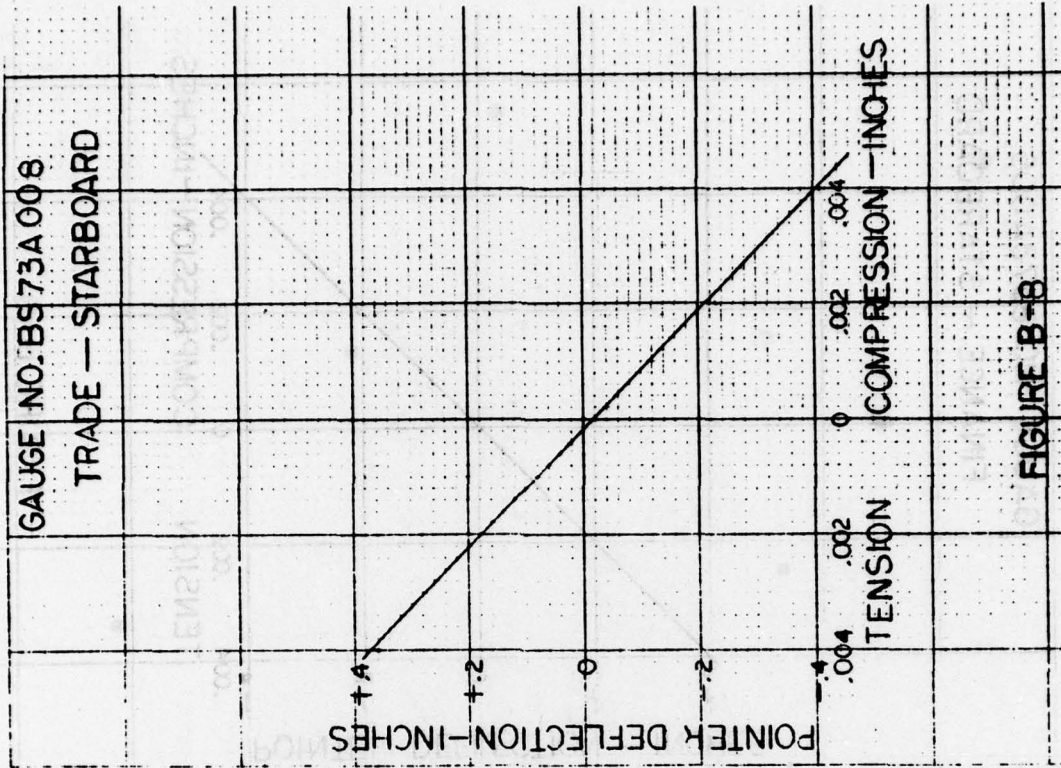
TABLE B-8
STRAIN GAUGE RECORDER CALIBRATION
DATA GAUGE SERIAL NO. BS 73A 008
SEA-LAND TRADE STBD
TUNNEL FR 186 3/4

INDICATOR Compression (in)	DEFLECTION Tension (in)	POINTER DEFLECTION (in)
0.0		0.0
0.001		0.128
0.002		0.232
0.003		0.252
0.004		0.408
0.005		0.50
0.006		0.60
	0.0	0.0
	0.001	0.06
	0.002	0.20
	0.003	0.28
	0.004	0.36
	0.005	0.46
	0.006	0.56

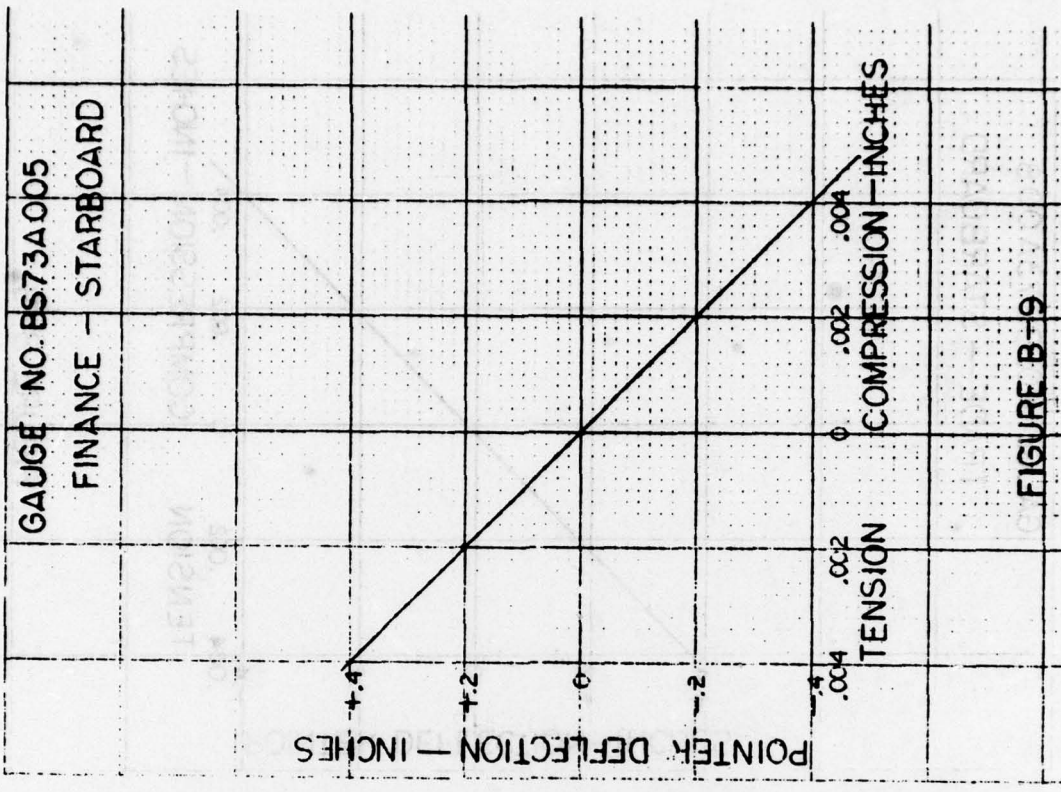
TABLE B-9
STRAIN GAUGE RECORDER CALIBRATION
DATA GAUGE SERIAL NO. BS 73A 005
SEA-LAND FINANCE STBD
TUNNEL FR 186 3/4

INDICATOR Compression (in)	DEFLECTION Tension (in)	POINTER DEFLECTION (in)
0.0		0.0
0.001		0.1
0.002		0.2
0.003		0.24
0.004		0.302
0.005		0.48
0.006		0.58
0.007		0.66
0.008		0.76
	0.0	0.0
	0.001	0.12
	0.002	0.20
	0.003	0.30
	0.004	0.40
	0.005	0.488
	0.006	0.60
	0.007	0.66
	0.008	0.76

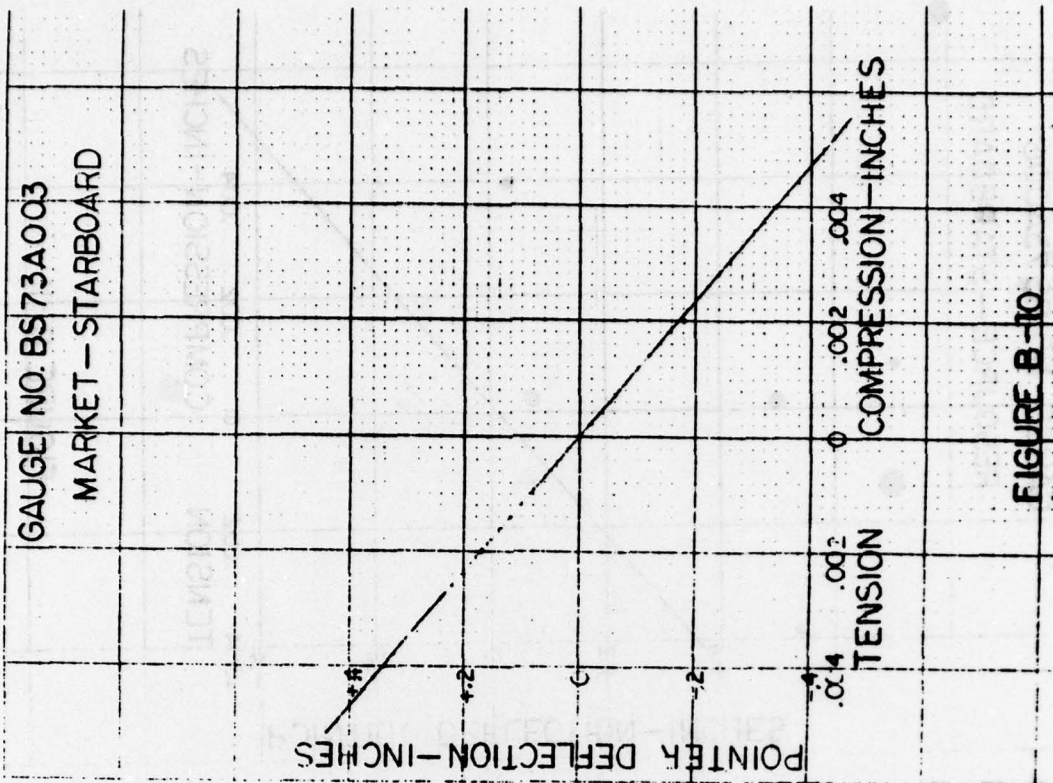
FIGURE B-10

GAUGE NO. BS 73A003
MARKET - STARBOARD

INDICATOR	DEFLECTION	POINTER DEFLECTION (IN)
0.0	Tension (in)	0.0
0.001		0.1
0.002		0.18
0.003		0.26
0.004		0.34
0.005		0.41
0.006		0.48
0.007		0.56
		0.64
		0.0
		0.1
		0.17
		0.26
		0.34
		0.42
		0.49
		0.56
		0.64

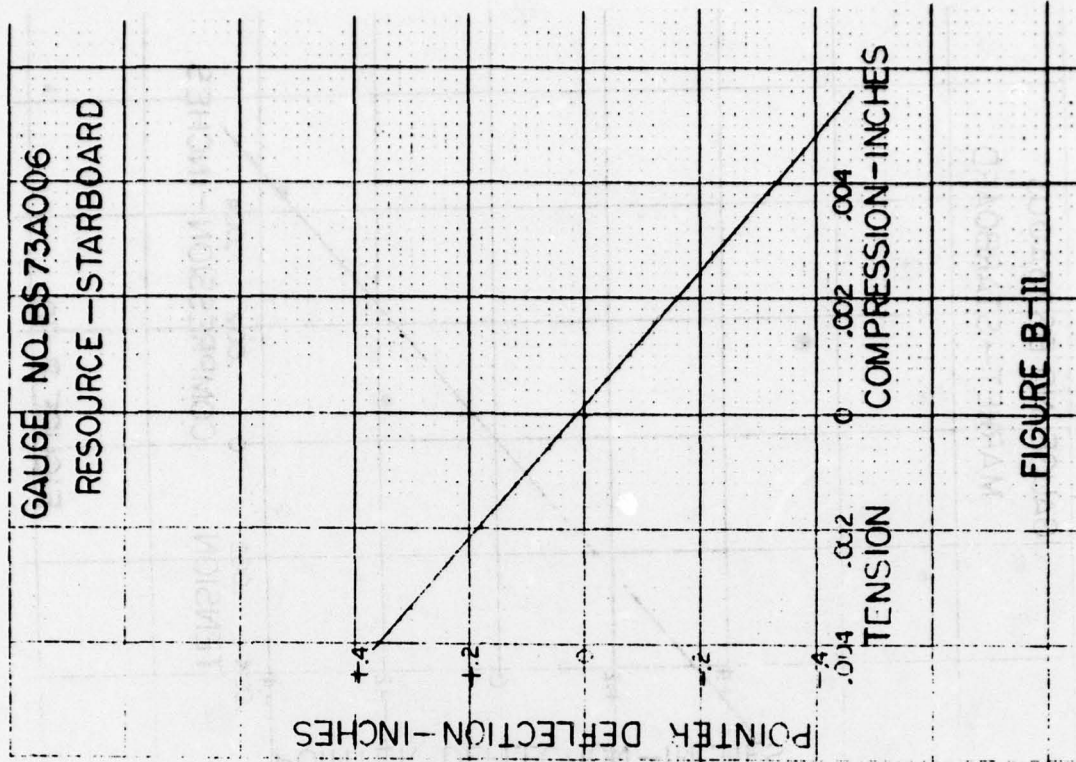
FIGURE B-II

GAUGE NO. BS 73A006
RESOURCE - STARBOARD

TABLE B-11
STRAIN GAUGE RECORDER CALIBRATION
DATA GAUGE NO. BS 73A 006
SEA-LAND RESOURCE
STBD TUNNEL FR 186 1/4
