Build 2 of an Accelerated Mission Test of a TF41 with Block 76 Hardware

Technical Report AFAPL-TR-79-2063

Final Report for Period 2 August 1978 - 20 September 1978

20. ABSTRACT (Continue on reverse side if necessary and identify by block number) An accelerated mission test (AMT) of a TF41 (S/N 142163) was conducted in the Air Force Aero Propulsion Laboratory's "D" Bay Sea-Level Engine Test Facility between 2 August 1978 and 20 September 1978. The primary objective of the test was to evaluate the structural reliability of a series of parts changes known as "Block 76" hardware. A two-hundred-sixty-three hour test program was initially planned but only one-hundred-eighty-nine hours were actually completed due to the failure of a first stage high pressure turbine blade. Post-test teardown showed all of the "Block 76" hardware to be in good condition. Engine perfor-

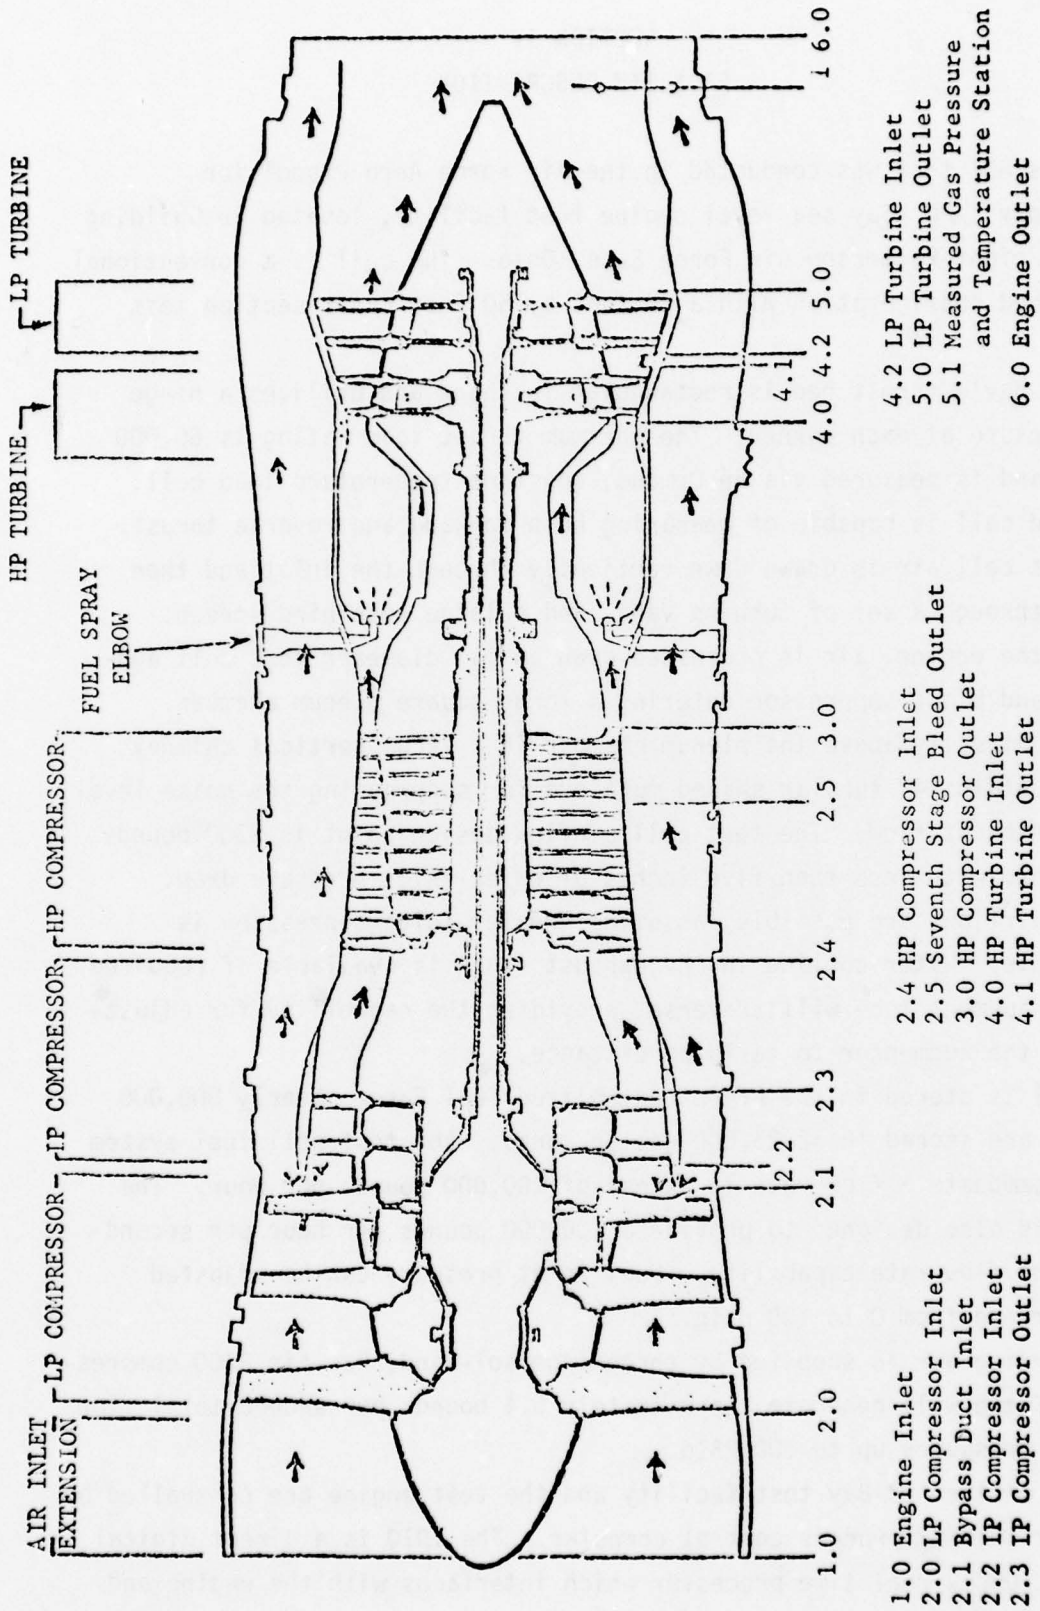
FIGURE 1 - TF41 ENGINE SCHEMATIC

The TF41-A-1 is a mixed flow turbofan engine manufactured by Detroit Diesel Allison Division of General Motors and is currently used to power the Air Force and Navy's A7 aircraft. The engine is a twin spool design with a three-stage low pressure compressor driven by a two-stage low pressure turbine. The core engine consists of a two-stage intermediate pressure compressor also driven by the low pressure turbine and an 11-stage high pressure compressor with variable inlet guide vanes driven by a two-stage high pressure turbine. In the production version, first and second stage vanes and the first stage blades of the high pressure turbine are aircooled. The main burner is an axial flow design incorporating ten cannular combustion chambers. The core engine exhaust gas and the bypass air are mixed downstream of the low pressure turbine and exhausted out a fixed area convergent nozzle. The engine is shown schematically in Figure 1.

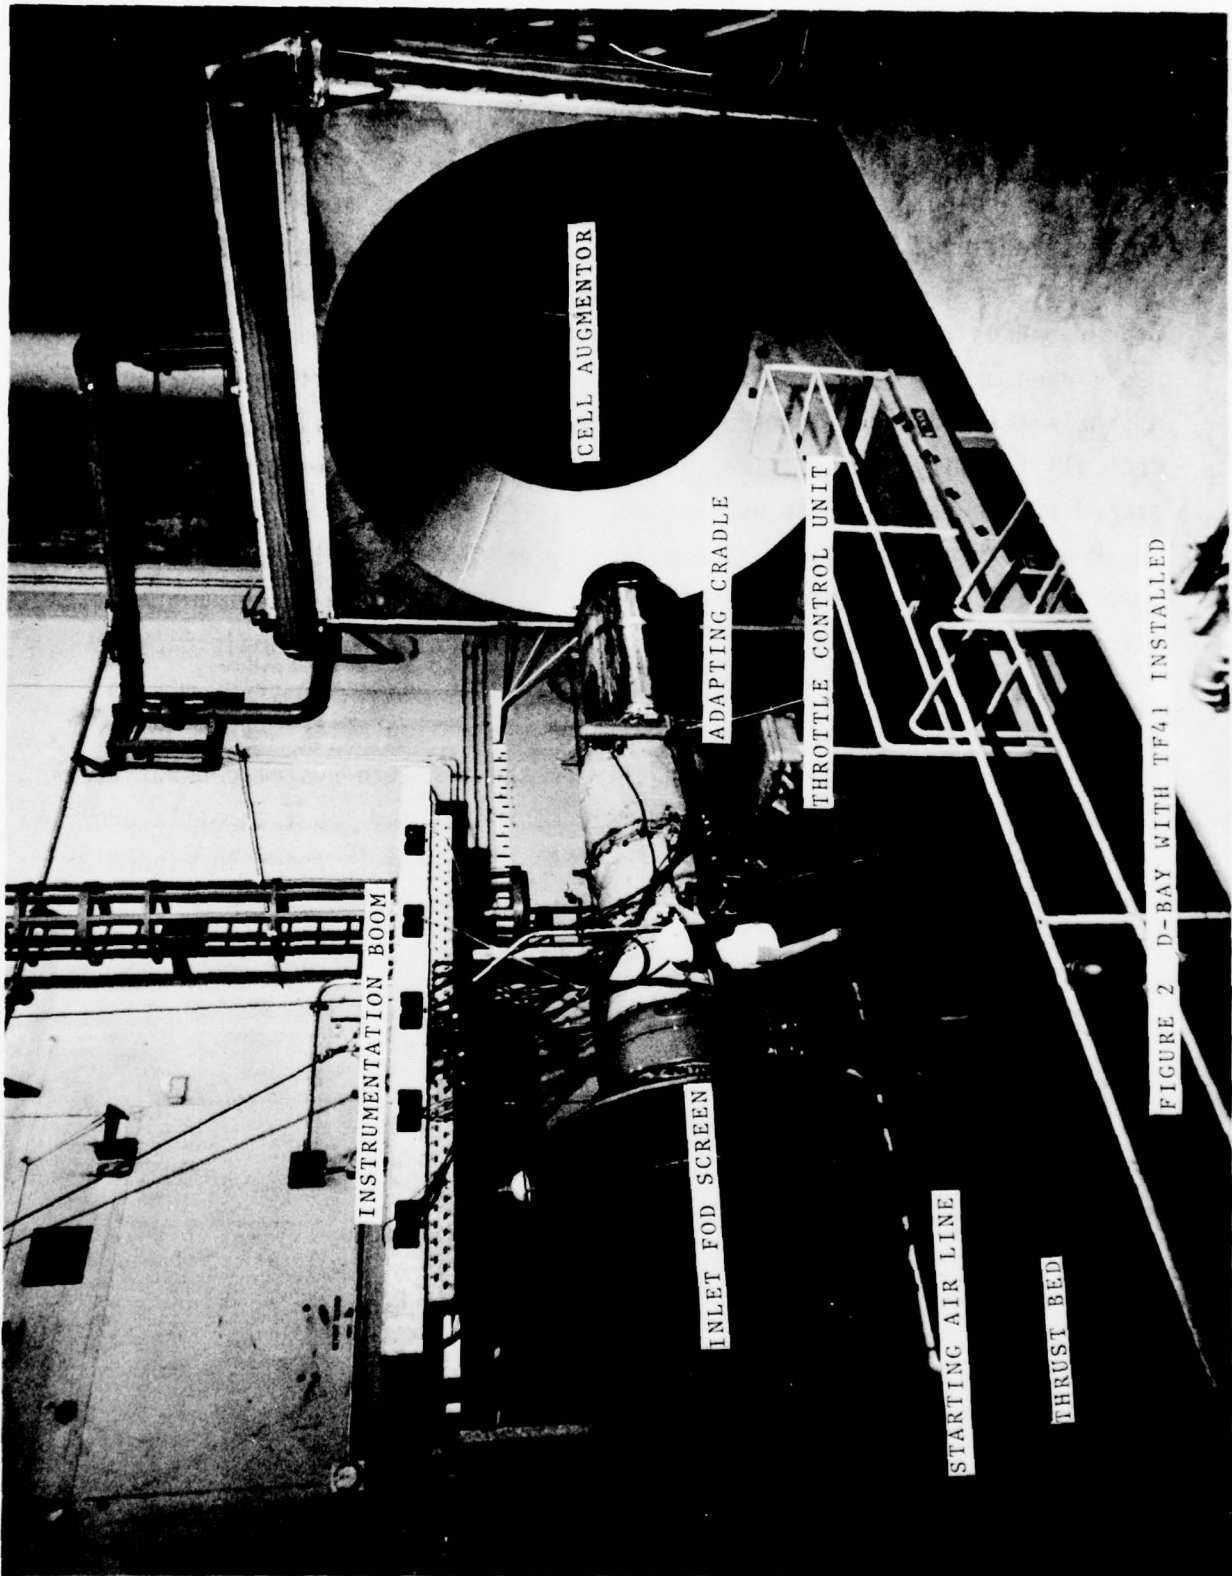
FIGURE 2 D-BAY WITH TF41 INSTALLED

A picture of the facility with the TF41 installed is shown in Figure 2. A more detailed description of the facility and the computer can be found in reference 1.

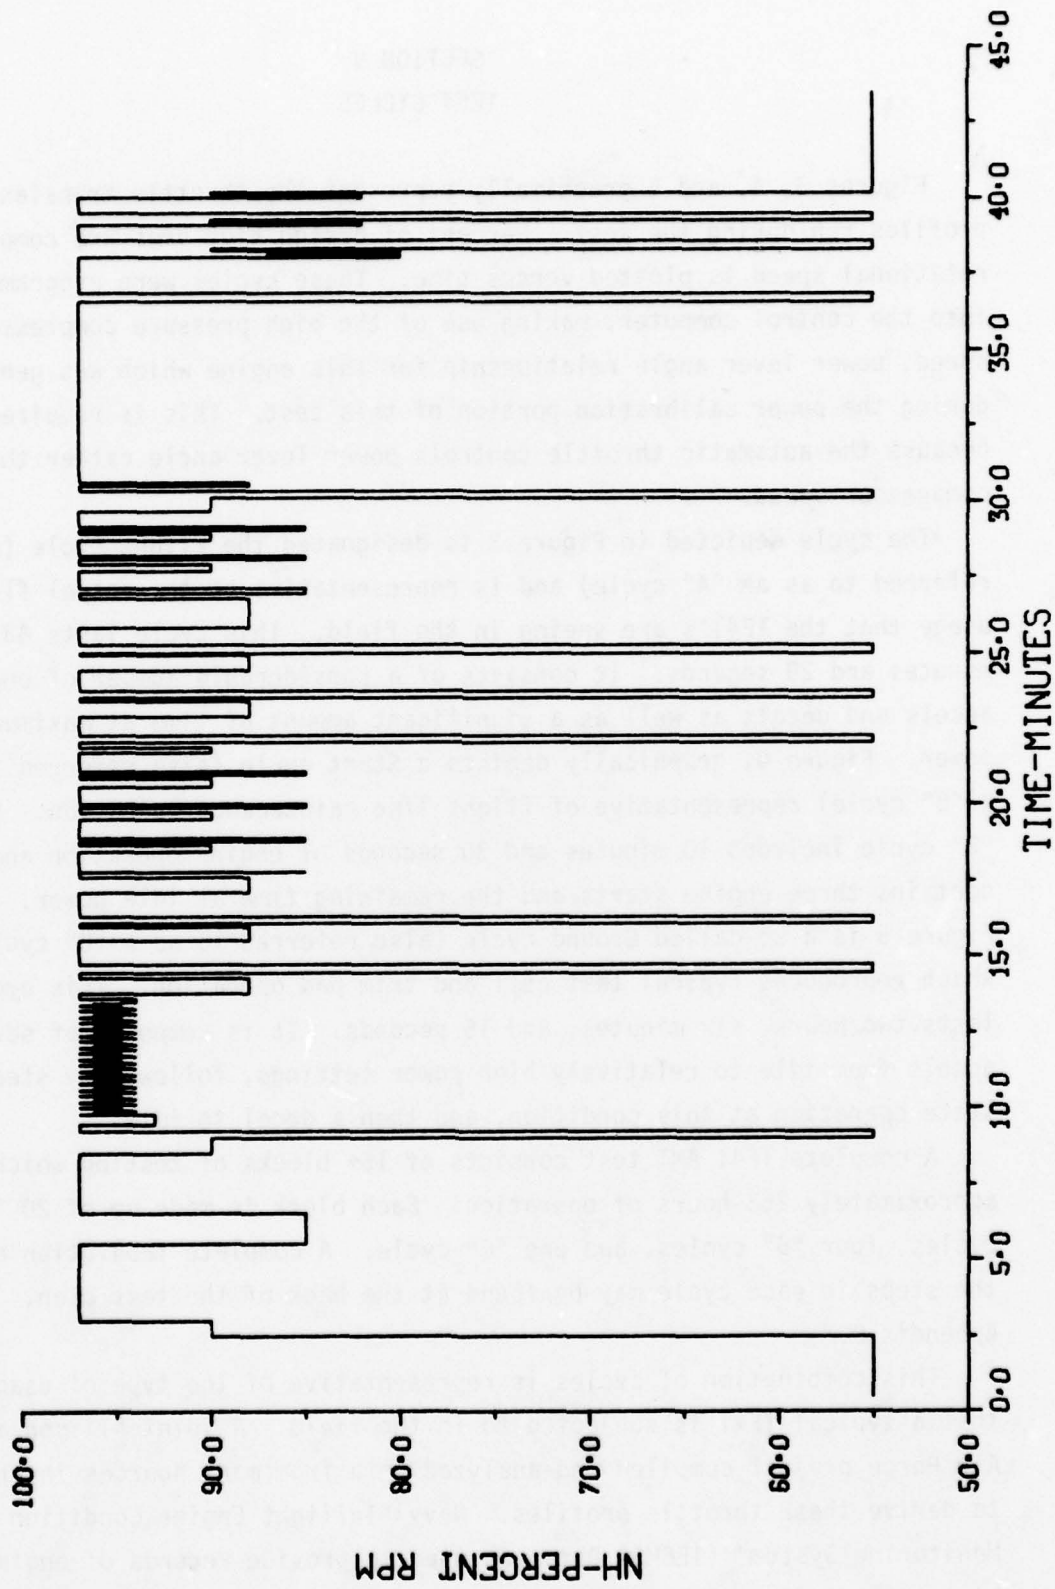
Figure 3 - TF41 Flight Cycle

A complete TF41 AMT test consists of 15+ blocks of testing which is approximately 263 hours of operation. Each block is made up of 20 "A" cycles, four "B" cycles, and one "C" cycle. A complete tabulation of the steps in each cycle may be found at the back of the test plan, Appendix D.

This combination of cycles is representative of the type of usage that a typical TF41 is subjected to in the field. A joint Allison and Air Force project compiled and analyzed data from many sources in order to derive these throttle profiles. Navy "Inflight Engine Condition Monitoring System" (IECMS) Data was used to provide records of engine histories during actual flight. An extensive program of pilot interviews

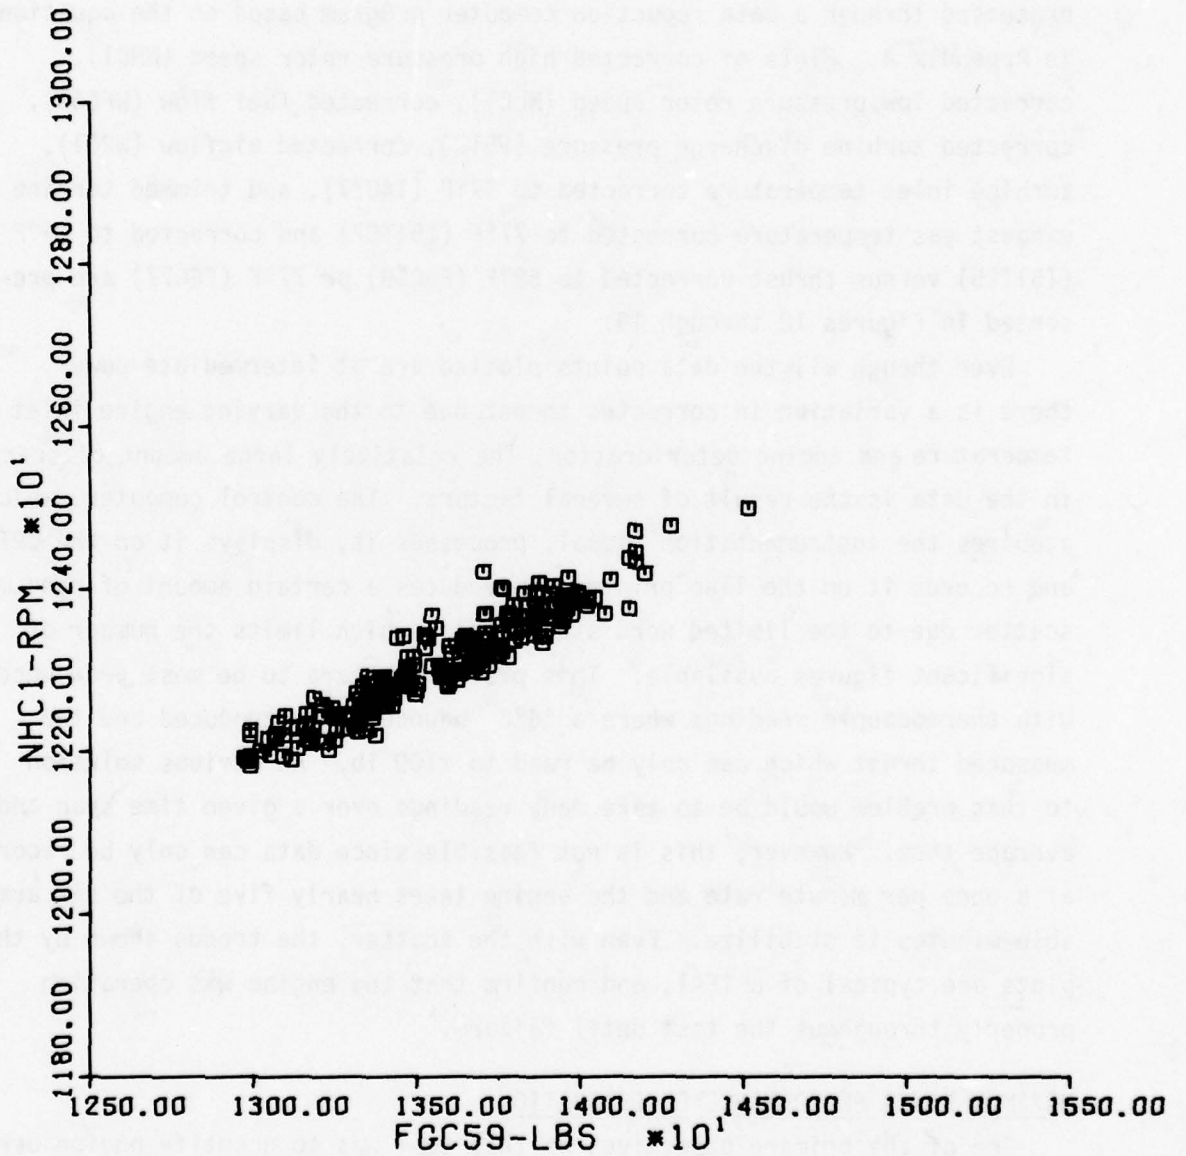
Figure 12

One of the primary objectives of this test was to quantify engine performance deterioration under realistic usage conditions. In past tests, one approach has been to track maximum power thrust (recorded during the six minute "flat" of each A cycle) as a function of engine operating time.

Corrected High Pressure Rotor Speed versus Corrected Thrust

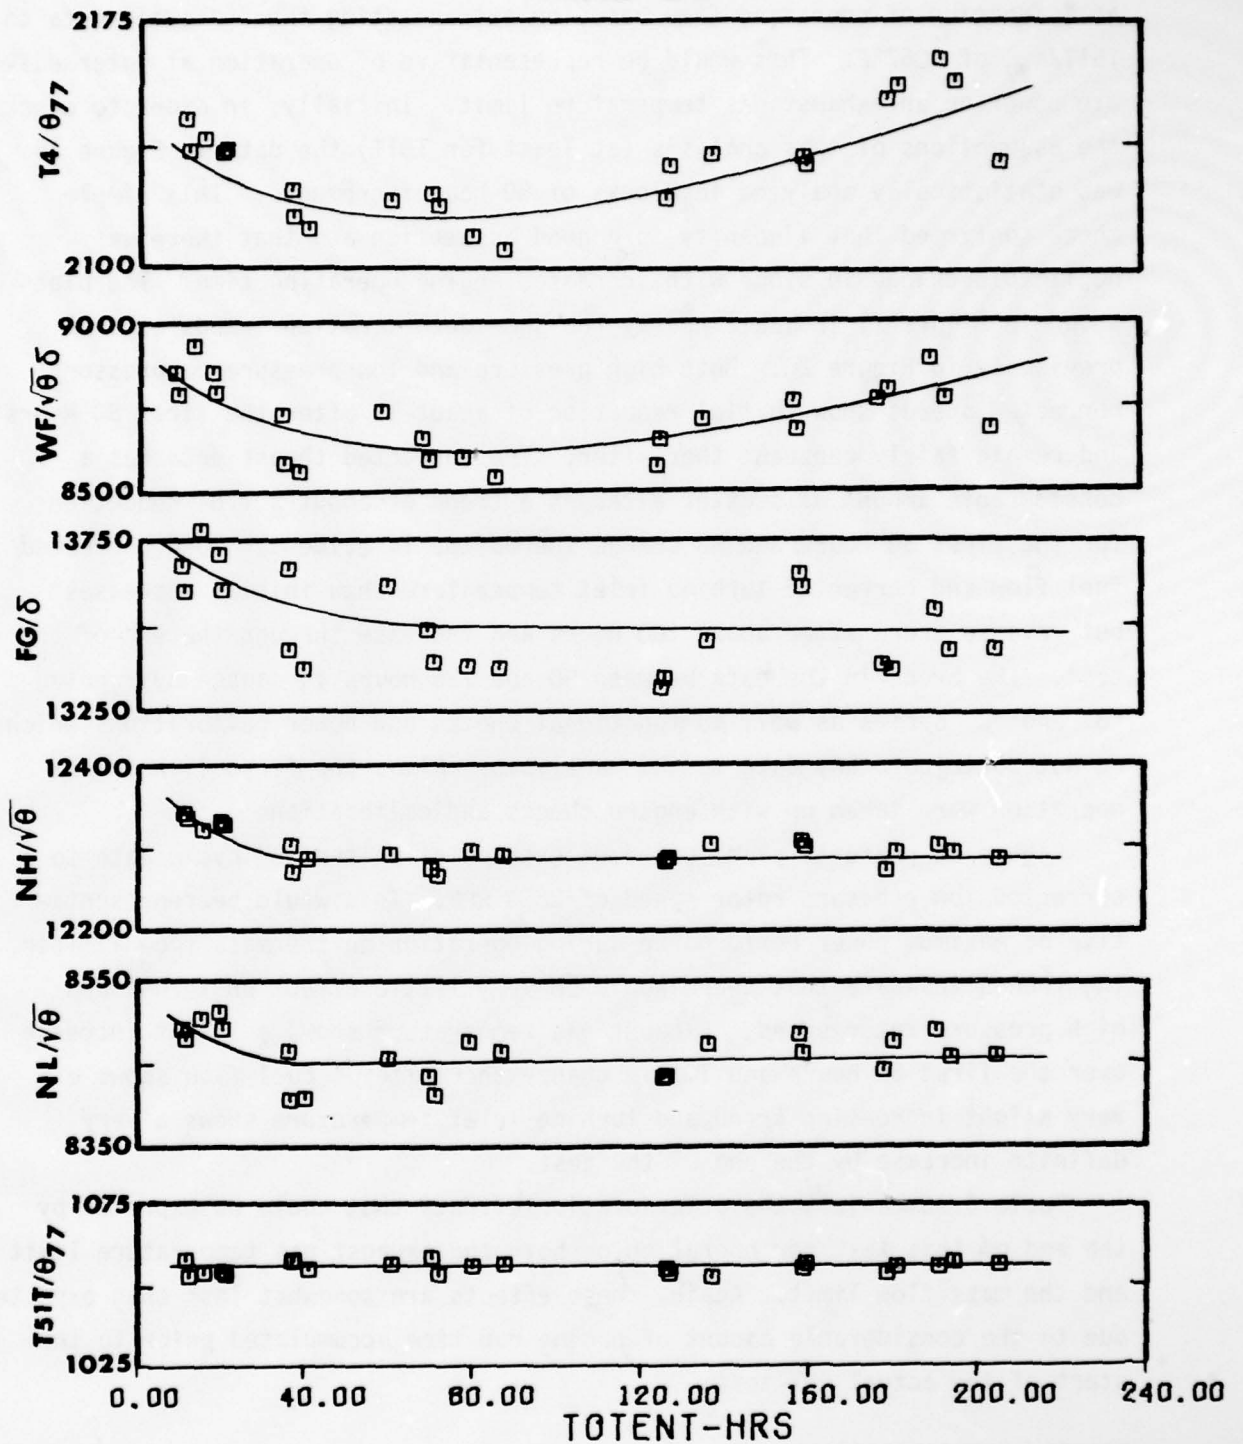
Figure 20

Another method for tracking engine performance deterioration was devised which made use of the entire mass of the "A" cycle data despite the differences in engine inlet temperature. Assuming that the data presented in Figures 12 through 19 are linear functions of corrected thrust and further assuming that the derivative of this relationship does not change with engine deterioration (i.e., the slope of the curve), then all the recorded data points can be extrapolated to the same condition allowing a consistent comparison as a function of total engine operating time. Comparisons were made extrapolating the data to a constant corrected trimmed exhaust gas temperature and also for a constant corrected low pressure rotor speed.

Deterioration Characteristics at Constant Ambient Temperature

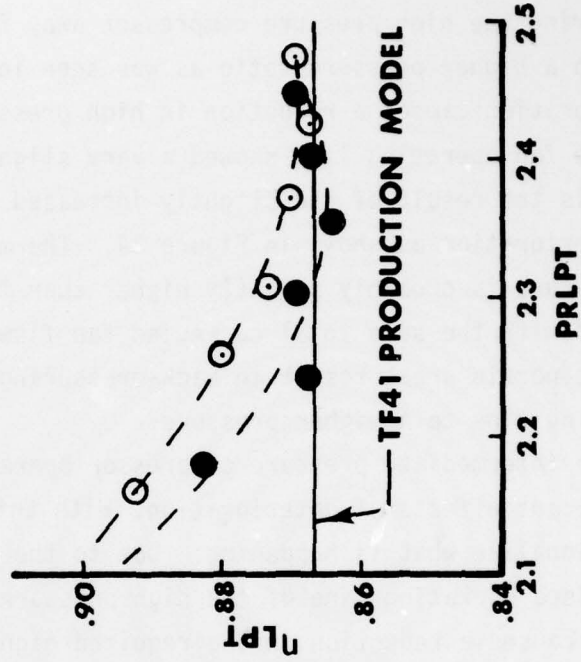
Figure 44 - Changes in Turbine Performance

capability. In order to choke the high pressure turbine nozzle with the higher turbine inlet temperature but the same flow, requires the deteriorated engine to have a higher pressure. This is the same as backpressuring the high pressure compressor away from its normal operating line to a higher pressure ratio as was seen in Figure 42. Thus, deterioration causes a reduction in high pressure compressor surge margin.

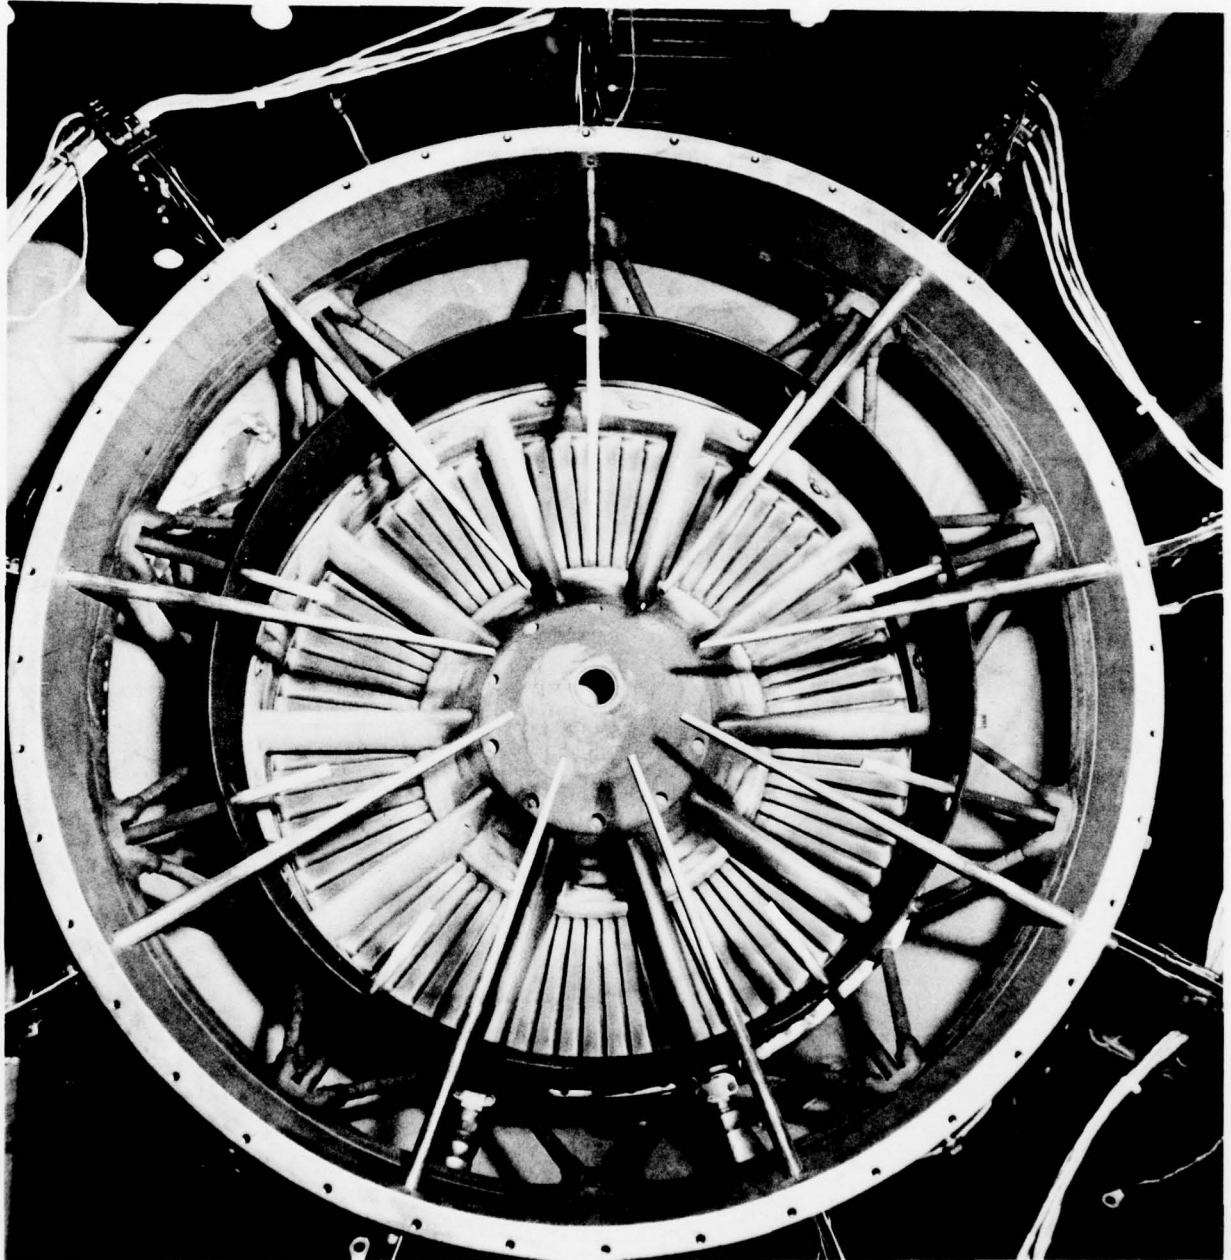
Figure 45  
Temperature Probes Installed in Tailpipe

An exhaust gas temperature survey was also run in conjunction with the steady-state performance calibrations at 0 and 100 AMT hours. A 45 thermocouple rake was positioned in the turbine exhaust (Figure 45). A steady-state data point was recorded. The rake was then rotated one tailpipe bolt hole to give a different angular positioning of the probes. This was repeated a total of four times giving a total of 180 temperature readings to map the exhaust gas temperature profile. The results of this survey at 0 and 100 AMT hours are plotted as isotherms in Figures 46 and 47.

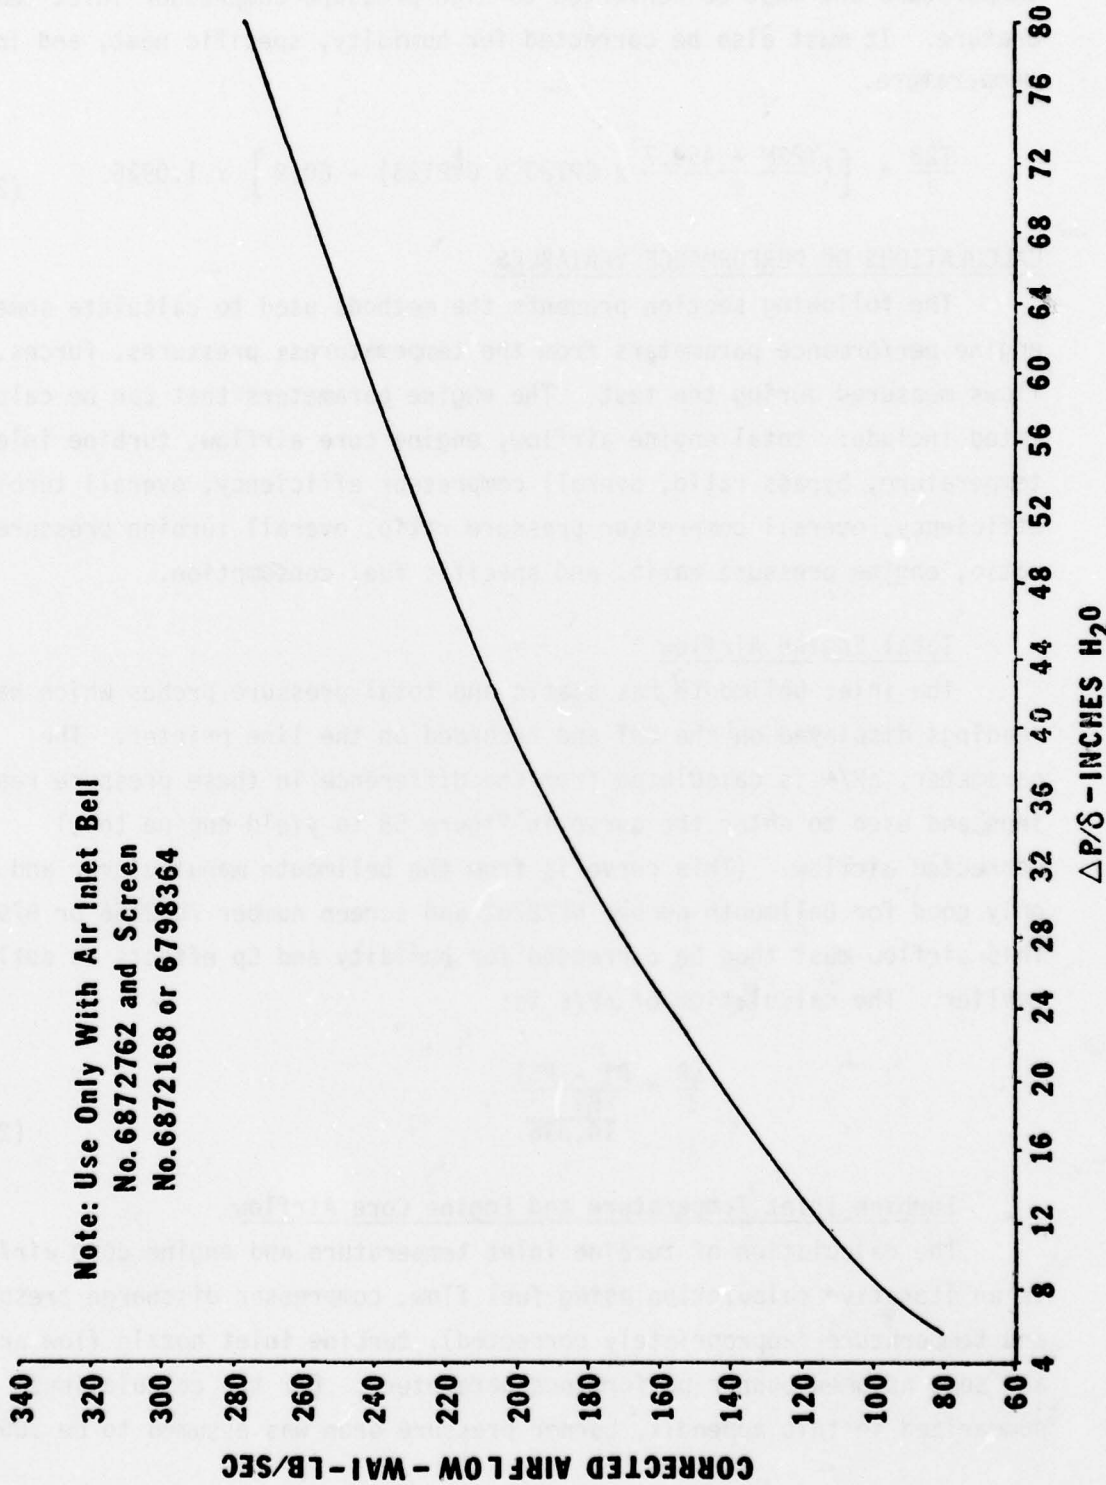
FIGURE 56 - INLET BELLMOUTH CHARACTERISTICS

**Note: Use Only With Air Inlet Bell  
No. 6872762 and Screen  
No. 6872168 or 6798364**

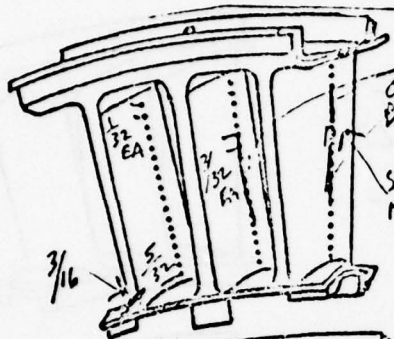
CRACKS BETWEEN HOLES  
SECTION MISSING

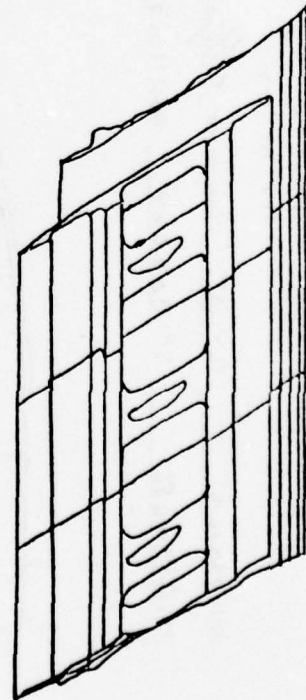
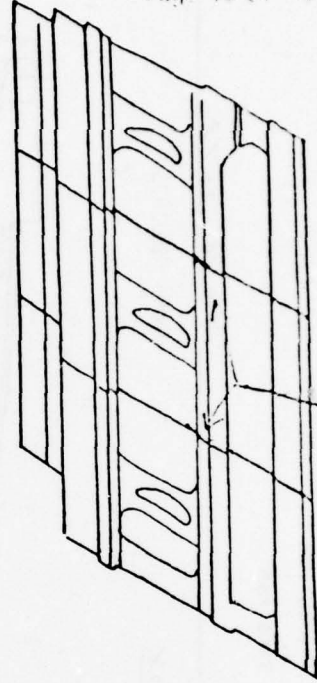
S/N 142163/A  
Page 18 of 20

SPOT WELDS CRACKED

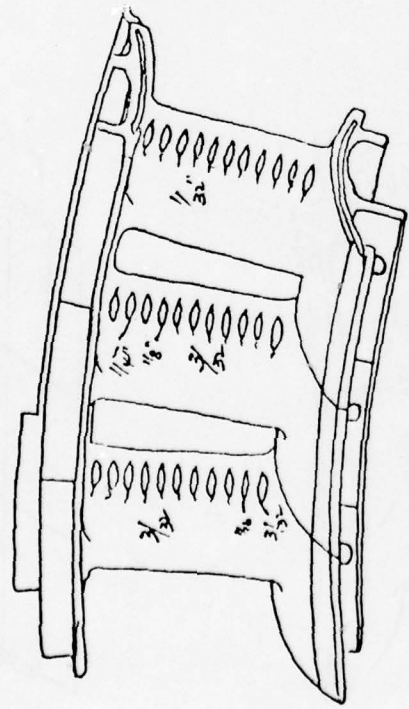
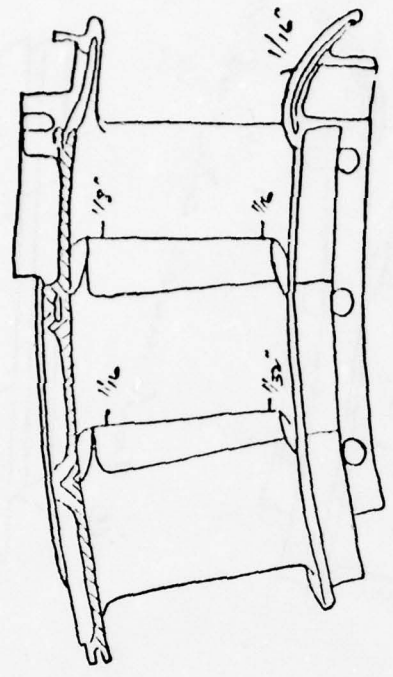
Unit 42163 TU 5 Inspector Stephen Date 10-17-78  
P/N: 6894686 S/N: C 01925 Position 10, 11, 12 Ref: 6962975

OUTER BAND  
all cracks inside band app 1/8" long

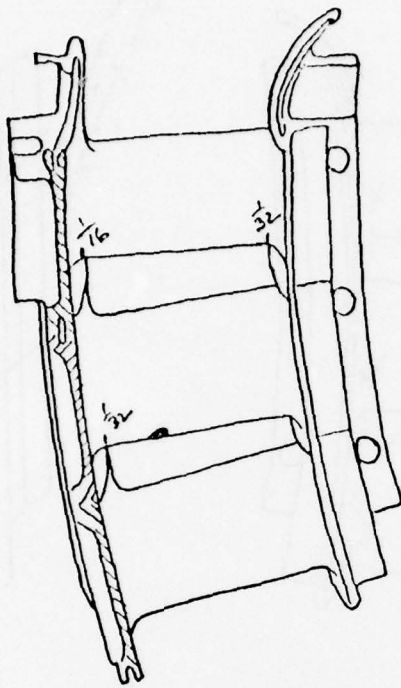
Unit 142163 TU 5 Inspector Chasey  
 P/N: PL6862973 S/N: 600534 Position 16-17-18  
6894686A

*Cracks inside  
 outer band between  
 vanes.*
