FAA-NA-79-27

FAA-RD-79-65

**CABIN HAZARDS FROM A LARGE EXTERNAL
FUEL FIRE ADJACENT TO AN AIRCRAFT FUSELAGE**

AUGUST 1979

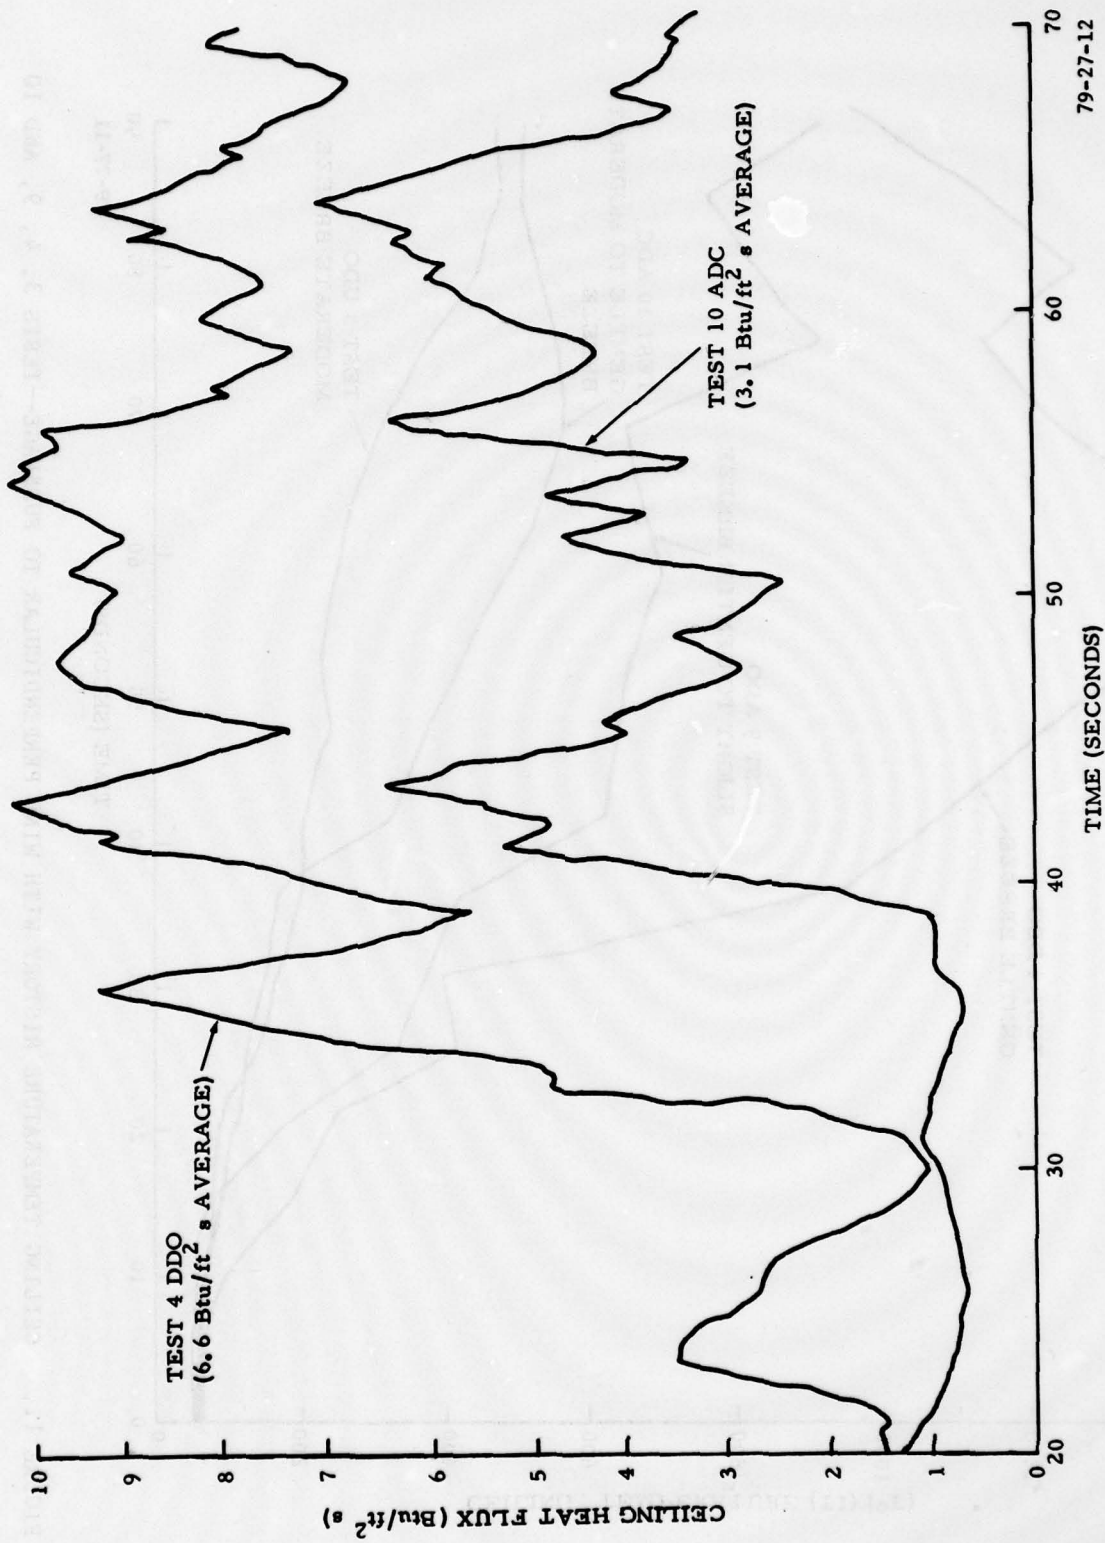
FIGURE 12. CEILING HEAT FLUX WITH WIND PERPENDICULAR TO FUSELAGE--TESTS 4 AND 10

The ceiling calorimeter outputs for test 9 (ADO) and test 10 (ADC) are included in figures 13 and 12, respectively. Intermittent flame penetrations occurred during tests 9 and 10. More severe flame penetrations in test 9 produced a higher accumulation of heat (appendix B page B-5) and a more rapid accumulation of smoke (appendix B page B-2) than during test 10. More smoke and heat inside the cabin when all doors are opened as opposed to when all doors are closed, with wind, produced the same trend as with calm wind conditions (figure 5). Figure 15 shows flame penetration during a perpendicular wind test (test 9). The smoke layer is evident near the top of the doorway.
