CONTRACTOR REPORT ARLCD-CR-79007

**HAZARD CLASSIFICATION TESTING OF M-10  
AND M-1 PROPELLANTS USED IN 81 MM,  
155 MM AND 8-INCH AMMUNITION**

**J. W. GEHRING  
SOUTHWEST RESEARCH INSTITUTE  
SAN ANTONIO, TEXAS**

**JUNE 1979**

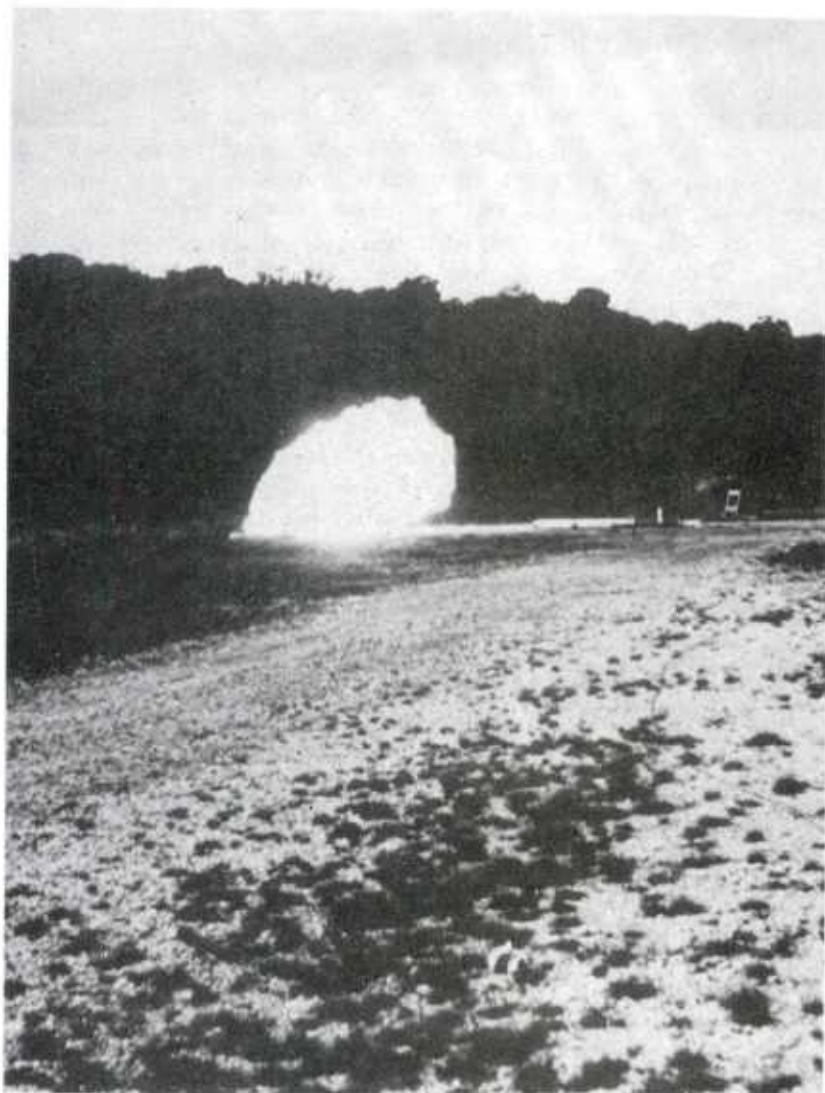
FIGURE 1. VIEW OF DONOR DRUM BURNING, WITH NO  
PROPAGATION TO ACCEPTORS

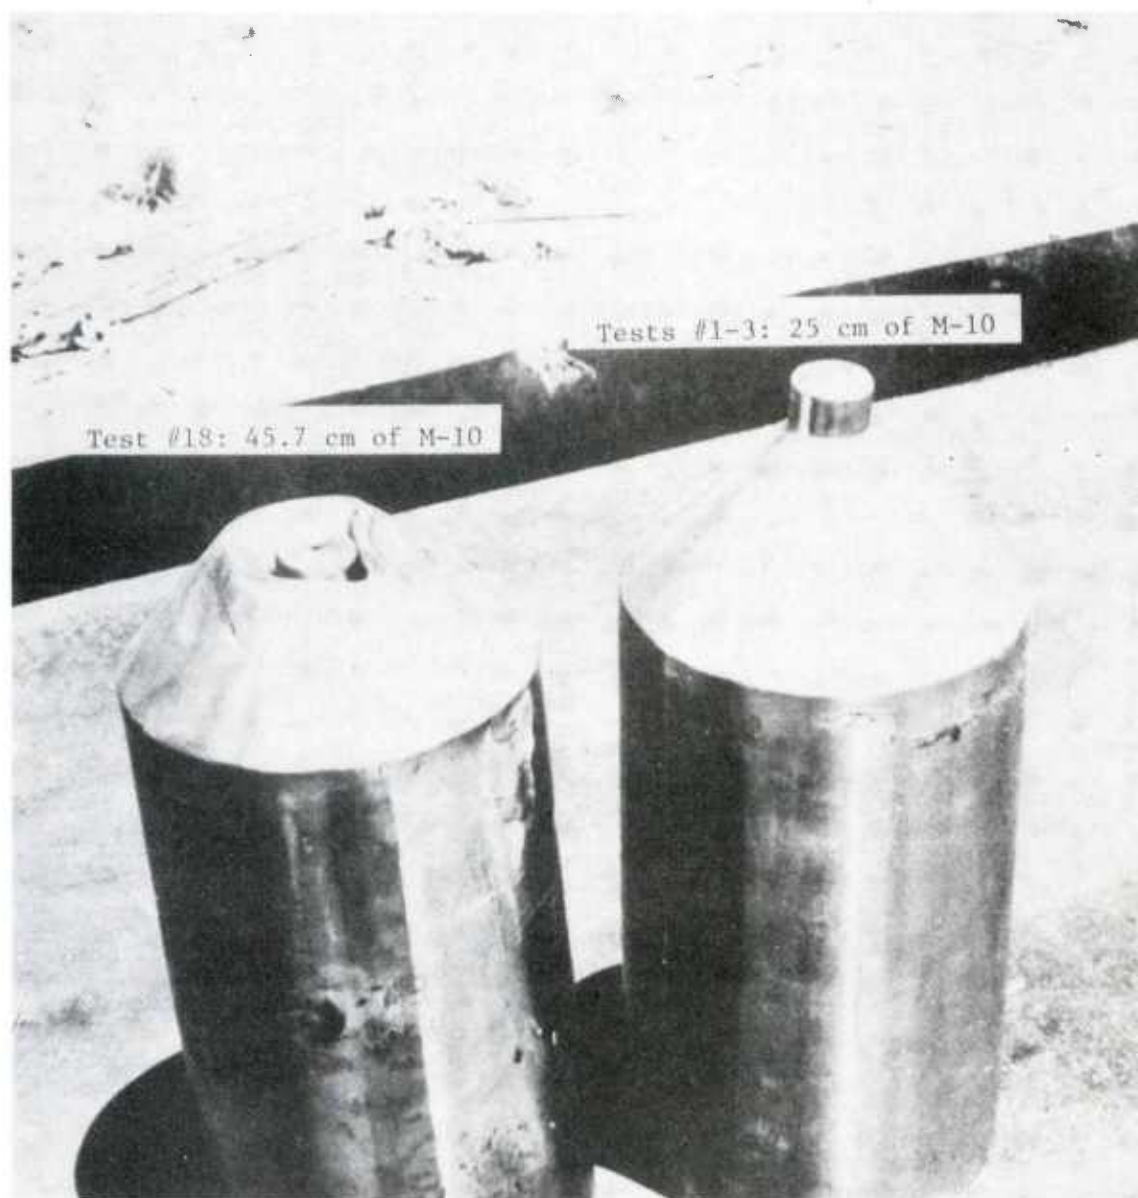
FIGURE 7. RELATIVE DAMAGE TO BASE OF M-10 HOPPERS

At this point it was judged that a true detonation occurred. The relative damage to the M-10 hoppers is shown in Figure 7 for the 25 cm height and 45.7 cm height of propellant. Obviously, at 50.8 cm where the propellant detonated, the hopper was totally destroyed.

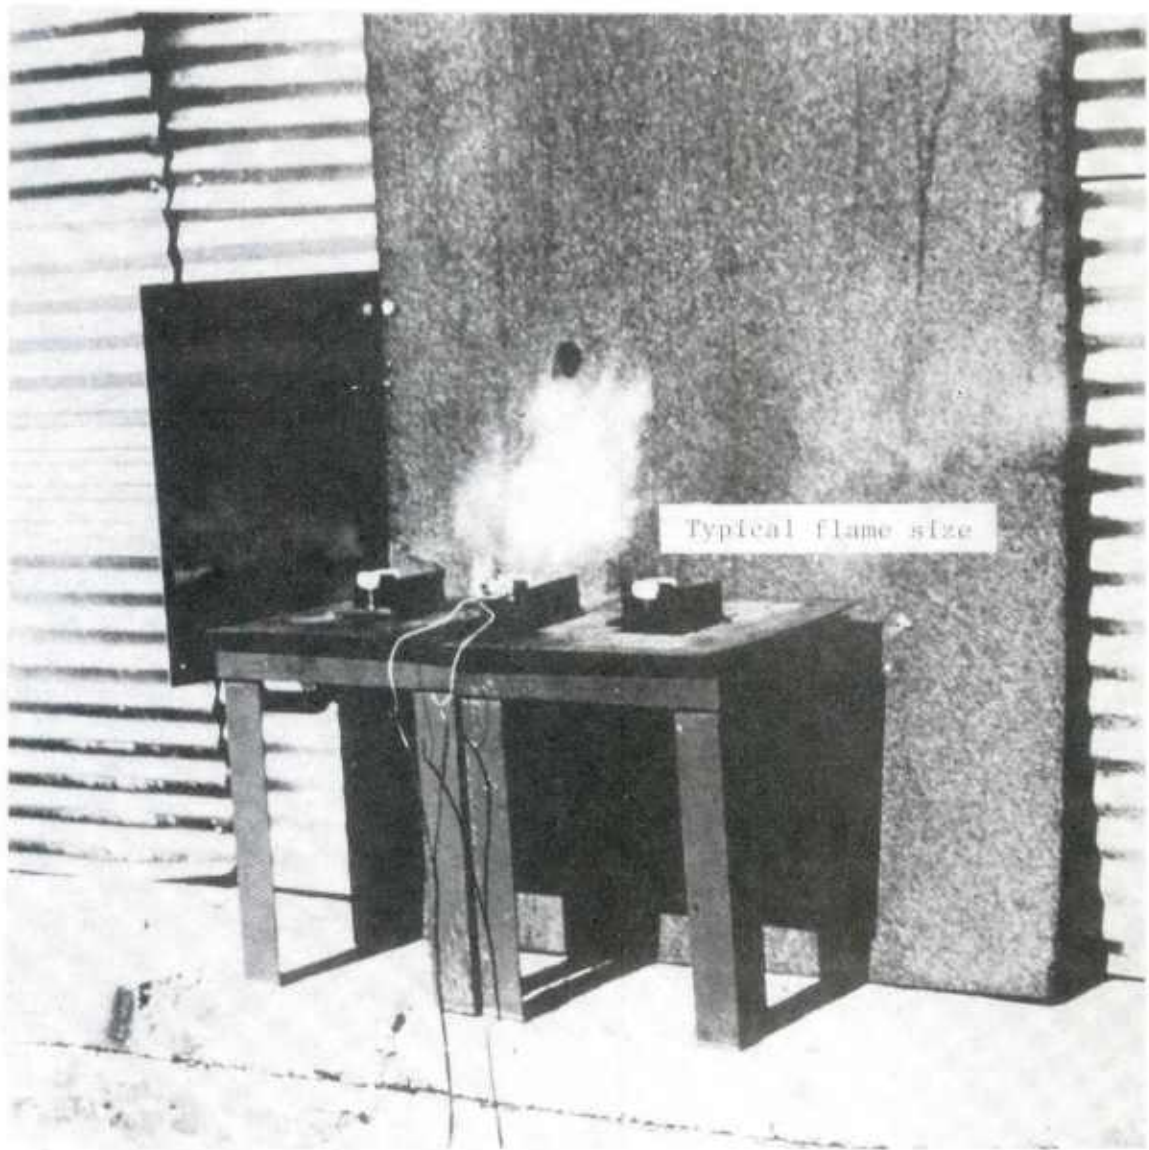
FIGURE 11. BURNING OF DONOR 81mm MORTAR INCREMENT

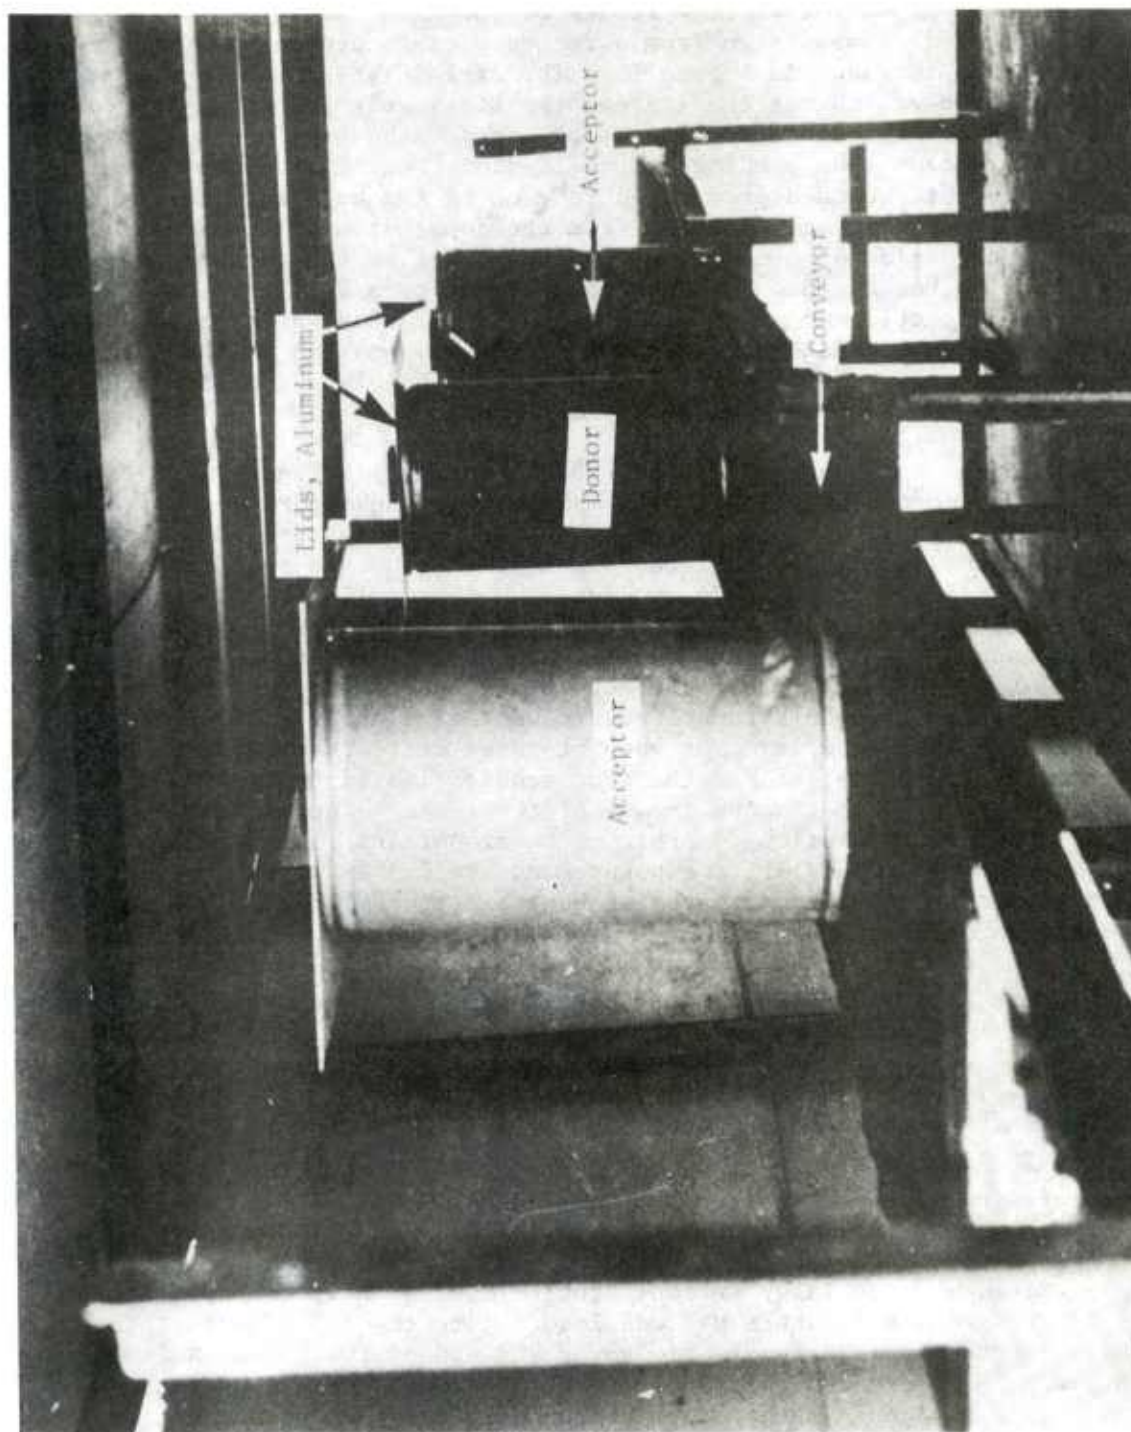
FIGURE 13. TEST #1 AT 2.4 m SHOWING DRUMS WITH LIGHTWEIGHT ALUMINUM LIDS
