EVALUATION OF 100 MM BORE BEARINGS AFTER ACCELERATED TESTING IN A SIMULATED SPACE ENVIRONMENT.

TECHNICAL REPORT AFML-TR-79-4083

Interim Report for Period October 1976 - September 1977

AIR FORCE MATERIALS LABORATORY
AIR FORCE WRIGHT AERONAUTICAL LABORATORIES
AIR FORCE SYSTEMS COMMAND
WRIGHT-PATTERSON AIR FORCE BASE, OHIO 45433

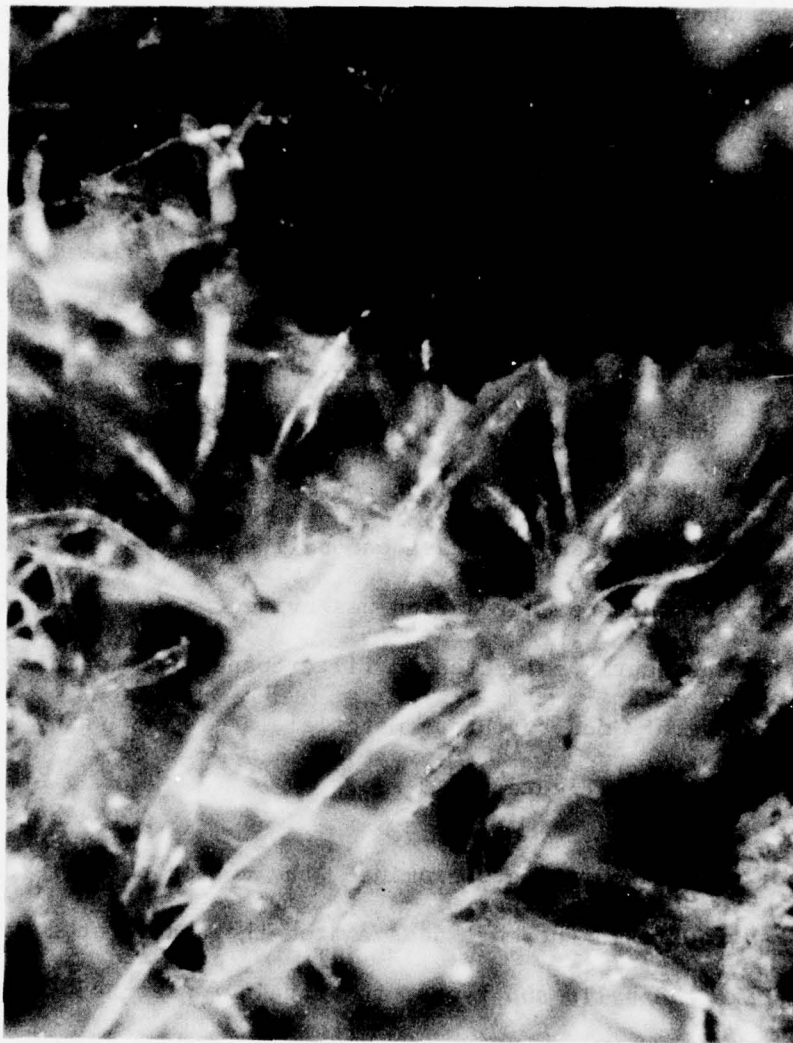
Figure 6. Heptane Wash Residue from Races

As previously mentioned, the balls and races were each pressure rinsed separately with heptane and the rinse solution was filtered leaving debris typified by that in Figures 6 and 9. Among this debris, there was a total of about four shiny metallic looking flakes. Attempts to pick up these flakes with a pointed magnet were unsuccessful. The fact that the flakes were not magnetic suggests that perhaps they were flakes of aluminum foil that found their way into the bearing from packaging. Surprisingly, some pieces of black debris were attracted to the magnet. At this time, it is
