MODEL 540 ROTOR BLADE CRACK PROPAGATION INVESTIGATION

August 1979

Final Report for Period January 1978 - February 1978

APPLIED TECHNOLOGY LABORATORY
U. S. ARMY RESEARCH AND TECHNOLOGY LABORATORIES (AVRADCOM)
Fort Eustis, Va. 23604

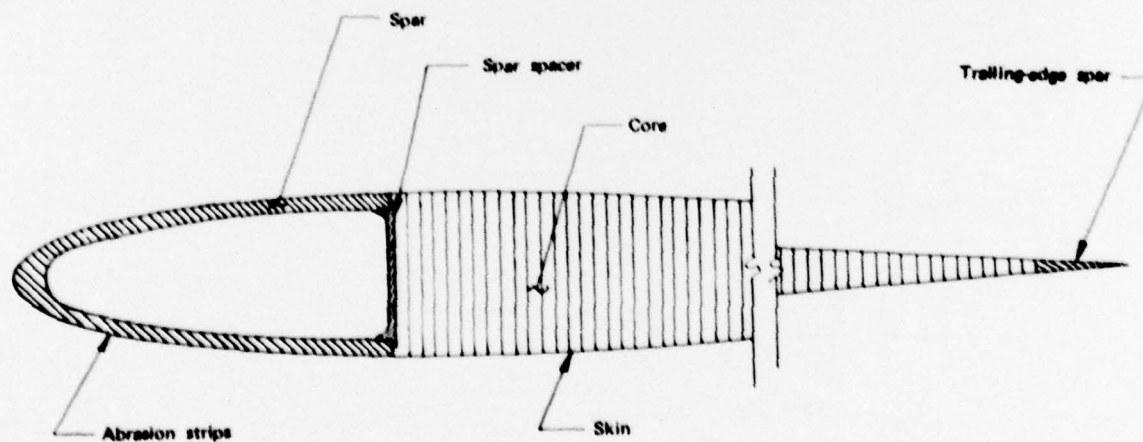
Figure 1. Cross section of 540 rotor blade.

The rotor blade tested was a Bell Helicopter Company (BHC) Model 540 main rotor blade and was residual property from the Model 540 Rotor Blade Fatigue Test Program (Reference 1). The blade is approximately 19 feet long with a 27-inch chord and a 9-1/3-percent-thick symmetrical airfoil section. Figure 1 shows a typical cross section of the 540 rotor blade. The spar is made from a C-section extrusion of 2024 aluminum alloy and forms the basic profile of the leading edge. The spar spacer is also a 2024 aluminum alloy extrusion and when bonded in place controls the airfoil thickness. The blade from the spar aft is composed of aluminum honeycomb core and skins bonded to the spar. The trailing edge is a strip of extruded aluminum. The spar and trailing edge strip are tapered between Stations 80 and 140 (see Figure 2) and are of constant chord outboard of Station 140.

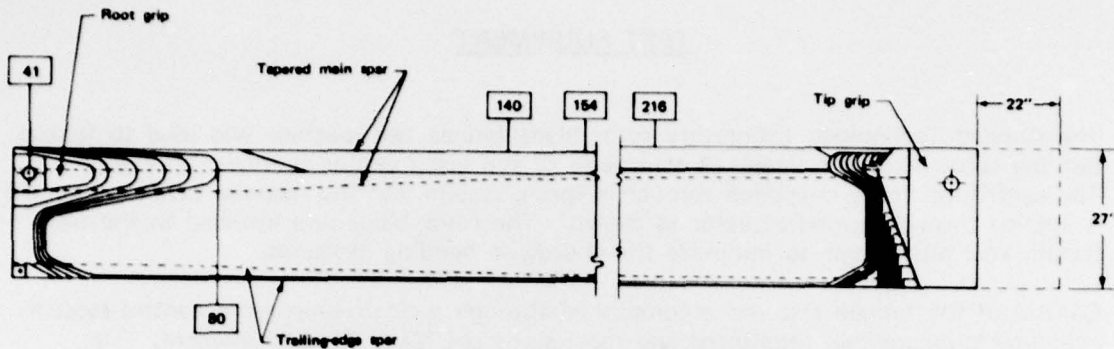
Figure 2. Modified 540 rotor blade for testing.

The tip end of the blade was modified by BHC for testing purposes. A 22-inch section of the tip was removed and a stepped aluminum doubler was installed (see Figure 2).

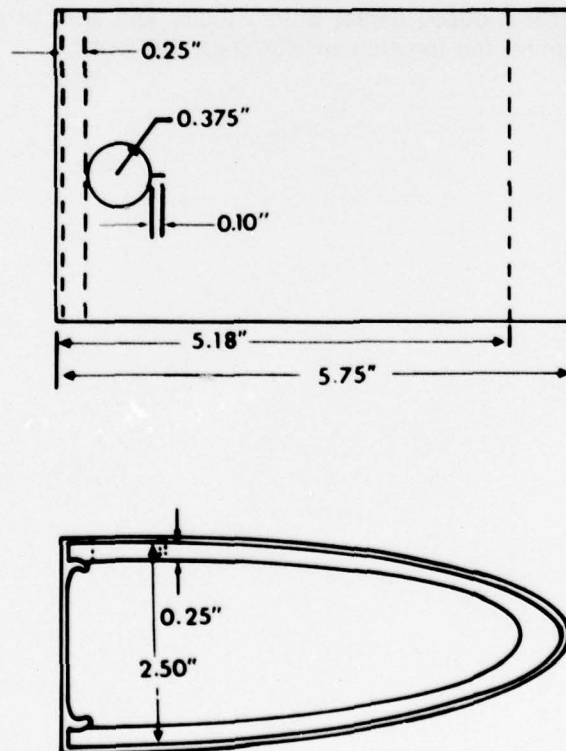
Figure 3. 540 rotor blade spar geometry at Station 154.

A 3/4-inch-diameter hole was counterbored in the top side of the blade at Station 154. A chordwise saw cut 0.10 inch in length was made from the hole toward the leading edge of the blade. A 1/64-inch hole was drilled at the tip of the saw cut to produce a controlled crack tip front. The geometry of the induced defect in the blade is shown in Figure 3.

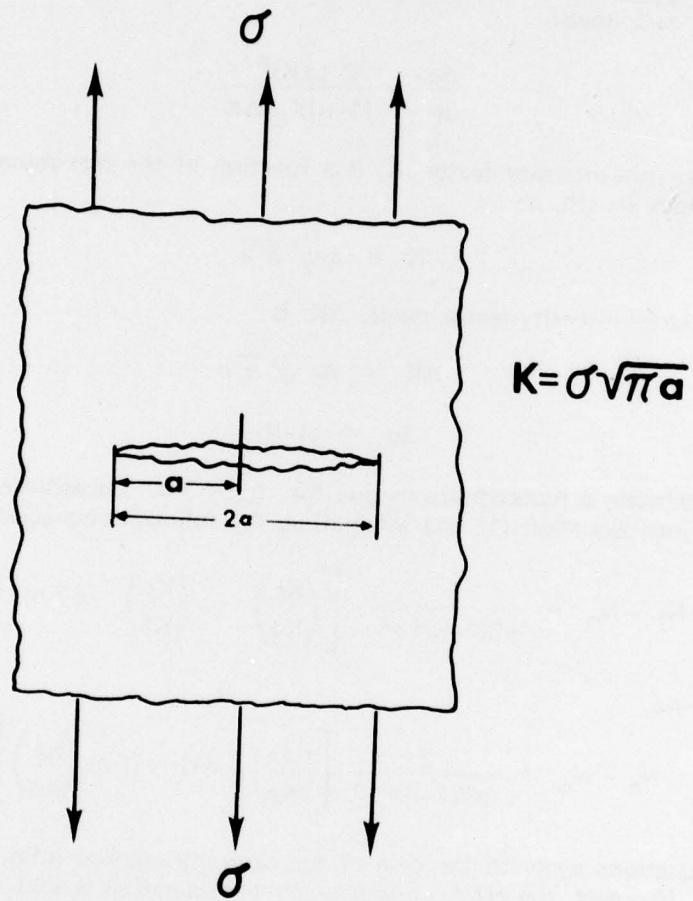
Figure 5. Geometry of central crack in an infinite plate.

The above equations apply to the case of the centrally cracked infinite plate as shown in Figure 5. However, the crack growth under consideration is that of a crack propagating from one side of a hole located eccentrically in a finite-width plate. To treat this case, modifications to the theoretical stress-intensity factors were made using the methodology of Figge and Newman (Reference 5).

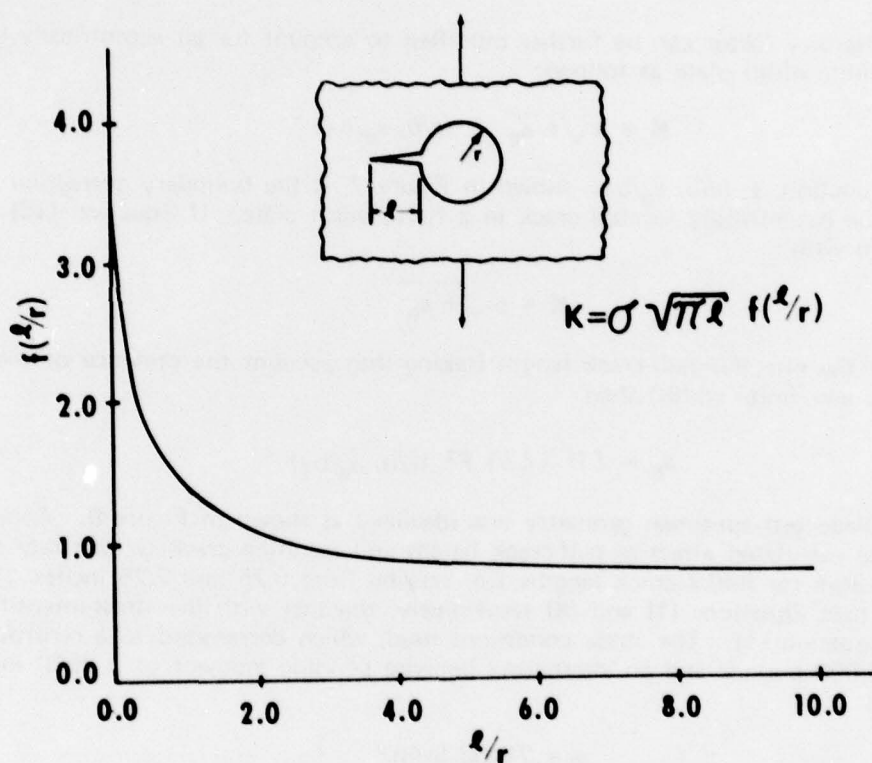
Figure 6. Stress-intensity-factor coefficient for a single crack emanating from a circular hole in a uniaxial stress state.

where the function $f(\ell/r)$ shown in Figure 6 describes the influence of the hole on the stress-intensity factor. Equating these and solving for a_e results in

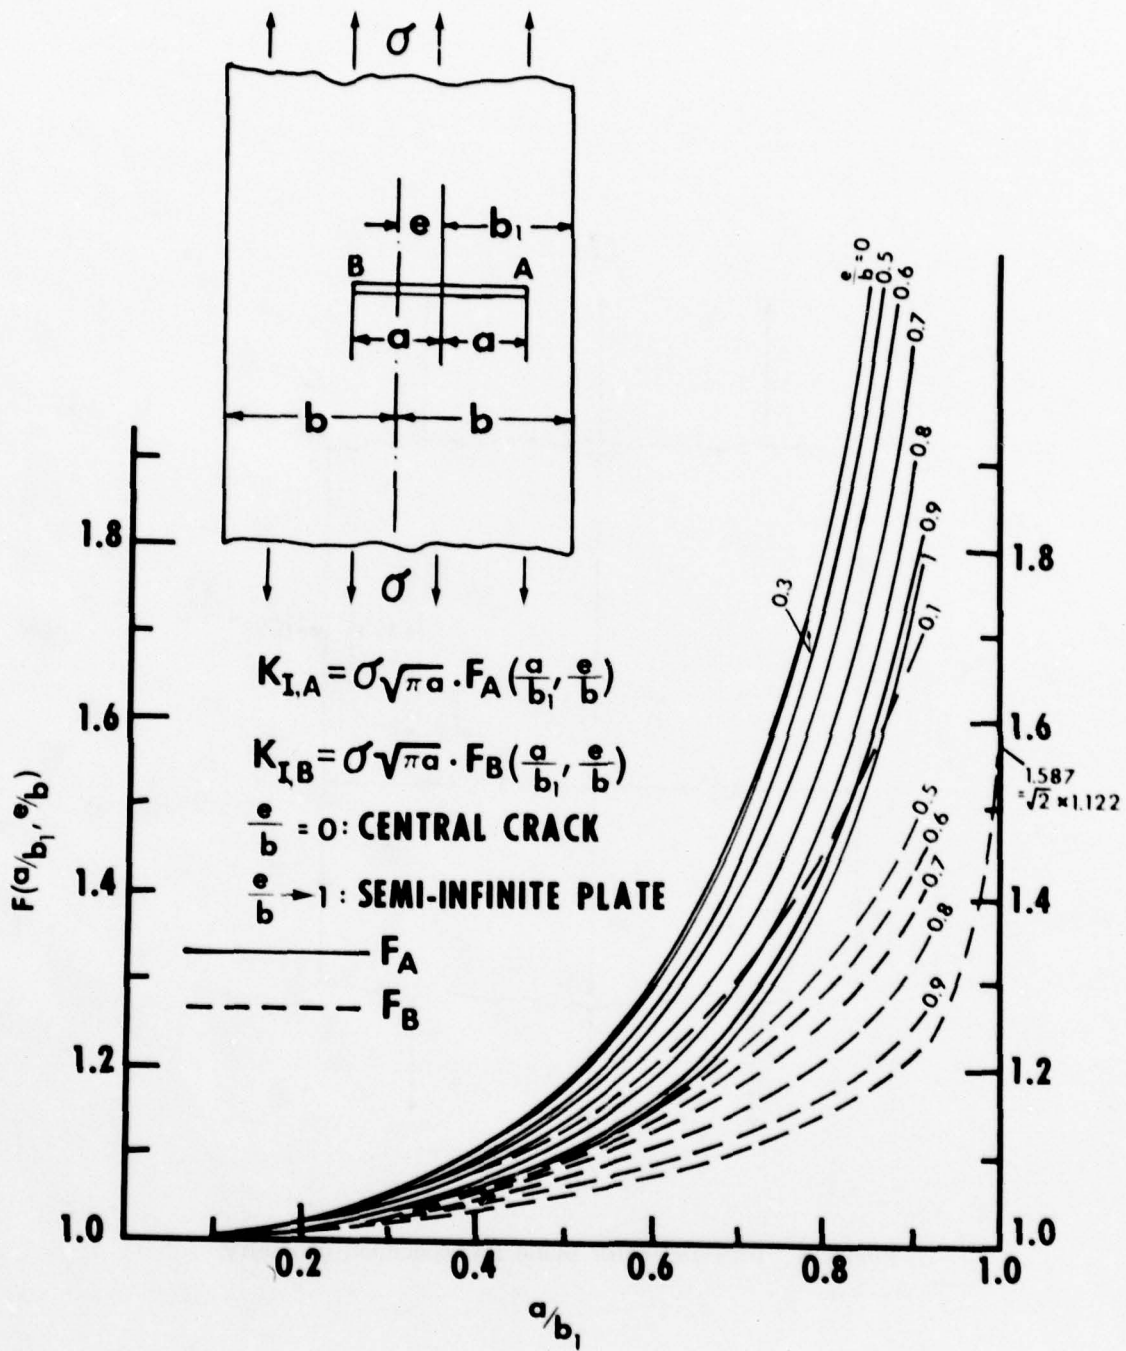
Figure 7. Correction factor for eccentricity and finite width.

where the function, $F(e/b, a_e/b_1)$, shown in Figure 7, is the boundary correction factor for the eccentrically located crack in a finite-width plate. If Equation (10) is then equated with

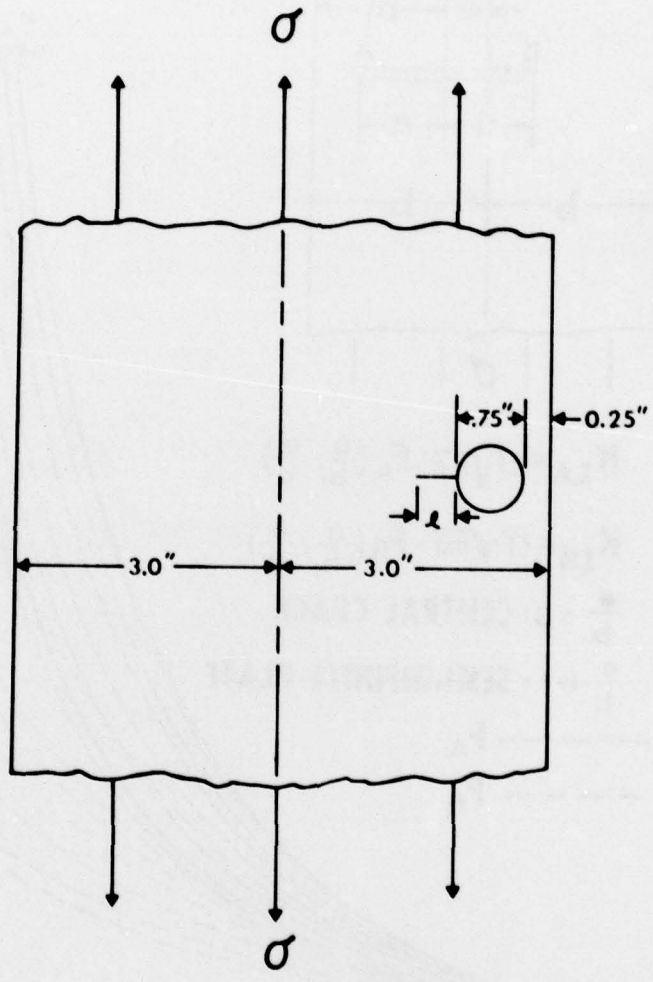
Figure 8. Idealized rotor blade test specimen geometry.

The rotor blade test specimen geometry was idealized as shown in Figure 8. Appendix A shows the calculated effective half-crack length and resulting crack growth rate and cycles to failure for initial crack lengths, ℓ_0 , varying from 0.25 and 2.75 inches. This calculation uses Equations (1) and (6) respectively, together with the stress-intensity factor of Equation (1). The stress conditions used, which correspond to a centrifugal force of 76,000 pounds and an alternating flapwise bending moment of ± 7500 inch-pounds, are

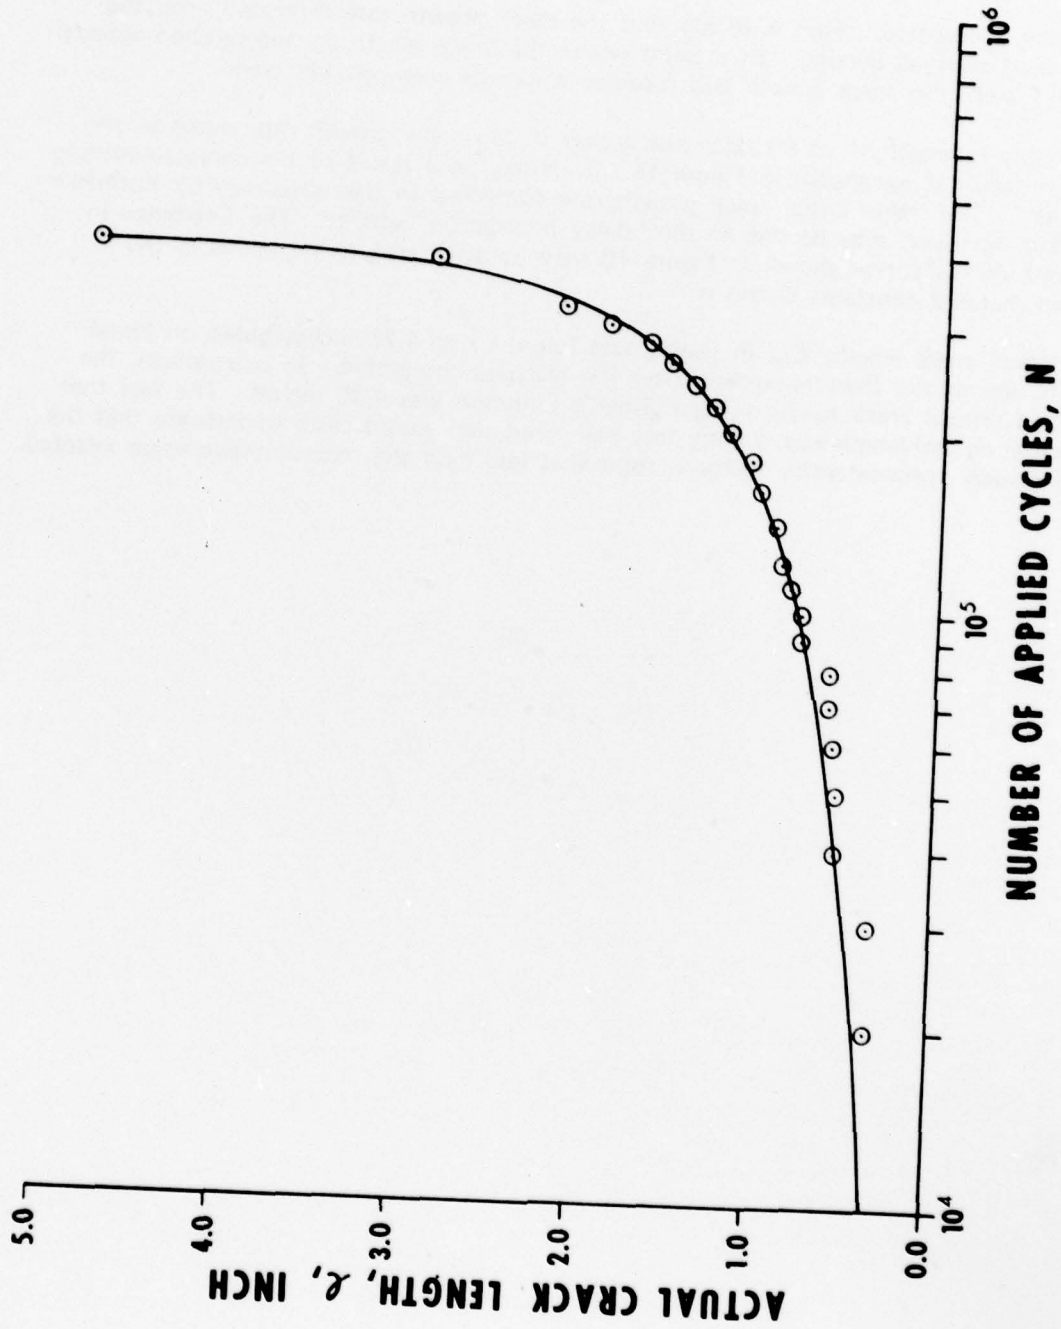
Figure 9. Actual crack length versus number of applied cycles.

The load history and measured crack length for the test specimen are set forth in Appendix B. The relationship between the actual crack length, ℓ , and the number of applied load cycles is shown in Figure 9, where the initial condition, $N_0 = 0$, is assumed to be the last cycle of load block 4. The corresponding initial crack length, ℓ_0 , is then 0.25 inch.

2. A best-fit curve was drawn through the data shown in Figure 9. The slope of the curve was determined using finite difference techniques. Figure 12 shows the resulting relationship between the crack growth rate, $d\ell/dN$, and the stress-intensity-factor range, ΔK .

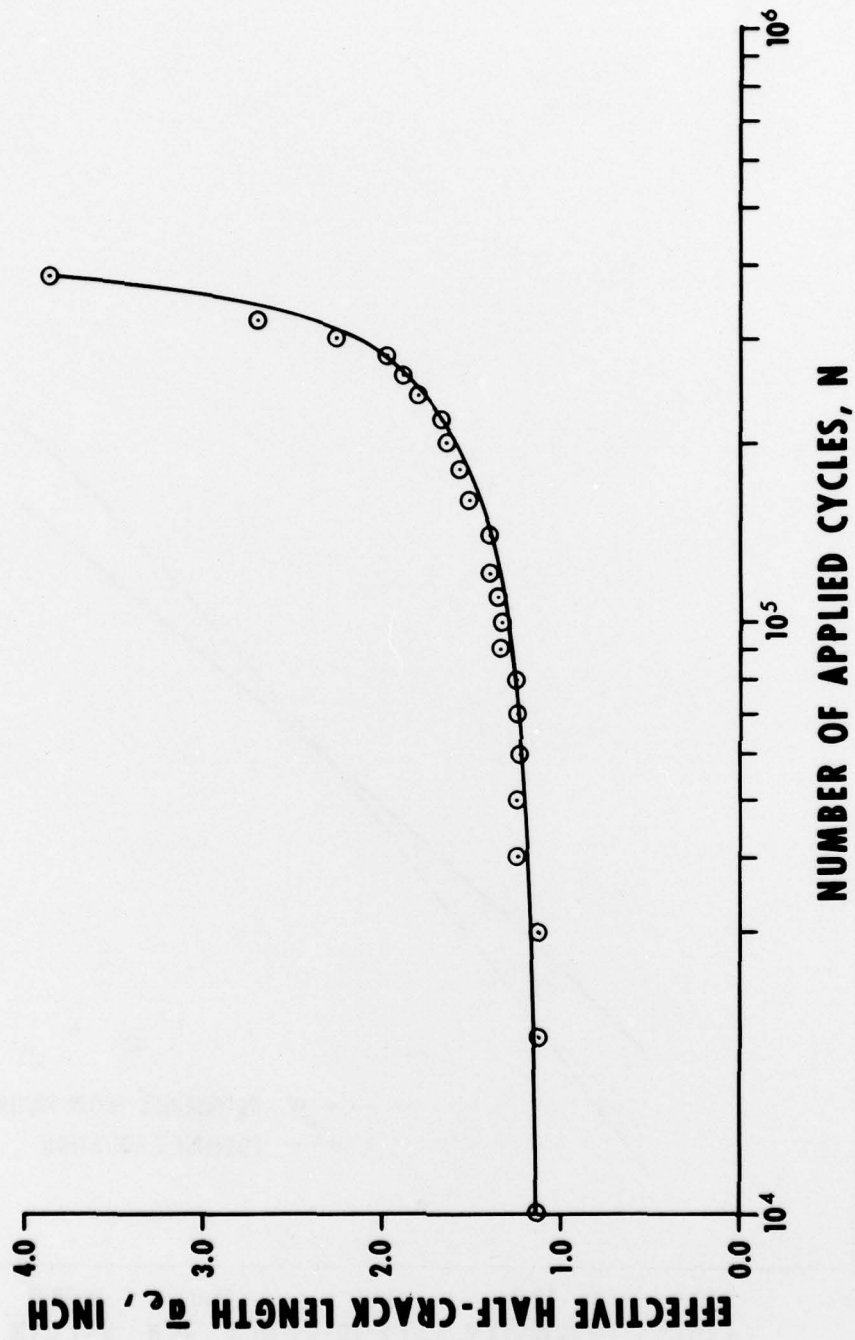
Figure 10. Effective half-crack length versus number of applied cycles.

Using the methodology of the previous selections, the effective half-crack length, \bar{a}_e , was determined for each crack length, ℓ . The resulting relationship between \bar{a}_e and the number of applied load cycles is shown in Figure 10.

1. A best-fit curve was drawn through the data shown in Figure 10. The slope of the curve was then determined using finite difference techniques. Figure 11 shows the resulting relationship between the crack growth rate, $d\bar{a}_e/dN$, and the stress-intensity-factor range, ΔK . For comparison the crack growth rate, $d\bar{a}_e/dN$, determined using Forman's Equation (Equation 10) is also shown in Figure 11.

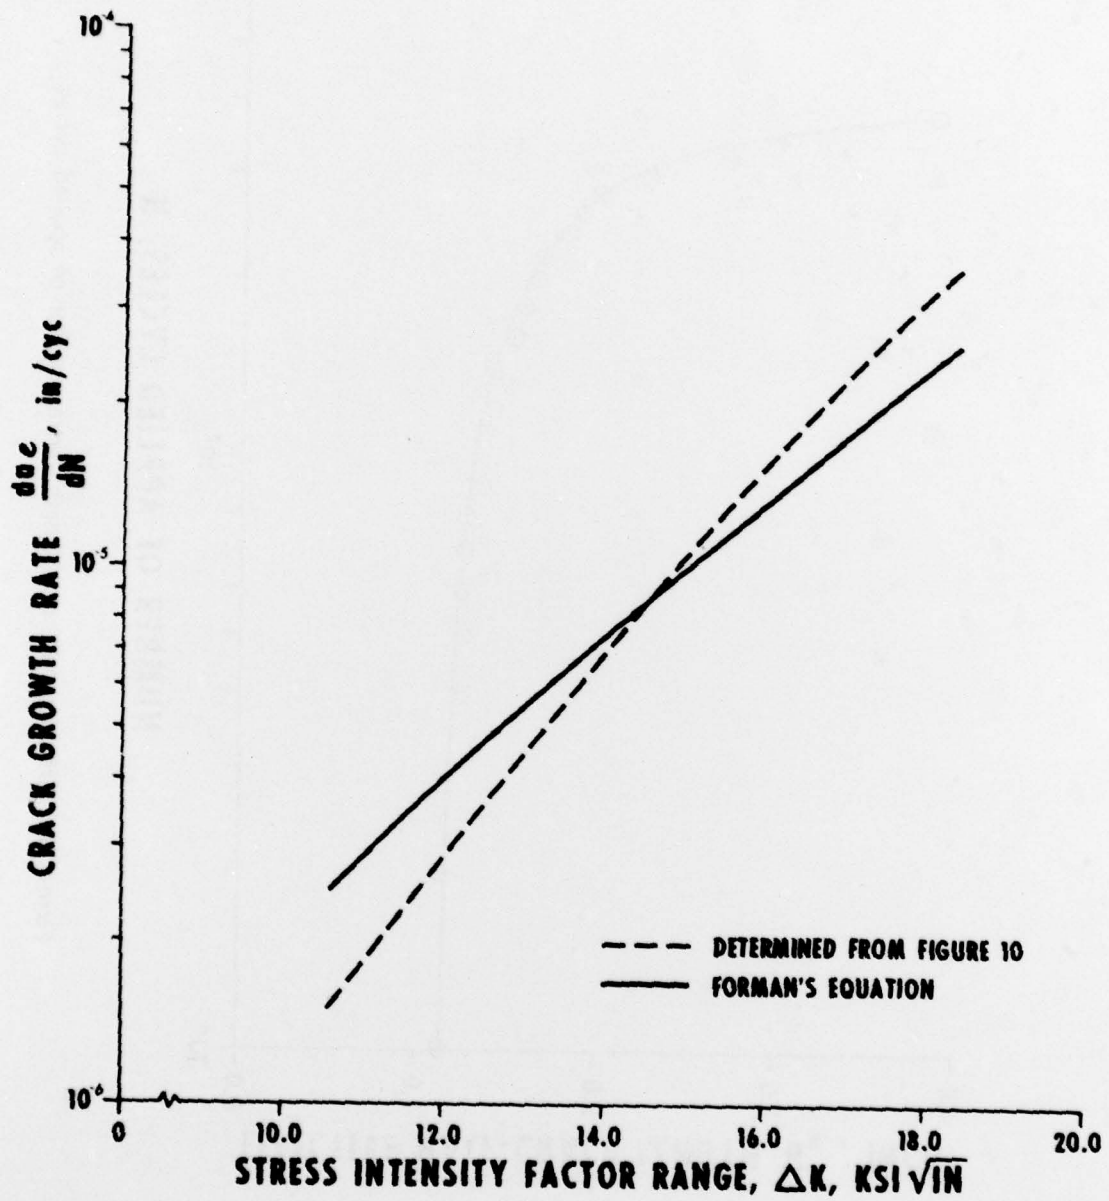
Figure 11. Crack propagation rate versus stress-intensity-factor range.

In each case above, the stress-intensity-factor range is based on the effective half-crack length, \bar{a}_e . Examination of the crack growth rate curves shown in Figure 11 shows a reasonable correlation between the crack growth rate interpolated from the test data and the rate predicted from Forman's Equation.

The "delay retardation" effect does not appear in the crack growth rate versus stress-intensity-factor range shown in Figure 11. This may be a result of the curve smoothing procedure. The lower initial crack growth rate compared to that predicted by Forman's Equation, however, may be due to the "delay retardation" effects. The difference in the slope of the curves shown in Figure 10 may be attributed to variations in the selected material constants C and n .

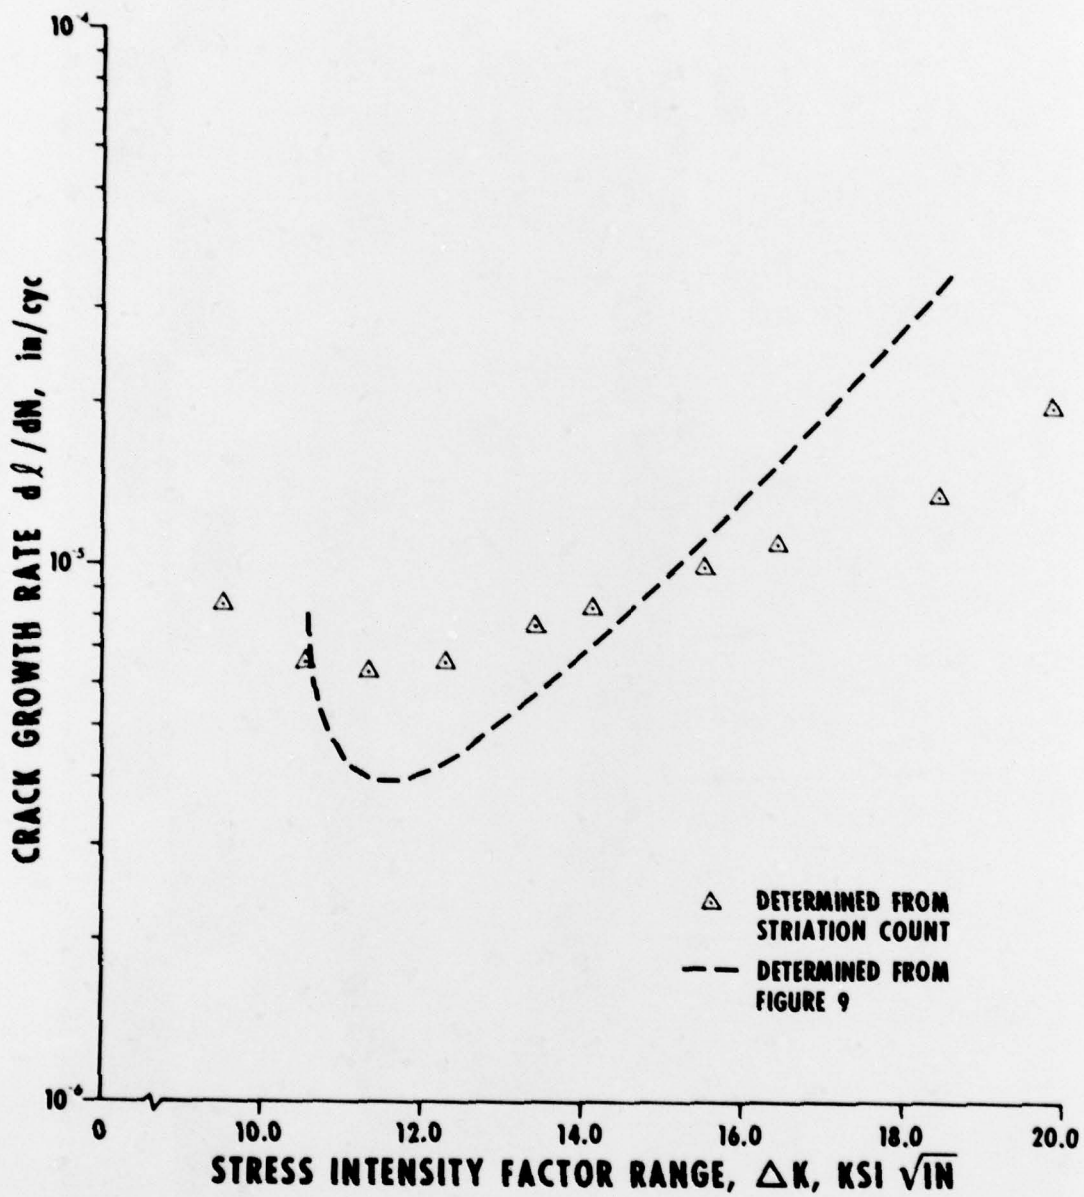
Figure 12. Crack propagation rate versus stress-intensity-factor range.

From the fractographs the fatigue striations were counted and the crack growth rate $d\ell/dN$ was subsequently determined. The resulting crack growth rates are shown in Figure 12.

Examination of the data shown in Figure 12 reveals a similar trend between the crack growth rates determined from the slope of the best-fit curve of Figure 9 and the crack growth rate determined from the striation count. The distinctive characteristic of the data shown in Figure 12 is that the crack growth rate is initially high and then drops off before continuing to increase. Recalling that the crack growth was originally initiated at the higher load level of $\pm 11,000$ inch-pounds and the load was then reduced to ± 7500 inch-pounds, it appears that the phenomenon referred to as "delay retardation" in

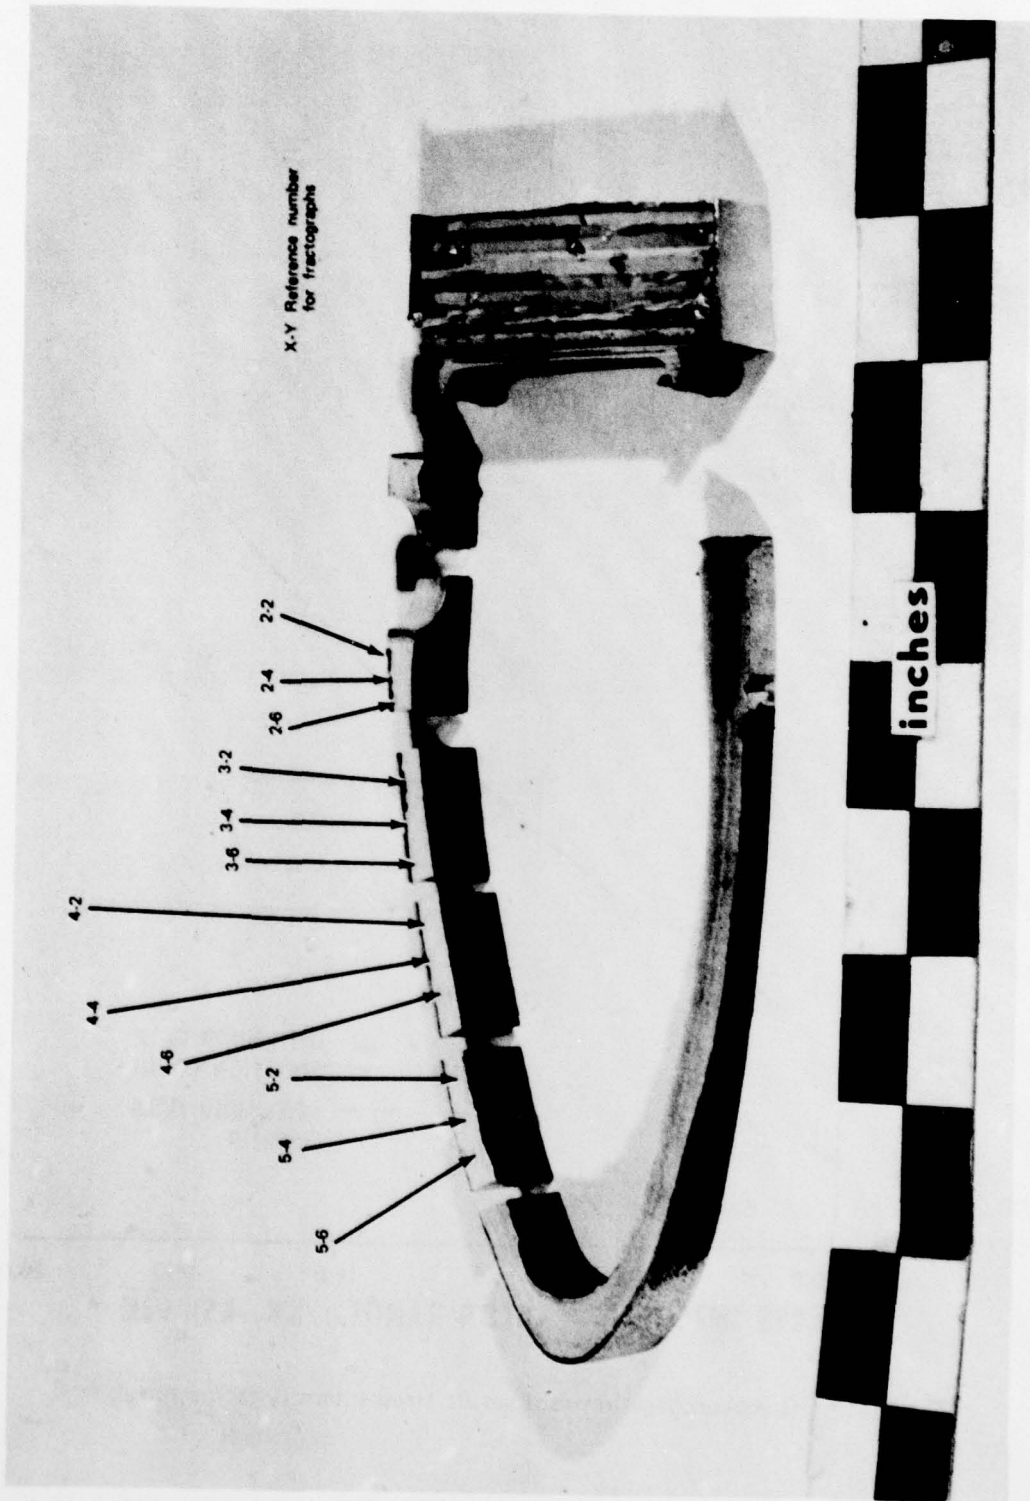
Figure 13. Sectioned spar after test.

3. The failed spar was sectioned as shown in Figure 13. The fracture surface was examined at the locations shown using the electron scanning microscope at NASA/Langley Research Center. Appendix C shows a series of fractographs of the areas of the fracture surface that was examined.

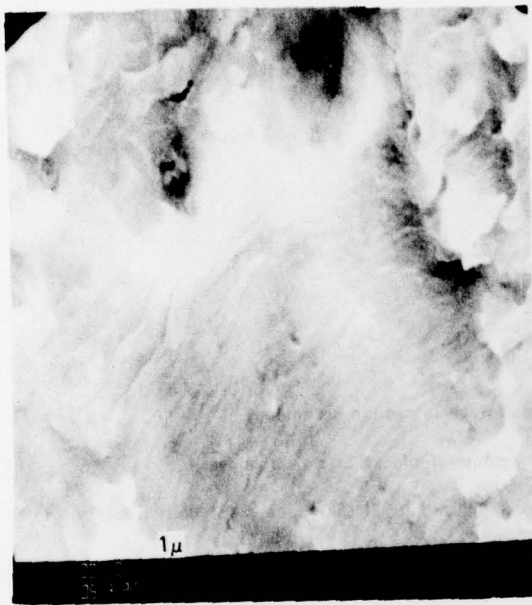
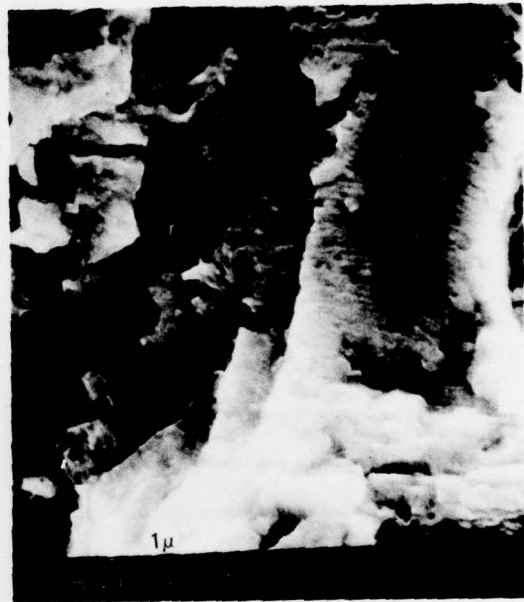
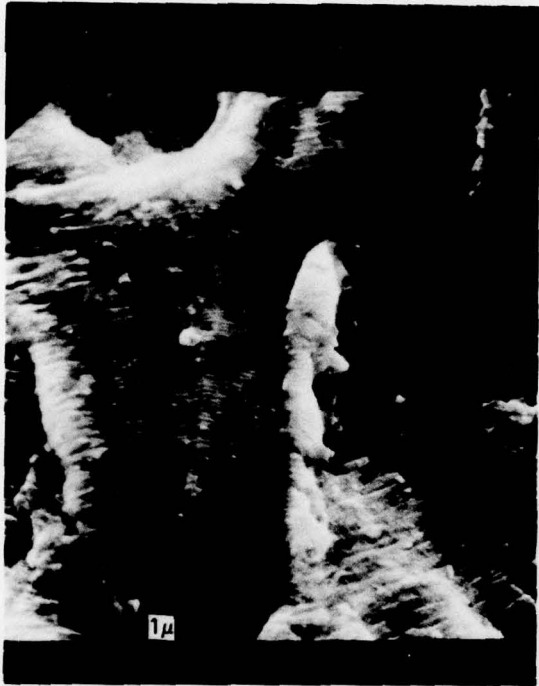
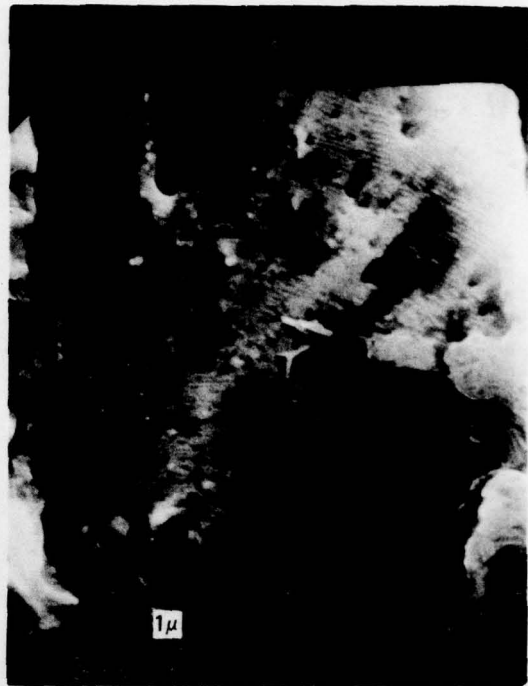
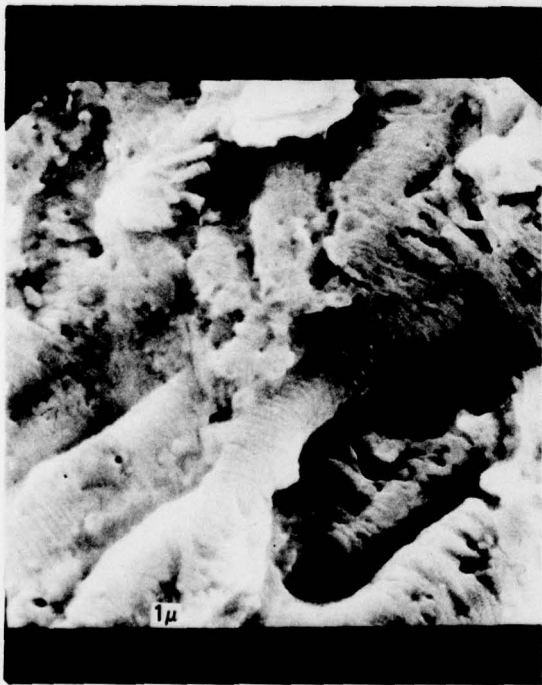
APPENDIX C
SCANNING ELECTRON FRACTOGRAPHS
OF FRACTURE SURFACE OF 540 ROTOR BLADE SPAR

↑
Direction of crack growth

NOTE: The last two three-digit numbers on each fractograph are the section and location numbers identified in Figure 10.

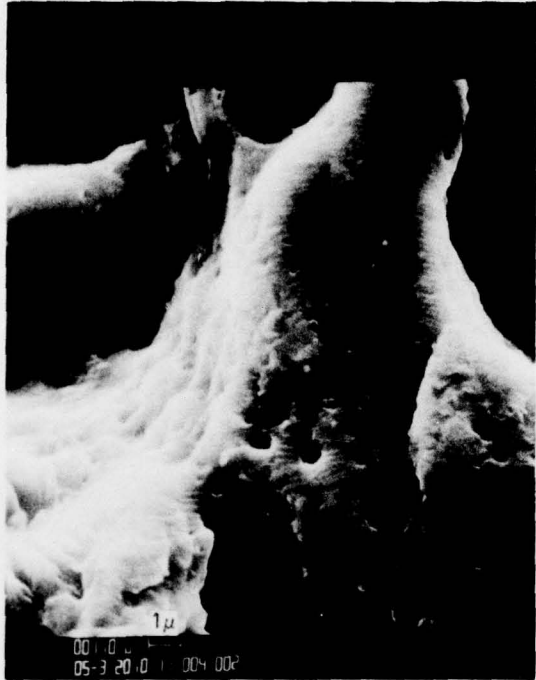
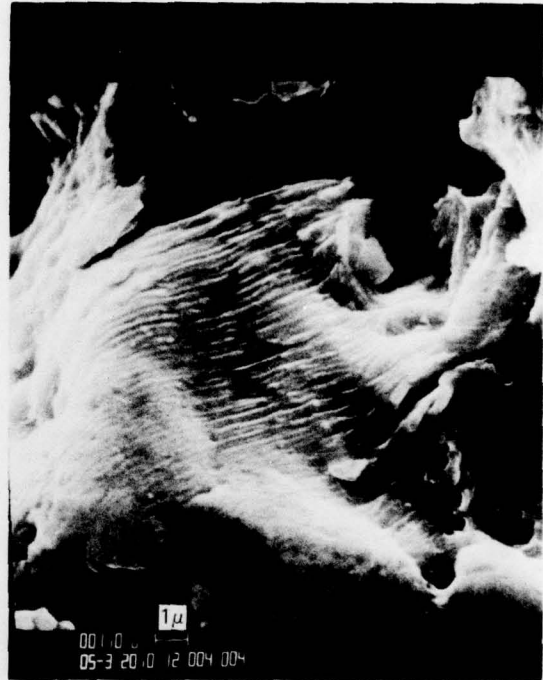
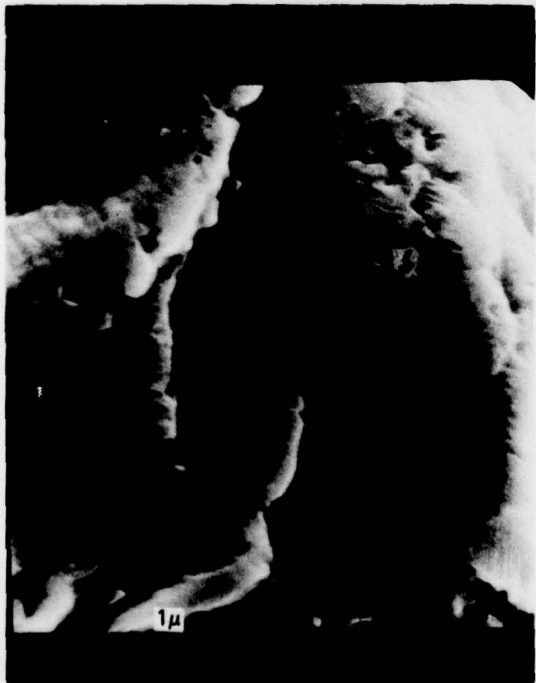
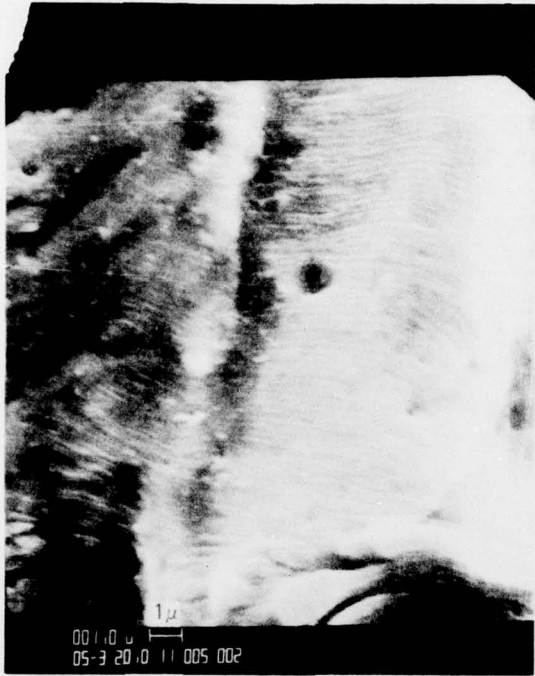
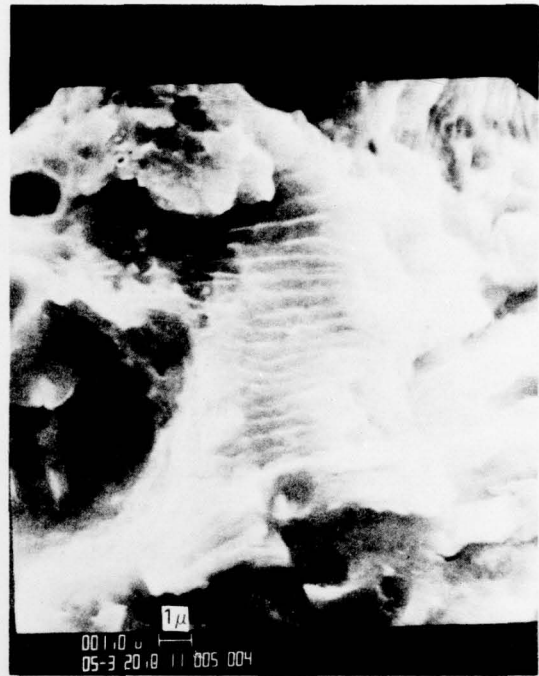
↑
Direction of crack growth
