**AIRCRAFT TRANSPARENCY FAILURE & LOGISTICAL  
COST ANALYSIS — SUPPLEMENTAL STUDY**

S. S. Brown

Rockwell International  
North American Aircraft Division  
P.O. Box 92098  
Los Angeles, CA 90009

Technical Report AFFDL-TR-79-3083  
Final Report for Period February-June 1979

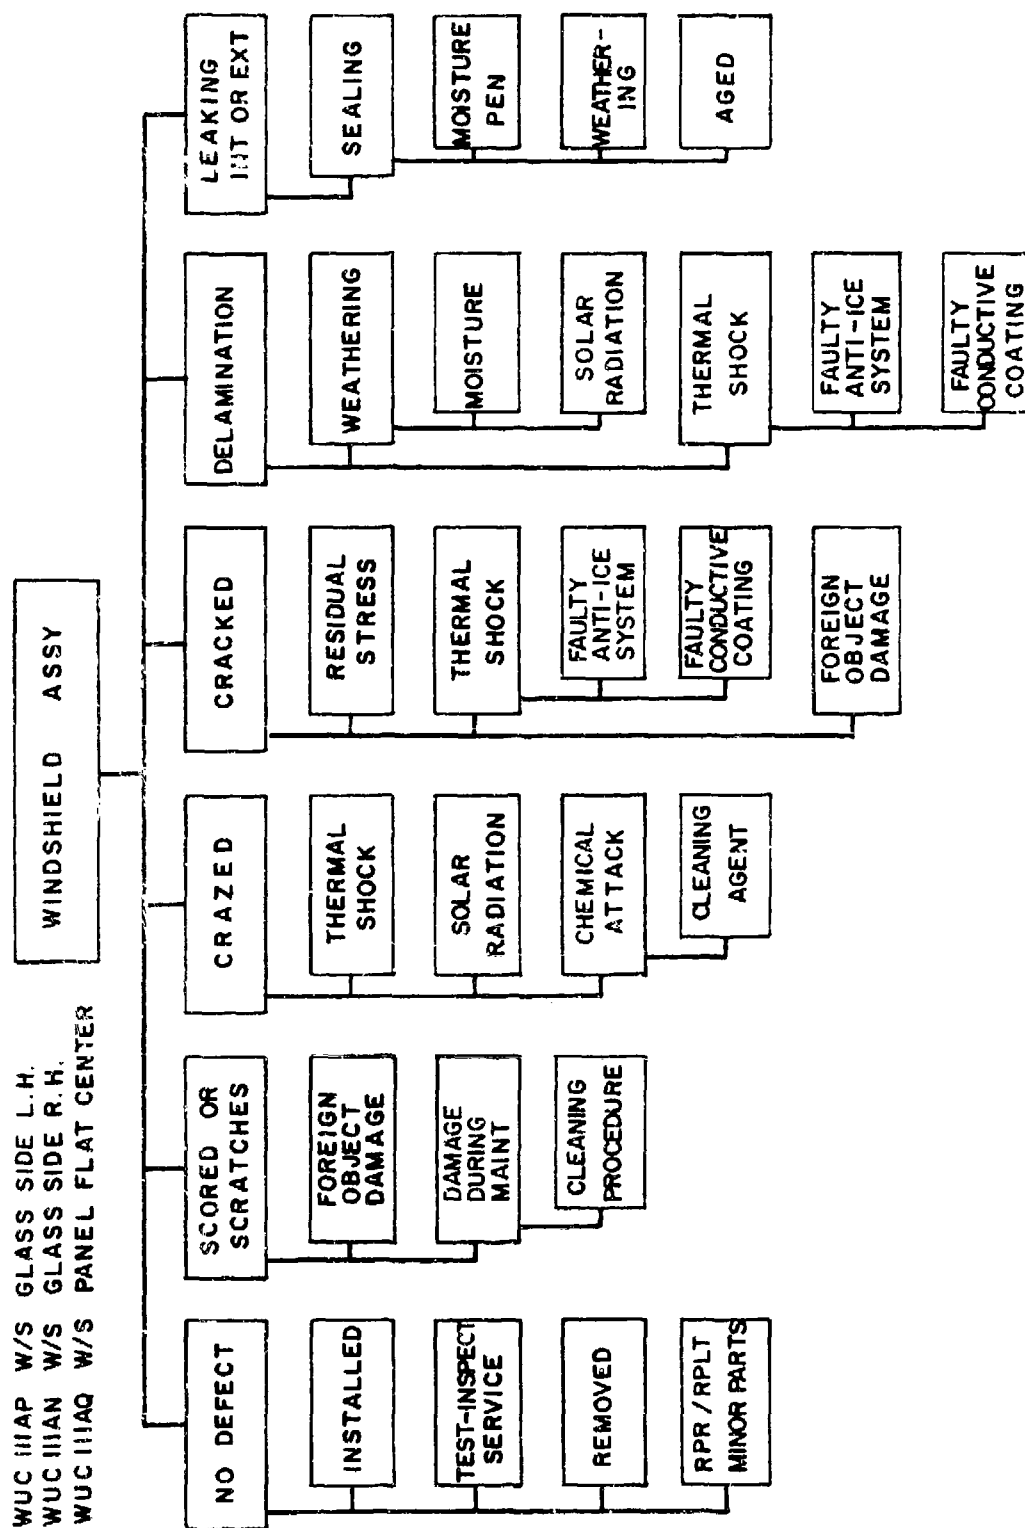
Figure 4. Fault Tree F-4 Windshield Assembly

An assessment of the component failures from the MAM's was made. These were condensed in the form of a failure fault tree (figures 4 and 5) and a failure analysis summary (figures 6 and 7) of the more significant How-Mal's, action taken, and probable cause.

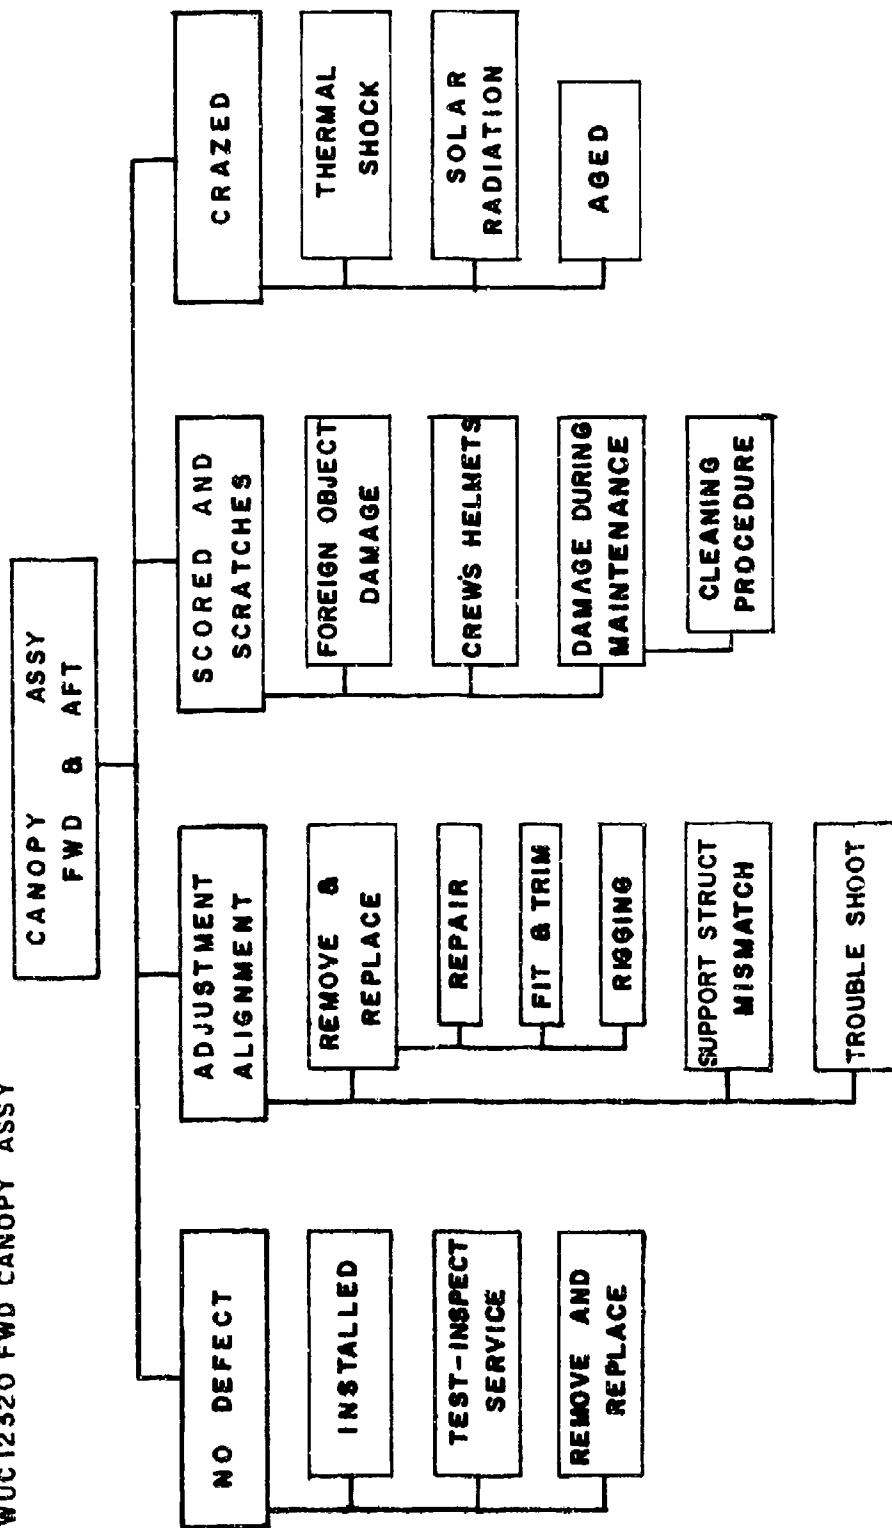
Figure 5. Fault Tree F-4 Forward and Aft Canopy Assemblies

WUC12350 AFT CANOPY ASSY  
WUC12320 FWD CANOPY ASSY

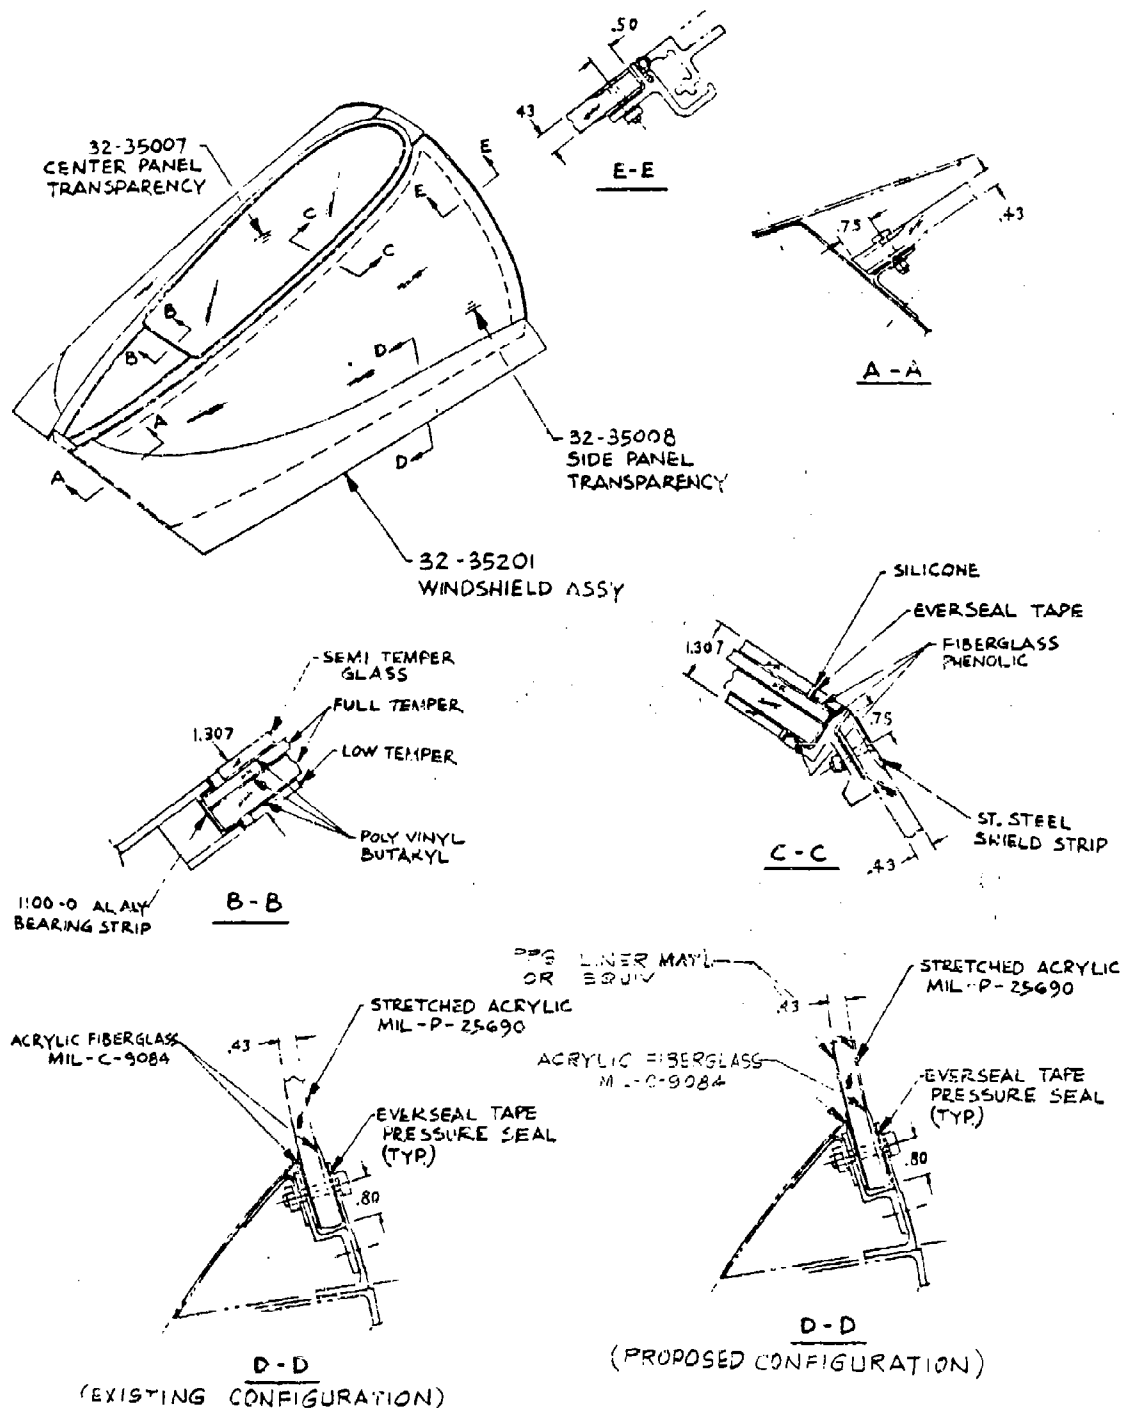
Figure 8. F-4 Windshield Assembly

Data obtained from the AFM 66-1 MDC, and collected from the ALC, indicates that more than 50 percent of the maintenance hours are expended in the removal, repair, and replacement of these transparencies. The degradation of the optical qualities requires the replacement of each canopy component at a rate in excess of 20 per month (reference 7). It is for this reason that a multi-laminated configuration incorporating the PPG-liner material is proposed. (See figures 8 through 10.)

The current configuration of the side and canopy transparent panels are monolithic stretched acrylic. The respective panel thicknesses of 0.43 and 0.34 inch are established by the requirements for optical qualities, birdstrike protection and cockpit pressurization. As previously stated, the PPG-liner material is believed to provide an improved abrasion resistance of the inner surface by a factor of 3 to 4 for an inner liner, and 2 to 2-1/2 for both an inner and outer liner.

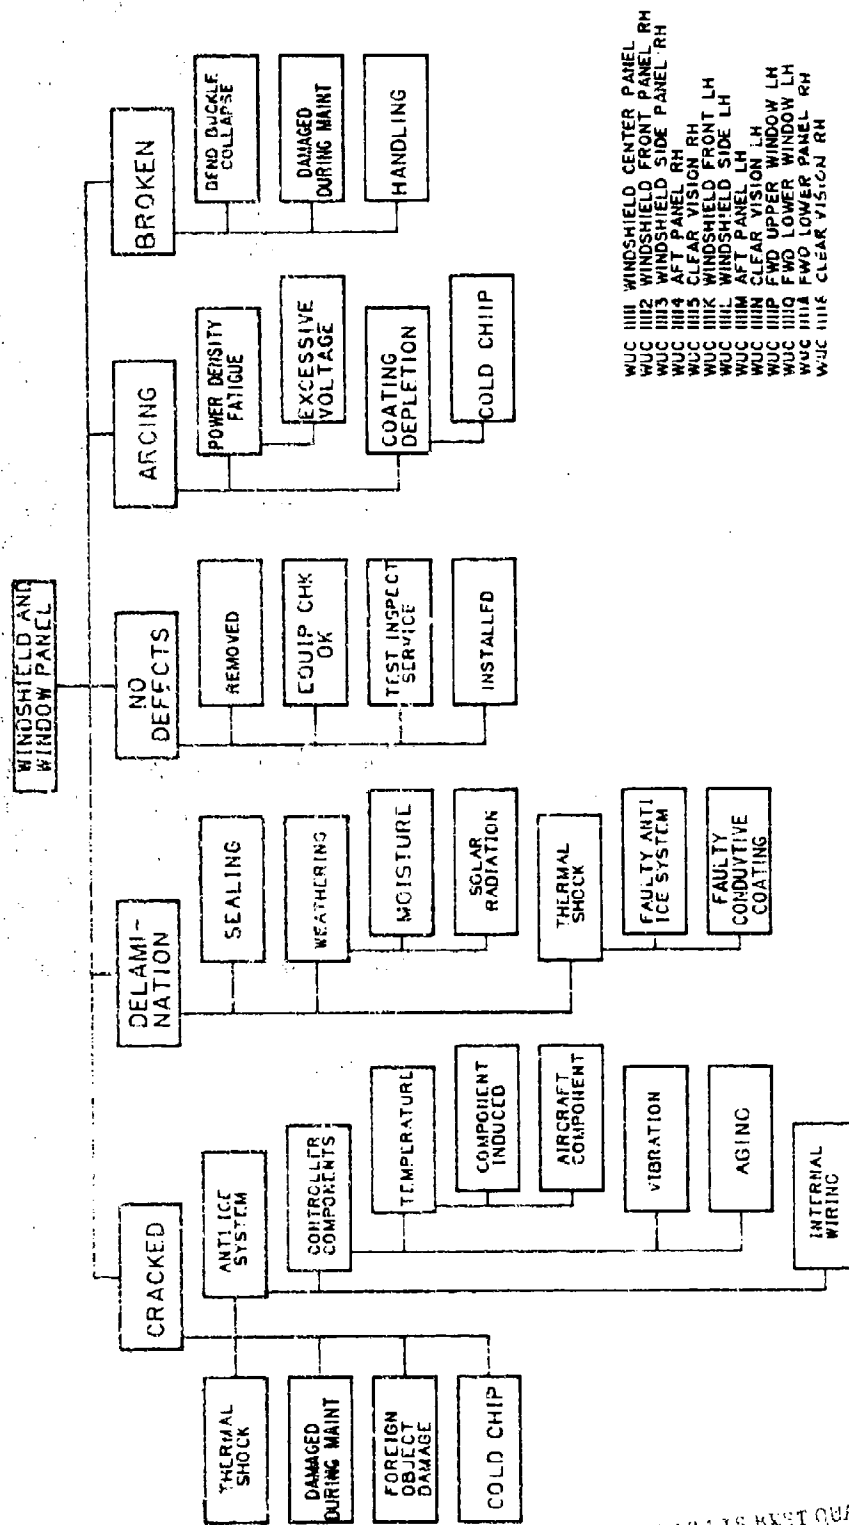
Figure 21. Fault Tree C-130 Windshield and Window Installation

The results of the C-130 failure analysis developed from AFM 66-1 MDC data and compiled in the MAM's program indicates that approximately 50 percent of the cost of maintaining the selected windshields and windows results from delaminations, cracking, and arcing. The failures for these components are block diagramed in the windshield and window fault tree, figure 21. In addition, the principal modes of failure (How-Mal) and the actions taken to repair and/or fix the failures are correspondingly listed. These factors along with the probable cause of failure are summarized in figure 22.

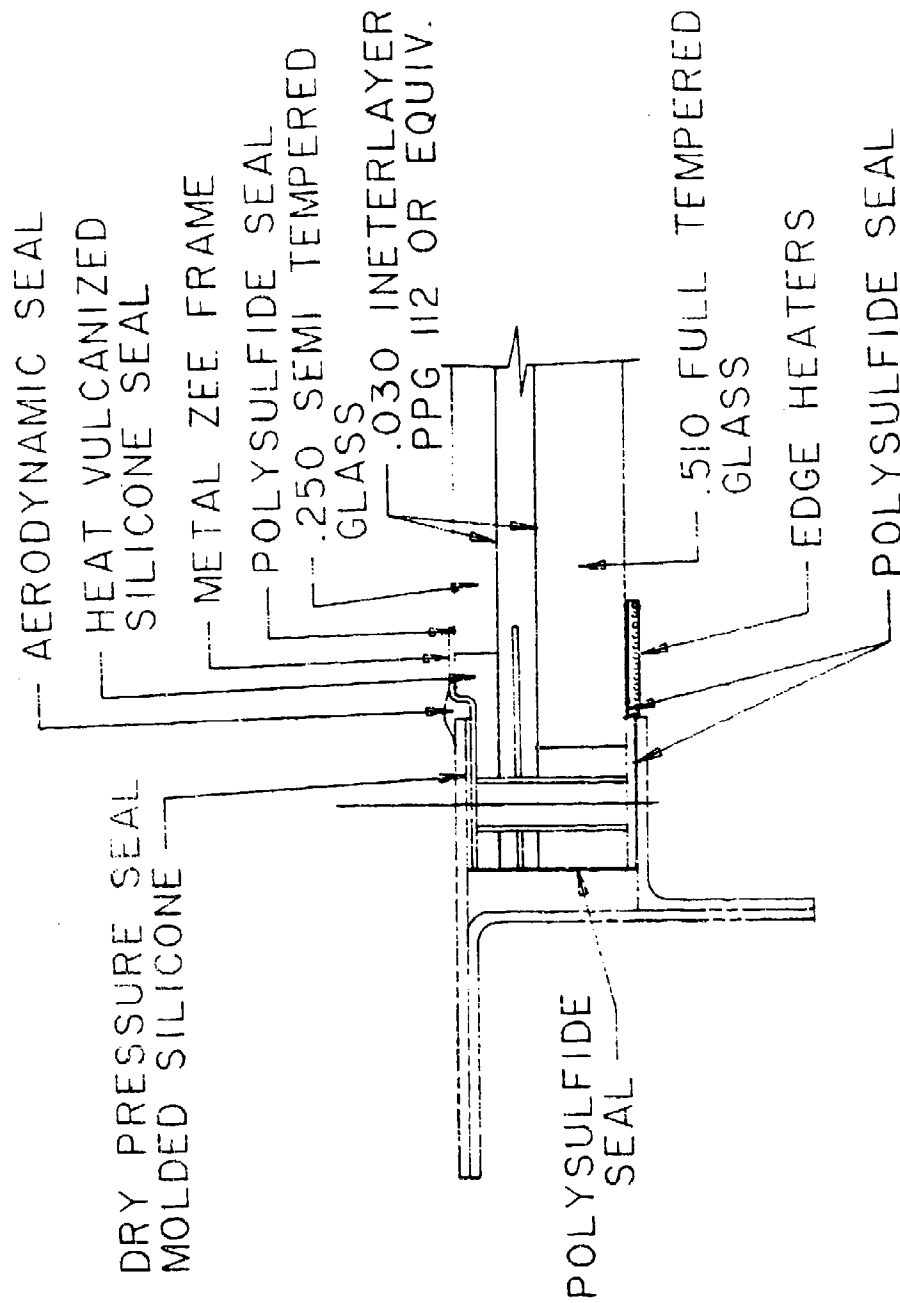
Figure 23. C-130 Proposed Windshield Typical Configuration

The maintenance people that are experienced with C-130 windshields state that cracking is largely due to thermal shock, service aging, and installation procedures. Further study of these factors indicates that under certain conditions, the temperature differential between the center of the panel and the edge causes a thermal variation that is the probable cause of a portion of the cracking problem. It is therefore recommended that an edge heater be incorporated to reduce this type of failure. (See figure 24.) The additional benefit of this change is the added protection against delamination.

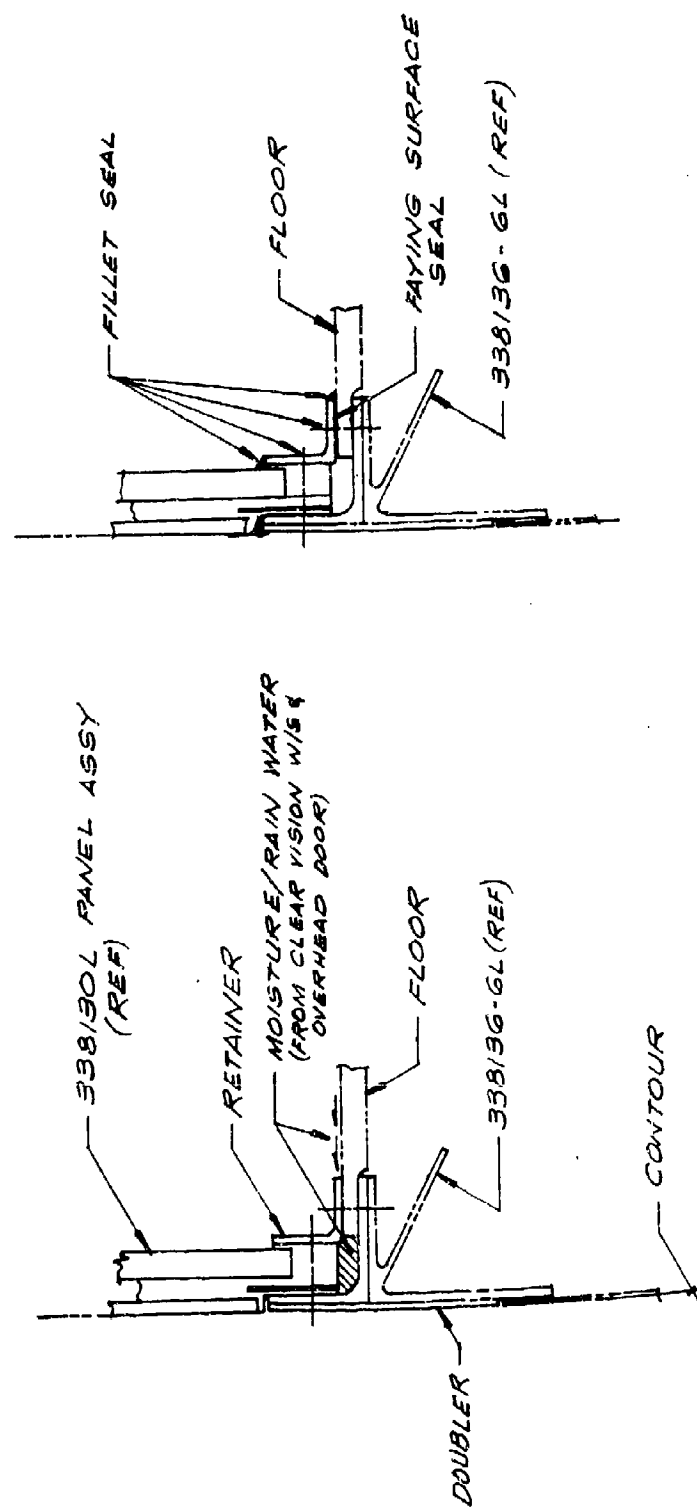
Figure 25. C-130 Side Windows Lower Attachment

The forward side windows as depicted in figure 19 and in figure 25 are subject to collection of moisture puddling between the side longeron and the floor assembly. The moisture collecting in this area causes the delamination of the side window panels. It is therefore proposed that fillet and faying surface seals as shown in figure 25 be incorporated to reduce the source of delamination. This proposed change should be considered as quickly as practical. Sufficient detailed maintenance and costing data were not available at this time.

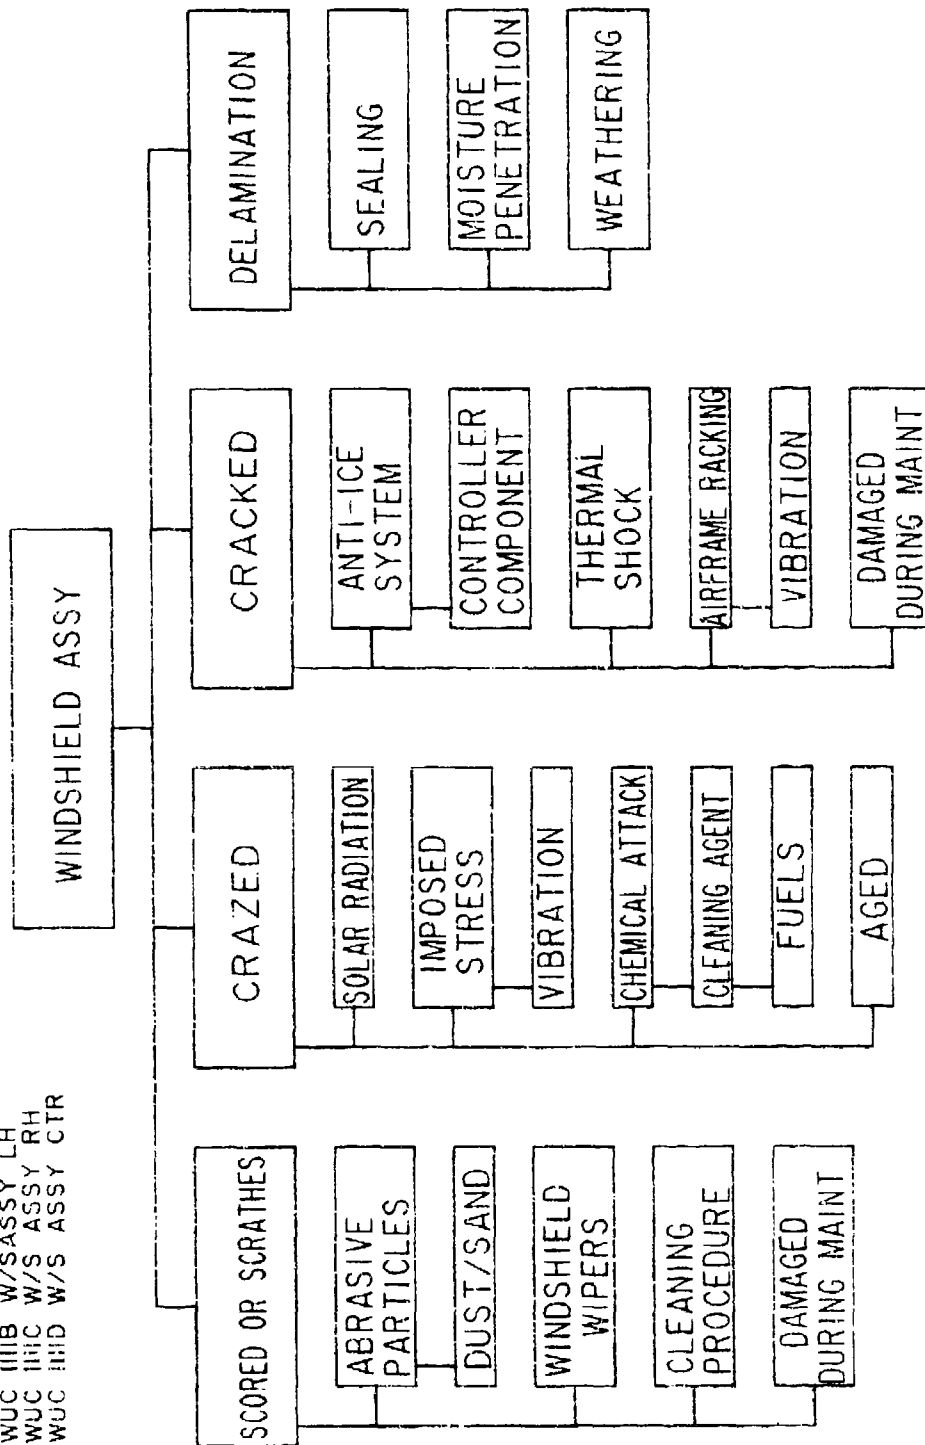
Figure 28. Fault Tree QI-53 Windshield Assembly

The description of these failures as diagramed in the fault trees, figures 28 and 29, were assembled from the MAM's program. Figures 30 and 31 present and summarize the more significant How-mals, action taken, and probable cause of failure. The failure mode descriptors in combination with flight hours, maintenance hours, and logistical cost are contained in the sampling MAM's tabulation shown in figure A-4 of Appendix A.

WUC IIIB W/SASSY LH  
WUC IIIC W/S ASSY RH  
WUC IIID W/S ASSY CTR

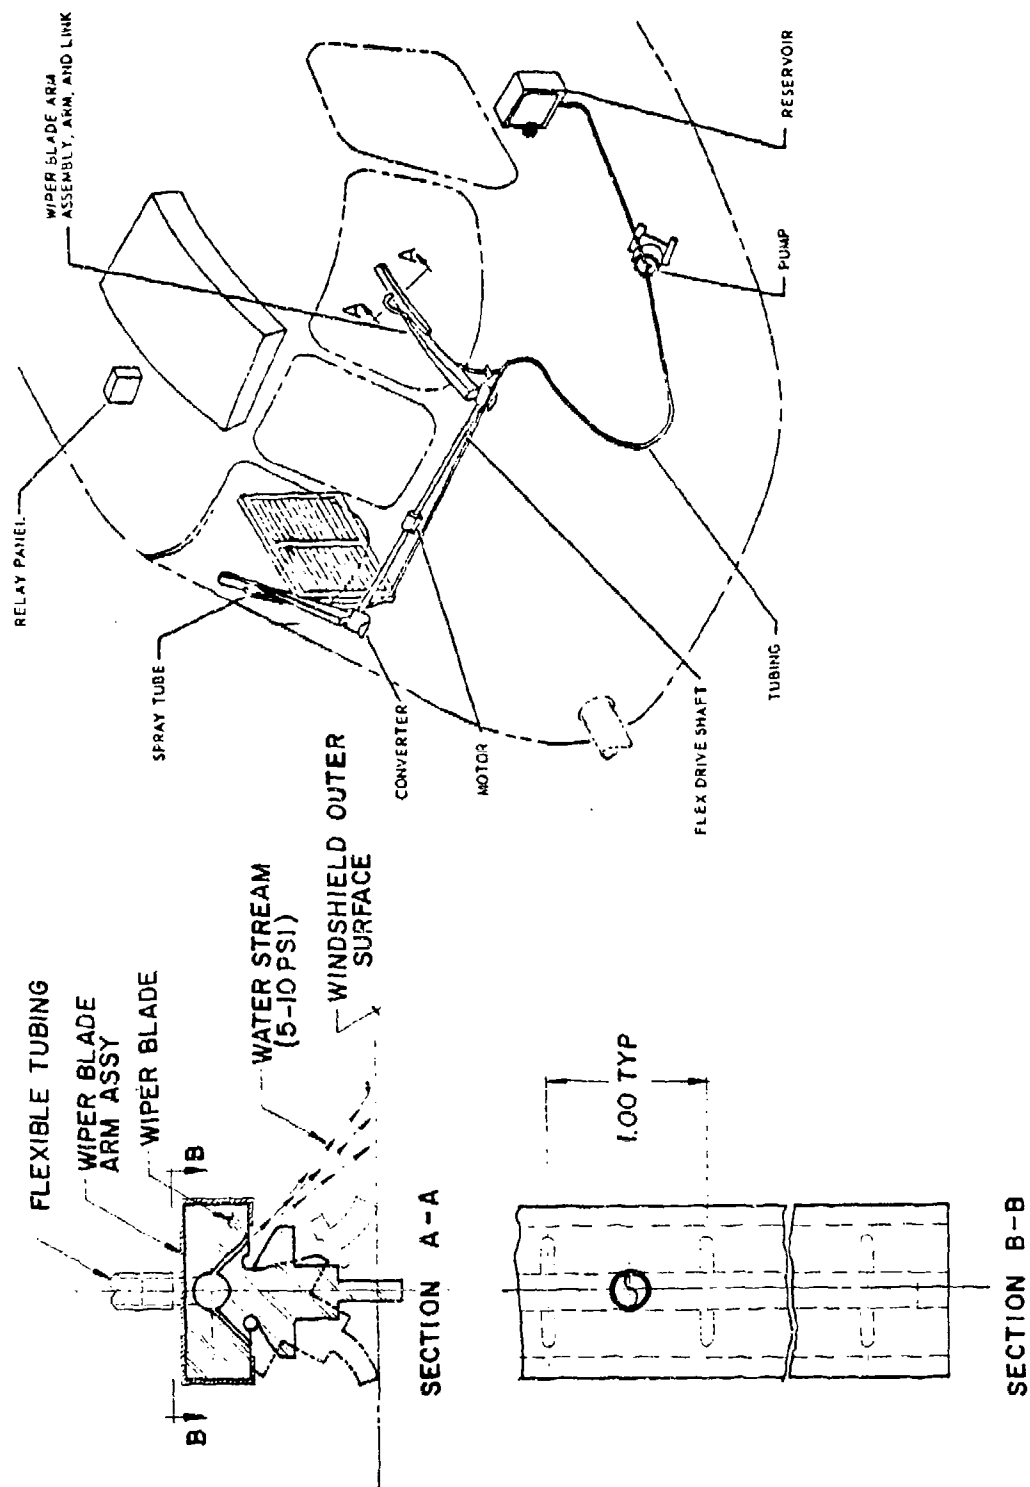
Figure 35. CI-53 Proposed Windshield Wiper Installation

It is therefore proposed that the "lube blade" concept as shown in figures 35 and 36 be incorporated as means of eliminating this problem. The principle utilized by the "lube blade" is dispersal of the wash fluid, through a jet stream, providing a uniform coverage across the full length of the wiper blade. The wash fluid is dispersed at the wiper blade wiping tip, as shown in figure 35. The fluid is pumped into an integral tubular manifold and dispersed through jet ports approximately 1 inch apart. The lower part of the wiper blade is formed to act as a valve, blocking off the jets on the retreating side of the blade and concentrating all the flow to the advancing side of the wiper blade. The concentration of the wash fluid at the "tip" point of contact will lubricate the surface and prevent scratching of the windshield surface.

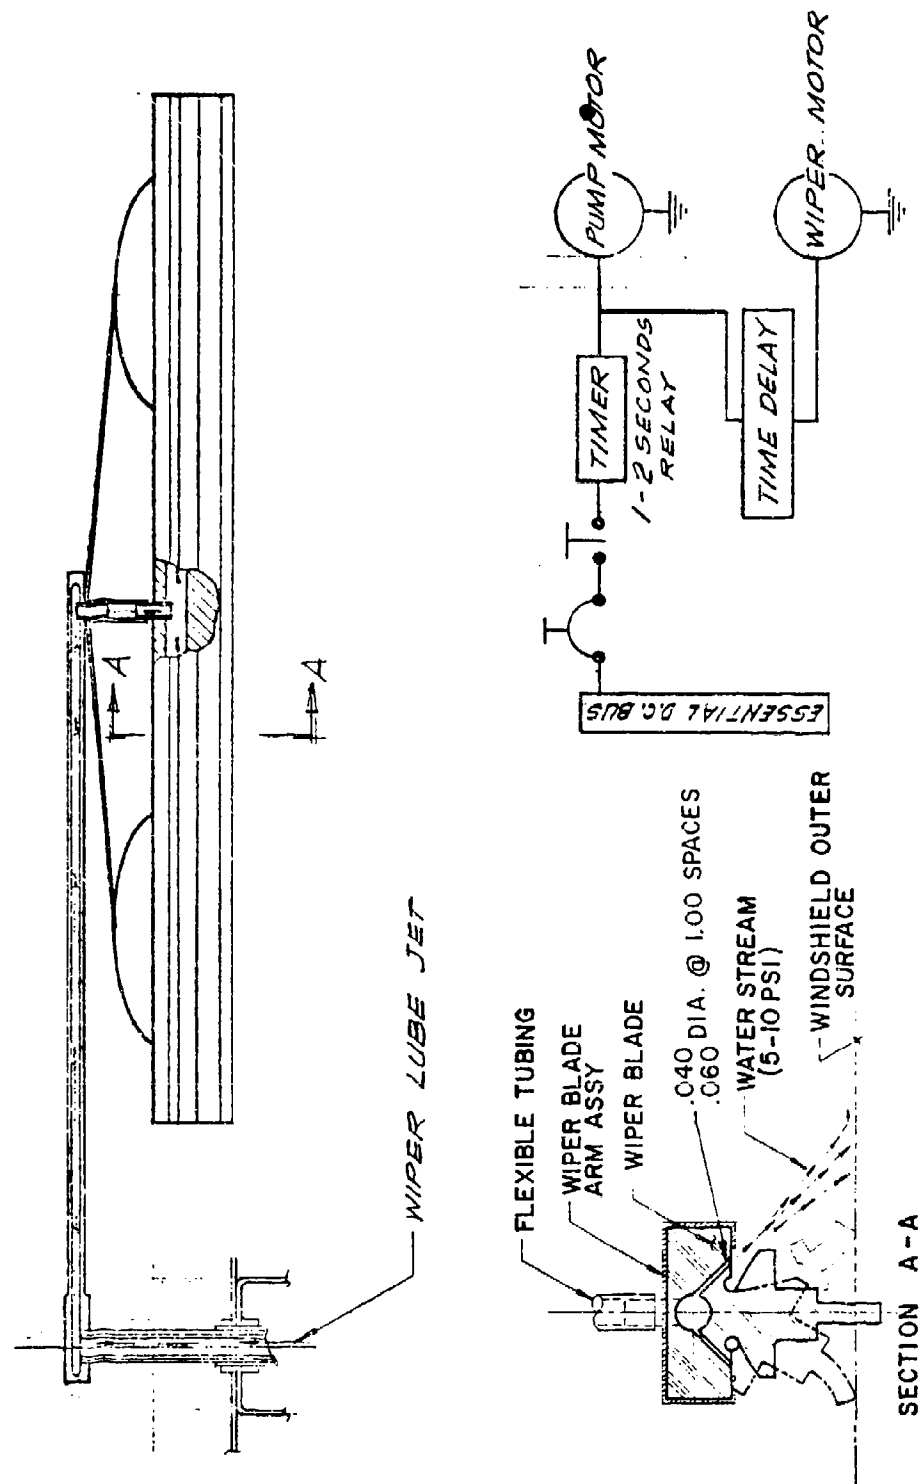
Figure 36. "Lube Blade" Windshield Wiper Concept

The "lube blade" washer system consists of a pump, reservoir, and wiper blades with built-in spray nozzles as depicted in figure 36. The system is operated by a switch. When the switch is placed to the ON position, power is applied to the wiper arm, and simultaneously to the wash fluid pump. After a 1-second time delay, the wiper arm automatically begins to operate. When sufficient wiping is accomplished after three to four cycles, the dispersion of wash fluid is stopped. If further washing is desired, the wash system can be manually engaged.

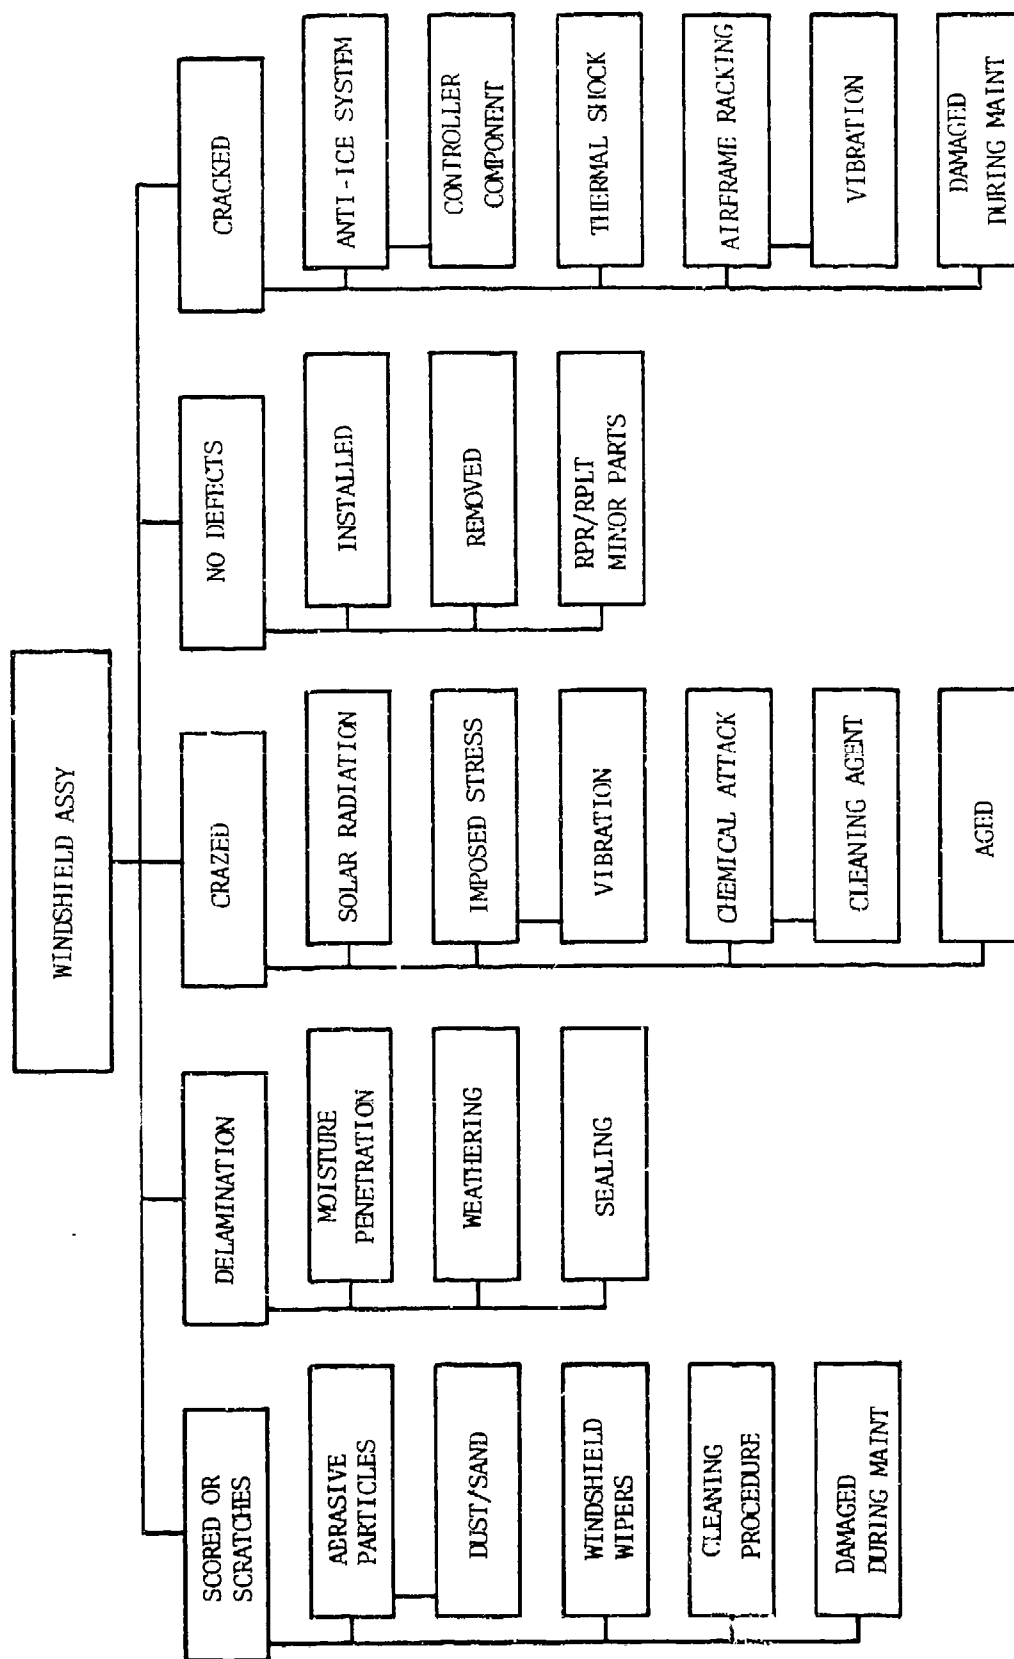
Figure 39. Fault Tree (II-3 Windshield Assembly

The description of the failures as diagramed in the fault trees, figures 39 and 40, was assembled from the MAM's program. Figures 41 and 42 present and summarize the more significant How-Mal's, actions taken, and probable cause of failure. The failure mode descriptors in combination with flight hours, maintenance hours, and logistical cost are contained in the sampling MAM's tabulation shown in figure A-5 of Appendix A.

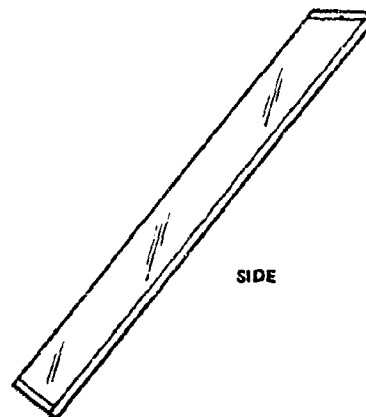
Figure 43. CH-3, Pilot's and Copilot's Windshield Panels

S6120-61228-1, -2, -3 OR -4  
TWO PLIES 0.125 IN. GLASS WITH 0.080 IN. INTERLAYER  
PER MIL-G-25871 (HEATED WINDSHIELD)  
S6122-87171-1 OR -2  
0.060 IN. CR-39 FACE PLY, 0.075 IN. INTERLAYER AND  
0.150 IN. ACRYLIC, MIL-P-25690 INNER PLY (UNHEATED)  
S6122-87172-1 AND -2  
0.060 IN. FACE PLY SIERRACIN 900 OR CR-39,  
0.075 IN. INTERLAYER, 0.150 IN. ACRYLIC,  
MIL-P-25690 INNER PLY (HEATED)

The proposed change to significantly reduce or eliminate the scratching and abrasion problems is to incorporate a multilaminate glass, acrylic, and PPG-liner material configuration for the pilot's and copilot's windshield assemblies. The existing design consists of an inner and outer ply of stretched acrylic with a PVB interlayer as shown in figure 43. The proposed design (see figure 44) is also configured as a multilaminate construction. The outer ply is 0.050-inch Chemcor glass to provide protection against scratching and spalling. For improved resistance to cold chipping, a PPG 112 interlayer (0.057-inch) is recommended. The remaining plies consist of an outer layer of 0.020-inch PPG-liner material bonded to a 0.150-inch stretched acrylic structural ply.
