ENGINEERING GEOLOGY AND GEOMORPHOLOGY OF STREAMBANK EROSION

TECHNICAL REPORT GL-79-7

EEL RIVER BASIN, CALIFORNIA

Lawson M. Smith and David M. Patrick

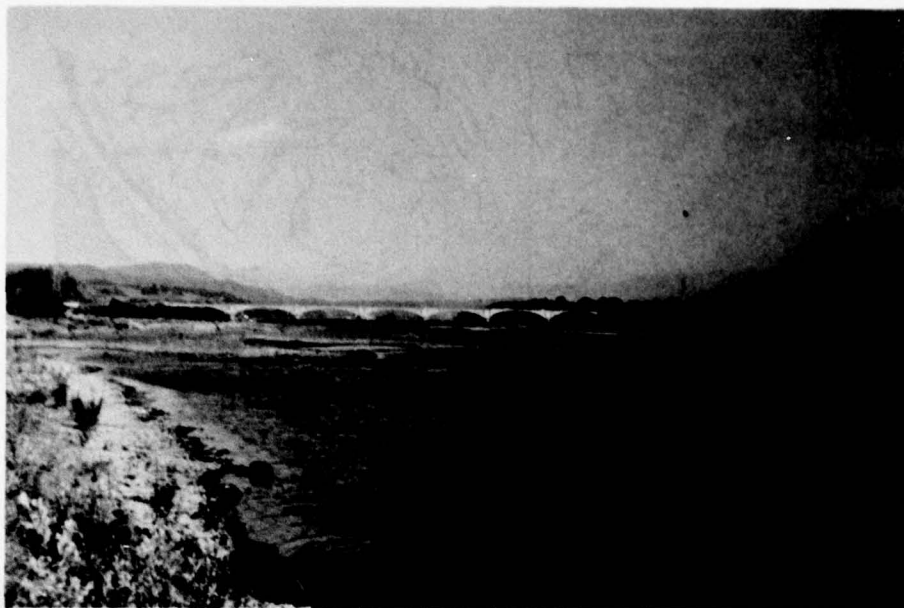
Figure 3. Eel River channel at demonstration site;
looking upstream, river mile 6

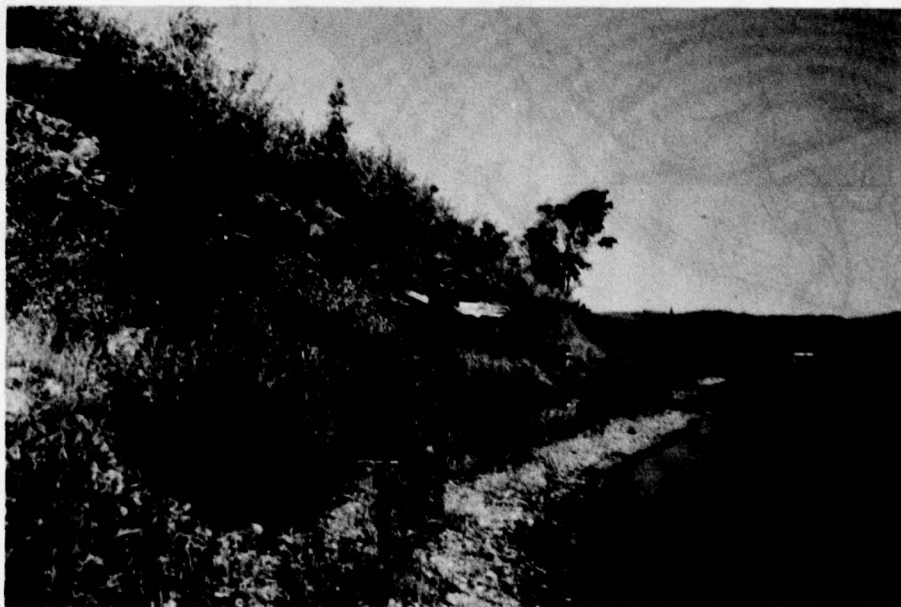
Figure 4. Bank material at Eel River demonstration site;
looking upstream, river mile 6 (Note: Bank heights are
approximately 15 ft above low flow water surface)

probably deposited during a period of high water, could be seen in the banks of finer alluvial deposits. Bank slopes are nearly vertical for the upper 60 percent and about 1 vertical on 1.5 horizontal for the lower talus portion.

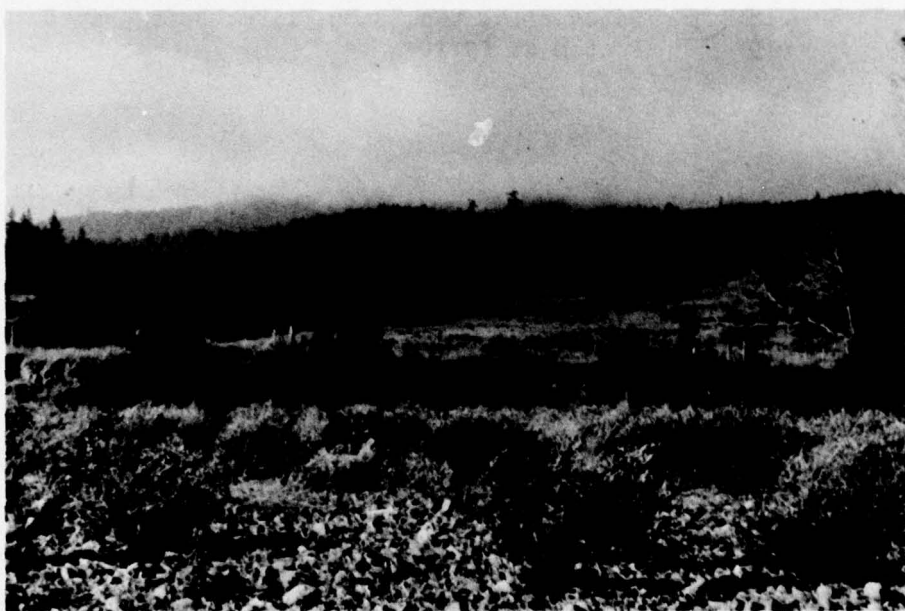
Figure 7. Bank and channel material at Van Duzen
River demonstration site; right
bank, river mile 8

17. The Van Duzen River demonstration site (Figure 5) is situated on the north bank approximately 8 miles upstream from the confluence of the Van Duzen with the Eel. The site is about 2 miles east of Carlotta and 20 miles northwest of Bridgeville. The Van Duzen at this point drains an area of about 280 square miles. Average bank-full width is about 1000 ft with an estimated capacity of approximately 30,000 cfs. Minimum flow is about 10 cfs with a maximum of 54,000 cfs. Bank heights range from 7 to 10 ft and are composed of sandy silts on gravel (Table 1). Bank slopes were similar to those at the Eel River Site (Figures 6 and 7).

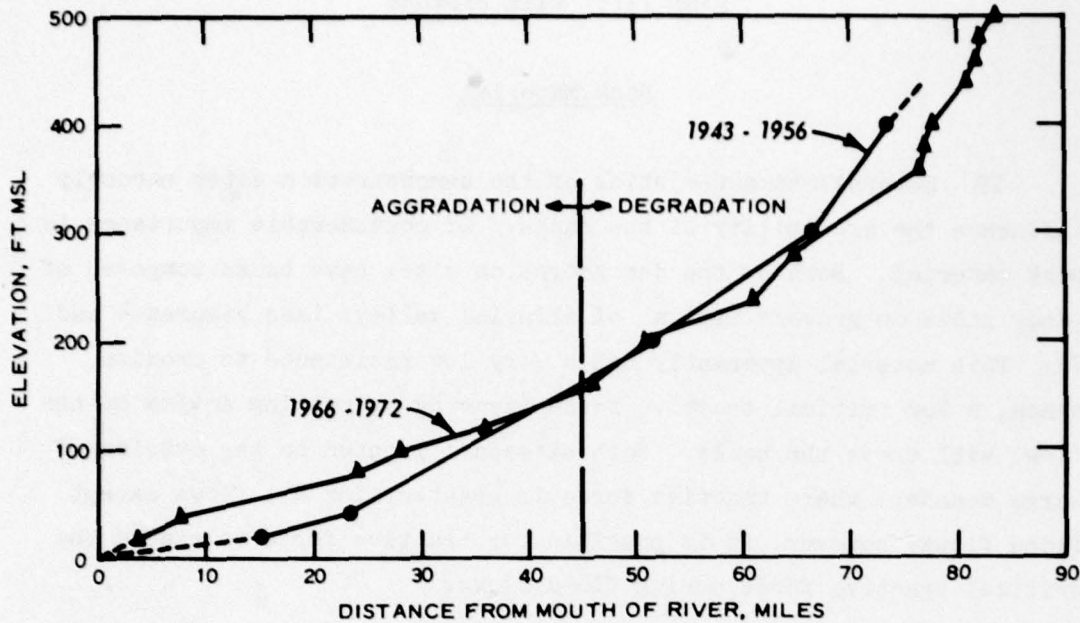
Figure 8. Changes in longitudinal profiles of the Eel River

21. Therefore, the longitudinal profile of the Eel River from its mouth to a point approximately 85 miles upstream was plotted from most recent (1966-1972) 1:24,000 scale U. S. Geological Survey (USGS) topographic maps. The longitudinal profile was also plotted from earlier 1:62,500 scale USGS topographic maps from the mouth to a point approximately 135 miles upstream. These two plots permitted historical comparison to be made of channel characteristics. The examination of these profiles shown in Figure 8 generally suggests that within the two periods of observation there had been considerable channel degradation 40 to 50 miles upstream of the demonstration site and that channel aggradation

had occurred at or near the site.* These phenomena are presumed to be related to the flows and sediment discharges associated with the 1964 and earlier floods (see paragraph 49).

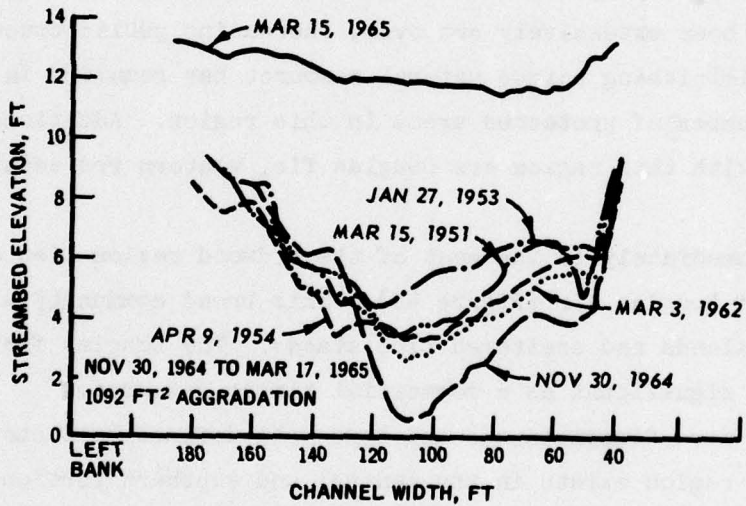
Figure 38. Cross sections of Van Duzen River at Pepperwood Falls

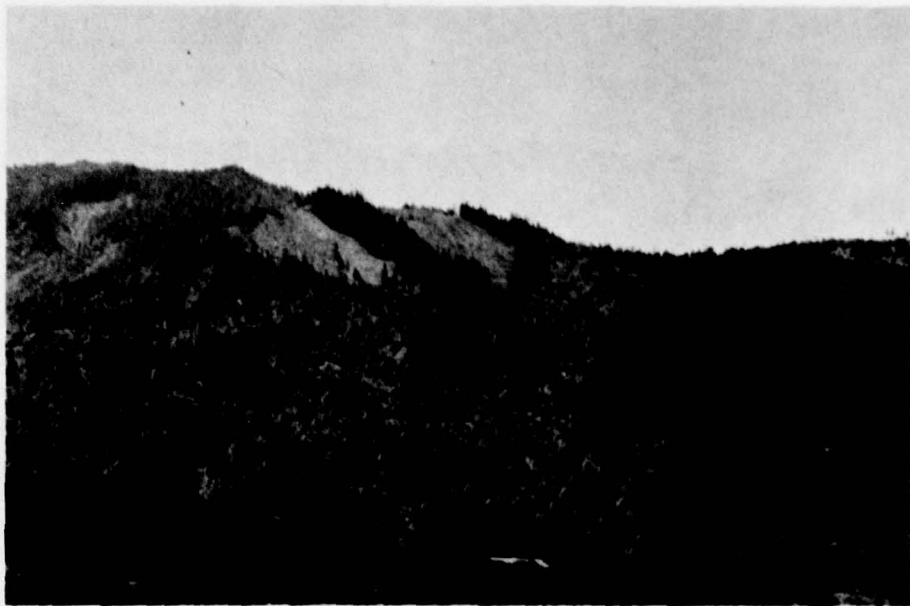
Figure 43. Evidence of logging on steep slopes
along the Van Duzen River, near Dinsmores
