18682  
8981  
WADC TECHNICAL REPORT 52-34, PART 1

AUTOGENOUS ELECTRIFICATION OF A B-45 AIRCRAFT

Part 1. Preliminary Investigation

DECEMBER 1951

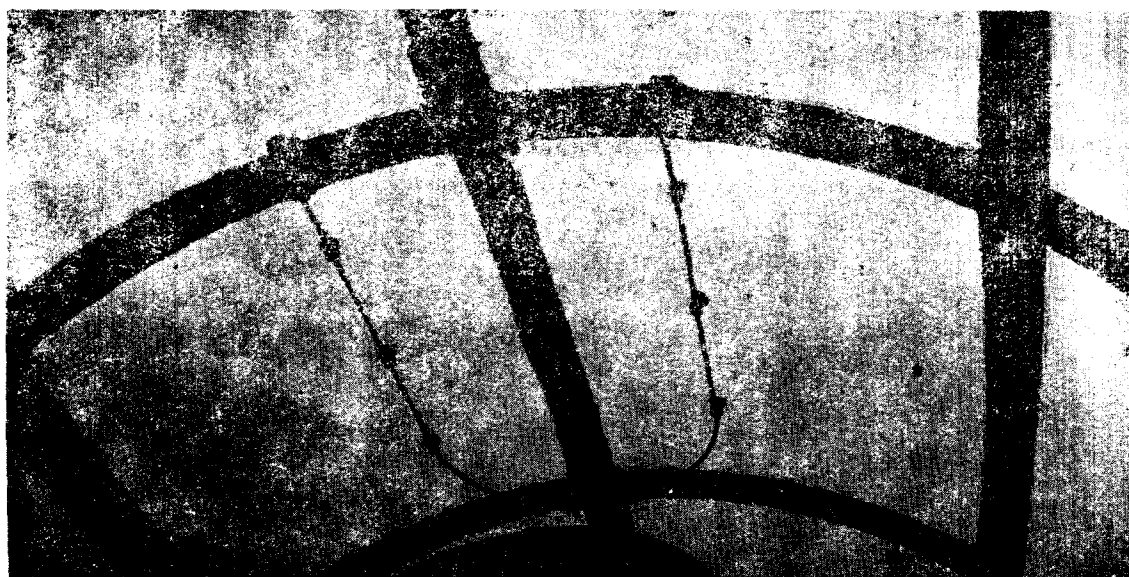
Figure 8  
External View of Pilot's Canopy of Test Aircraft

Figure 9  
Internal View of Pilot's Canopy of Test Aircraft

the pilot's canopy which contains the sense antenna. The "U" shaped antenna showing in the photographs is the localizer antenna. The sense antenna is buried in several of the Fiberglas ribs.
