AMMRC MS 79-2

# **CORROSION/EROSION BEHAVIOR OF SILICON NITRIDE AND SILICON CARBIDE CERAMICS - GAS TURBINE EXPERIENCE**

R. NATHAN KATZ

April 1979

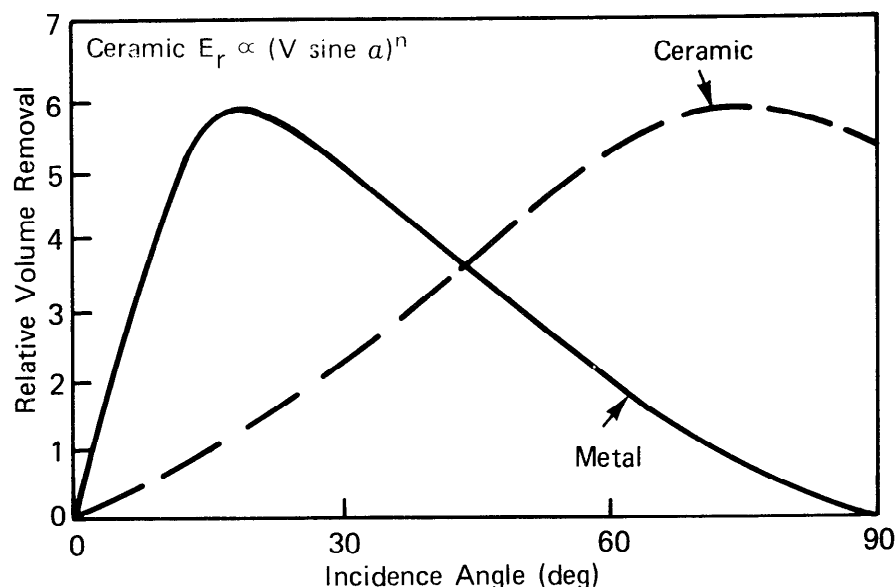
Figure 1. Comparison of ceramic versus metallic particulate erosion resistance behavior.

Only solid particle erosion will be considered. An extensive literature on liquid droplet erosion exists, and interested readers are referred to References 4 and 5. The phenomenology of the solid particle erosion behavior of metals and ceramics are significantly different as illustrated schematically in Figure 1.

A particle impingement angle of 15 to 20° results in a maximum erosion rate for metals, whereas this is a relatively benign situation for a typical ceramic. The maximum erosion rate for ceramics occurs at 90° impingement.<sup>6</sup> In general, erosive wear of ceramics follows an empirical equation of the form:

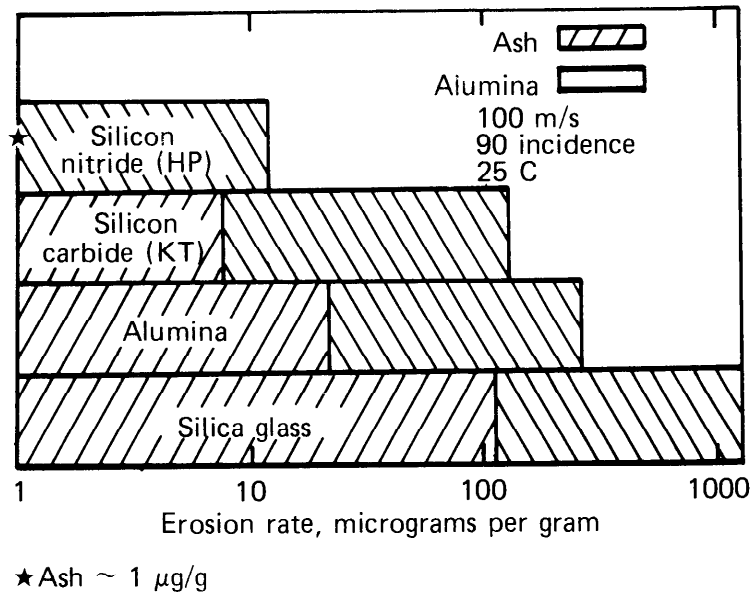
Figure 2. Erosion rate of ceramics by ash one-tenth the rate using alumina (after Meyers et al., Reference 7).

As part of a program to utilize ceramics in helical expander Brayton cycle turbomachines for coal-fired topping cycles, Myers et al.<sup>7</sup> have acquired data on the relative resistances of various ceramics to both fly ash and alumina particulates. The results of these room temperature tests are shown in Figure 2. Subsequently, erosion tests of HPSN, HPSiC, and Crystar-sintered SiC were conducted in a 1360 C combustion gas steam containing 6 g/min of coal fly ash impinging at 100 M/S. Erosion was not a problem; ash build-up was!

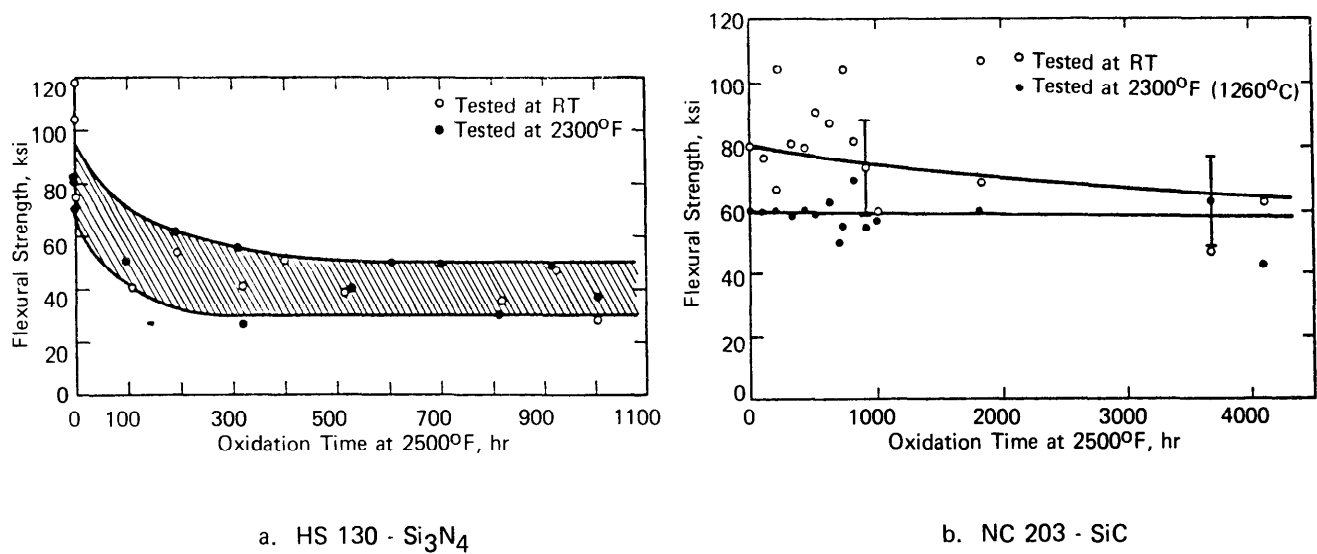
Figure 3. Retained strength after 2500 F oxidation of hot-pressed  $\text{Si}_3\text{N}_4$  and  $\text{SiC}$  at RT and 2300 F (Reference 9).

Miller et al. have obtained data on the effect of long-term oxidation on the retained strength of HS 130 (the predecessor of NC 132), hot-pressed silicon nitride, and NC 203 silicon carbide. The results for HS 130 (Figure 3a) show that retained strength is significantly degraded after long-term oxidation at 2500 F, even at temperatures as high as 2300 F. This strength reduction is attributed to surface pitting at the  $\text{Si}_3\text{N}_4/\text{SiO}_2$  interface. The results for NC 203 (Figure 3b)

show slight degradation of RT strength and no degradation of 2300 F strength, even with exposure to 4000 hours. The strength reduction in the RT tests is attributed to cracking of the  $\text{SiO}_2$  surface layer on cooling.

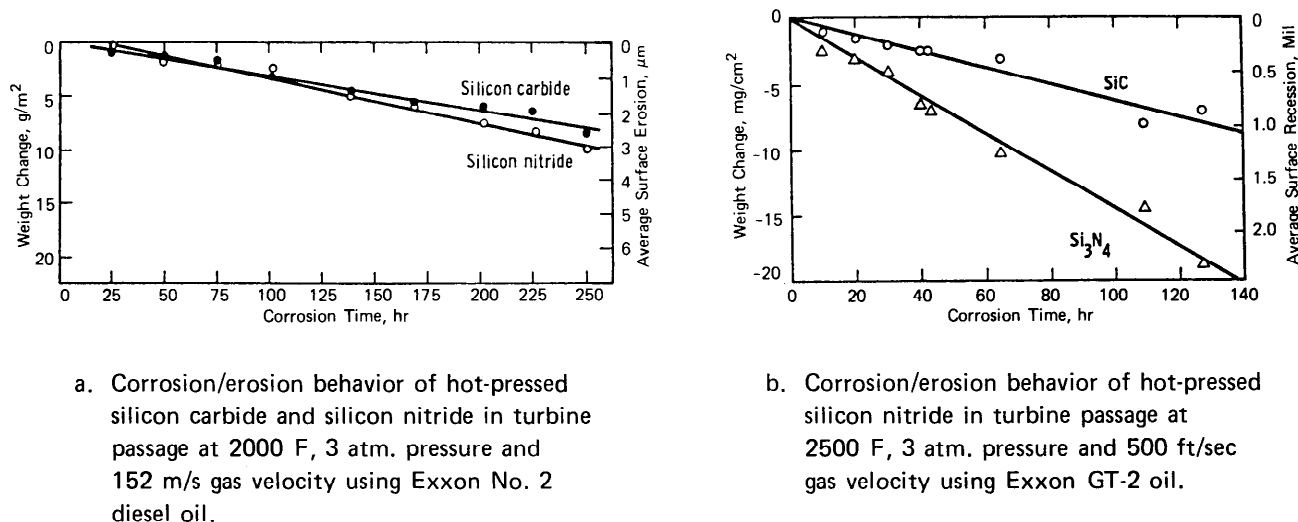
Figure 4. Corrosion/erosion behavior of hot-pressed SiC and Si<sub>3</sub>N<sub>4</sub> (Reference 9).

Work by investigators at Westinghouse documented in the ARPA "Brittle Materials Design" program final report<sup>9</sup> provides data on corrosion/erosion behavior of HS 130 and NC 203 materials in a 3 atm. combustor rig burning Exxon #2 diesel fuel. This fuel was barium free and had: 0.35 w/o (max) S; 0.01 w/o (max) ash; and 0.2 w/o (max) carbon residue. Results of 250-hour test programs for 2000 F and 2500 F exposures are shown in Figures 4a and b. The effect of these exposures on retained strength at 2000 F (1100 C) are presented in Figure 5 and Table 4. No room temperatures retained strength data are available. It is evident from Figure 5 that exposures at 2000 F had no effect on strength at 2000 F. (Miller et al. note some effect on longer duration testing.) Strengths of both materials at 2000 F are severely degraded by the 2500 F exposures.

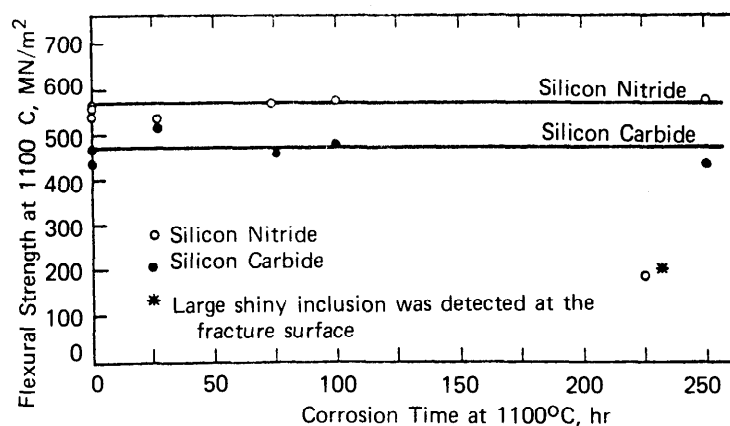
Figure 5. Effect of gas turbine environment on the flexural strength of hot-pressed  $\text{Si}_3\text{N}_4$  and  $\text{SiC}$  (Reference 9).

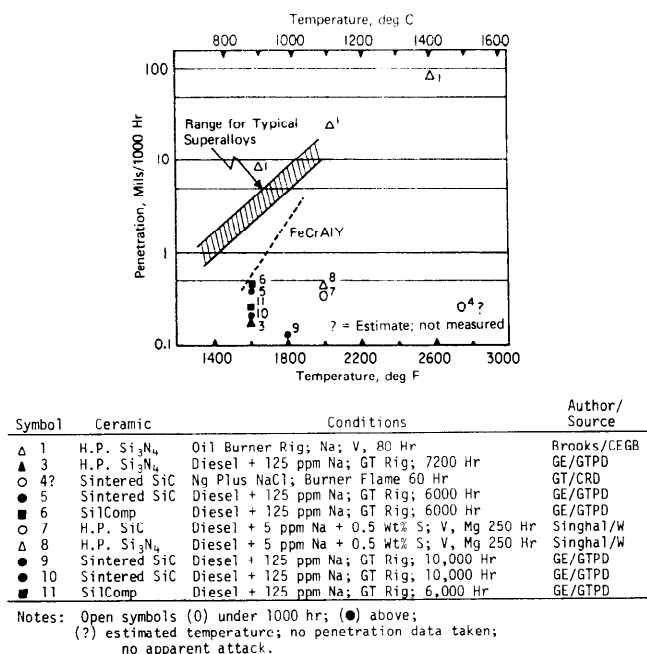
Figure 6. Corrosion behavior of ceramics  
 (after Sims & Palko, Reference 10).

Gas turbine engineers refer to the corrosion caused by the joint attack of Na and S as hot corrosion. Sims and Palko<sup>10</sup> have recently reported on hot corrosion studies on several  $\text{Si}_3\text{N}_4$  and  $\text{SiC}$  carried out by themselves, and others. Their results, shown in Figure 6, indicate that except for the oil-fired boiler data (a heavy slagging environment) the ceramics seem to perform much better than the super alloys. It is important to note that some of the G.E. tests go to 10,000 hr at 1600 F.

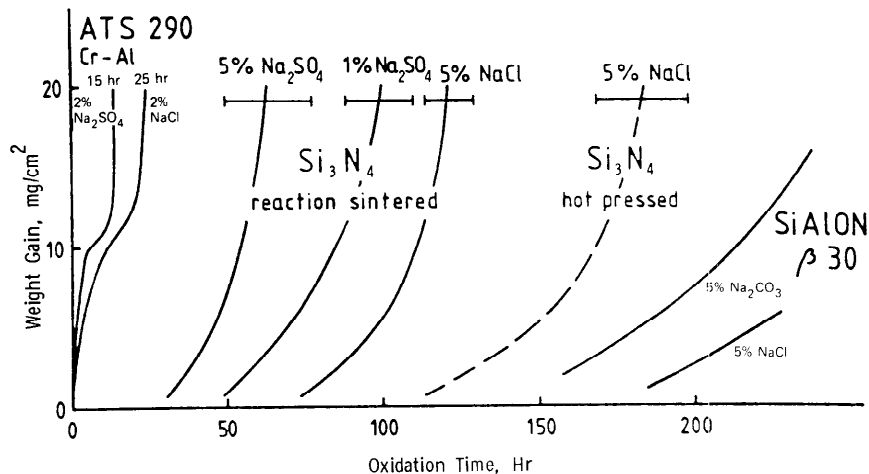
Figure 7. Corrosion of Si<sub>3</sub>N<sub>4</sub>, SiALON and a Cr-aluminized superalloy in burner gas under cycling conditions (after Schlichting, Reference 14).

second phases). The tests were performed in a burner rig (fuel unspecified) cycling between 1000 and 1200 C. Sodium chloride and H<sub>2</sub>S added into the burner gas were found not to corrode the ceramics. The presence of compounds which form alkali melts in which a surface sodium silicate glass may dissolve the Si<sub>3</sub>N<sub>4</sub>, such as Na<sub>2</sub>SO<sub>4</sub> or Na<sub>2</sub>CO<sub>3</sub>, do cause hot corrosion. However, as is shown in Figure 7, RBSN is several times more resistant to hot corrosion than is the superalloy tested; and the SiALON is more than an order of magnitude more resistant. Schlichting points out that controlling the Na<sub>2</sub>O content of the contaminant will significantly increase the ceramic lifetime.

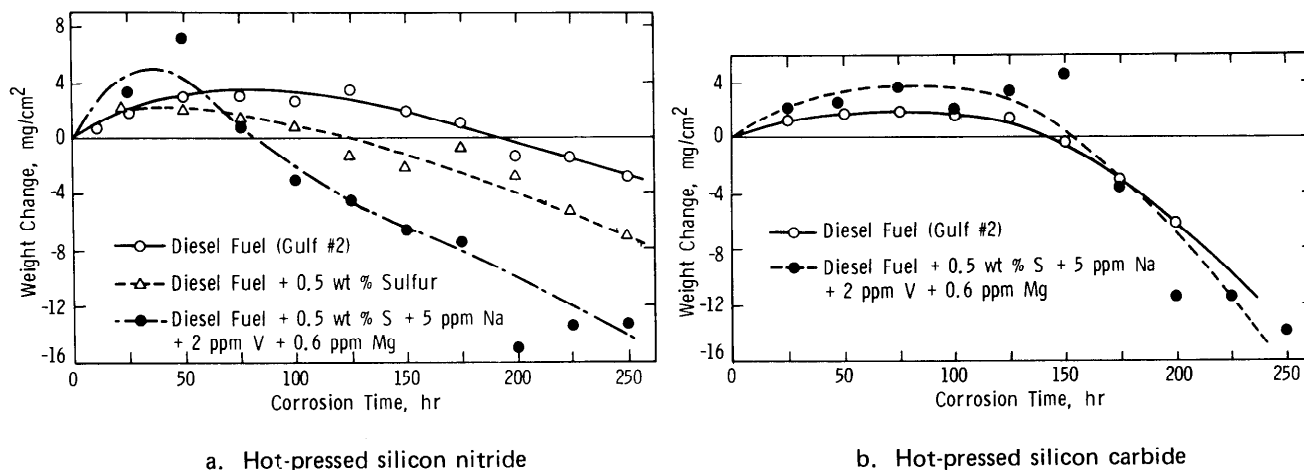
Figure 8. Effect of fuel contaminants on the corrosion of hot-pressed silicon nitride and hot-pressed silicon carbide in a turbine test passage at 2000 C and 3 atm. pressure (Reference 15).

Schlichting<sup>14</sup> studied the addition of  $V_2O_5$  to the burner gas stress described above. He observed little dissolution (corrosion) of  $Si_3N_4$  or SiALON's in this environment. Investigators at Westinghouse<sup>15</sup> have examined the combined effects of S, Na, V, and Mg on the behavior of HS 130 and NC 203 at 2000 F as shown in Figures 8a and b. Impurities seem to affect the corrosion/erosion behavior of HS 130 but not NC 203. However, the maximum weight gains after 250 hours are similar for both materials.

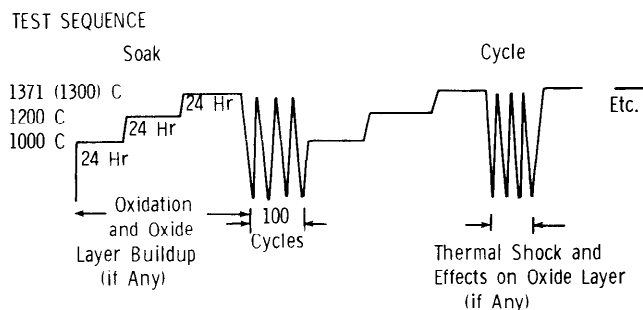
Note: Maximum temperature of 1300 C is used for SiC materials with free silicon as a constituent.

Figure 9. Combined thermal exposure/thermal cycling test sequence.

Quinn has been investigating combined high temperature exposure in air with thermal cycling, under a joint DOE/AMMRC program.<sup>17</sup> Three hundred and sixty hours of exposure in air at temperatures ranging between 1000 and 1371 C plus 500 thermal cycles are accumulated on each material studied according to the schedule shown in Figure 9. The thermal cycles are carried out in an oxygen-MAPP gas

flame (clean flame) with air quenching as described in Reference 18. Silicon nitrides and silicon-free SiC's are given a maximum exposure/cycle temperature of 1371 C (2500 F); for SiC materials with free silicon such as G.E.'s SilComp the maximum temperature is 1300 C (2372 F). "Virgin" materials properties (4-point modulus of rupture and Weibull "m," both at RT) were obtained on a population of 16 samples per material. Environmentally exposed materials properties (retained strength and Weibull "m," at RT) were obtained on a population of 11 to 12 samples per material. Materials tested to date are NC 132 (HPSN), NC 203 (HPSiC), NC 350 (RBSN), KBI - RBSN, and G.E. SilComp. Quinn's results are shown in Table 9. His results on NC 132 and NC 203 are in good agreement with the Westinghouse results on oxidation exposure in air shown in Figure 3. This would indicate that the effect of thermal cycling in the manner shown in Figure 9 is less important than is the effect of oxidation exposure. Both grades of RBSN evaluated suffered ~20% strength reduction after exposure. This is less than one might have anticipated from the work of Mangels and Godfrey cited earlier. Quinn's data covers higher temperatures and longer times than the AiResearch work discussed above, therefore it is not appropriate to draw comparisons. The SilComp data is the first on the retained strength of this class of materials. Therefore, no comparisons can be made.

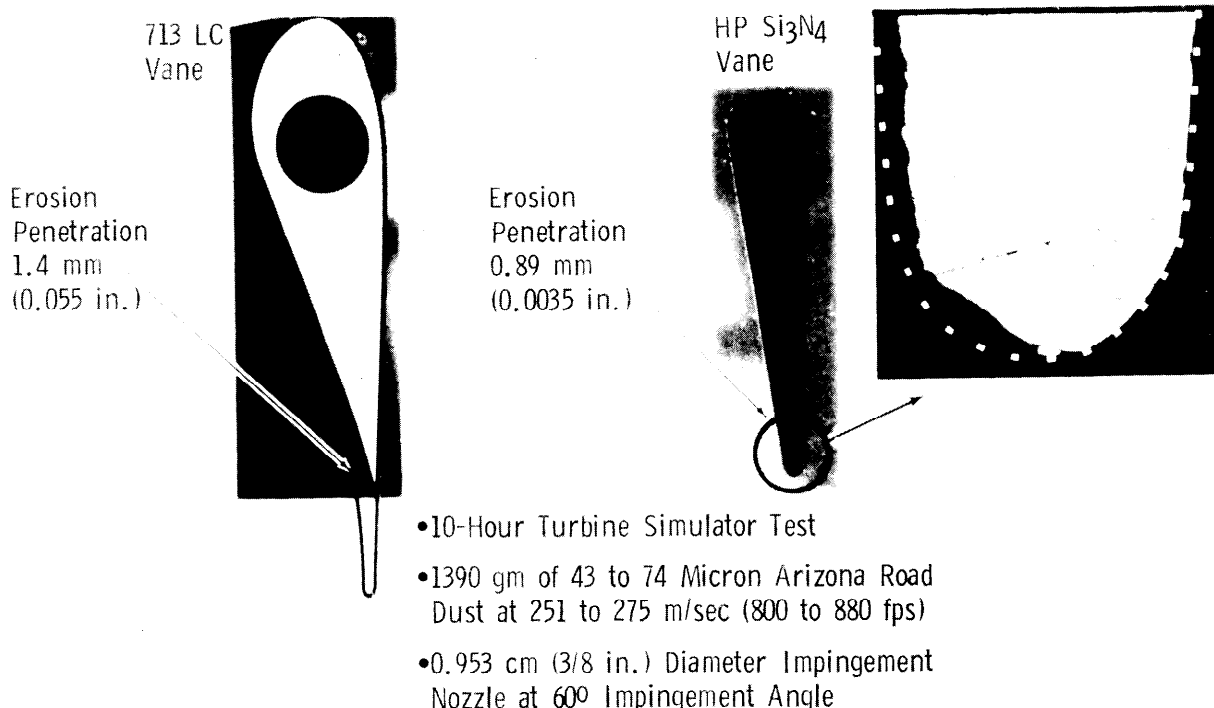
Figure 10. Erosion at 1700 F.

The 10-hour accelerated erosion test used 43 to 74  $\mu\text{m}$  Arizona road dust, which was impinged on selected vanes at a 1700 F vane temperature and 1750 ft/sec gas velocity. The results were dramatic (Figure 10) and showed the clear superiority of HPSN over the 713 LC superalloy. The 70-hour corrosion test was carried out at 1700 F, with 3 ppm of artificial sea salt injected into the gas stream. The results showed that HPSN was 27 times more corrosion resistant than 713 LC alloy, or a 0.0004-inch recession for HPSN versus 0.0011 for 713 LC.

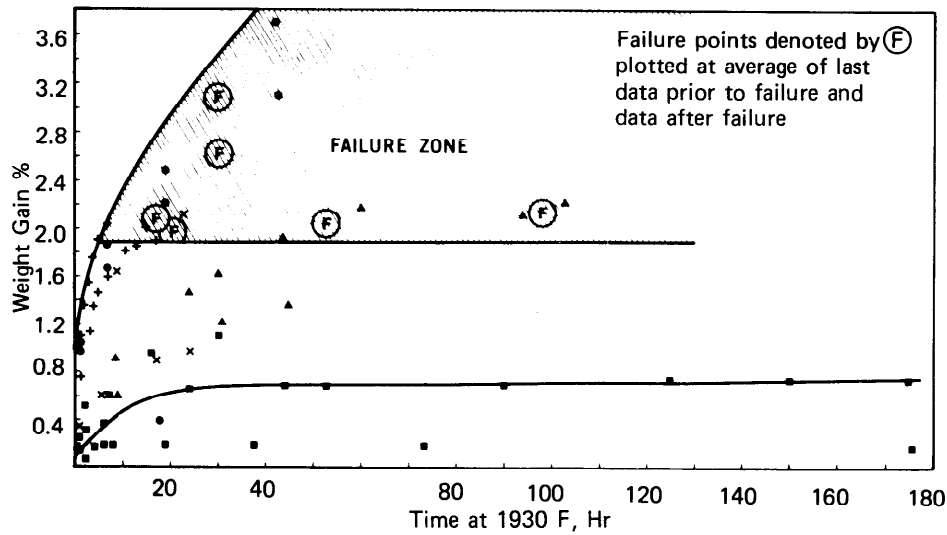
Figure 11. Weight gain versus engine rig test time at 1930 F for Ford 2.55 g/cc density RBSN stators showing failure zone (Reference 21).

Figure 11 shows early data on Ford 2.55 g/cc RBSN relating weight gain and stator lifetime in an engine rig.<sup>21</sup> Figure 12 shows more recent results for newer 2.7 g/cc RBSN components (both stators and nose cones).<sup>20</sup>

While the investigators at Ford do not offer a mechanism for the weight gain, the porosity and previously observed oxidation weight gain behavior of RBSN would lead one to speculate that the gain is due to oxidation. The observation that the weight gain of the reaction-sintered SiC in the same test was negligible<sup>20</sup> lends support to this speculation. This correlation between oxidative weight gain and component performance has obvious implications as a component qualification and NDE technique for RBSN.

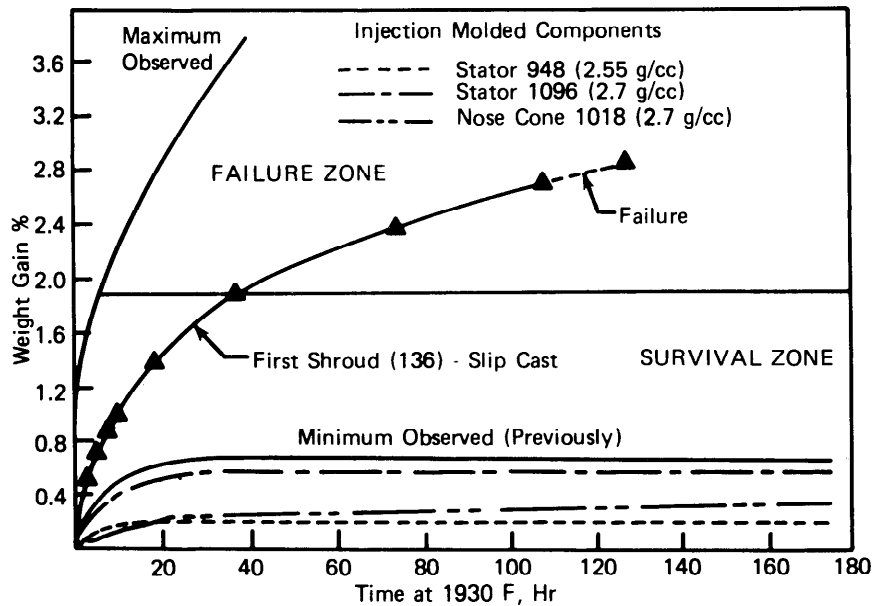
Figure 12. Weight gain versus engine rig test time at 1930 F for Ford 2.55 and 2.7 g/cc RBSN stators showing failure and survival regimes.
