NASA CR-159676  
R79-914364-12

# DEVELOPMENT OF SILICON NITRIDE OF IMPROVED TOUGHNESS

by J.J. Brennan

UNITED TECHNOLOGIES RESEARCH CENTER

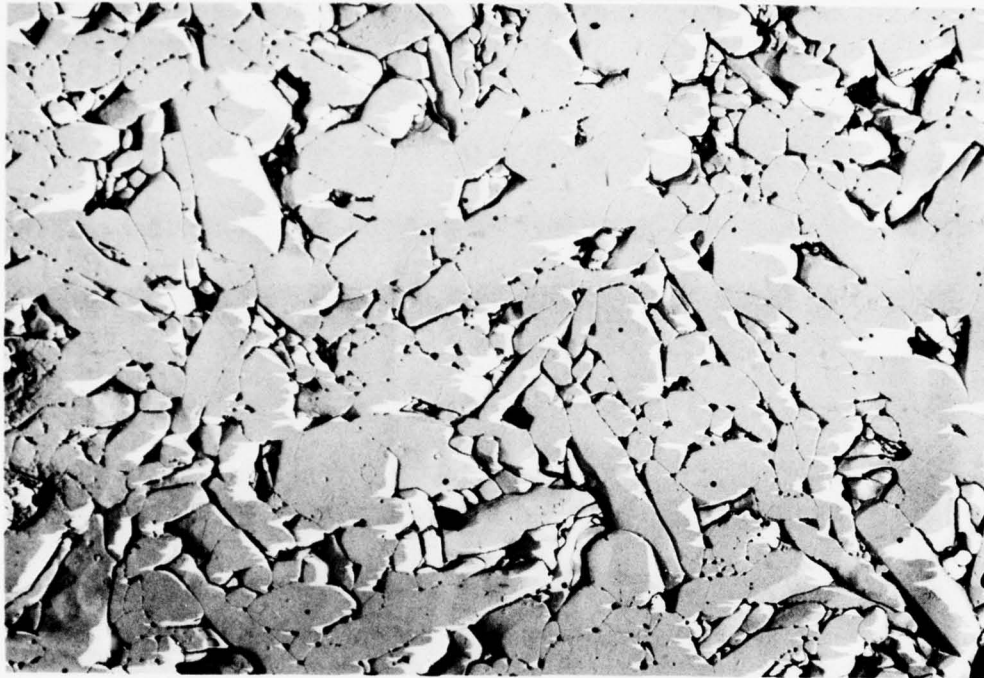
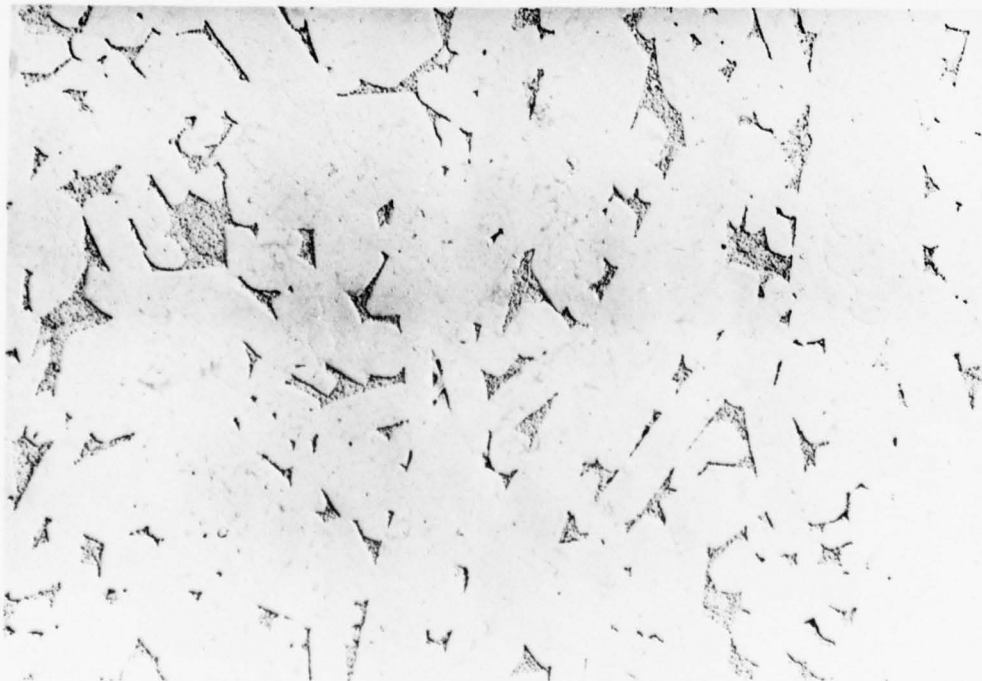
MICROSTRUCTURE OF NC-132 (a) AND NCX-34 (b) HOT-PRESSED  $\text{Si}_3\text{N}_4$  (TEM REPLICA)

Randomly selected specimens from each billet were characterized as to density, grain size, impurity content, and surface defects. The grain size and morphology was determined by replication techniques using the electron microscope. Impurity content was determined by spectrochemical analysis. Zyglo dye penetrant inspection was used to detect surface cracks or pits.

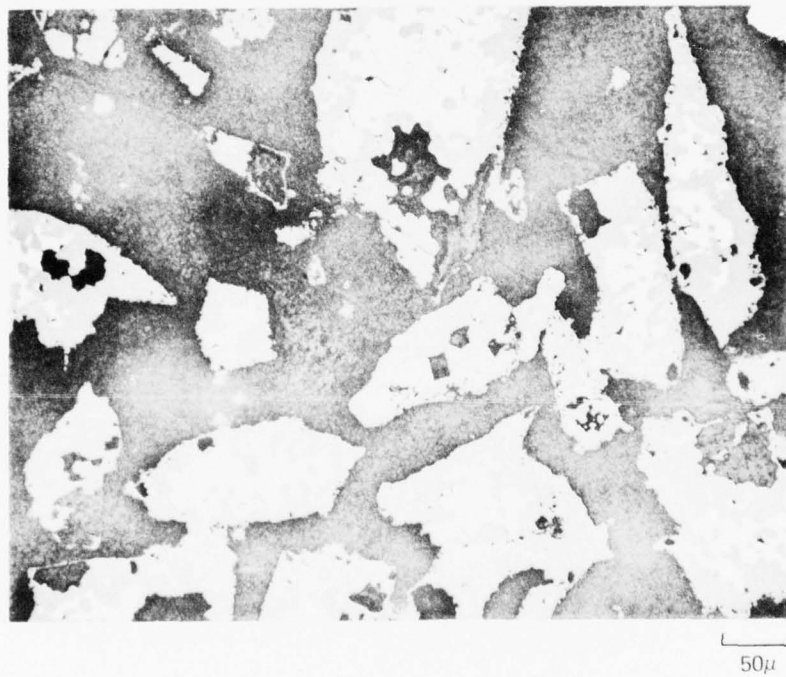
RSSN LAYER (-100, +200 Si) NITRIDED TO 1375°C, 24 HRS, N<sub>2</sub>  
(25-30 V/O UNREACTED Si)

In order to evaluate the effect of unreacted Si on the ballistic impact resistance, both NC-132 and NCX-34  $\text{Si}_3\text{N}_4$  substrates with layers of -100,+200 Si were nitrided according to the above schedule except that the 1375°C nitridation step was reduced to 24 hrs. From X-ray analysis and optical microscopy of the nitrided layers, it was found that this nitriding schedule resulted in approximately 25-30 vol % unreacted Si in the interior of the -100,+200 nitrided Si particles, as shown in Fig. 7. The results of RT ballistic impact tests on these samples are given in Table VII.

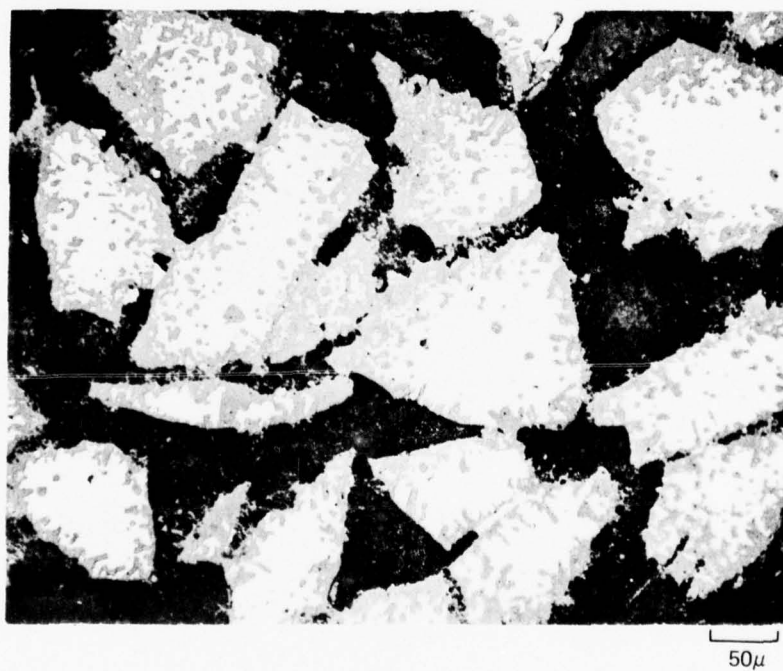
RSSN LAYER (-100, +200 Si) NITRIDED TO 1375°C, 8 HRS, N<sub>2</sub>  
(60 V/O UNREACTED Si)

The results of RT ballistic impact tests on the samples nitrided to 1375°C for 8 hrs are given in Table VIII. As in the case of -100,+200 Si layers nitrided for 24 hrs at 1375°C, an impact energy in excess of 11.4 joules was necessary to fracture the NCX-34  $\text{Si}_3\text{N}_4$  substrates. However, the nitrided -325 Si layers could only withstand up to 6.2 joules before the substrate fractured. From X-ray analysis and optical microscopy of the nitrided layers, it was found that the 8 hr, 1375°C nitriding schedule resulted in approximately 60% unreacted silicon within the large  $\beta$ - $\text{Si}_3\text{N}_4$  grains of the -100,+200 Si nitrided layer (Fig. 8), while the -325 Si nitrided layers were essentially completely nitrided (Fig. 9) to a mixture of ~65%  $\beta$ , 35%  $\alpha$ - $\text{Si}_3\text{N}_4$ .

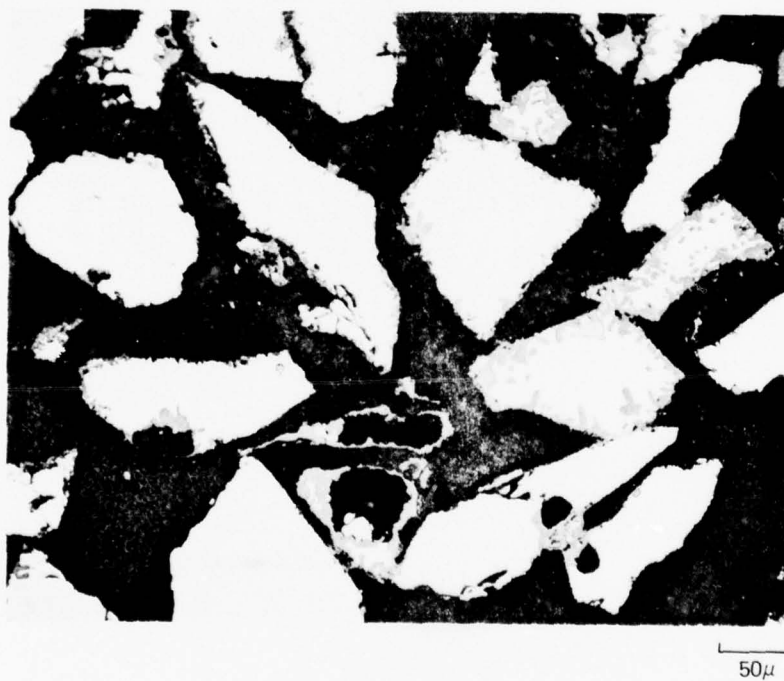
RSSN LAYER (-100, +200 Si) NITRIDED TO 1300°C, 8 HRS, N<sub>2</sub>  
(10 V/O OF Si CONVERTED TO Si<sub>3</sub>N<sub>4</sub>)

The -100,+200 Si samples that were deliberately nitrided to only 1300°C, 8 hrs, exhibited RT ballistic impact resistance less than the -100,+200 Si samples nitrided to 1375°C, 8 hrs. They were also somewhat friable, indicative of poor particle-to-particle bonding. From X-ray analysis and optical microscopy it was evident that very little of the Si had been converted to  $\text{Si}_3\text{N}_4$  (~10 vol %), as shown in Fig. 10. Not enough  $\text{Si}_3\text{N}_4$  had been formed to bond the particles together, thus resulting in the observed friable layer.

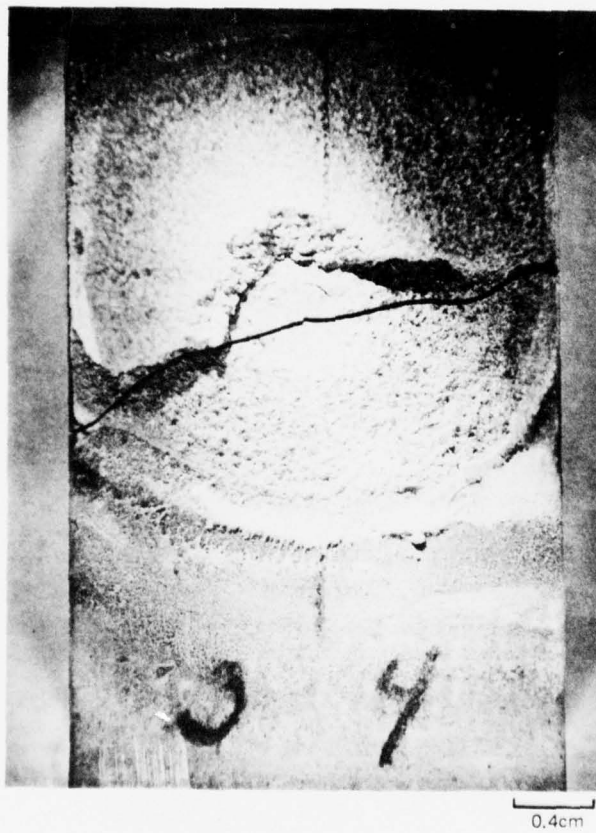
BALLISTIC IMPACT SAMPLE OF NCX-34  $\text{Si}_3\text{N}_4$  WITH -200 RSSN  
LAYER (21 V/O Si) AFTER 17.2 JOULE IMPACT

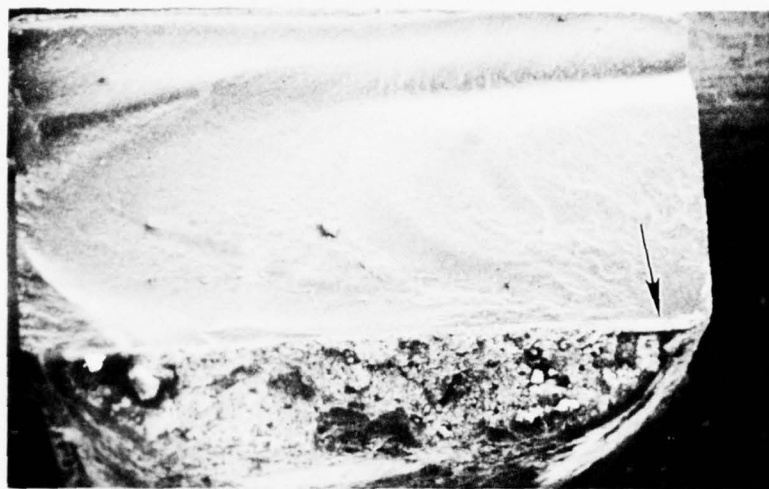
FRACTURE SURFACE OF NC-132  $\text{Si}_3\text{N}_4$  WITH  $\sim 325$  Å Si LAYER (NITRIDED AT MAXIMUM TEMP. OF 1250°C FOR 24 HRS.)

$\text{Si}_3\text{N}_4$  (1370°C, 24 hrs) resulted in severe strength degradation (~325 MPa) of the NC-132  $\text{Si}_3\text{N}_4$  when the layered side was tested in tension, while nitriding conditions of 1250°C, 24 hrs that resulted in only slight conversion of Si to  $\text{Si}_3\text{N}_4$  (~10%) did not lead to strength degradation of the  $\text{Si}_3\text{N}_4$  substrate. Examination of fracture surfaces revealed that the fracture origin of degraded samples appeared to be small voids within the RSSN layer lying very close to the RSSN/HPSN interface.

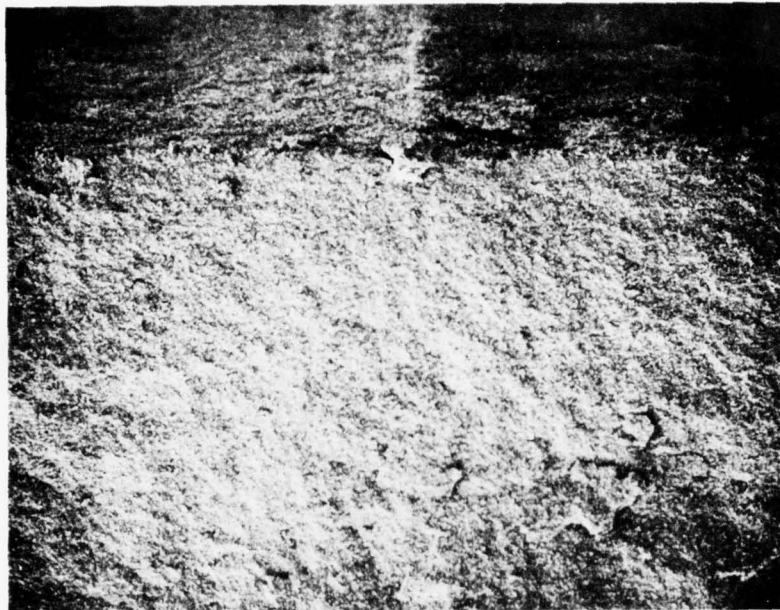
FRACTURE ORIGIN OF NCX-34  $\text{Si}_3\text{N}_4$  WITH LOOSE -100, +200 Si PARTICLES  
ON THE SURFACE, NITRIDED TO 1375°C, 60 HRS,  $\text{N}_2$

RT 4-pt bend tests of NCX-34  $\text{Si}_3\text{N}_4$ , nitrided to 1375°C for 60 hrs in  $\text{N}_2$ , with well bonded RSSN surface layers indicated that, as previously found for NC-132  $\text{Si}_3\text{N}_4$ , the nitriding of the Si powder layers introduces strength limiting flaws at the HPSN/RSSN interface that result in a 40-50% drop in bend strength when the nitrided layer is tested in tension. Nitriding tests with Si powder lightly sprinkled on the NCX-34 tensile surfaces showed that the fracture origin of degraded samples was always associated with a nitrided particle of Si or a depression that appeared to be at one time associated with a nitrided Si particle.

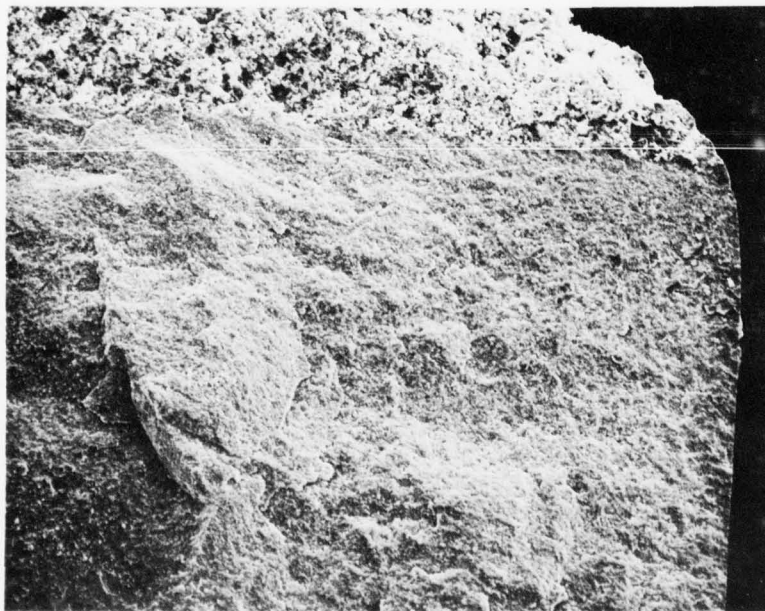
FRACTURE SURFACE OF -325 Si (98%) RSSN LAYER ON NC-132 Si<sub>3</sub>N<sub>4</sub>,  
NITRIDED IN 96% N<sub>2</sub>/ 4% H<sub>2</sub> TO 1375°C, 60 HRS

However, results of 4-pt bend tests on NC-132 and NCX-34  $\text{Si}_3\text{N}_4$  with RSSN layers of various purity nitrided in a  $\text{N}_2/\text{H}_2$  mixture indicate that a minimal amount of substrate degradation occurs for well bonded layers of 98% purity -325 Si and -200 Si on both NCX-34 and NC-132  $\text{Si}_3\text{N}_4$ . Nitriding in  $\text{N}_2/\text{H}_2$  mixtures (96%  $\text{N}_2/4\% \text{H}_2$ ) also led to a much faster rate of conversion of the Si to  $\text{Si}_3\text{N}_4$  and an  $\alpha$  to  $\beta$ - $\text{Si}_3\text{N}_4$  ratio of ~2:1, whereas nitriding in 100%  $\text{N}_2$  gave an RSSN product of ~70%  $\beta$ , 30%  $\alpha$ . The much greater amount of  $\alpha$ - $\text{Si}_3\text{N}_4$ , which forms primarily as fine whisker-like crystals interconnecting the  $\beta$ - $\text{Si}_3\text{N}_4$  grains, may be responsible for the lesser amount of substrate degradation observed for the samples nitrided in  $\text{N}_2/\text{H}_2$  mixtures, due to the  $\alpha$ - $\text{Si}_3\text{N}_4$  whisker mat not allowing the  $\beta$ - $\text{Si}_3\text{N}_4$  grains to bond directly to each other or to the HPSN substrate. Thus, no large stress-concentrating flaws are bonded directly to the HPSN surface and cracks initiating in the RSSN layer cannot propagate directly through  $\beta$ - $\text{Si}_3\text{N}_4$  grains and into the HPSN substrate.

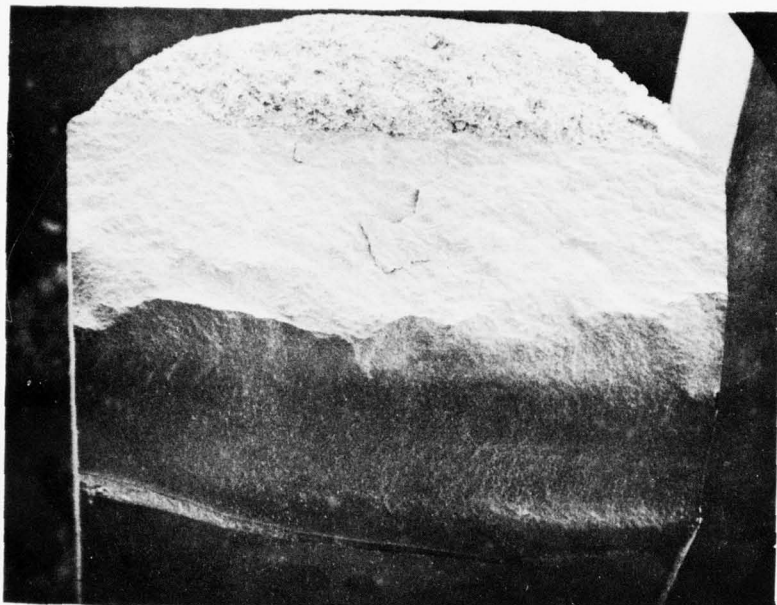
FRACTURE SURFACE OF -325 Si (98%) RSSN LAYER ON NCX-34 Si<sub>3</sub>N<sub>4</sub>,  
NITRIDED IN 96% N<sub>2</sub>/4% H<sub>2</sub> TO 1375°C, 60 HRS

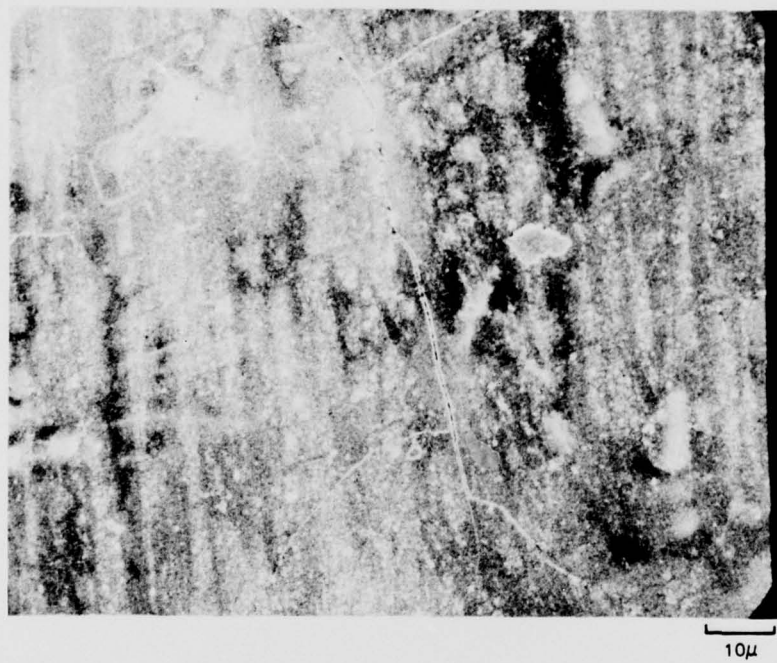
OXIDIZED SURFACE OF CVD SiC OVERLAYER AFTER 75 CYCLES TO 1370°C.

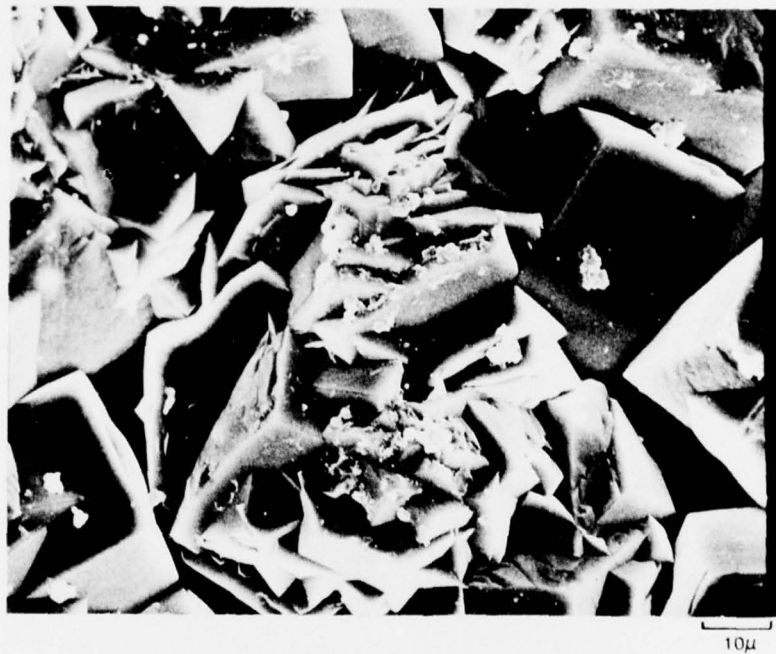
SURFACE OF CVD  $\text{Si}_3\text{N}_4$  OVERLAYER ON A -200 RSSN/HPSN EROSION SAMPLE.
