MEMORANDUM REPORT ARBRL-MR-02955
(Supersedes IMR No. 601) TH

AN INVESTIGATION OF THE IMPACT
RESISTANCE OF GLAZING MATERIALS FOR
RAILROAD VEHICLES

US ARMY ARMAMENT RESEARCH AND DEVELOPMENT COMMAND
BALLISTIC RESEARCH LABORATORY
ABERDEEN PROVING GROUND, MARYLAND

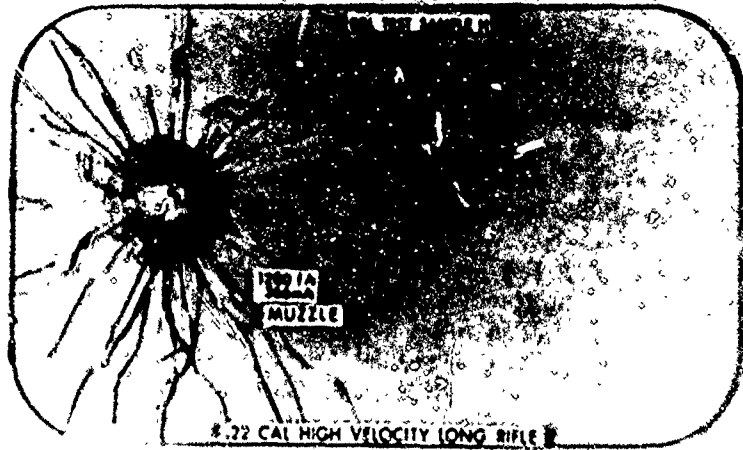
Figure 6. Example of Typical Impact Damage from Projectile Impacts.

The results of the projectile impact tests against those types of glazing materials previously listed in Table I are summarized in the following table (Table III) and in Appendix B. Illustrations of typical damage are shown in Figures 5 and 6.

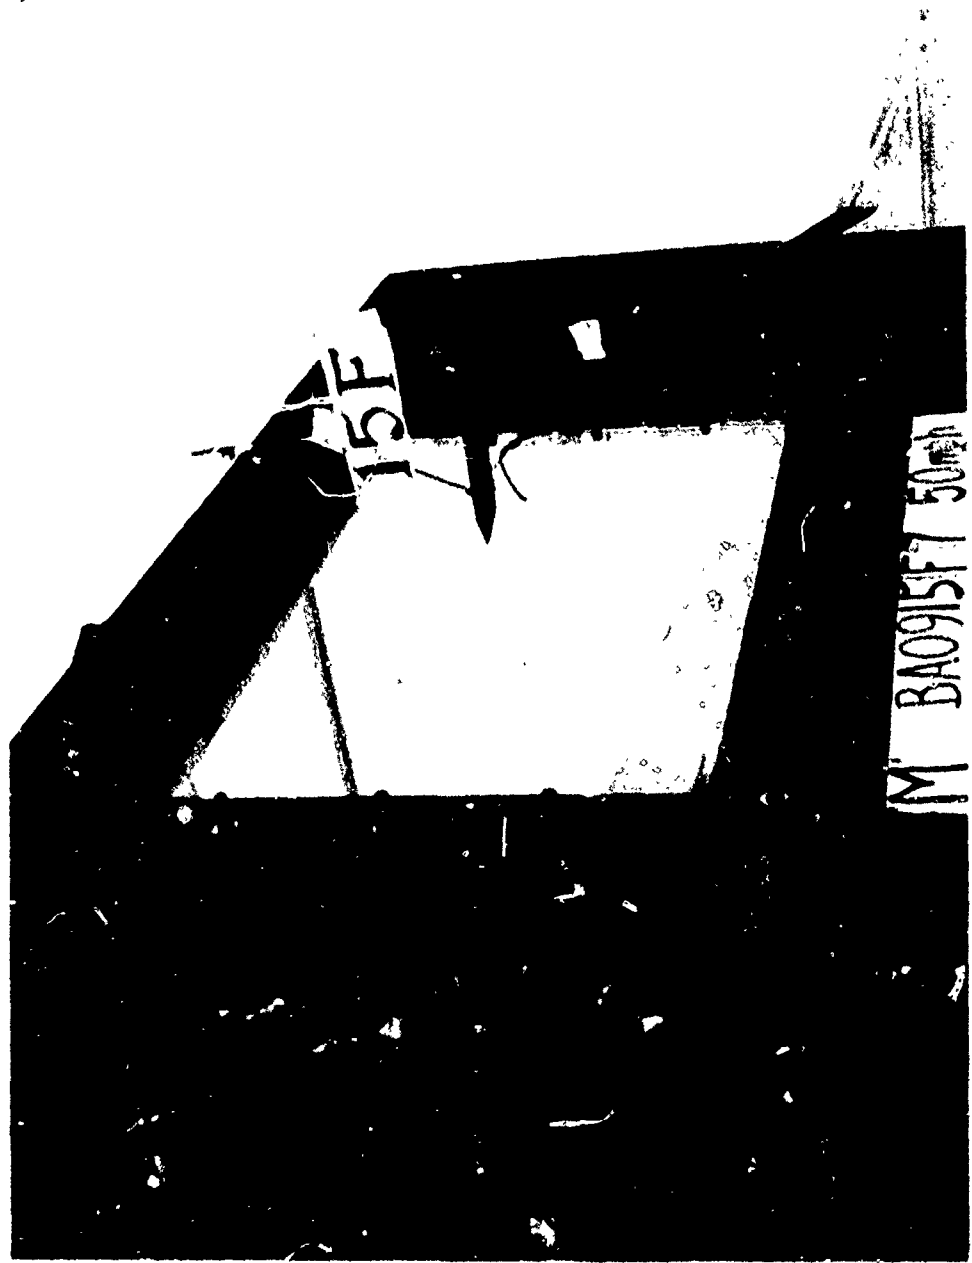
Figure 9. Test Set-up for Impact Tests Against a Suspended Railroad Spike

In order to obtain some additional information on the impact resistance of these glazing materials, it was decided to suspend a railroad spike in place of the cinder block. This was to provide data for an object commonly found along railroad lines and likely to be thrown at passing railroad vehicles. All other components of the test system remained as before.
