OSWEGO RIVER BASIN

DAM NO 5 (MINETTO)

INVENTORY NO NY 402

PHASE I INSPECTION REPORT
NATIONAL DAM SAFETY PROGRAM

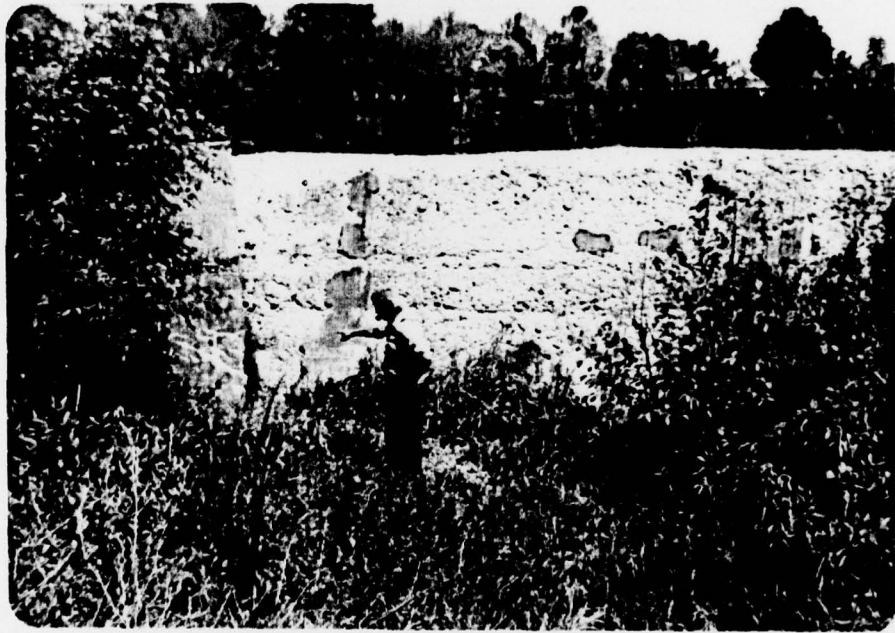
5. Deteriorated concrete wall surface at hydropower intake channel on west side of river. Pictures taken on both sides of tree.

A land wall upstream of the dam on the west side of the river and adjacent to a Minetto Village street permits the dam's upstream water level to be maintained above the elevation of the street. The concrete in the land side of this wall has experienced significant deterioration and spalling, and through-the-wall leakage occurs. It also appears that seepage below ground level occurs. No indication of structural instability was noted. Sections of this wall may be supported on pile foundations.

In addition to maintenance repairs to correct the surface deterioration which has occurred in the concrete land wall protecting Village property from the river upstream of the dam, the below ground seepage occurrence should be investigated to ascertain the cause and provide measures for correction of the condition.

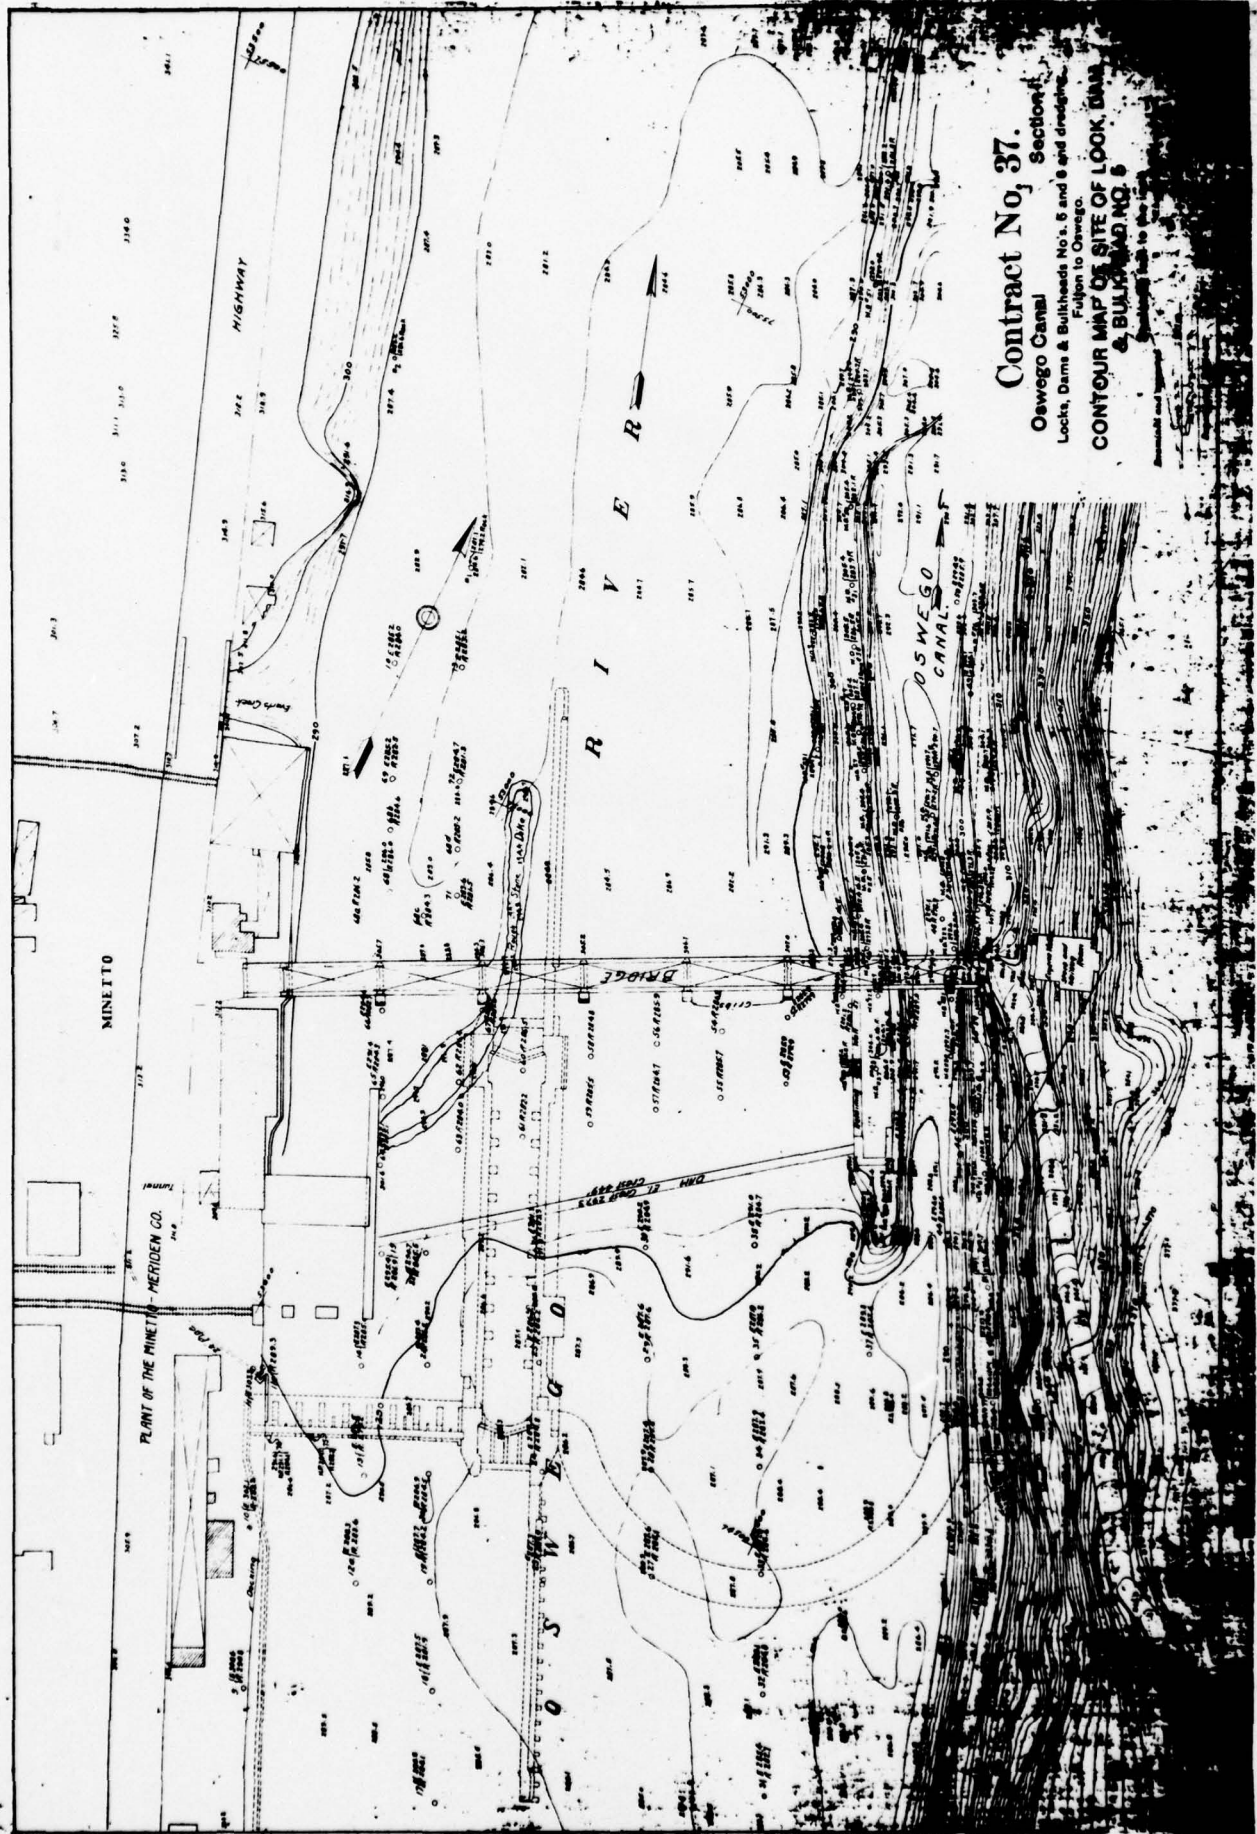
FIGURE 10

Contract No. 37.
Oswego Canal Section 1
 Locks, Dams & Bulkheads No. 5 and 6 and dredging.
 Pullman to Oswego.
CONTOUR MAP OF SITE OF LOCK, DAM & BULKHEAD NO. 5
