THE CORROSION FATIGUE BEHAVIOR OF A HIGH PURITY
Al-Zn-Mg-Cu ALLOY

Edward F. Smith III
D. J. Duquette
Materials Engineering Department
Rensselaer Polytechnic Institute
Troy, New York 12181

November 1979

Technical Report to the Office of Naval Research

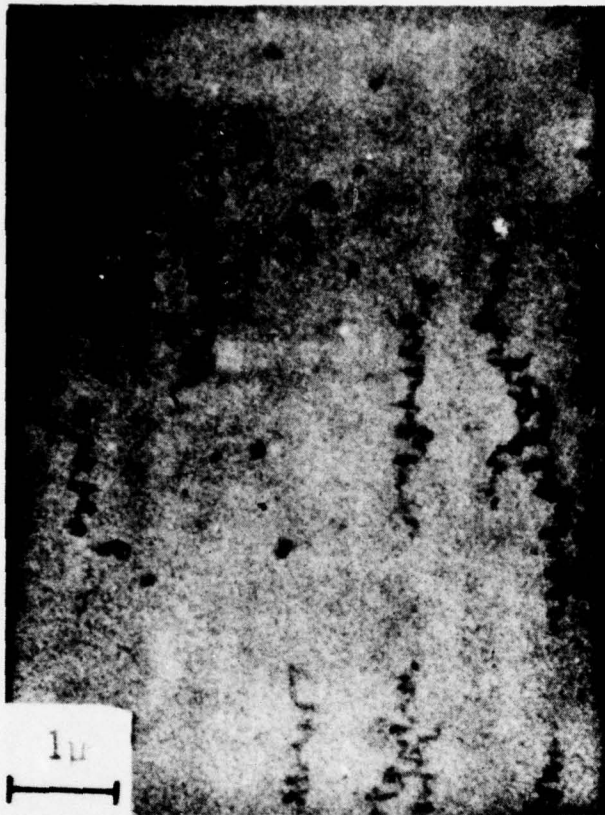
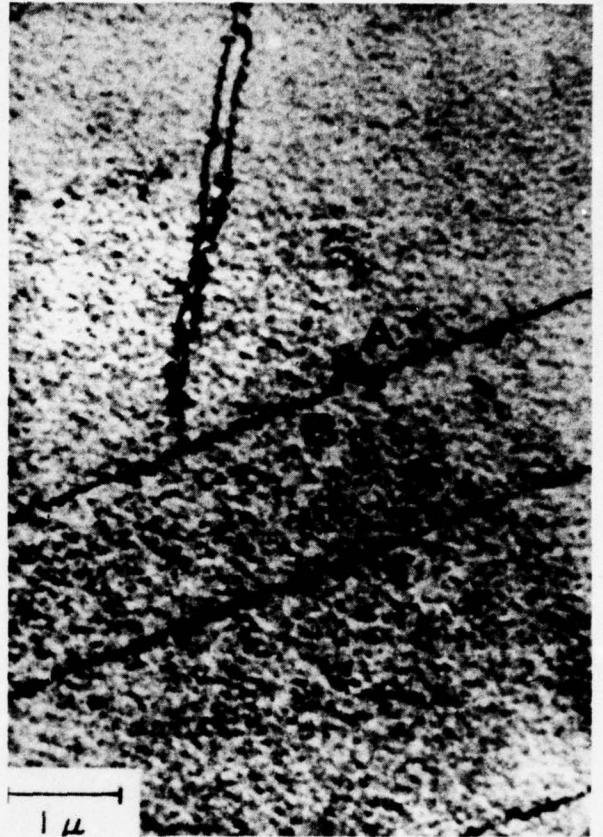
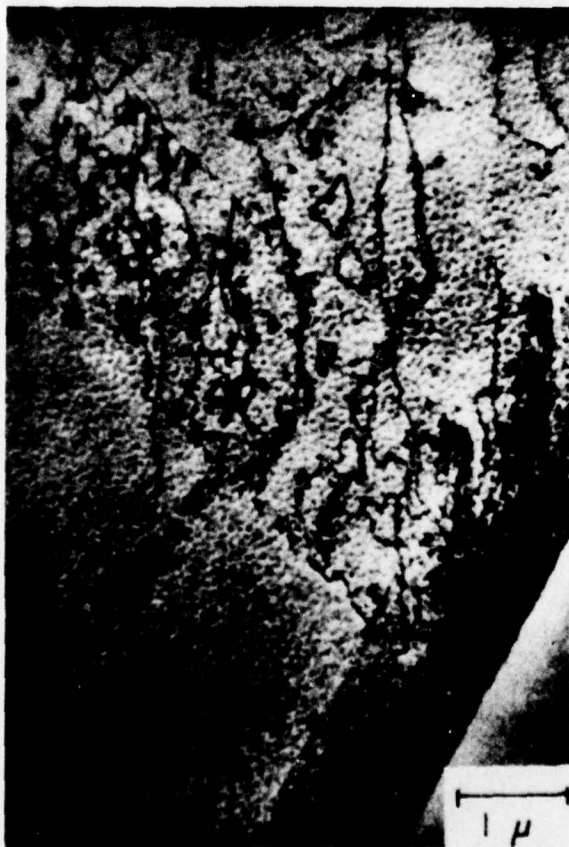
Figure 1

- a) 0% - illustrating helical dislocations characteristic of quenched in structure
- b) 1% ($N_i = 10^4$ cycles) - illustrating a jogged screw dislocation where the components A 112 and B 110 were found to lie on different slip planes
- c) 67% ($N_i = 6.7 \times 10^5$ cycles) - illustrating a slip band containing dislocation in various stages of development

These loops continue to form throughout the cycling process. Figure 1c, for example, is at 67% of N_i and it shows that within a single slip band there are a large number of loops in all stages of formation. The completed loops were found to be primarily of an edge nature and lie across the primary slip plane. Duquette and Swann¹⁶ formulate that since edge dipoles have been shown to exert a tensile force across the plane of the dipole, fracture will occur when a critical dipole density is reached, the exact level being determined by the combined total of the applied tensile stress and the dipole induced tensile stress. When this total exceeds the fracture stress of the metal, a crack is initiated.

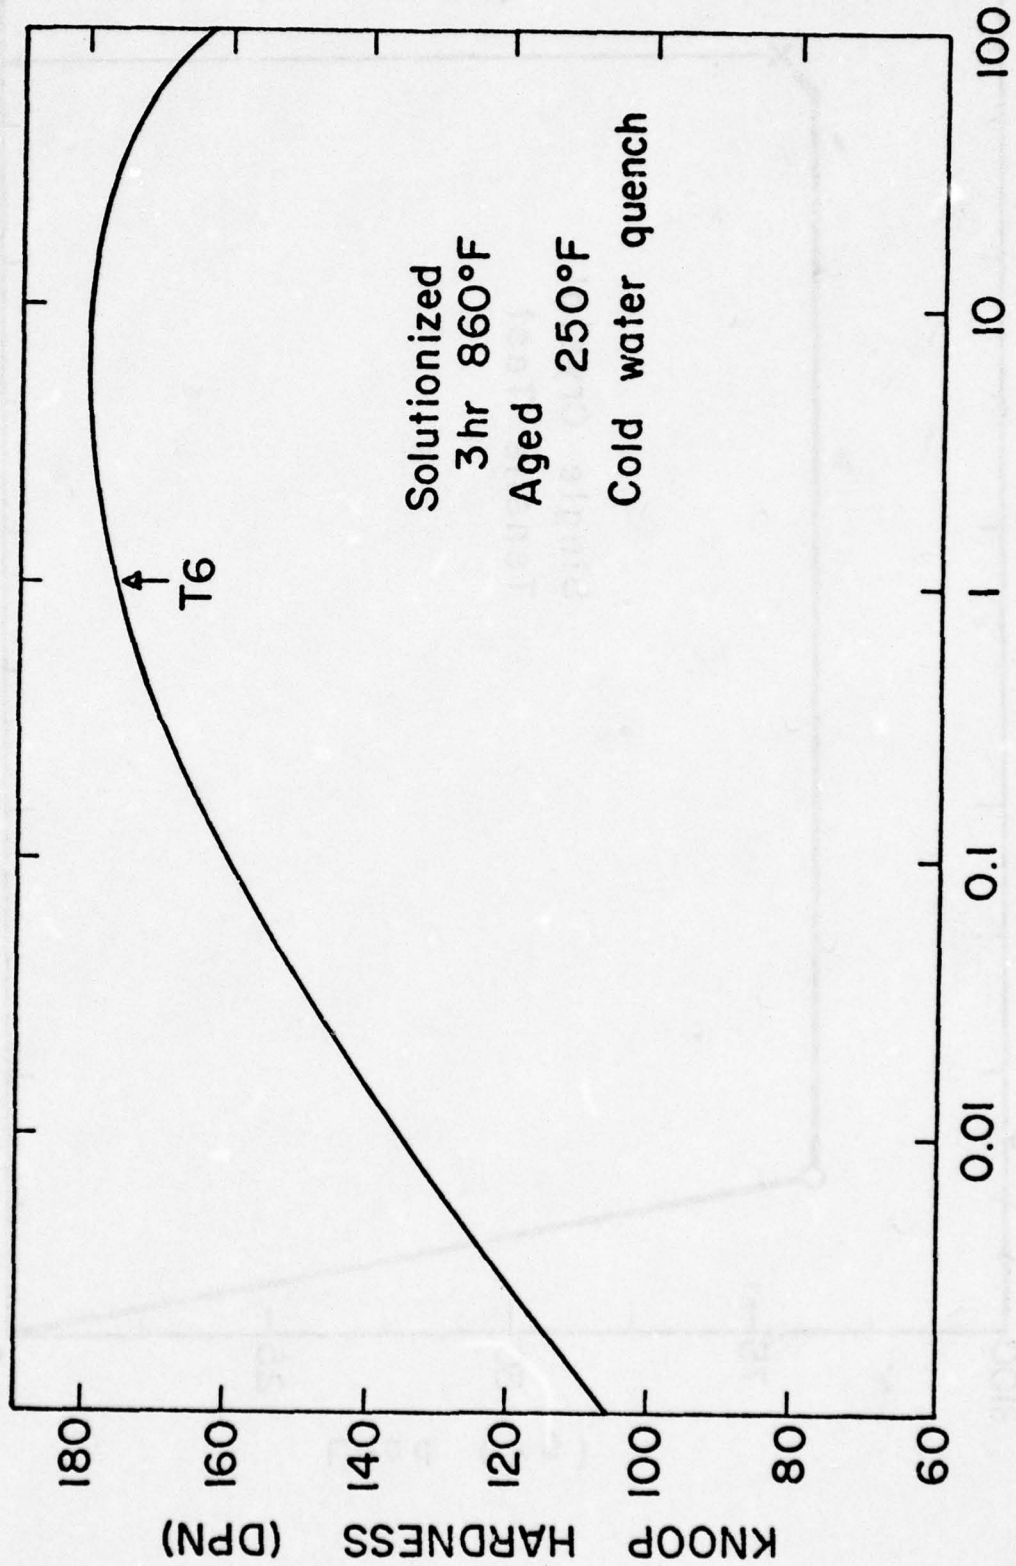
Figure 9.

The hardness as a function of aging time at 120°C. Prior to the aging treatment, the specimens were solutionized for 3 hours at 465°C and cold water quenched.

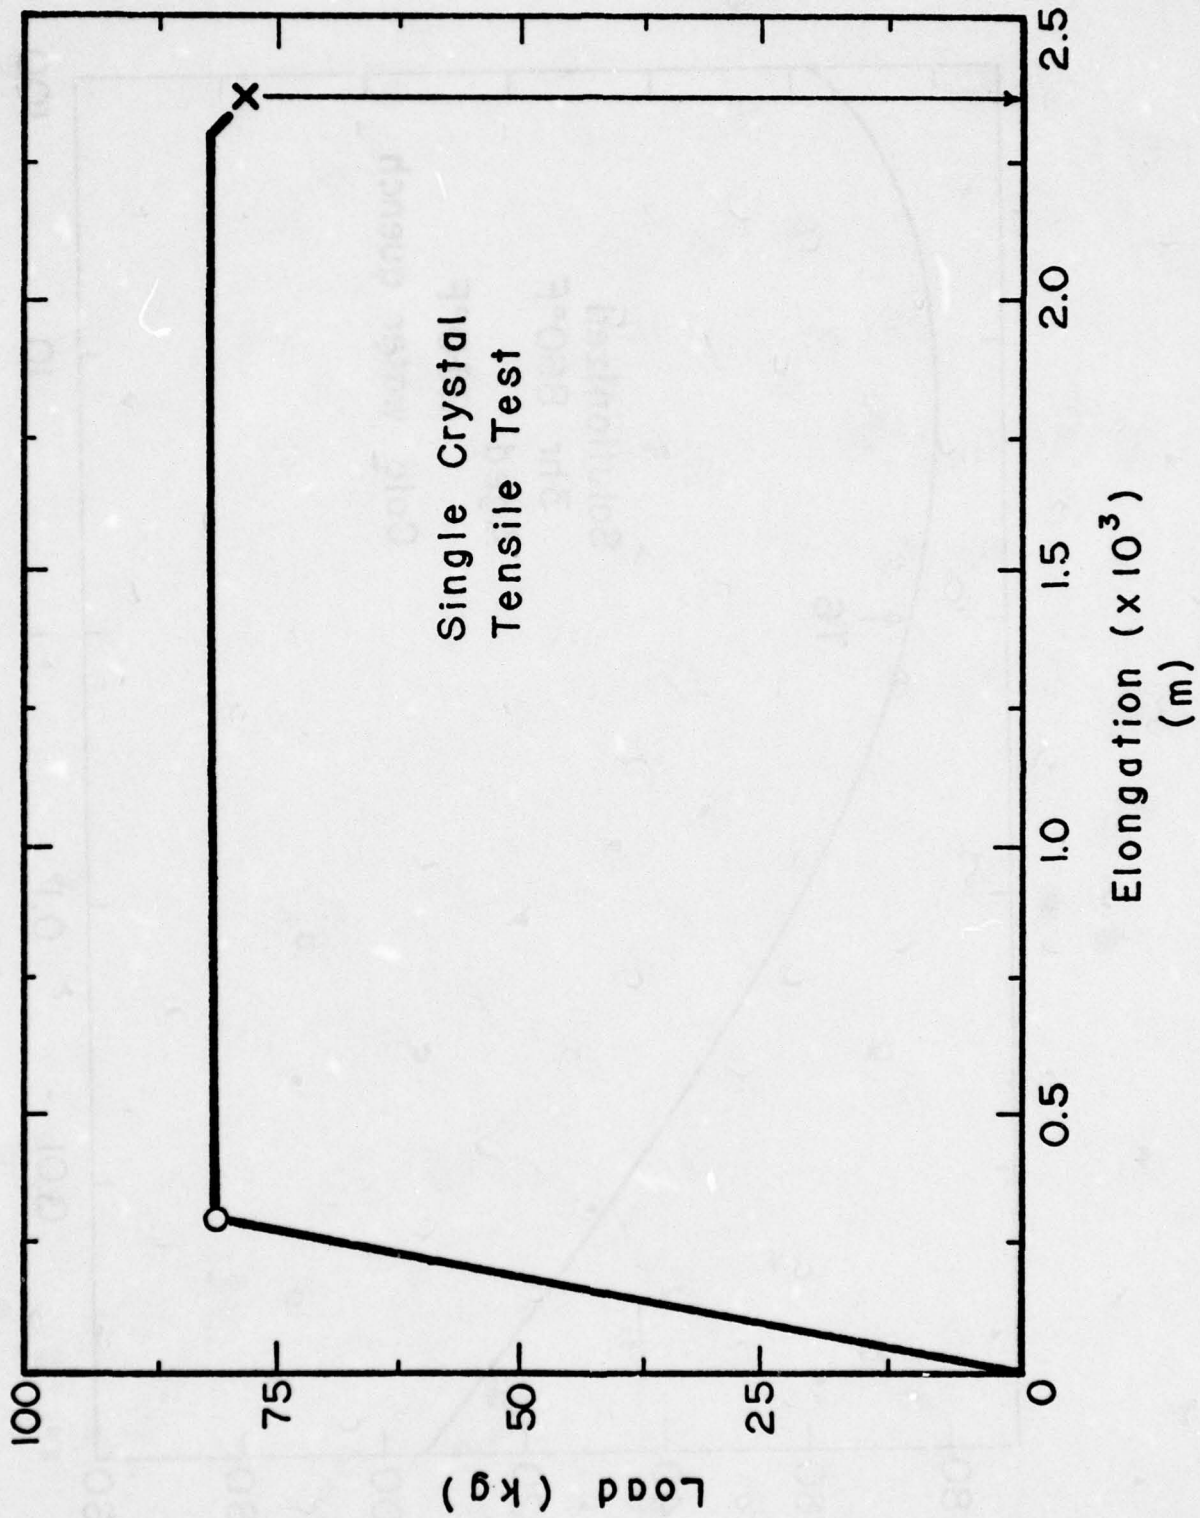
Figure 10. Single crystal data. (a) Load elongation curve for single crystal specimen pulled to failure; (b) Stereographic triangle orientations of all single crystal specimens used in this investigation.

It should be noted that due to the lower yield strengths of the single crystal samples, these specimens were tested with an applied near tensile stress of 172 MN/m^2 . In an effort to convert this to the resolved shear stress, the tensile orientation of these specimens was determined by the Laue Back reflection technique. The laue patterns were obtained after the fatigue failure by sectioning the specimens just below the fracture surface. Although a jewelers saw was used to minimize the deformation damage, a short electropolish was given to each specimen prior to the x-ray exposure. As illustrated in Figure 12, this procedure yielded a diffraction pattern which was characterized by clear, distinct spots. This type of pattern is characteristic of a relatively strain free metal. As noted earlier, the individual tensile orientations are shown in Figure 10b.

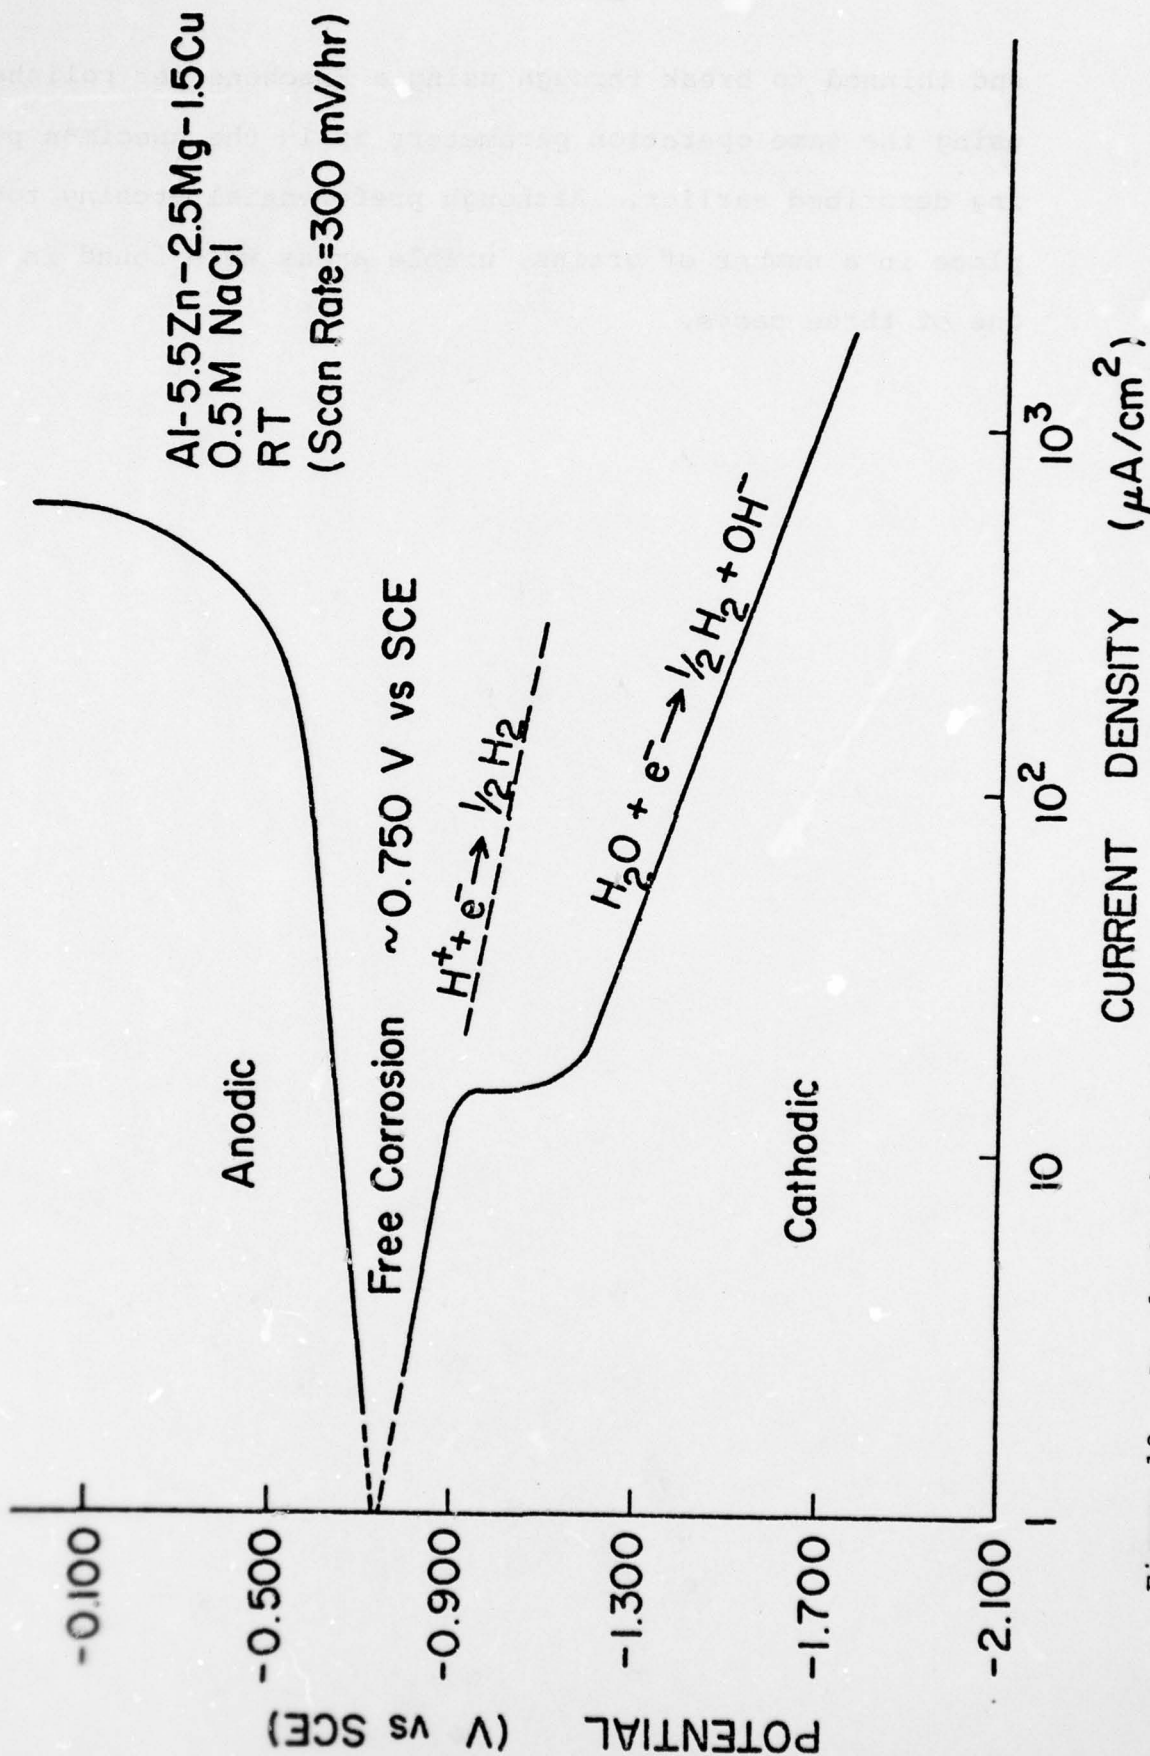
Figure 13. An electrochemical polarization diagram for the Al-5.05Zn-2.5Mg-1.5Cu alloy tested in 3% NaCl at a scan rate of 300mv/hr.

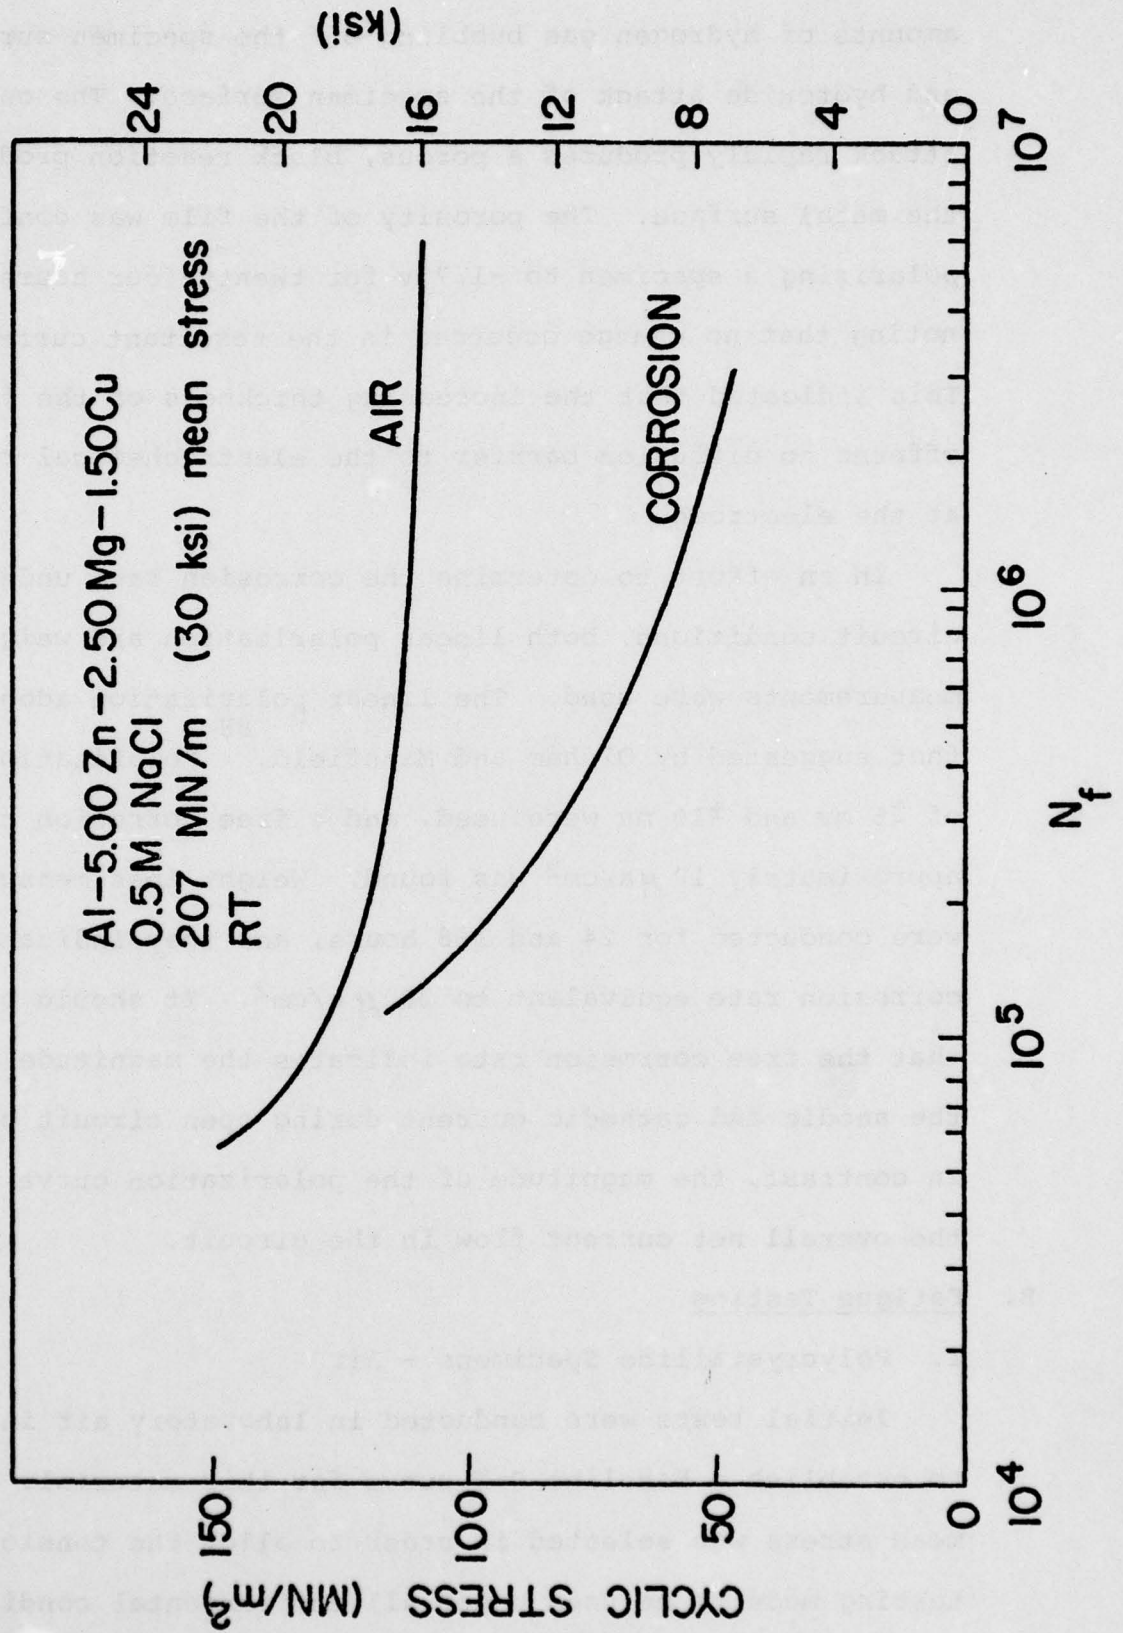
Figure 15. The S-N behavior of polycrystalline, T-6 specimens test in air and .5M NaCl.

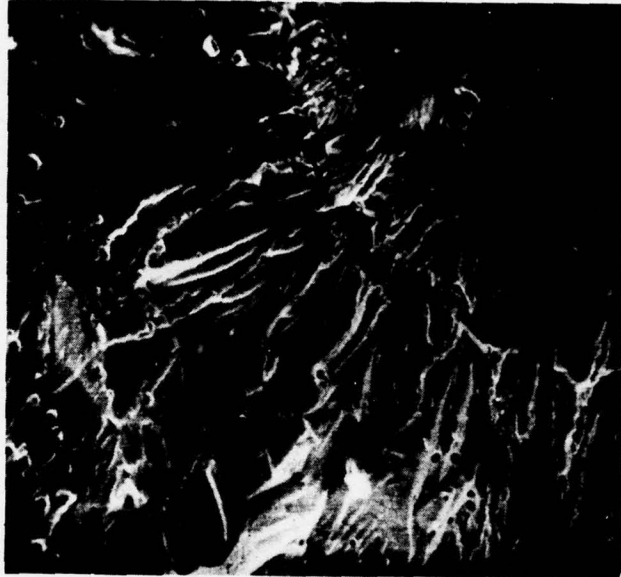
Figure 16

A characteristic SEM micrograph
of the fracture surface taken from
a specimen tested in laboratory air (100x)

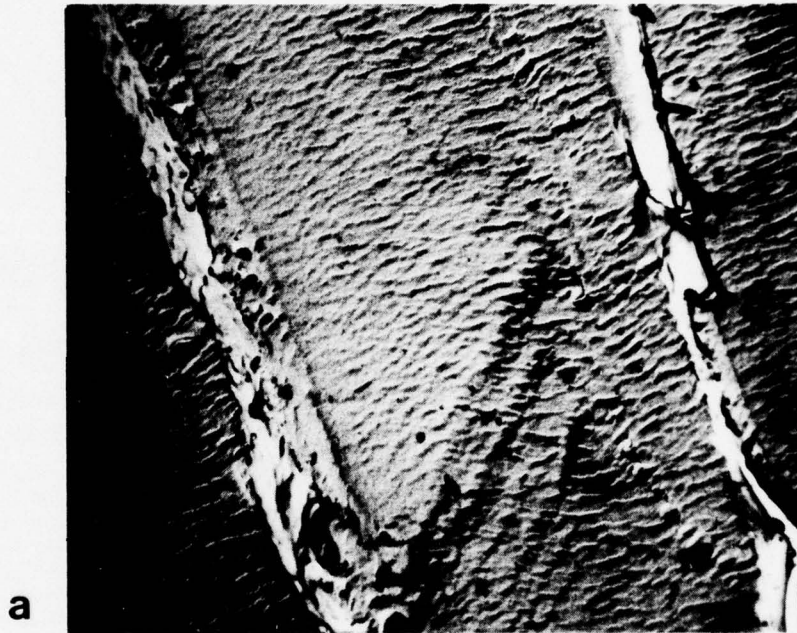
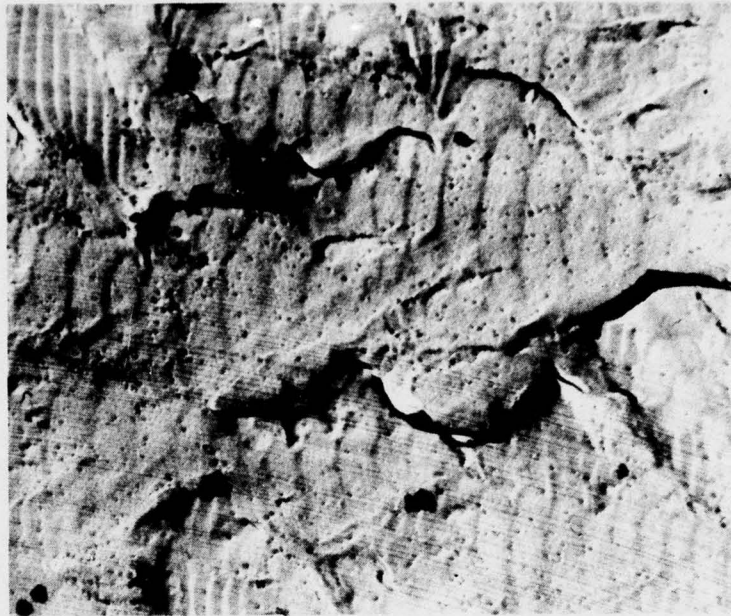
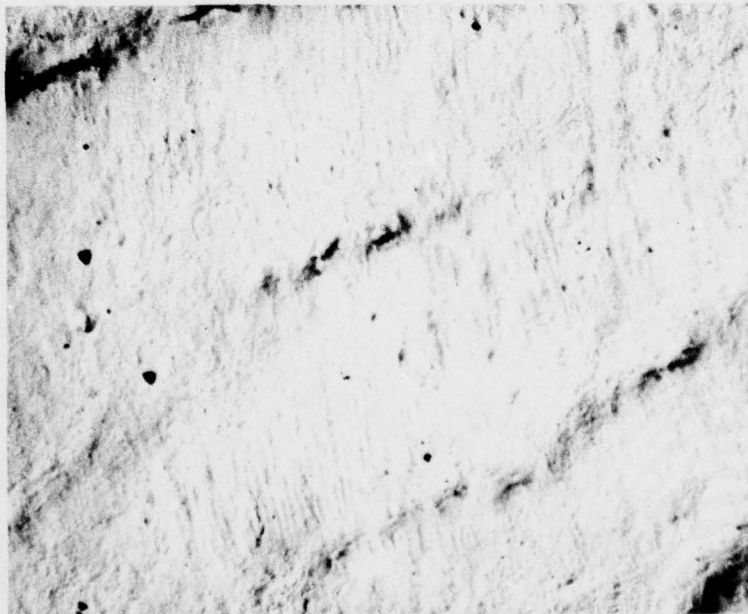
Figure 17

- a) A rippled type fracture morphology found near the initiation site. (8500x)
- b) Ductile striations characteristic of the later stages of crack propagation (5000x)
- c) An area illustrating the early stages of striation formation. (8500x)

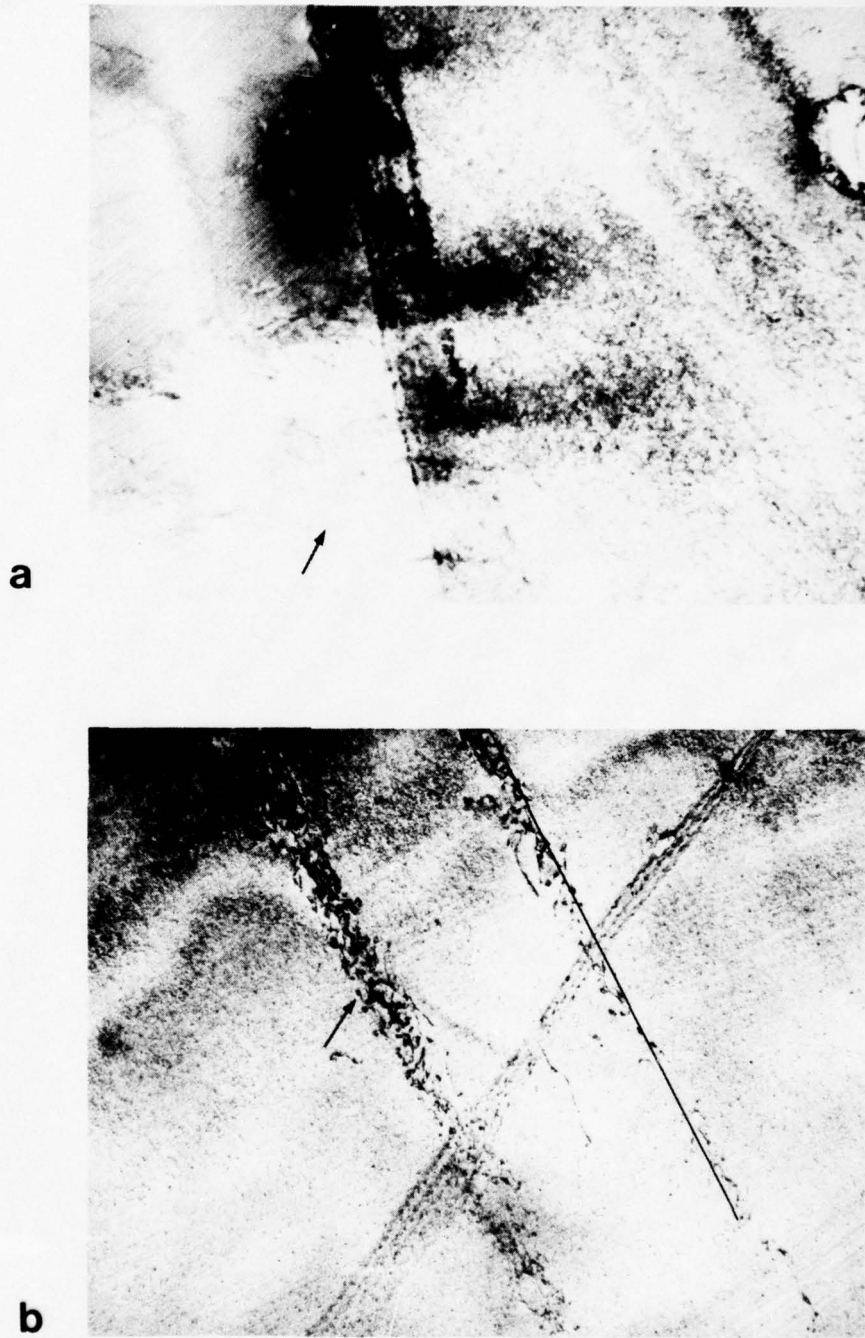
Figure 18. The dislocation substructures found near the tip of an air tested fatigue crack

In an effort to overcome these obstacles, a pre-notched specimen was fatigued until a crack had propagated partially across the gauge section. The fatigue process was stopped and a thin foil was taken containing the crack tip. TEM examination of this foil revealed the characteristic fatigue substructure shown in Figure 18. The planar slip bands are seen to interact with grain boundaries in two ways. Most boundaries act as effective barriers to dislocation motion. Therefore, whenever a slip band intersects such a boundary, it produces a large strain field across the boundary and into the next grain. This process is clearly illustrated in Figure 18. Occasionally, boundaries were found which offered little resistance to the dislocations. This is shown in Figure 18b.

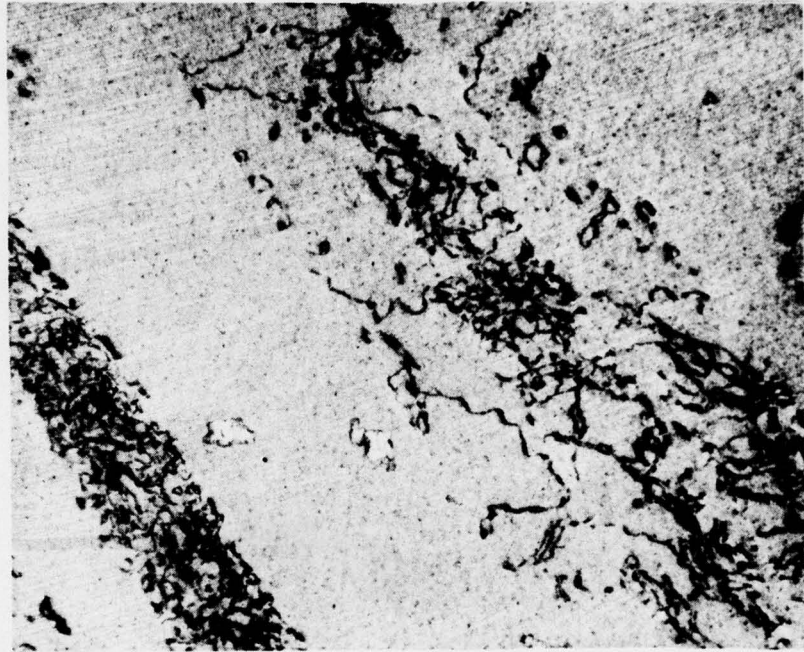
Figure 19

A TEM micrograph from a strain
cycled specimen illustrating two adjacent
slip bands in different stages of formation
(20,000x)

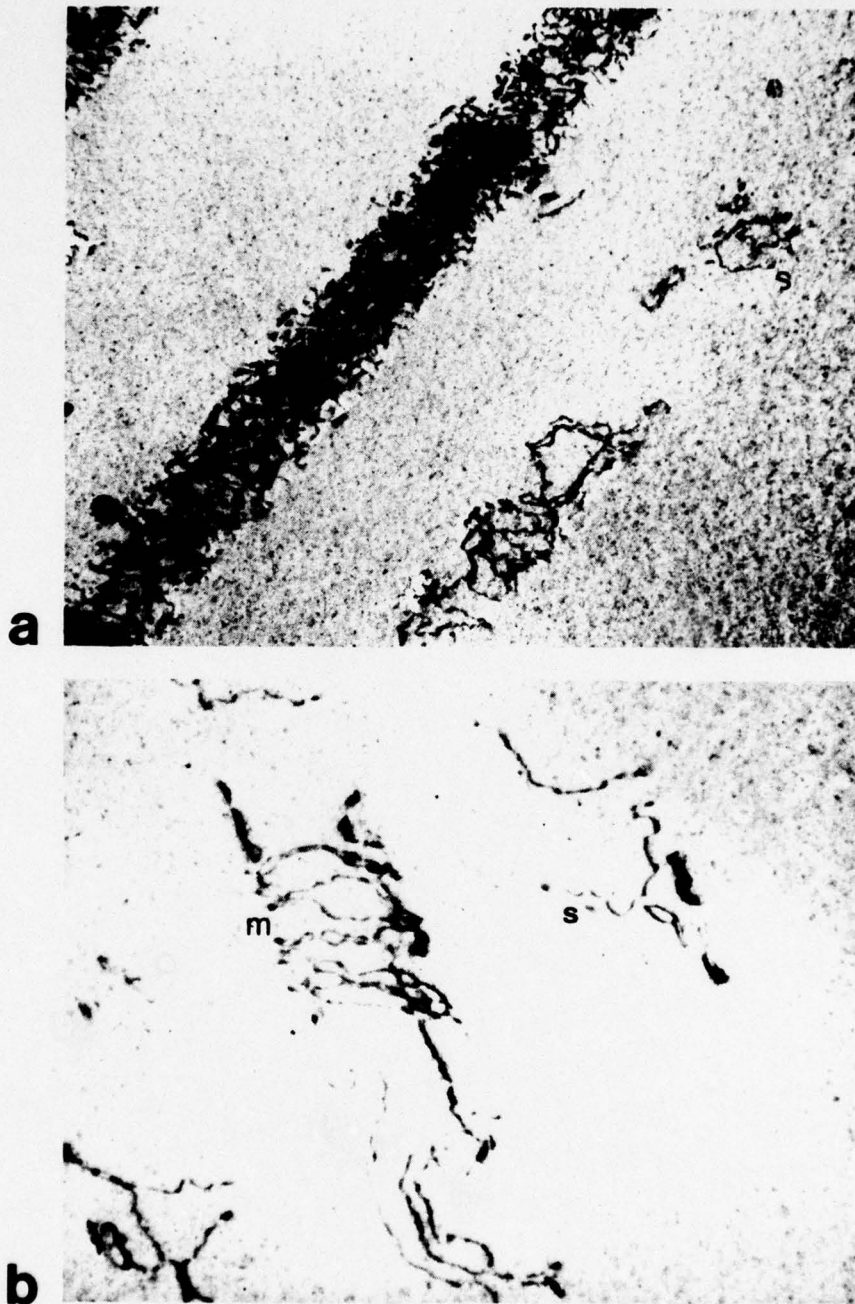
Figure 20. A TEM micrograph from a strain controlled specimen illustrating the various methods of dipole loop formation.

- (a) An example of dislocation loop formation through the pinch off of a single dislocation (S) (15,000x)
- (b) An example of loop formation though both a single (S) and multiple (M) dislocation interaction (26,000x)

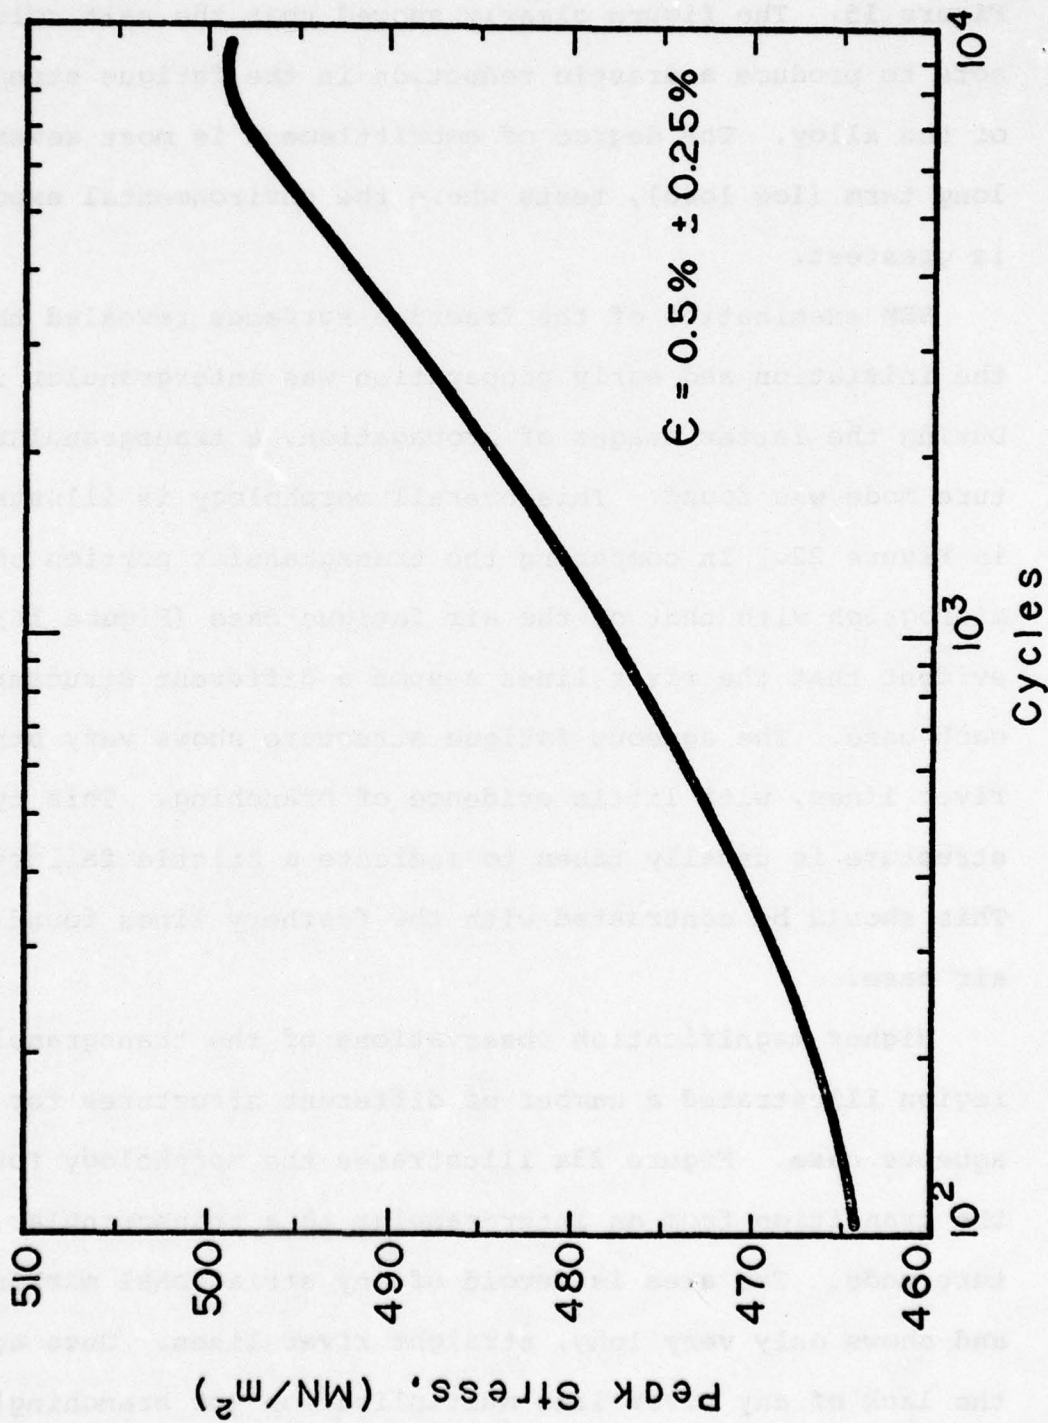
Figure 21. A cyclic hardening curve for a T-6 specimen fatigued in laboratory air at $.5\% \pm .25\%$.

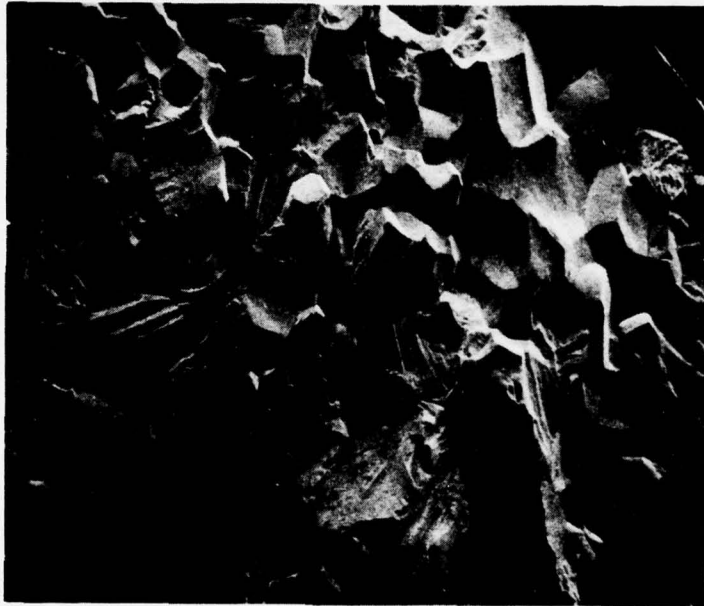
Figure 22

SEM examination of the fracture surfaces revealed that the initiation and early propagation was intergranular in nature. During the latter stages of propagation, a transgranular fracture mode was found. This overall morphology is illustrated in Figure 22. In comparing the transgranular portion of this micrograph with that of the air fatigue case (Figure 16) it is evident that the river lines assume a different structure in each case. The aqueous fatigue structure shows very straight river lines, with little evidence of branching. This type of structure is usually taken to indicate a brittle failure. This should be contrasted with the feathery lines found in the air case.

An SEM fractograph illustrating the overall fracture morphology of a specimen tested in a .5N NaCl solution (100x).

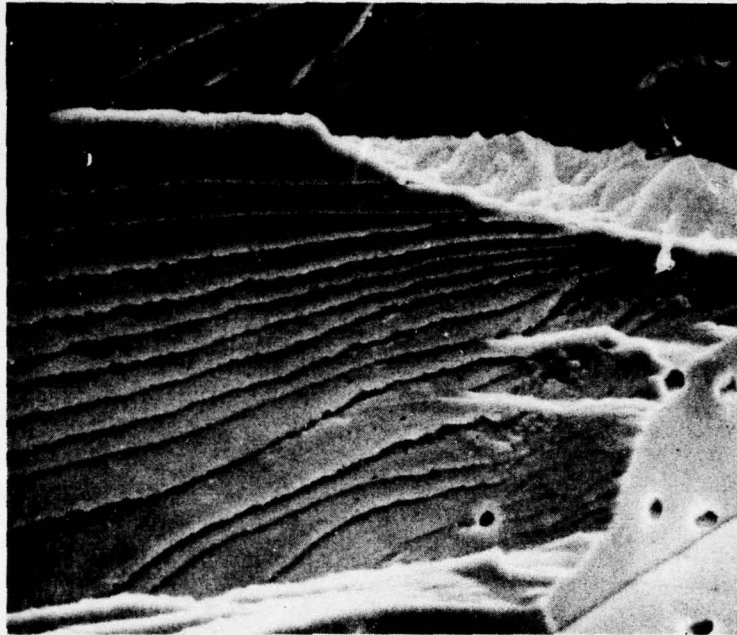
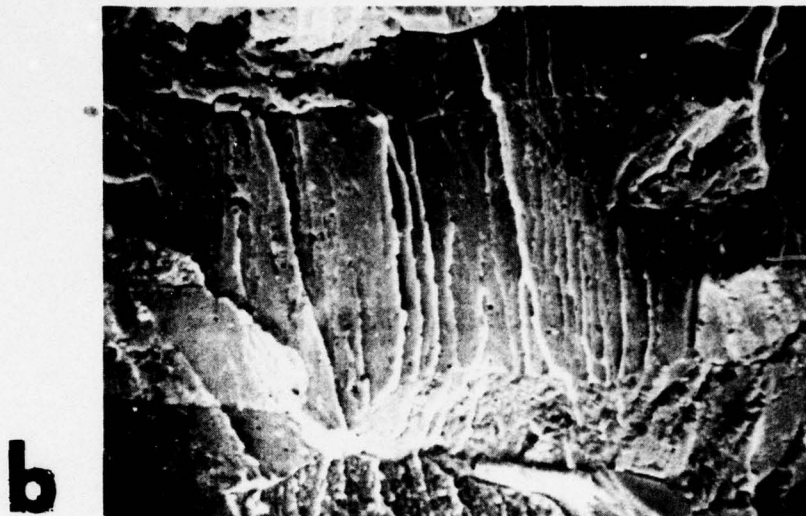
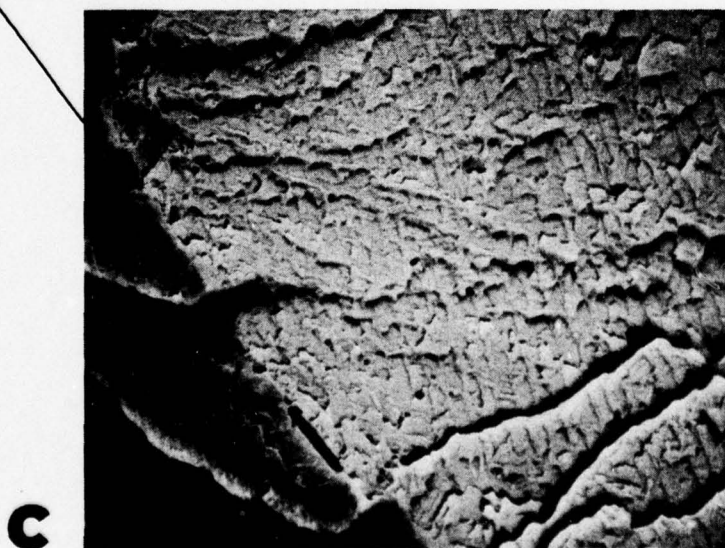
Figure 23

- a) An area of cleavage-like failure illustrating the transition from intergranular to transgranular failure (500x)
- b) An area away from the intergranular initiation region devoid of striational markings and exhibiting only river lines (500x)
- c) An area further removed from the initiation site illustrating the Type B, brittle striation characteristic of the later stages of fatigue propagation (1000x).

Higher magnification observations of the transgranular region illustrated a number of different structures for the aqueous case. Figure 23a illustrates the morphology found near the transition from an intergranular to a transgranular fracture mode. The area is devoid of any striational markings, and shows only very long, straight river lines. Once again, the lack of any river line multiplication (or branching) points to the severely brittle nature of the fracture process.

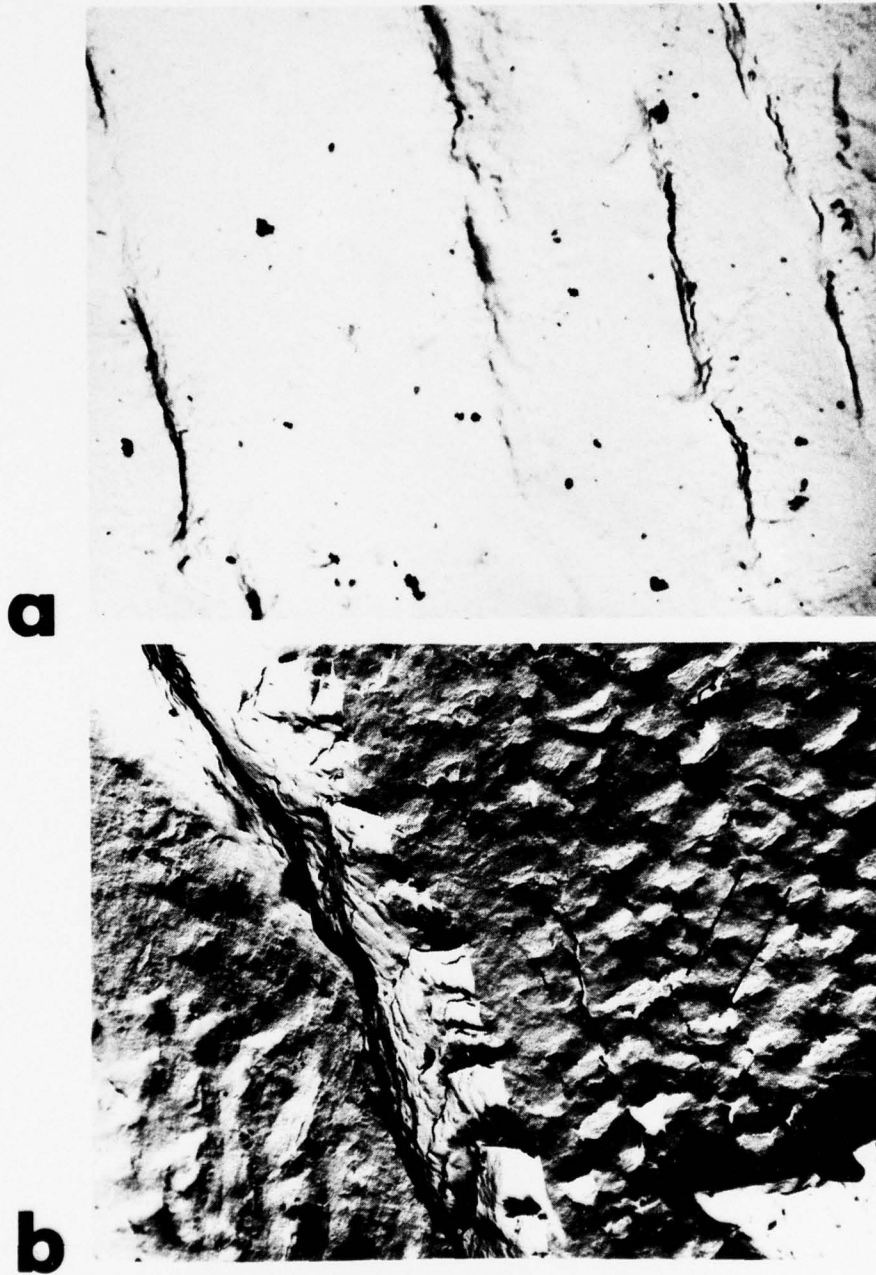
Figure 24. Two stage carbon replicas characteristic of the fracture morphology found in aqueous corrosion fatigue.

- (a) An area of striationless fracture illustrating the brittle nature of failure (10,000x)
- (b) A view of the type B striations adjacent to a river line. The black lines illustrate the striation spacing (8500x)

these replicas provided no additional information beyond that obtained by the SEM, they acted to confirm the structures presented. For example, Figure 24 shows the striationless structure associated with the cleavage type failure. The river lines act to demonstrate the brittle nature of this fracture mode. Figure 24b is a view of the type B striations adjacent to a river line. The back lines indicate the crack growth per cycle (i.e. striation spacing). It should also be noted that no secondary fatigue cracks were found under the free corrosion testing condition.

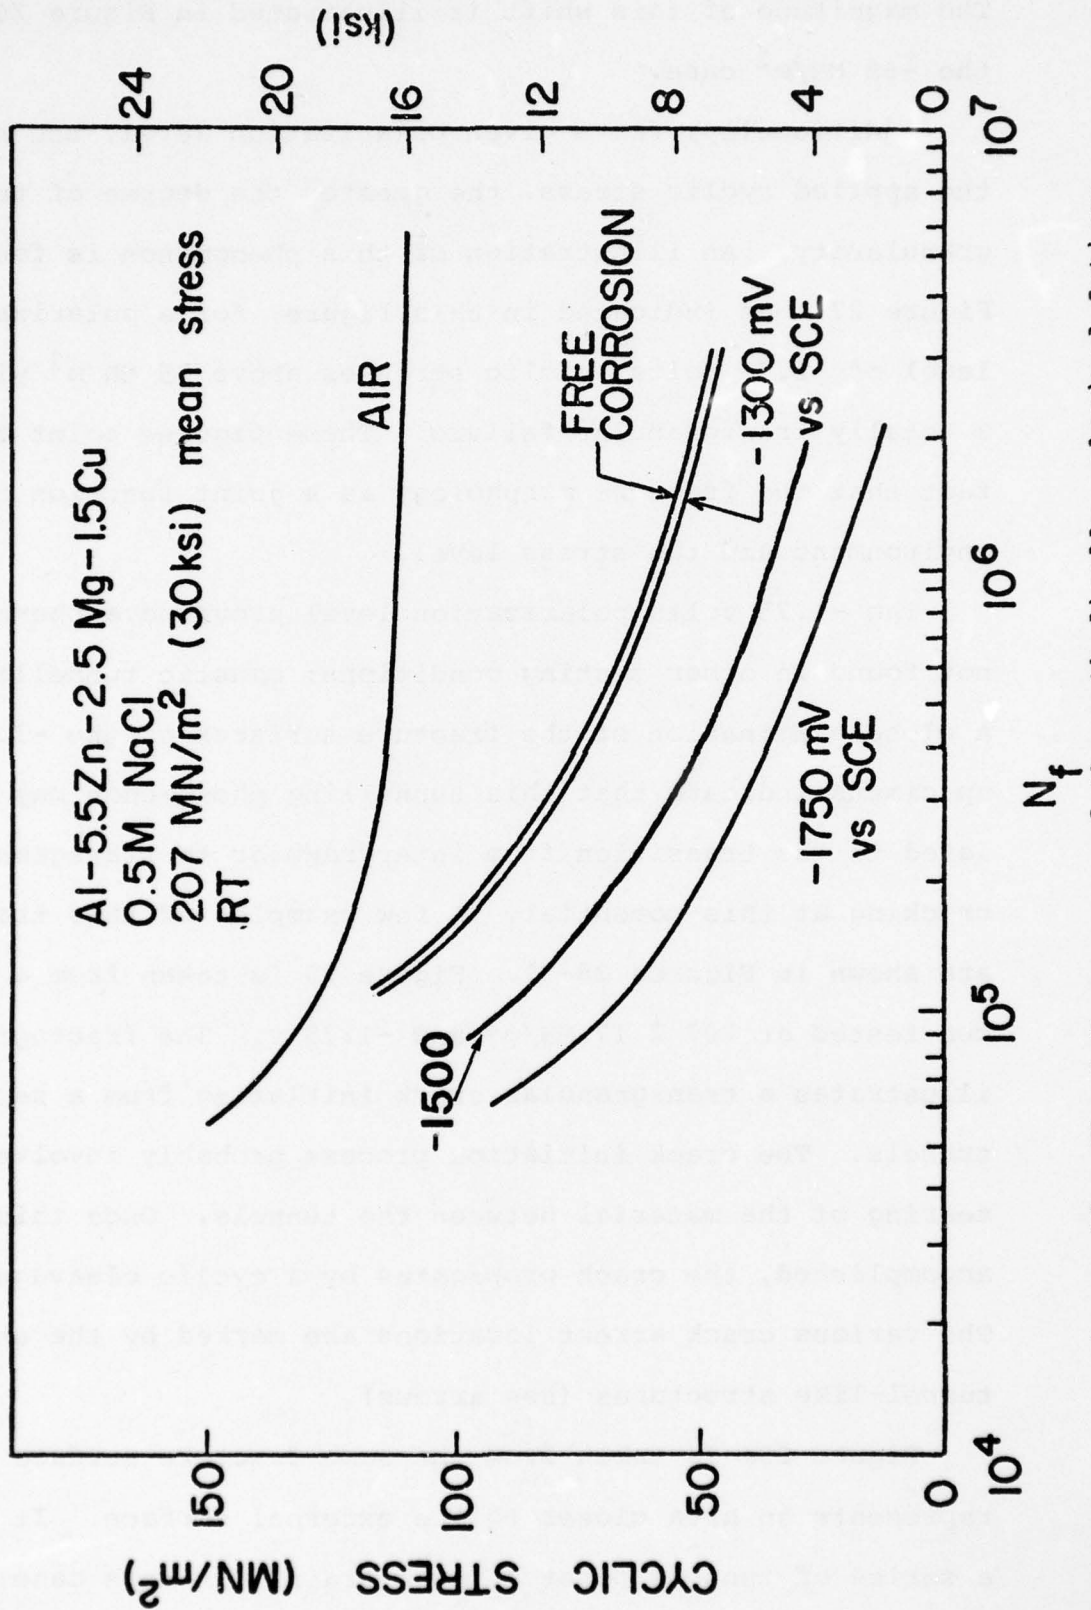
Figure 25. The S-N response of the cathodically polarized fatigue specimen.

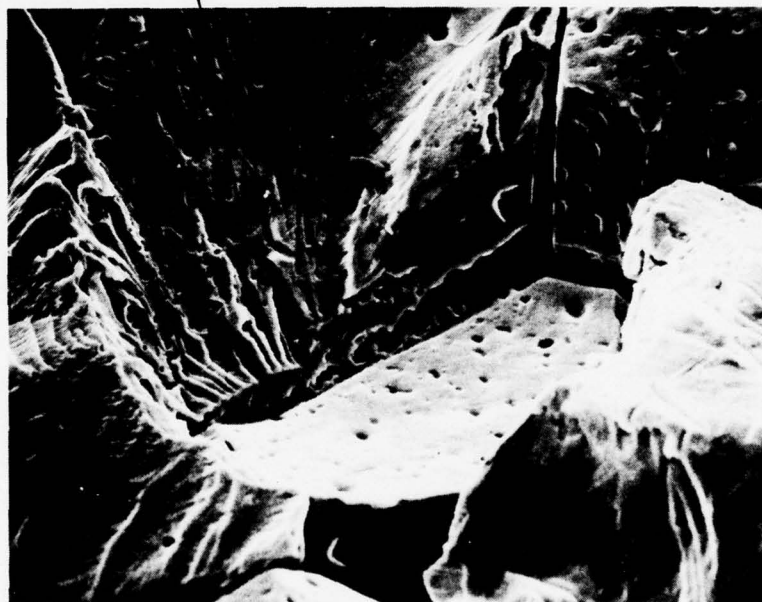
Figure 28

An SEM micrograph illustrating the case of caustic tunnels acting as the transition morphology between intergranular and transgranular failure modes (500x)

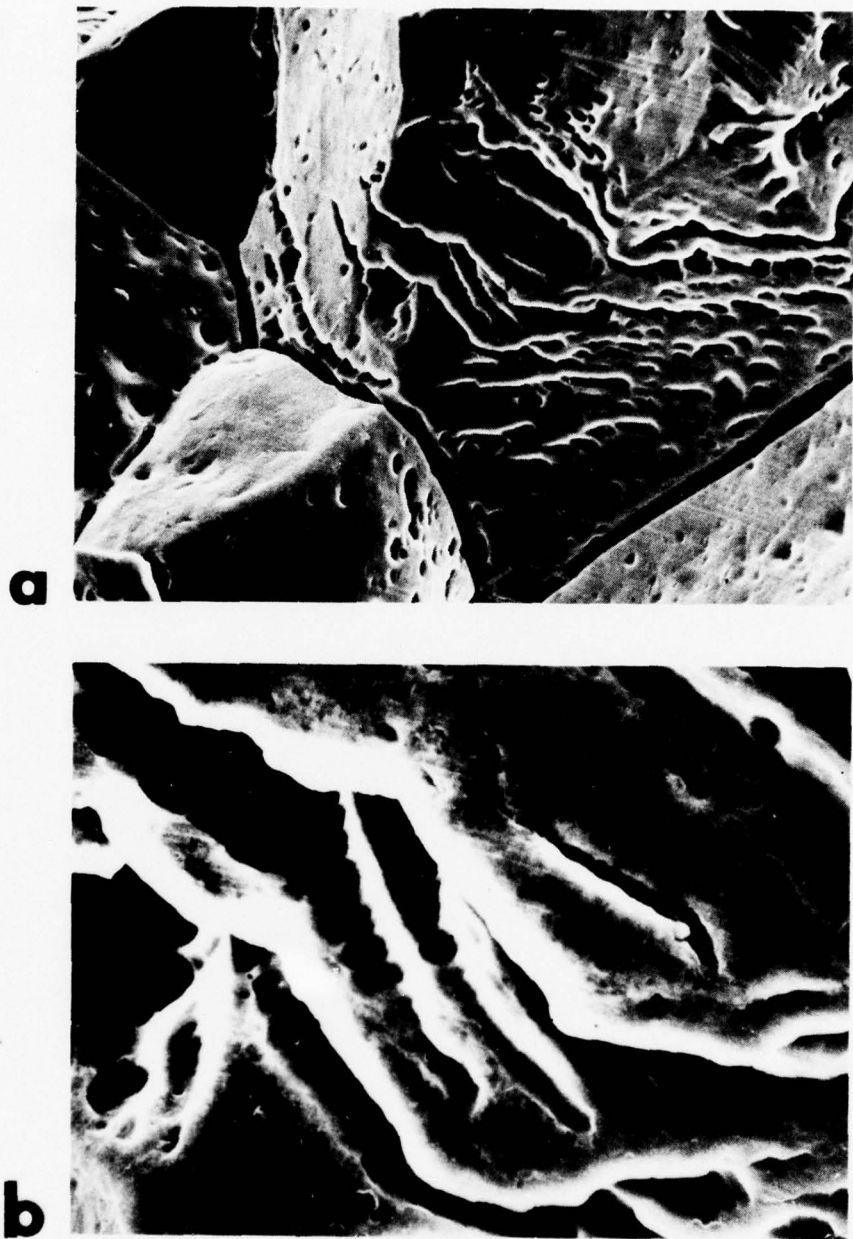
Figure 29. Caustic tunnels found near the external surface of a specimen charged at -1.75v
