THE CORROSION FATIGUE BEHAVIOR OF A HIGH PURITY
Al-Zn-Mg-Cu ALLOY

Edward F. Smith III
D. J. Duquette
Materials Engineering Department
Rensselaer Polytechnic Institute
Troy, New York 12181

November 1979

Technical Report to the Office of Naval Research

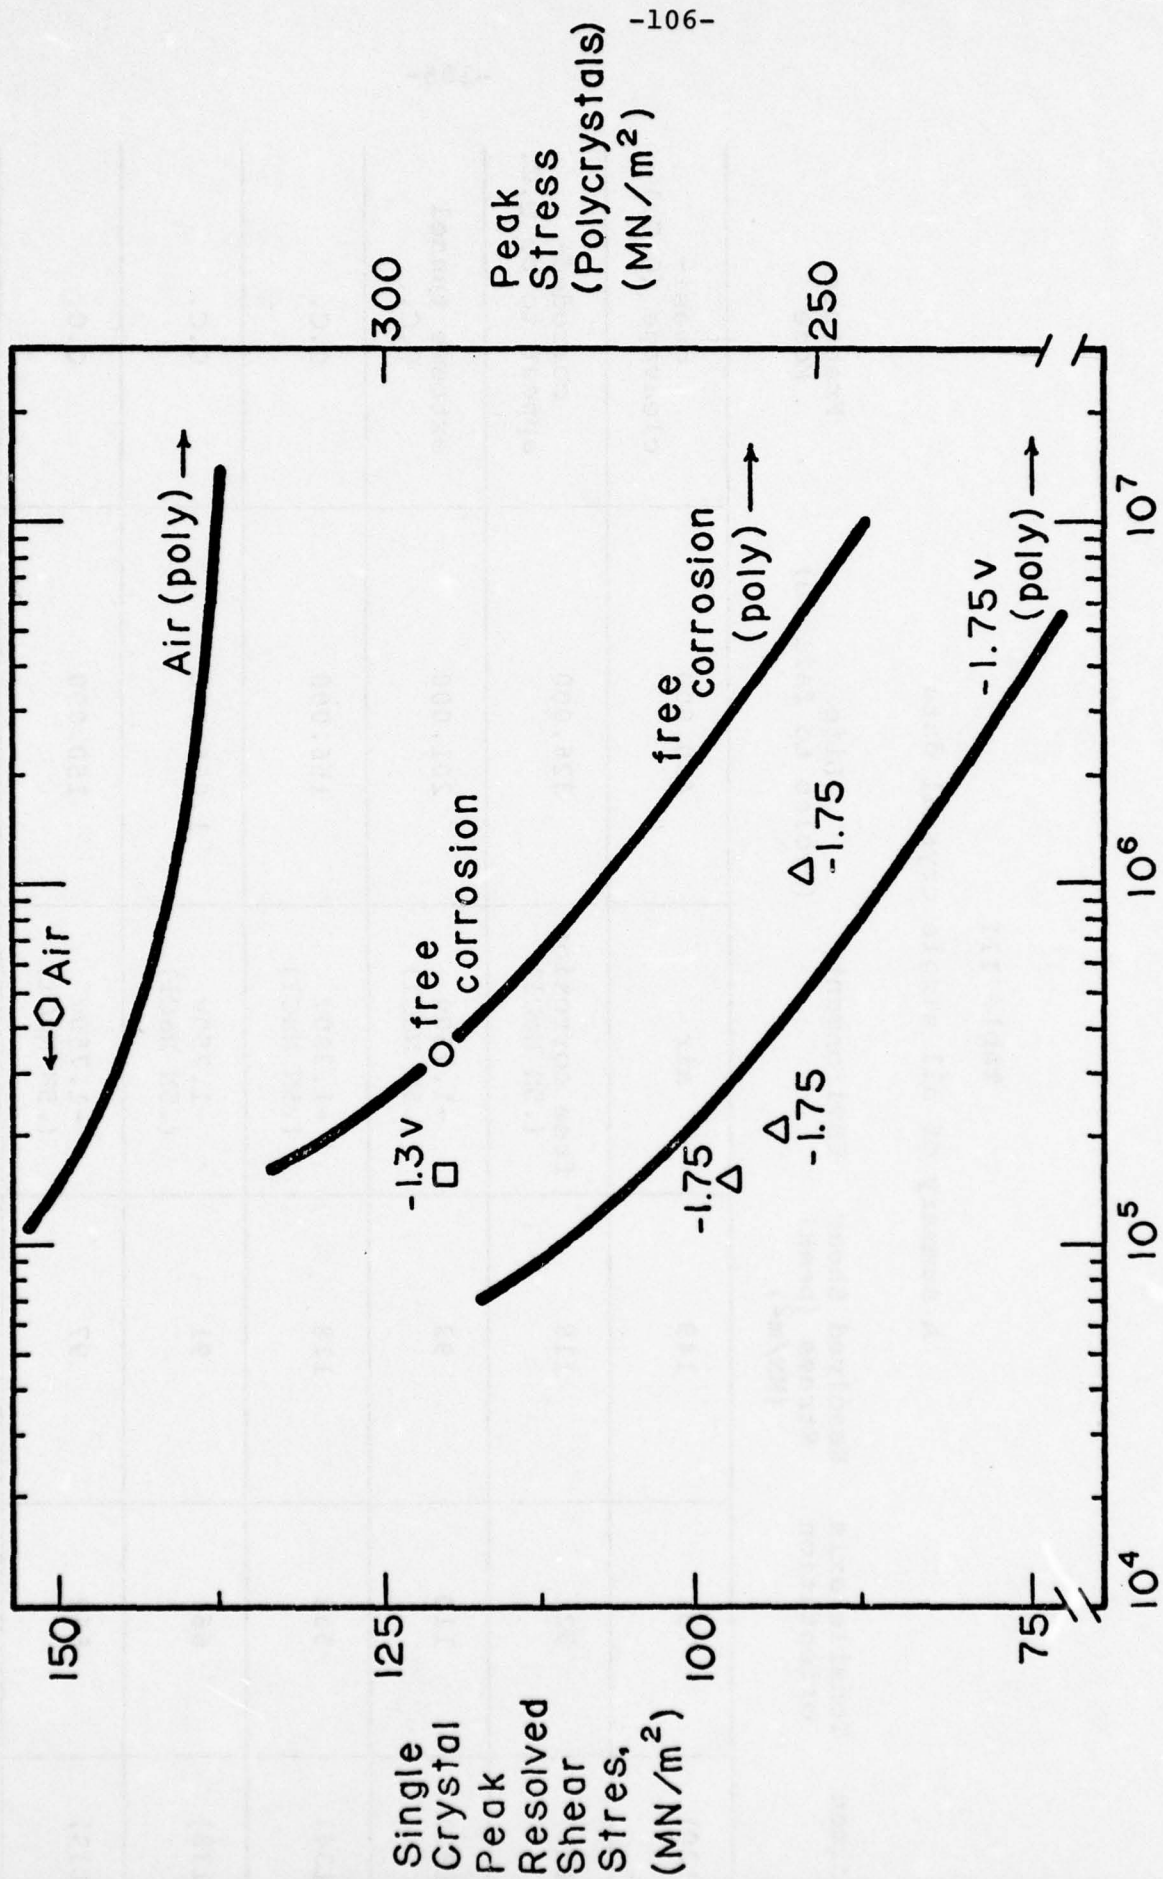
Figure 32. A plot of resolved shear stress versus the number of cycles to failure for the various single crystals tested in fatigue. (The reference lines illustrate the stress and spacing of the polycrystalline behavior.)

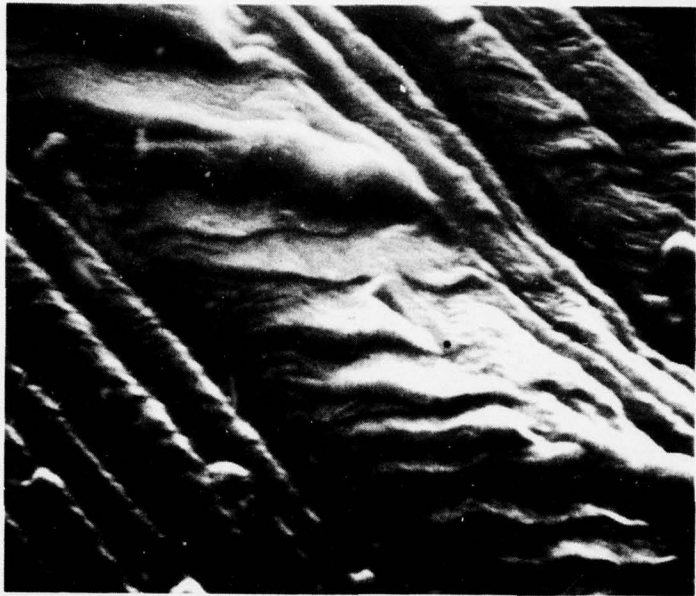
- a) An overall view of the fatigue portion of the fracture surface (500x)
- b) A high magnification SEM micrograph illustrating slip line intersections found in the cleavage area (5000x)
- c) A micrograph taken from the surface roughened area illustrating two small areas of ductile striations (2000x).

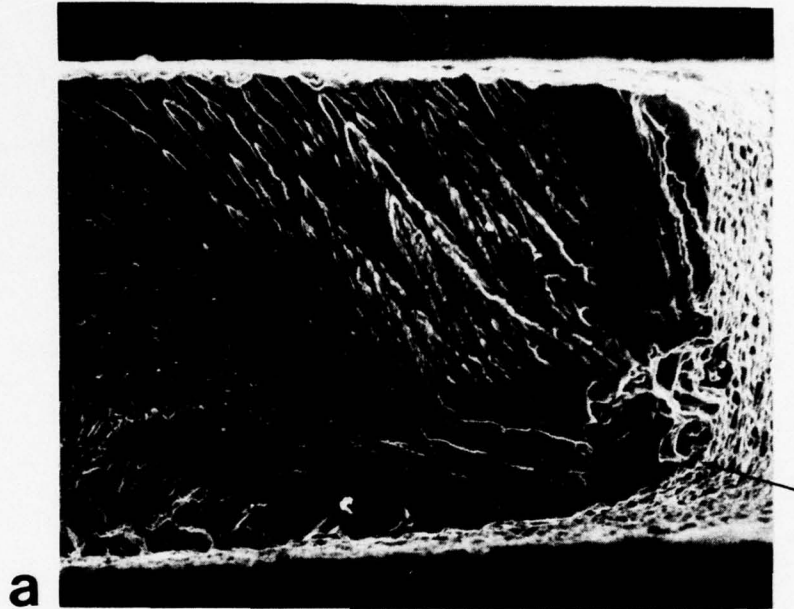
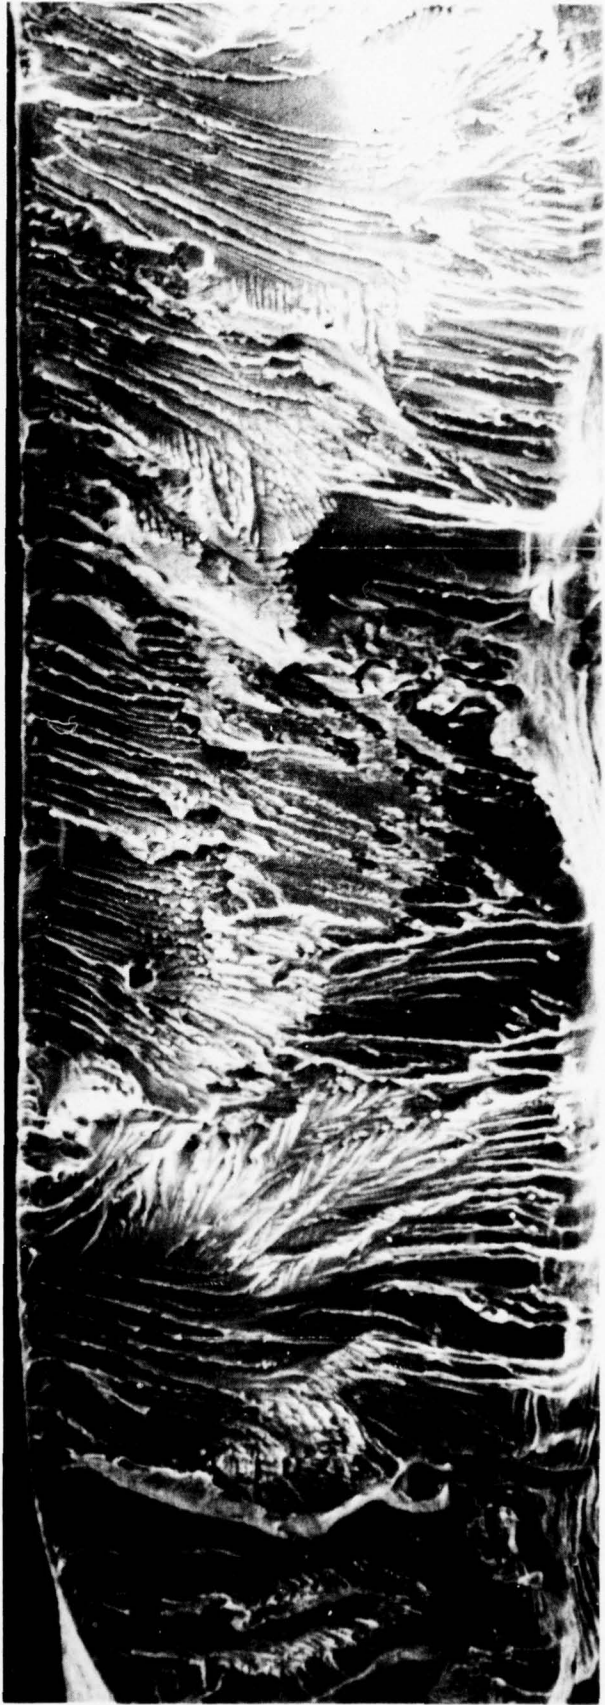
Figure 34

- a) An overall view of the -1.3v fracture surface, with the arrow pointing toward the corrosive attack at the initiation site (200x)
- b) An overall view of the -1.75v fracture surface, with the arrows illustrating surface attack (250x)

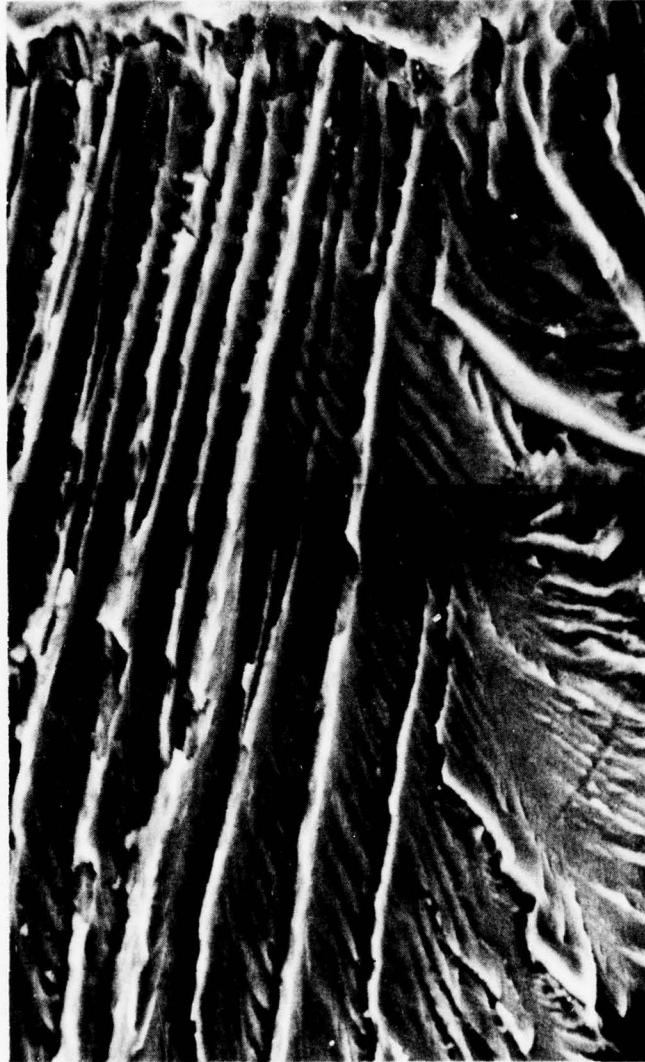
Figure 35

SEM fractograph illustrating the brittle nature of the river lines found on the surface of the single crystal polarized to -1.75v (2000x).

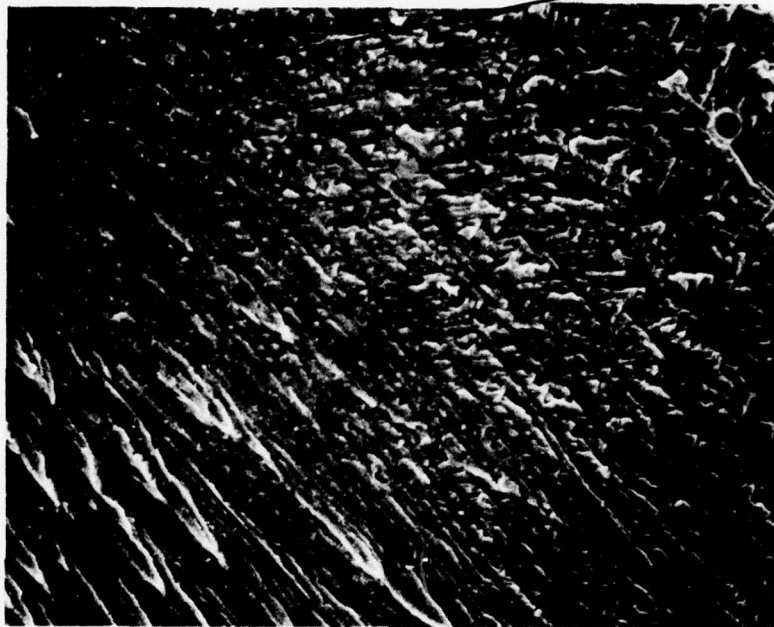
Figure 36

An SEM fractograph illustrating the structure of the surface roughened region from a single crystal polarized to -1.3v . The black lines indicate the direction of the intersection of river line patterns (1000x).

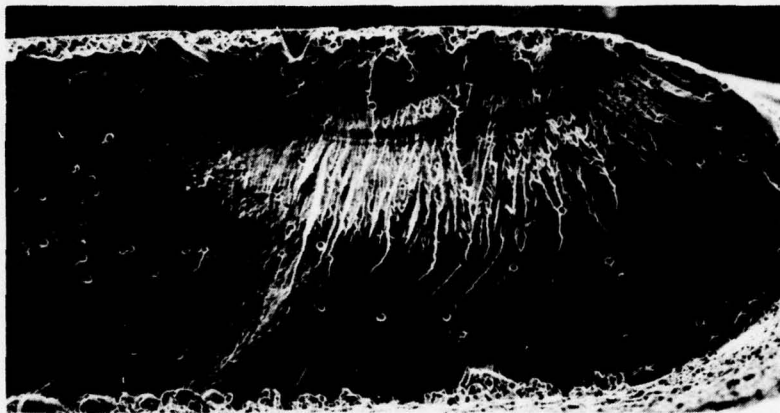
Figure 37

The overall fatigue fracture morphology of a (110) tensile axis orientation crystal polarized to -1.75v. (100x)

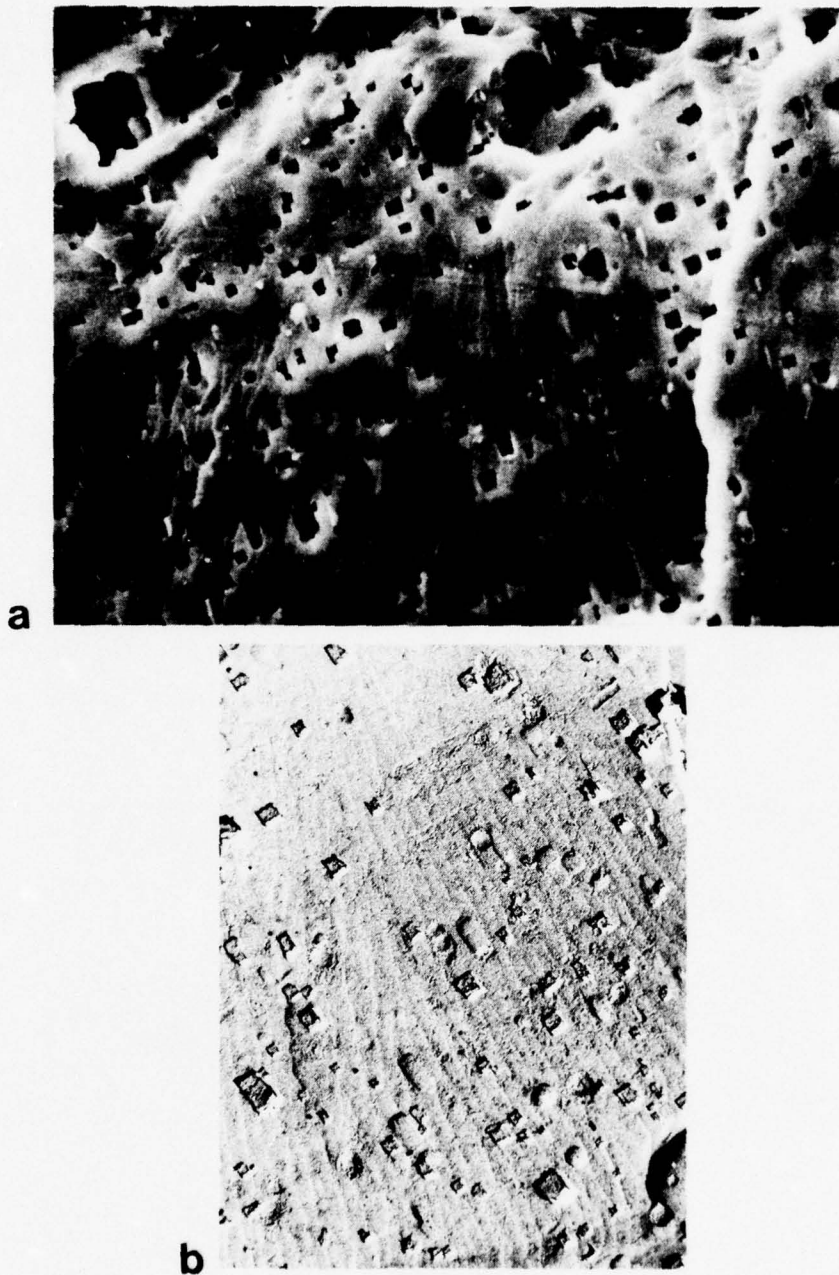
Figure 38

- a) An SEM fractograph of the initiation sites shown in Figure 37. (2000x)
- b) A two-stage carbon replica of the same area. (2000x)

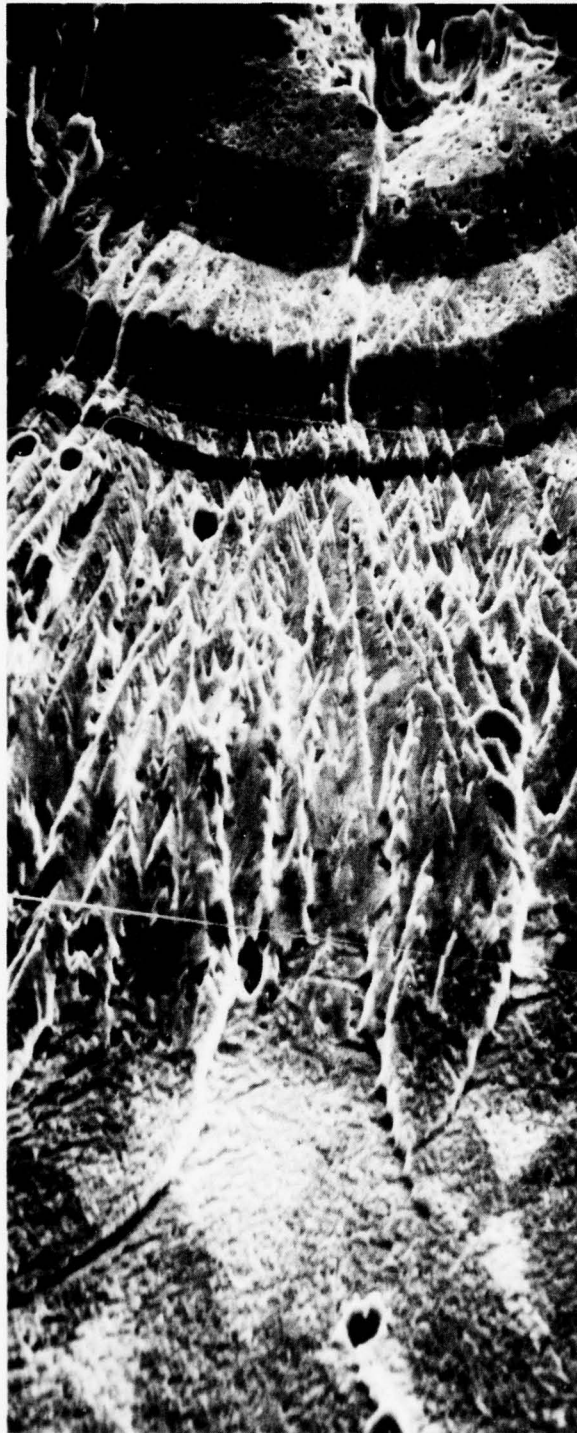
An SEM composite micrograph illustrating the various regions found on the $\langle 110 \rangle$ tensile orientation single crystal fatigued at -1.75v. (500x)

Figure 40 is a higher magnification composite of the right hand portion of the fracture surface. After the initial plateau, an area of featureless cleavage is found. This morphology then alternates with a river line structure similar to that seen on the other cathodically charged specimens. One should note that as the fracture alternates between the two morphologies, a drastic reduction in the number of river lines occurs as the crack passes through the cleavage area. This points to the very brittle nature of the cleavage morphology, and acts to confirm the fact that these features are indeed cleavage in origin and not the result of a corrosion reaction. The river line structure transforms to a general surface rough-

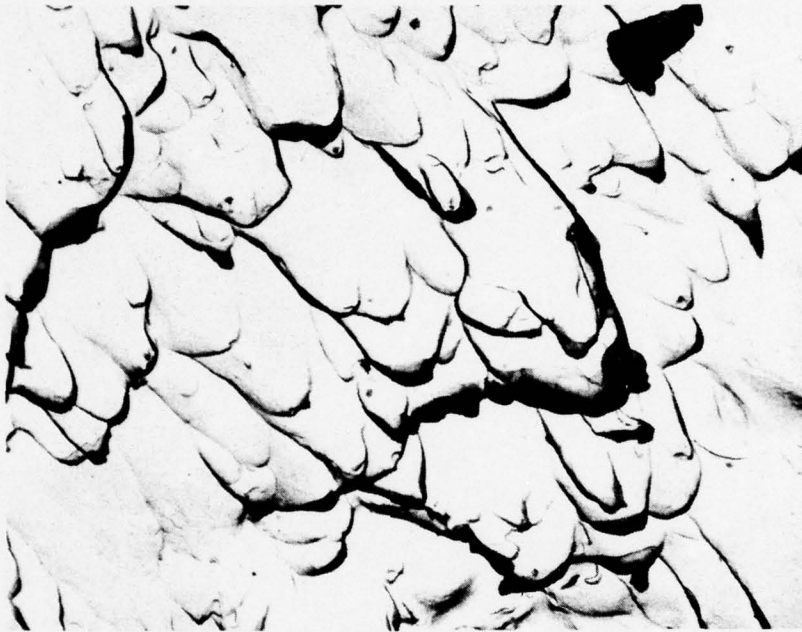
Figure 42

A two stage carbon fractograph
taken from the surface of a single crystal
pulled to failure in tension.

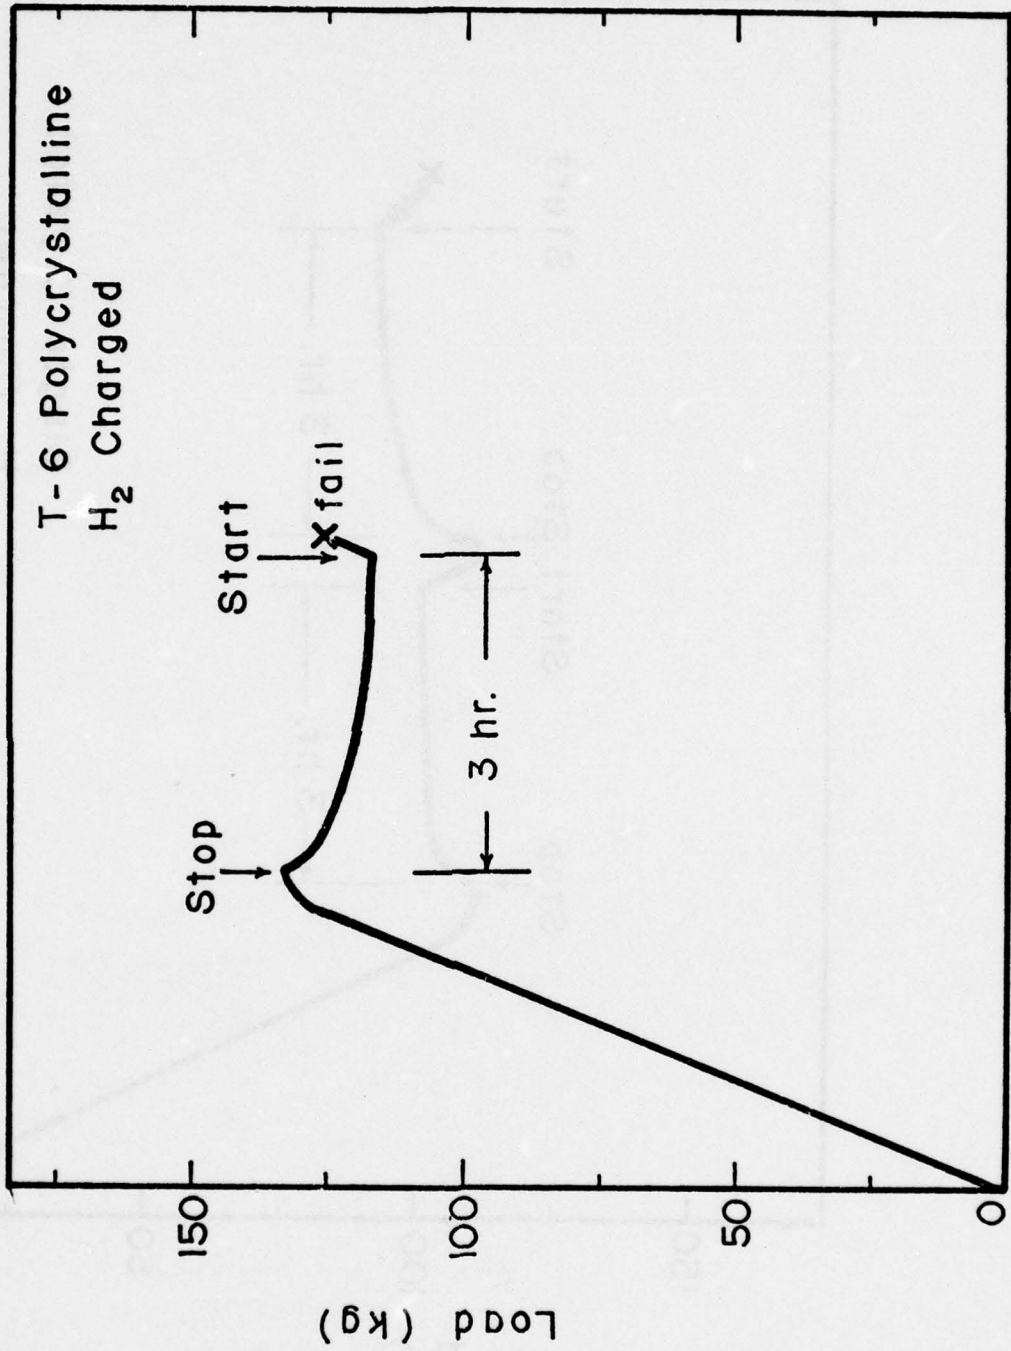
Figure 44. Stress relaxation curve for T-6 aged, polycrystalline, Al-5.0Mg-2.5Zn-1.5 tested in 1N H₂SO₄ + .2N NaAsO₃ at -1.75V vs. SCE.

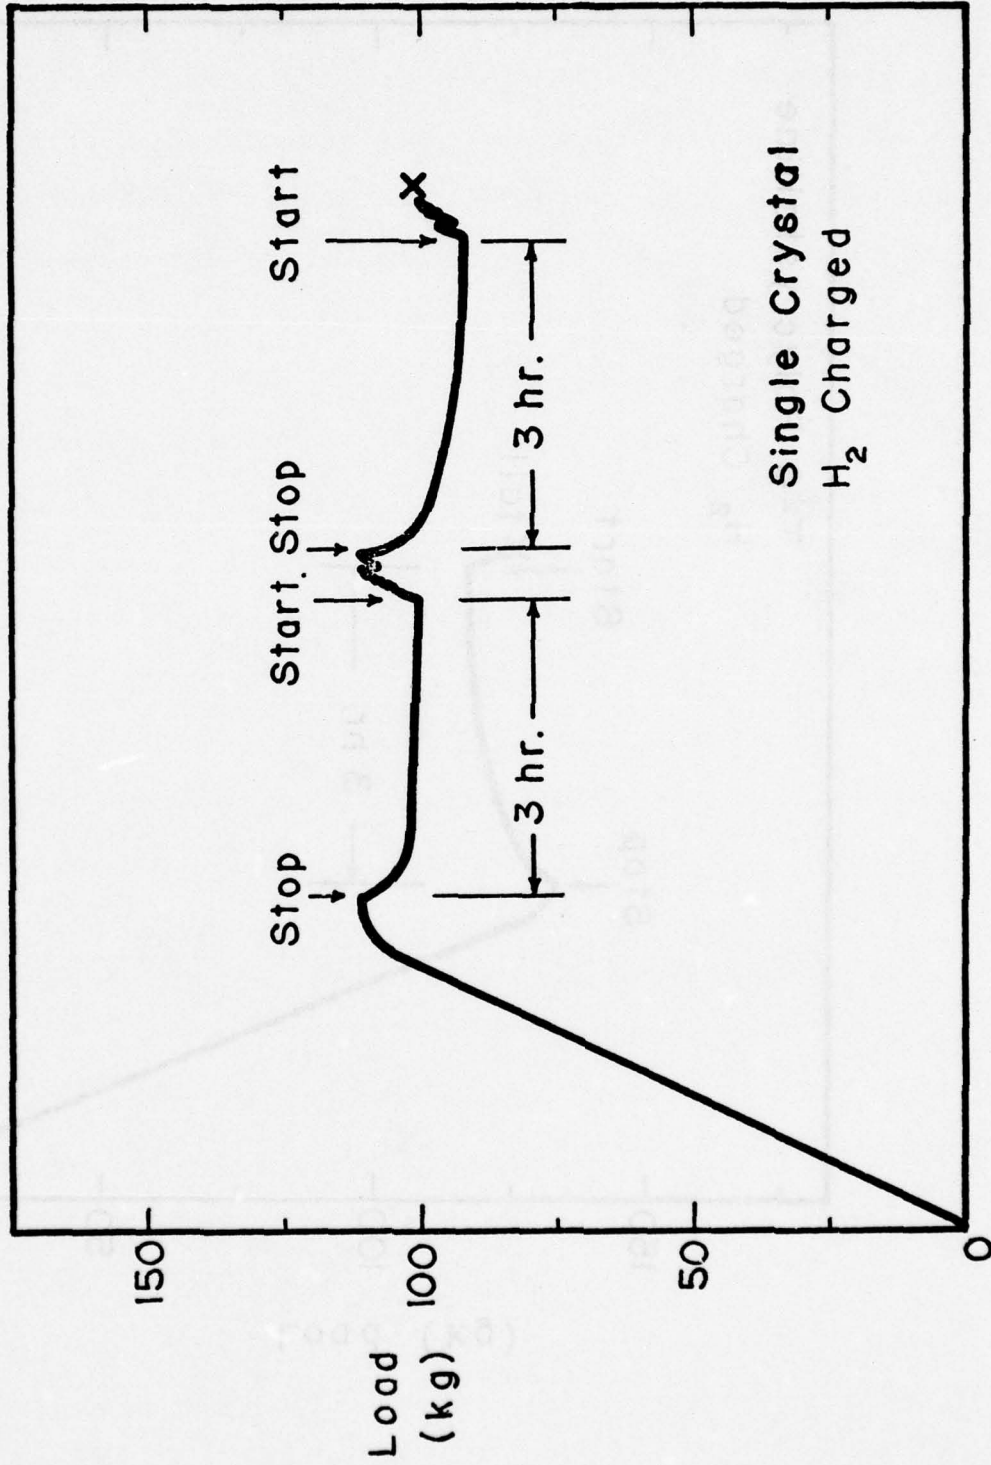
Figure 45. Stress relaxation curve for T-6 aged single crystal specimen tested in 1N H₂SO₄ + .2N NaAsO₃ at -1.75v vs. SCE.

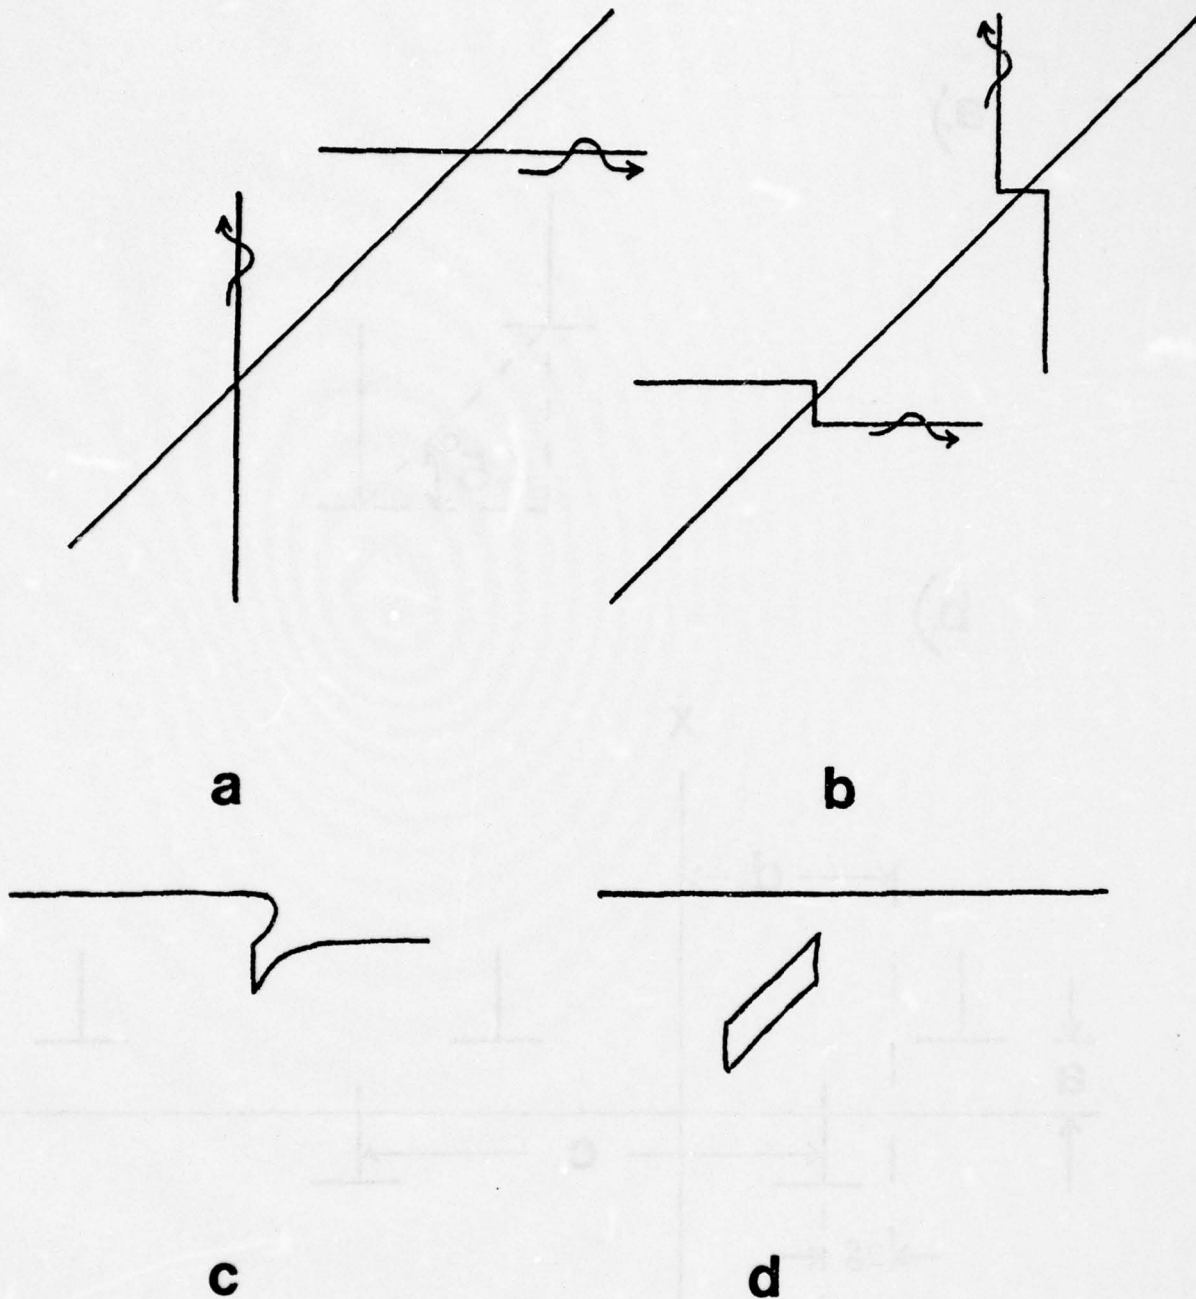
Figure 47. The proposed steps in transforming a screw dislocation into sessile dipoles.

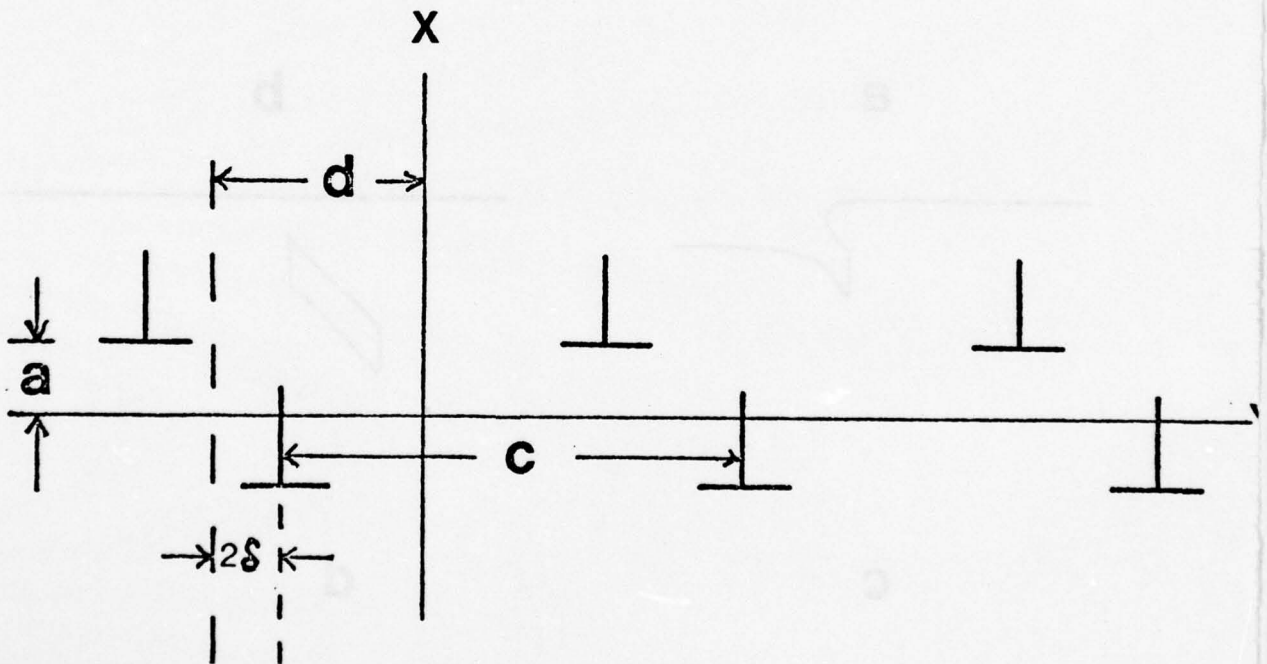
Figure 48. Dislocation dipoles geometries.

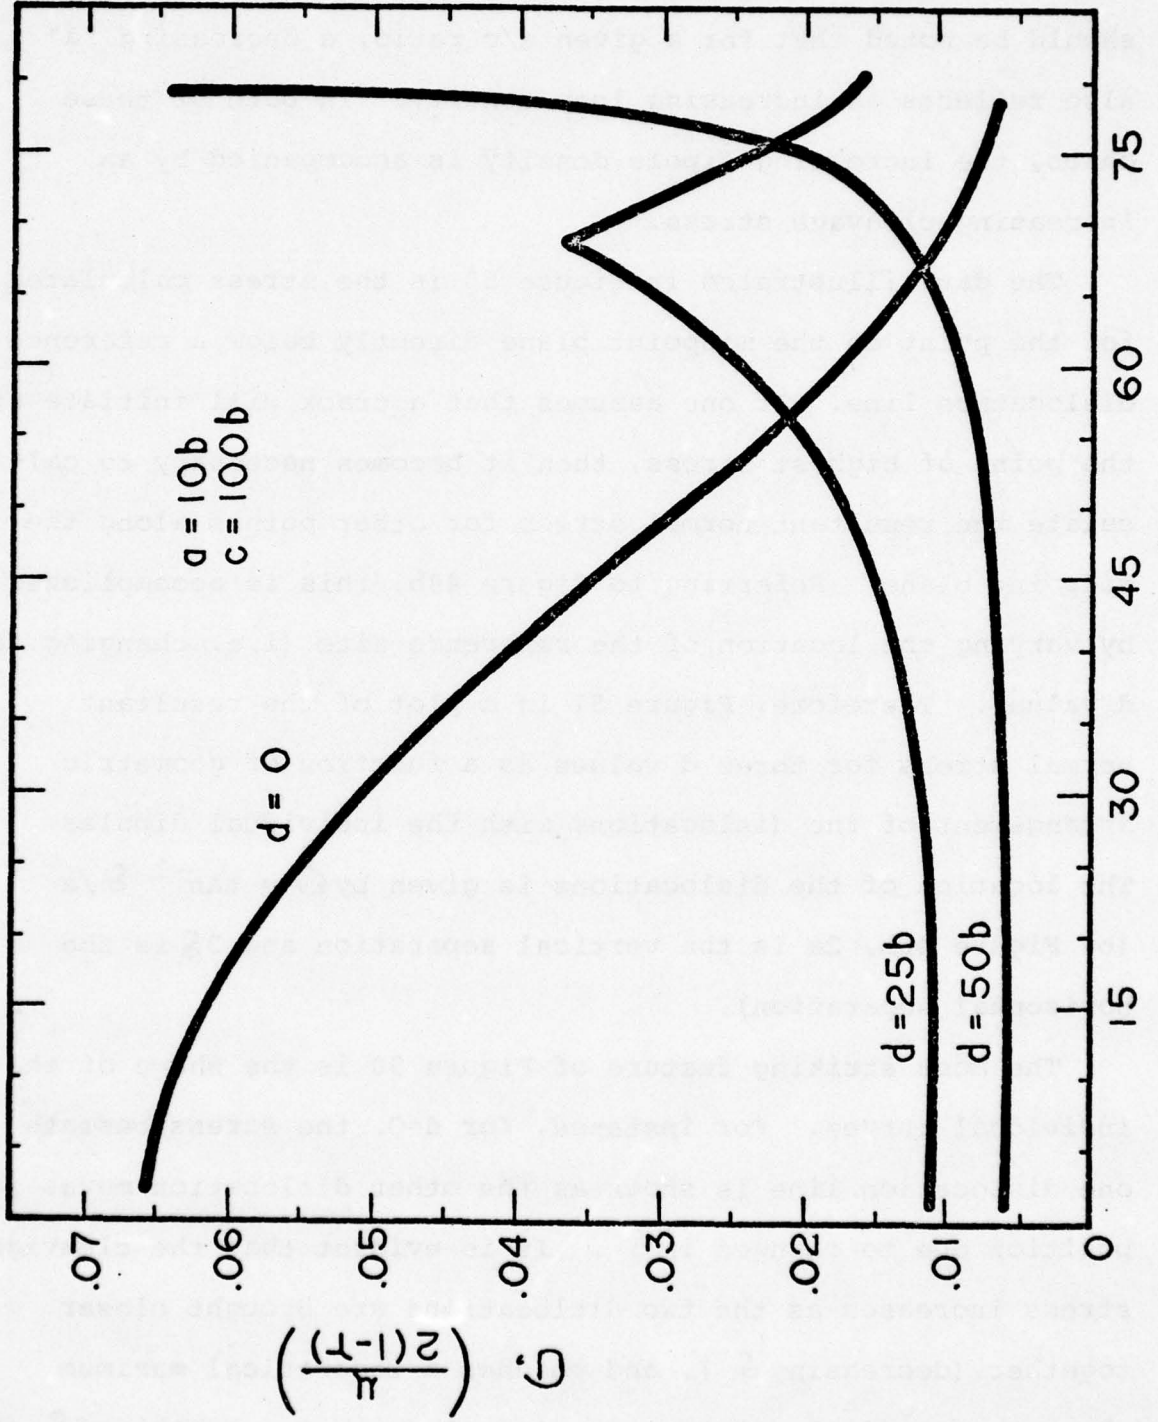
Figure 50. The normal stress on the midpoint plane of a dipole array as a function of the dipole geometry.

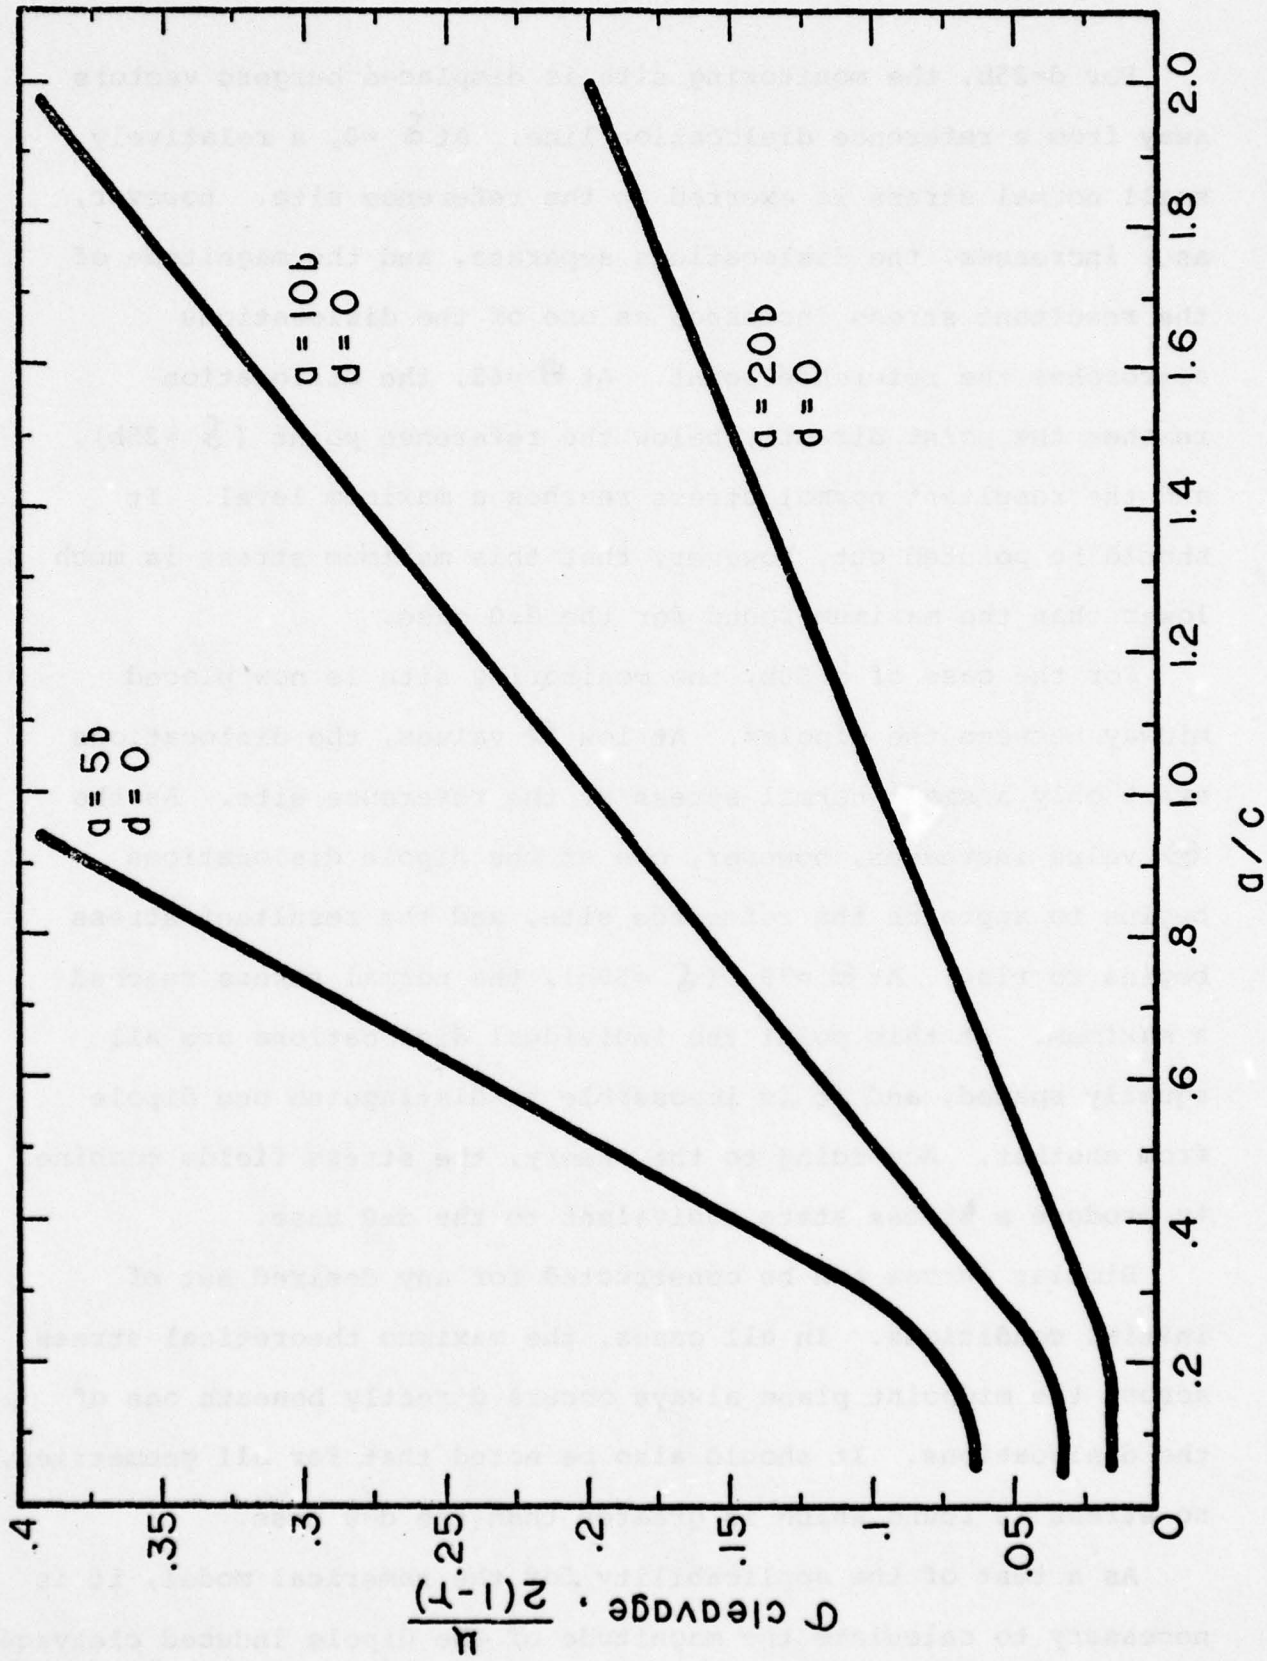
Figure 51. The normal stress of a dipole array for various locations along the midpoint plane as a function of the individual dipole geometry.
