In House Report
September 1979

**EXPERIMENTAL IMAGE COMPRESSION
SUBSYSTEM (EICS) COMMUNICATION
TESTING**

**ROME AIR DEVELOPMENT CENTER
Air Force Systems Command
Griffiss Air Force Base, New York 13441**

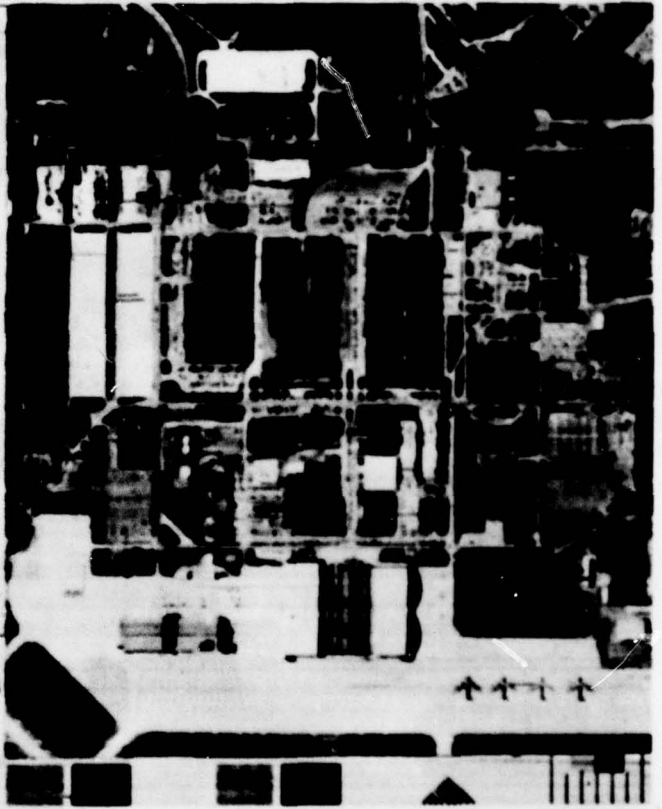
PHOTO 2
 STD Telephone Wire Line

Photo #2 was transmitted over standard telephone line at a data rate of 9600 bps with a predetermined measured bit error rate of 1.25×10^{-3} . The signal to noise ratio of the telephone line was 19.0 db. Review of the Pestrecov Star area shows a high degree of distortion compared to Photo #1. The reconnaissance image area is still highly usable.

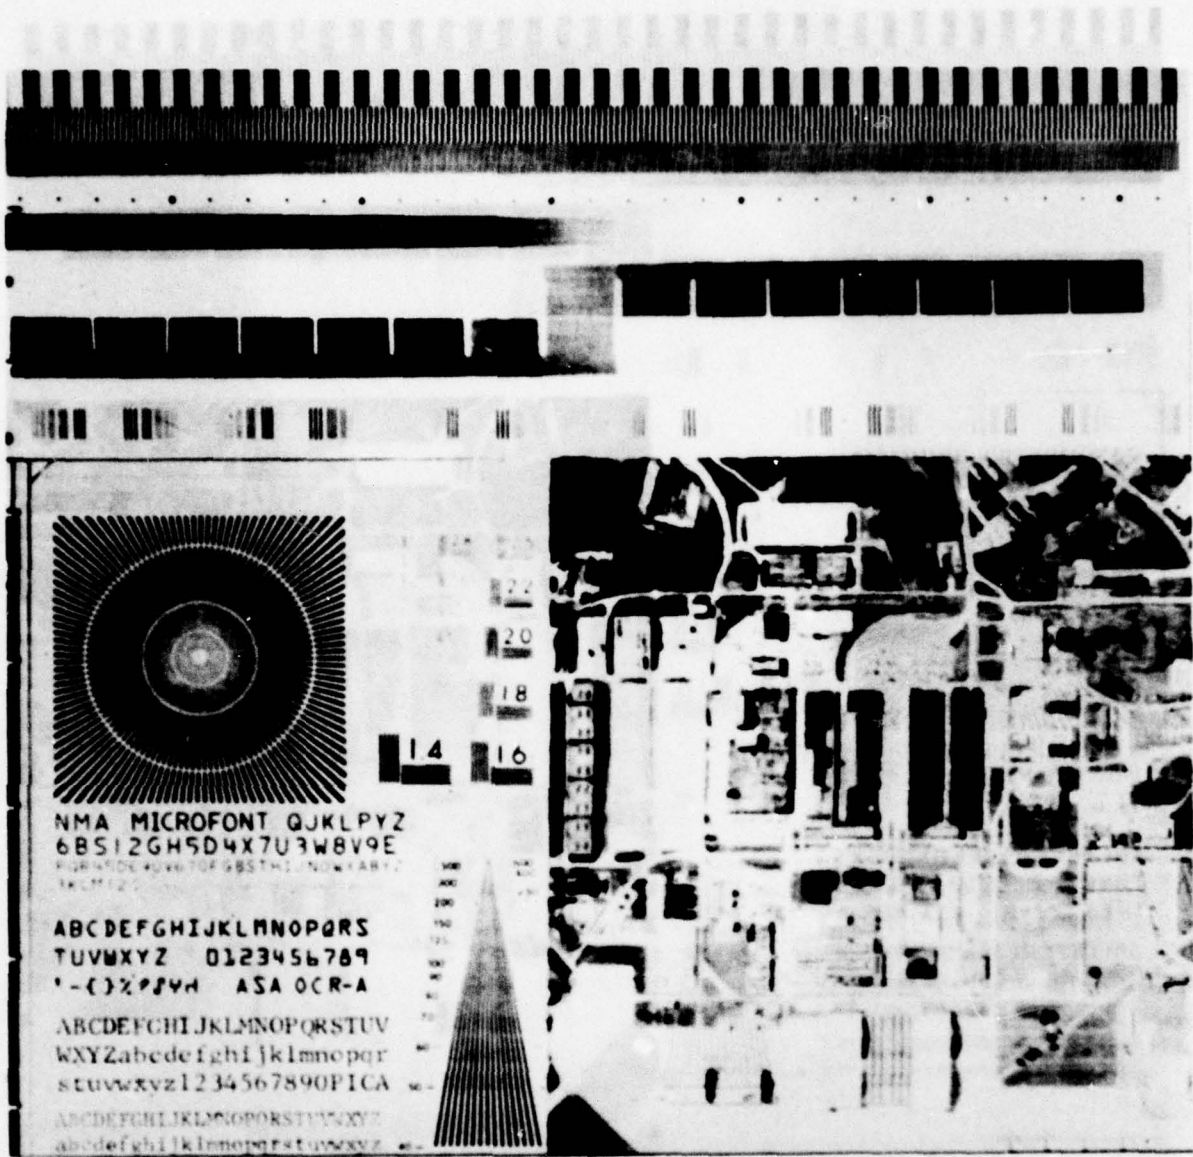
PHOTO 3
 STD Telephone Wire Line

Photo #3 was also transmitted over standard telephone line at a data rate of 9600 bps with a predetermined measured bit error rate of 2.5×10^{-7} .

Review of the Pestrecov Star area shows very little distortion, and the reconnaissance image area is of good quality, and highly usable.

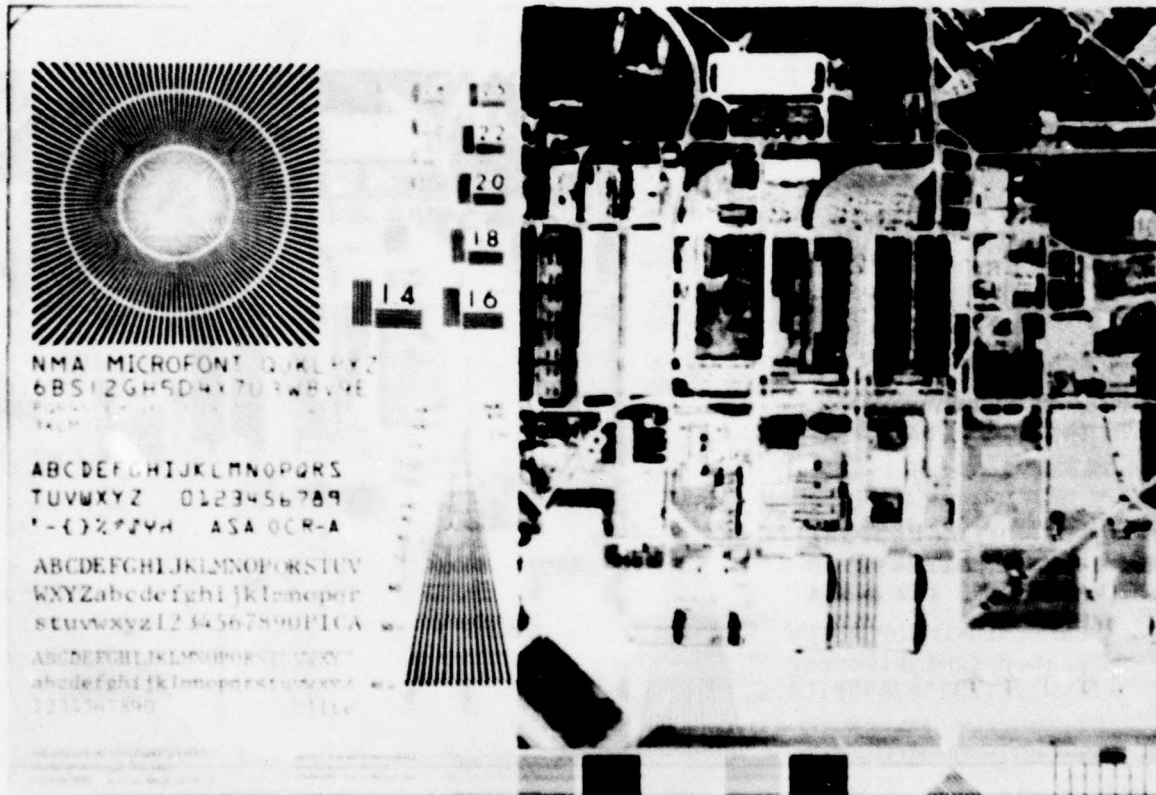
PHOTO 4
AUTOVON TESTING

Photo #4 was transmitted over an Autovon line between Rome Air Development Center, Rome, N.Y. and Tully, N.Y. and back to RADC at a data rate of 9600 bps. The signal level was -16db out and -10db back in, with a bit error rate of 1×10^{-6} . The Pestrecov Star and the reconnaissance image are of excellent quality.

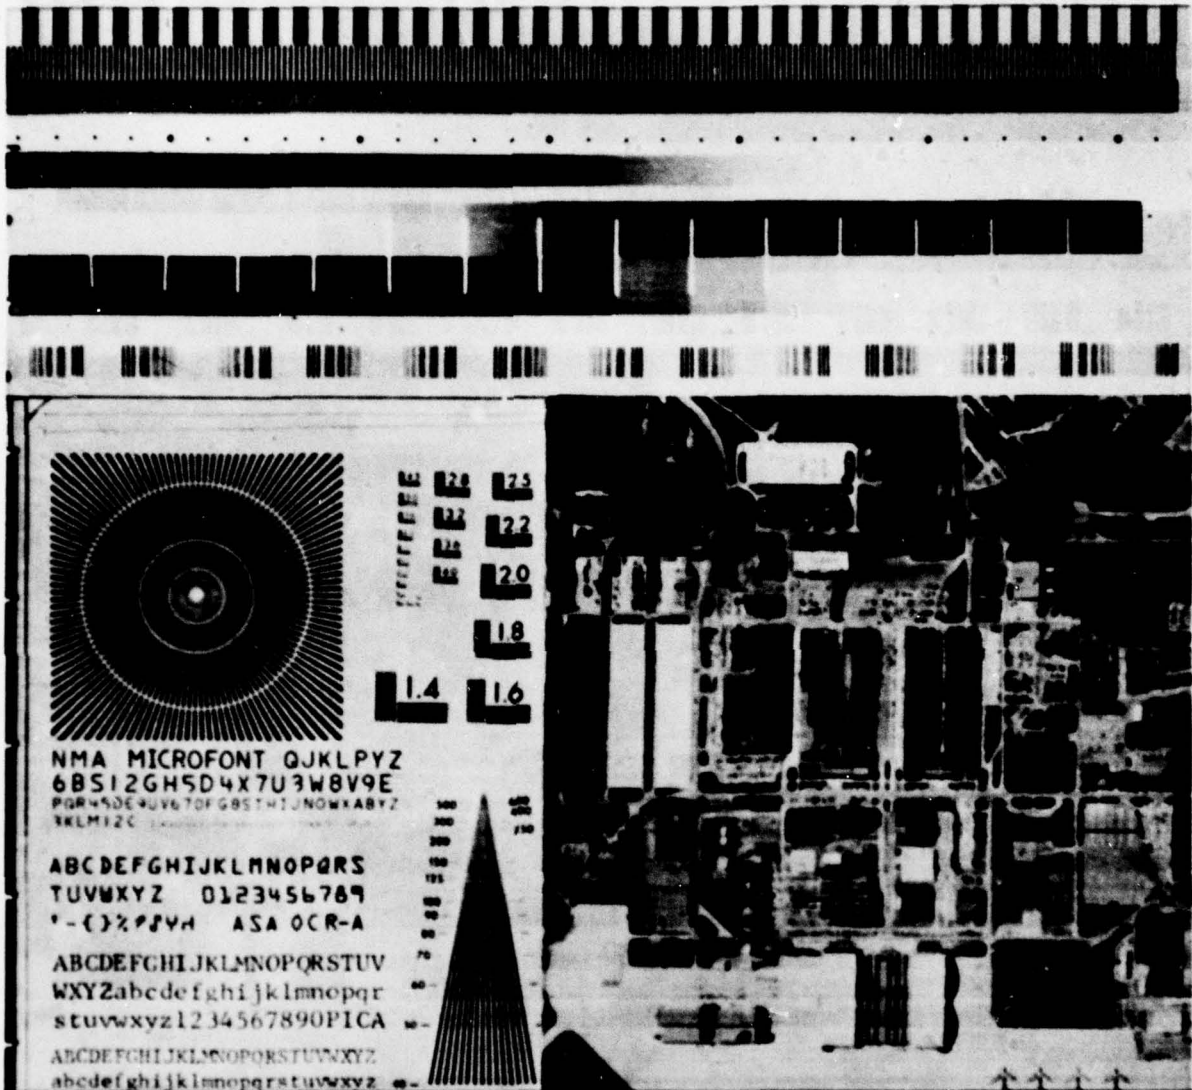
PHOTO 6
 AUTOVON TESTING

Photo #6 was transmitted over an Autovon line between two links, RADC, Tully, Potstown and back to RADC, and the data rate was 9600 bps. The signal was -11db out and -6db in, and had a bit error rate of 1.1×10^{-5} . Again, there seems to be little or no noticeable distortions in the Pestrecov Star.

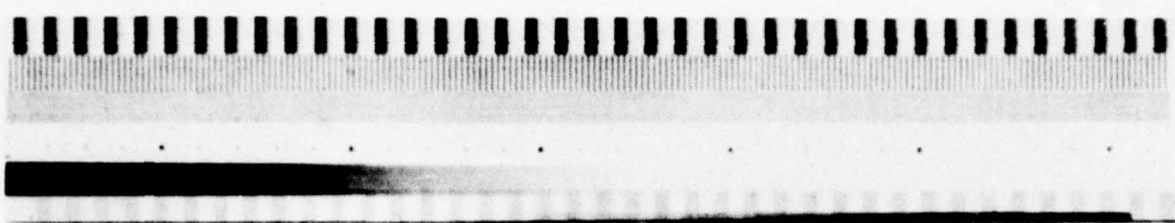
PHOTO 7
AUTOVON TESTING

Photo #7 was transmitted over Autovon line between four links, however, due to a tape read error only five minutes was recorded.

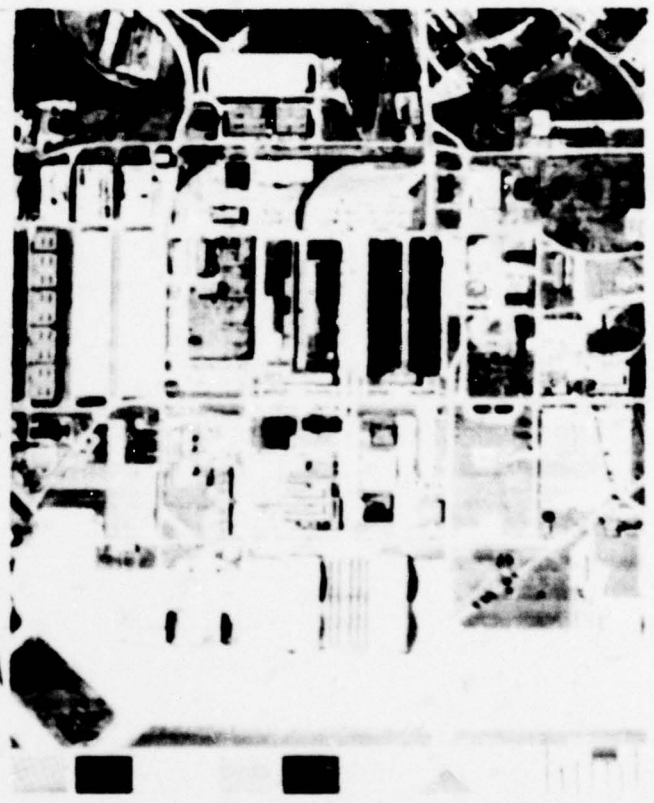
PHOTO 8
 AUTOVON TESTING

Photo #8 was transmitted over an Autovon line between four links, and the data rate was 9600 bps. The signal was -11db out and -9db in and had a bit error rate of 1.1×10^{-4} . Image evaluation of photo #8 shows little or no distortion of the Pestrecov Star. Transmit time was approximately twenty-five minutes.

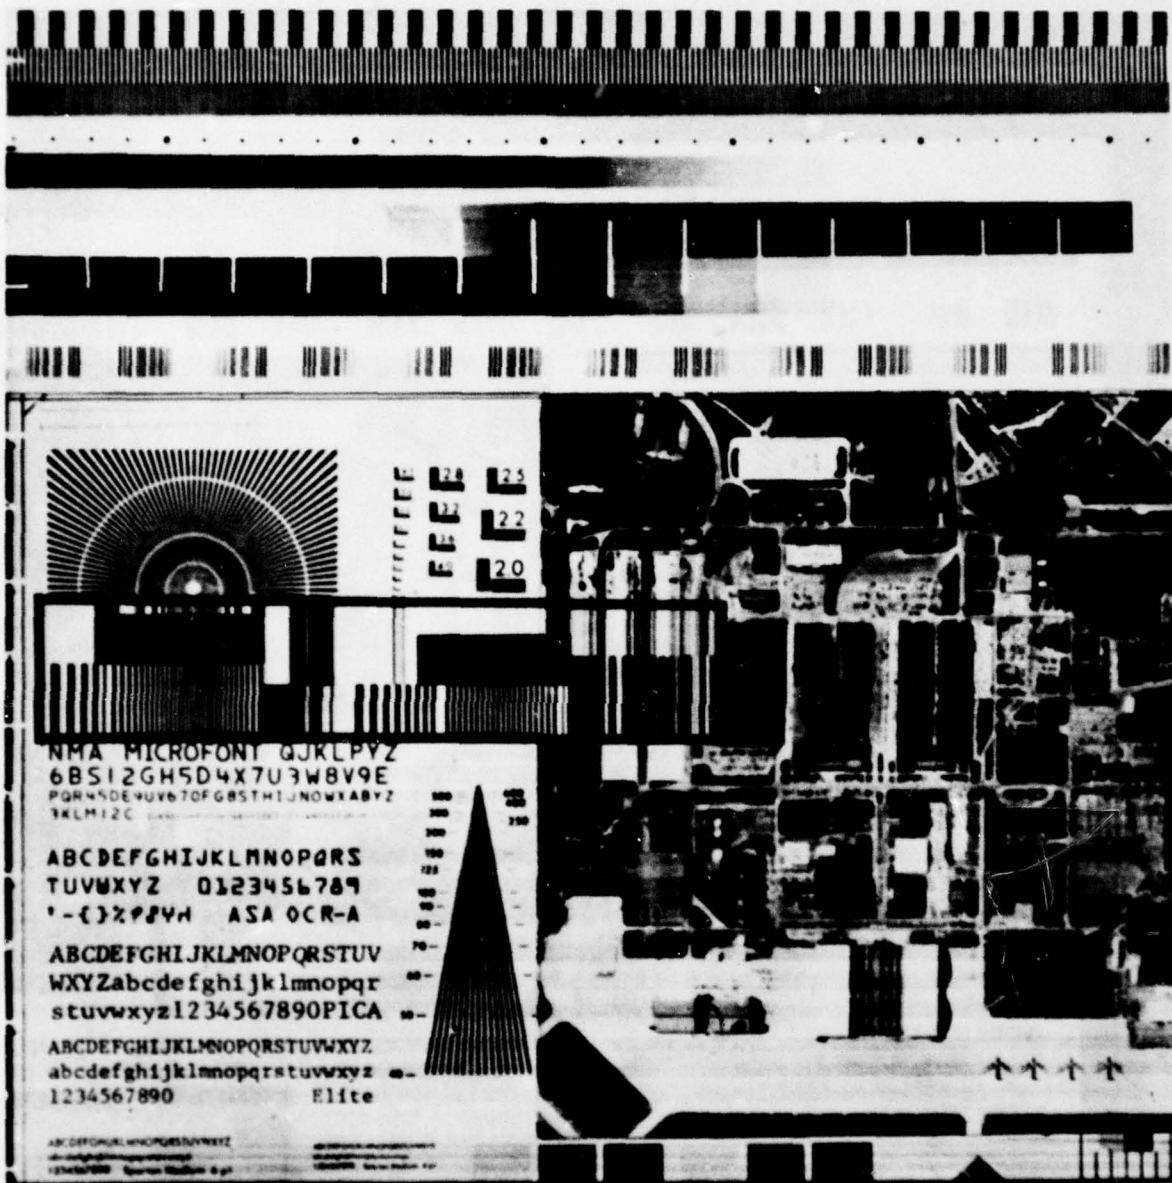
PHOTO 10
 AUTOVON TESTING

Photo #10 was transmitted over an Autovon line with five links, however, the data rate was reduced from 9600 bps to 7200 bps. The signal was -11db out and -12.5db in and had a

bit error rate of 1.1×10^{-4} .

Lowering of the data rate allowed for a successful transmission. The outlined area designated a programming error, and shows its result on the image.

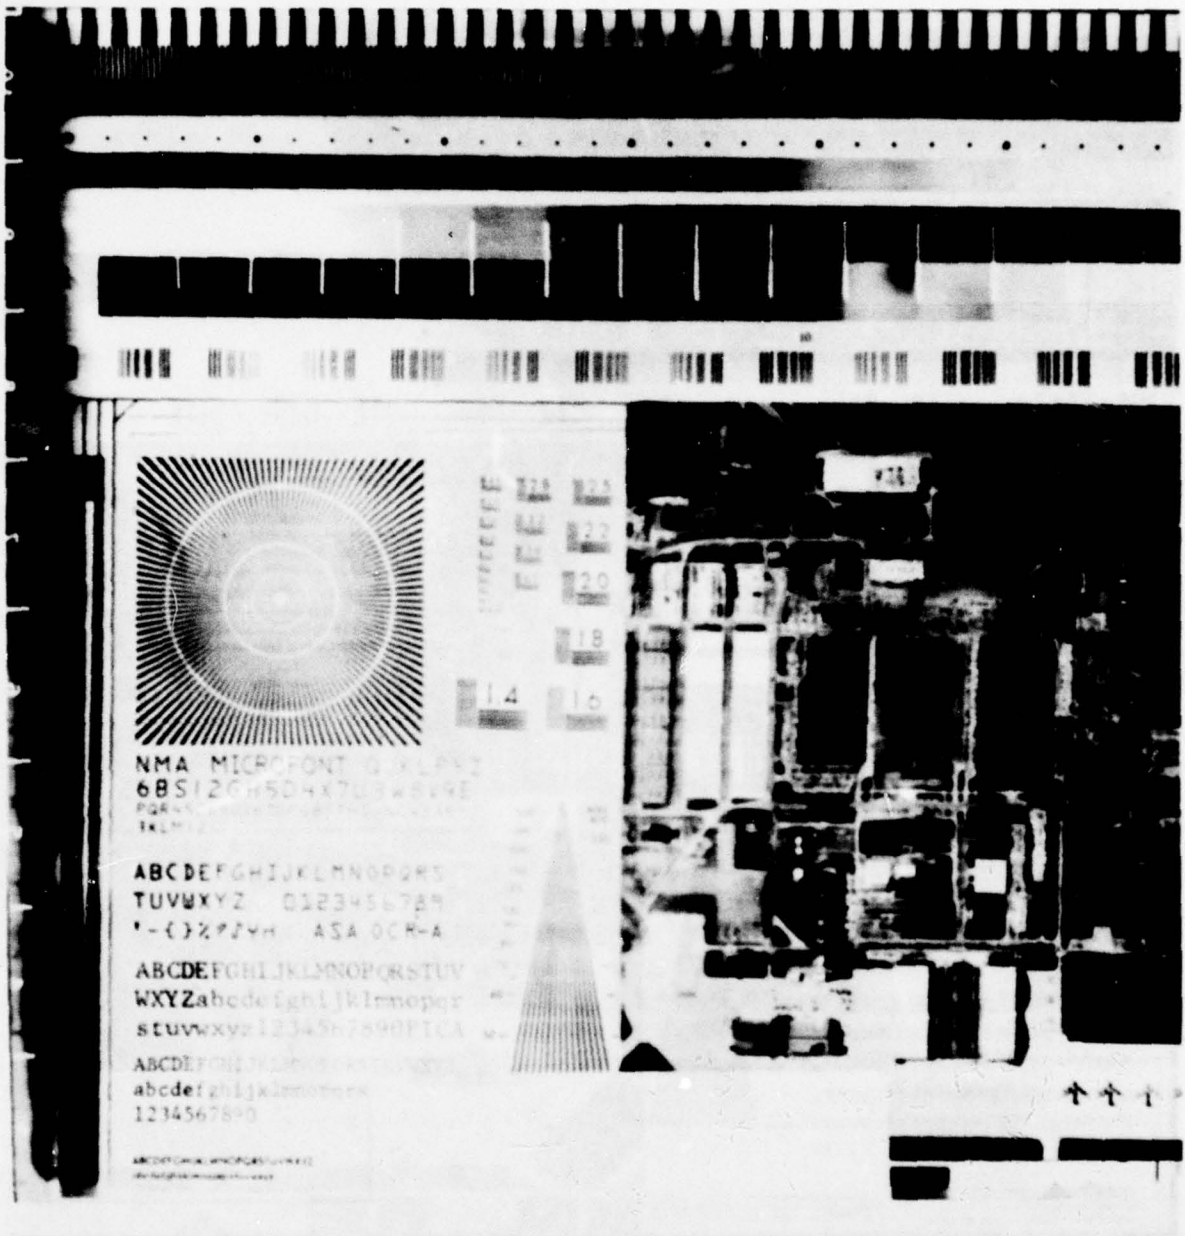
PHOTO 11
 MICROWAVE 2 LINK

Photo #11 was transmitted over Microwave between two links, and the data rate was 9600 bps. The bit error rate was 1×10^{-5} . The Pestrecov Star shows some distortion, however; the reconnaissance image is not affected by the distortion and is considered good image quality.

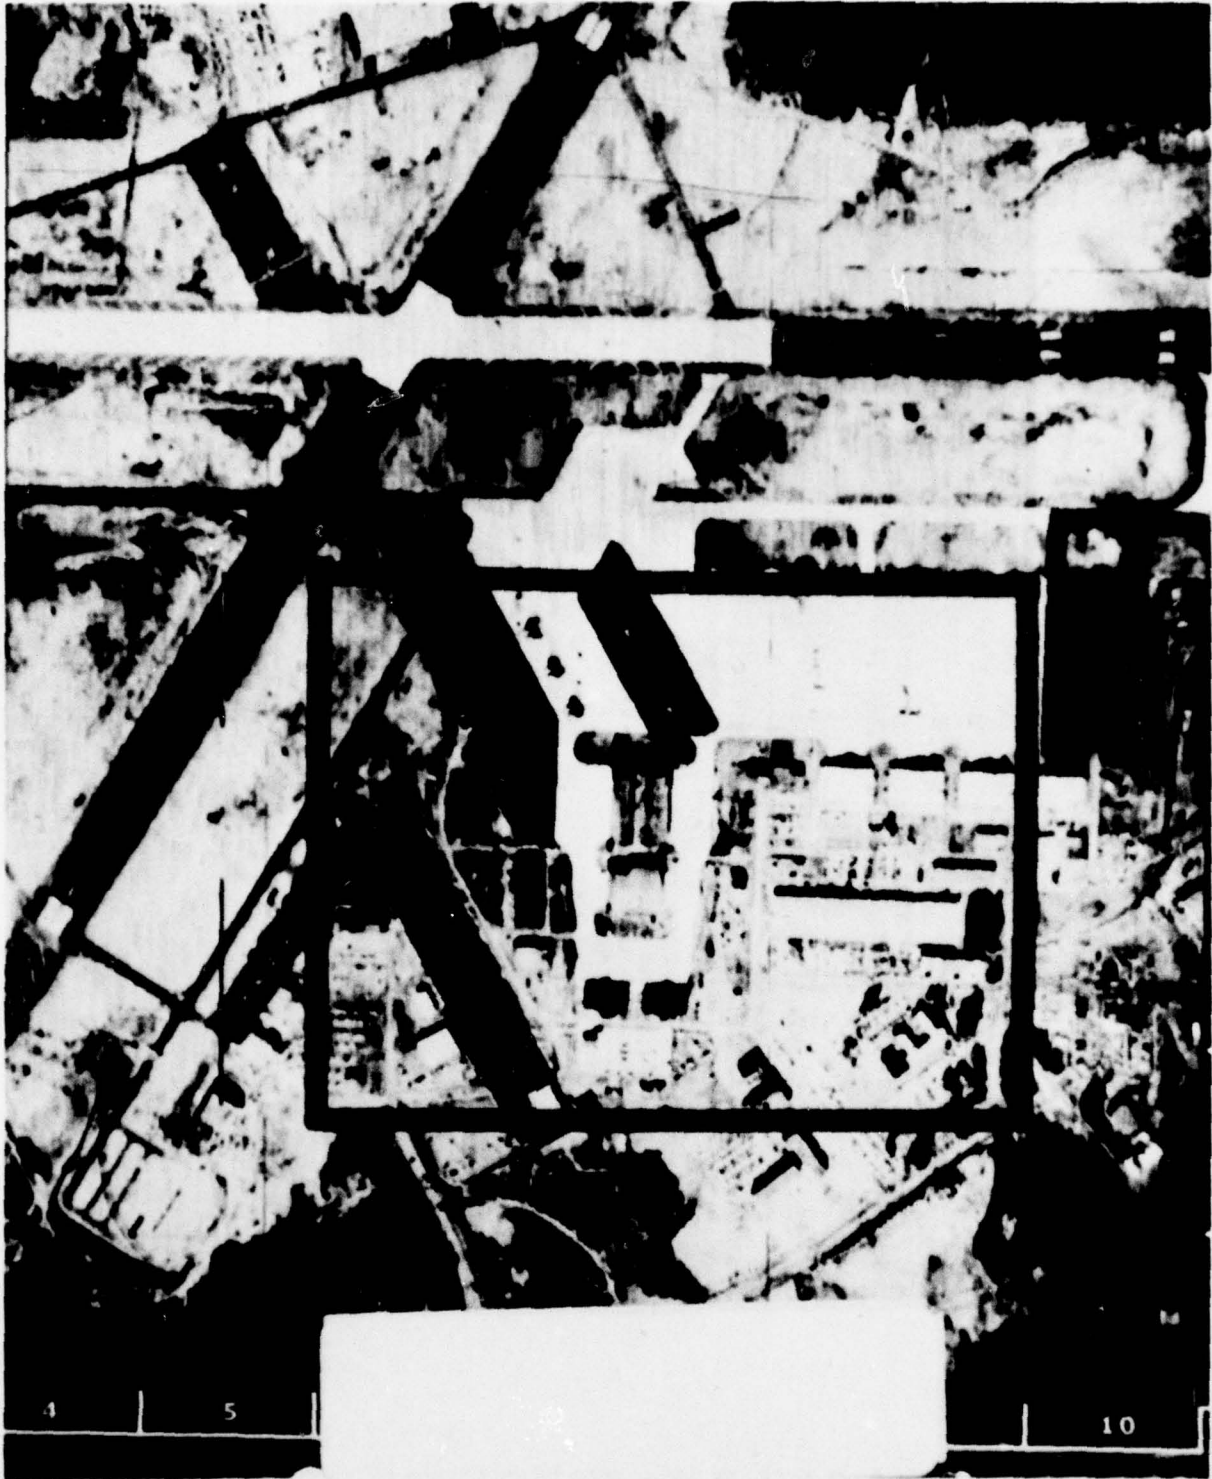
PHOTO 14

Photo #14 was transmitted over Tropo with two hops at a data rate of 4800 bps. Lowering the data rate allowed for a successful transmission. This photo also utilized the REARCS scheme. The area outlined represents the area of high interest

and therefore was transmitted at full resolution. Transmission and reception time was approximately fourteen minutes for the full 8" x 8" photo.

Only two photos were transmitted over troposcatter. More time was spent on tropo transmission than any other. The tropo equipment transmitted only the EICS imagery, and therefore it is not considered a true test, where the tropo equipment would be loaded down with other voice transmissions. Of the two images transmitted, only the 4800 data rate image was successful. The 9600 data rate proved to be too high.
