# Coil Spring Failures in Aerospace Hardware

S. W. FROST and K. T. KAMBER  
Materials Sciences Laboratory  
Laboratory Operations  
The Aerospace Corporation  
El Segundo, Calif. 90245

8 November 1979

Interim Report

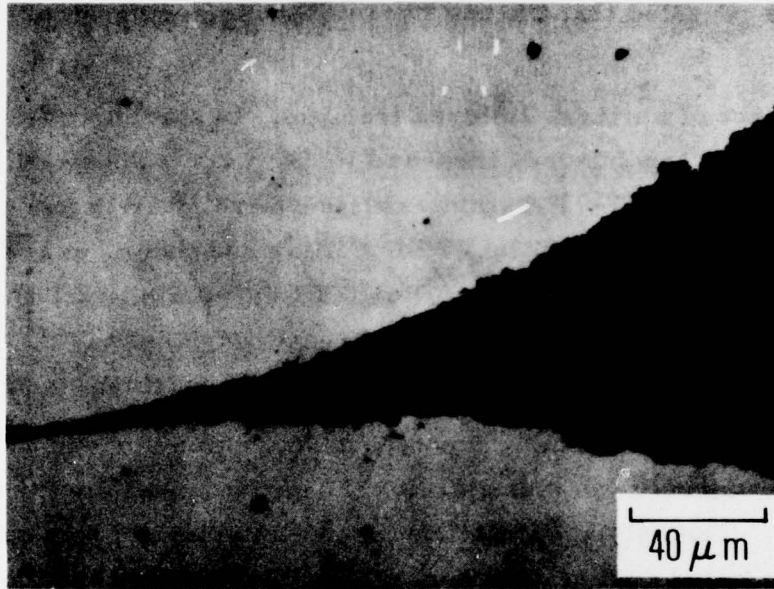
Figure 1. As-Polished Cross-Sectional View of Two Adjacent Coils on a Spring Subjected to a Black Oxide Coating Treatment. Typically, the exposed surface of the wire was rough, whereas unexposed areas near the crevice between adjacent coils were comparatively smooth.

The surface roughness varied along the circumference of the wire (Fig. 1). This surface condition was attributed to a mild chemical attack that was a result of the black oxide coating treatment. The microstructural damage, which was concentrated at the base of an end hook, is shown in Fig. 2 as many radial cracks on the end coil that forms the base of the end hook. Similar damage was found on the opposite end hook of the same spring.

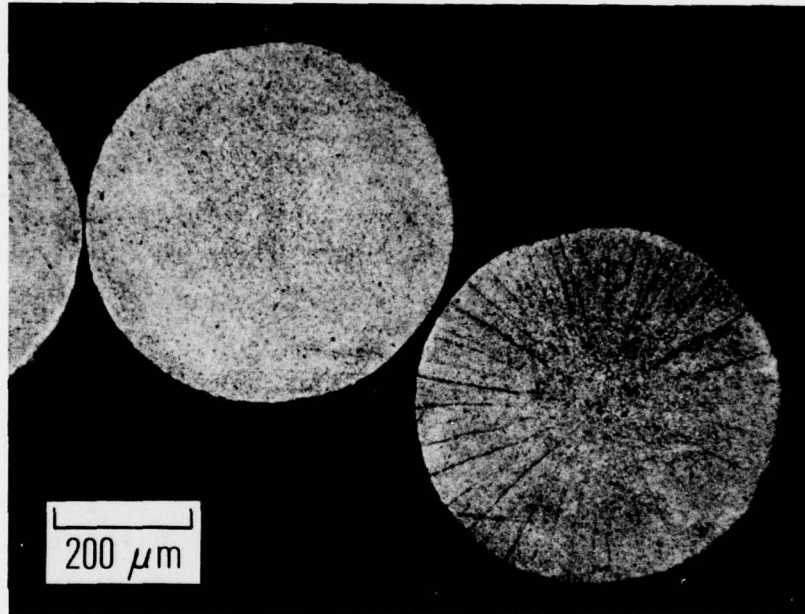
Figure 2. Polished and Etched Cross-Sectional View of the Coils Adjacent to an End Hook of a Failed Spring. Numerous radial cracks were confined to the end coil (on the right) forming the base of the end hook. Similar cracks were found concentrated at the base of the opposing end hook on the same spring. Etched with Marbles Reagent.

The radial crack pattern at the base of an end hook on the failed spring (Fig. 2) strongly resembles the type of damage caused by torsional fatigue in shafts.<sup>2</sup> This indicates that the torsional stresses were concentrated in this area of the end hooks. Thus, the source of the stress concentration was investigated.

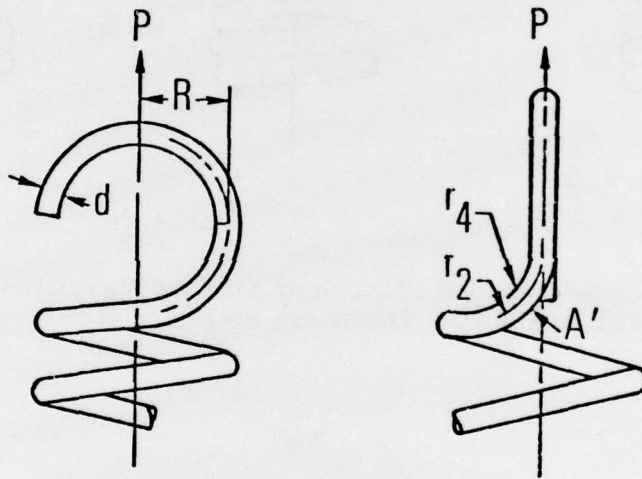
Torsional Stress  $S_t$  at Section A'

$$S_t = \frac{16 PR}{\pi d^3} \times \frac{r_2}{r_4}$$

Figure 3. Stress Concentration at the Base of an End Hook Due to End Hook Geometry

A concentration of torsional shear stress that results from the geometry of the bend at the base of the end hook is identified in MIL-STD-29A, a commonly used mechanical spring design standard.<sup>3</sup> The severity of the stress concentration depends on the sharpness of the bend (i. e., the ratio of  $r_2$  to  $r_4$ , Fig. 3). Variations in end hook arrangement, however, but not in end hook bend radii, correlated with fatigue damage at the base of the end hooks.

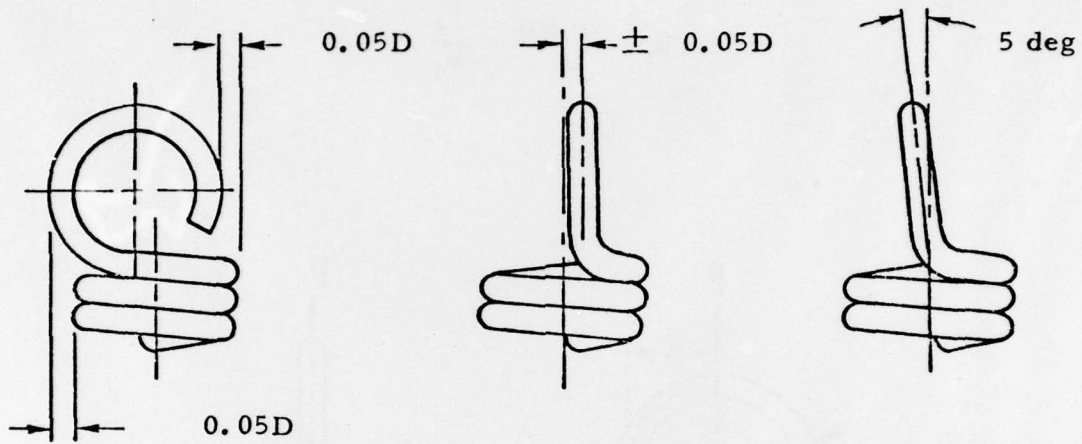
Figure 4. Recommended Maximum Allowed Variation in Alignment of End Hooks.  $D$  = mean coil diameter.

The design standard does not consider how the end hook stresses are affected by variations in end hook arrangement. Limits on the amount of variation in end hook arrangement are recommended, however, and these limits must be considered important to spring reliability. Unfortunately, these limits concern spring size (Fig. 4) and are not mandatory requirements. Consequently, as spring size decreases, these limits become increasingly difficult to maintain and, therefore, less likely to be adhered to. Thus, for small springs, where variations in end hook arrangement can be a significant part of the spring dimensions, the manner in which this arrangement affects the end hook stresses must be considered for the sake of reliability.

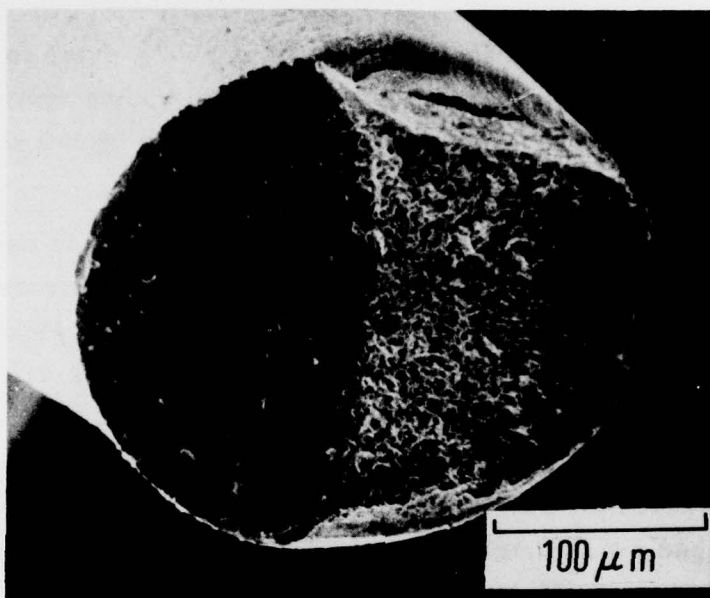
Figure 5. Typical Appearance of the Fracture Surface on End Hooks of Cyclic-Loaded Miniature Extension Springs Made from 0.010-in. -diam AISI 302 Stainless Steel Wire

Examination of several failed springs revealed that, in each case, a fatigue crack developed approximately midway through the cross-sectional area of an end hook before complete failure occurred. A typical fracture surface is shown in Fig. 5. The flat, generally featureless area on the fracture surface corresponds to the fatigue-cracked area, whereas the highly textured, dimpled area opposite the fatigue region corresponds to material pulled apart by a single application of load. For each failure examined, a fatigue crack origin could be associated with either tool marks on the end hook (Fig. 6) or with a rough surface (Fig. 7).

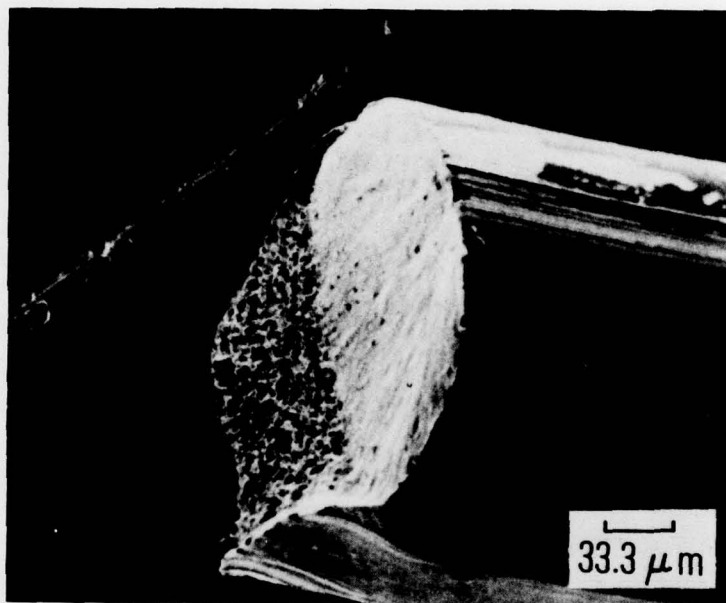
Figure 6. Tool Marks Found on the End Hooks of Failed AISI 302 Springs

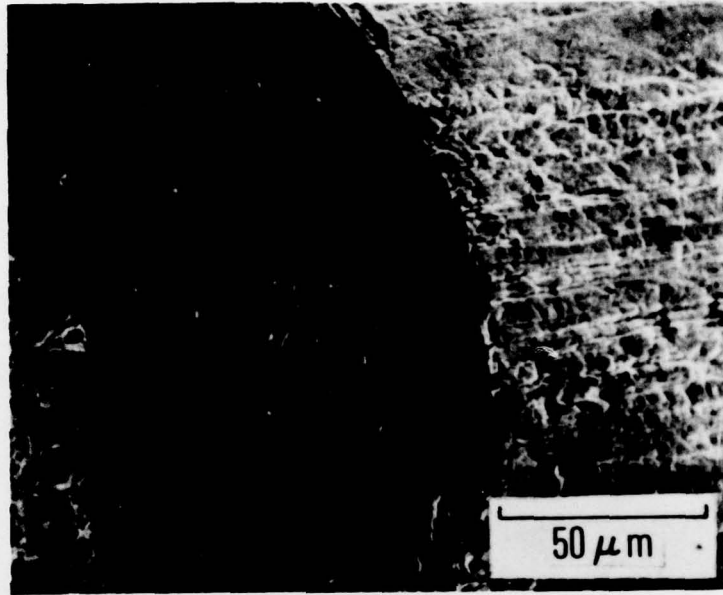
Figure 7. Surface Roughness Associated with Fatigue Crack Origin on Failed AISI 302 Stainless Steel Springs

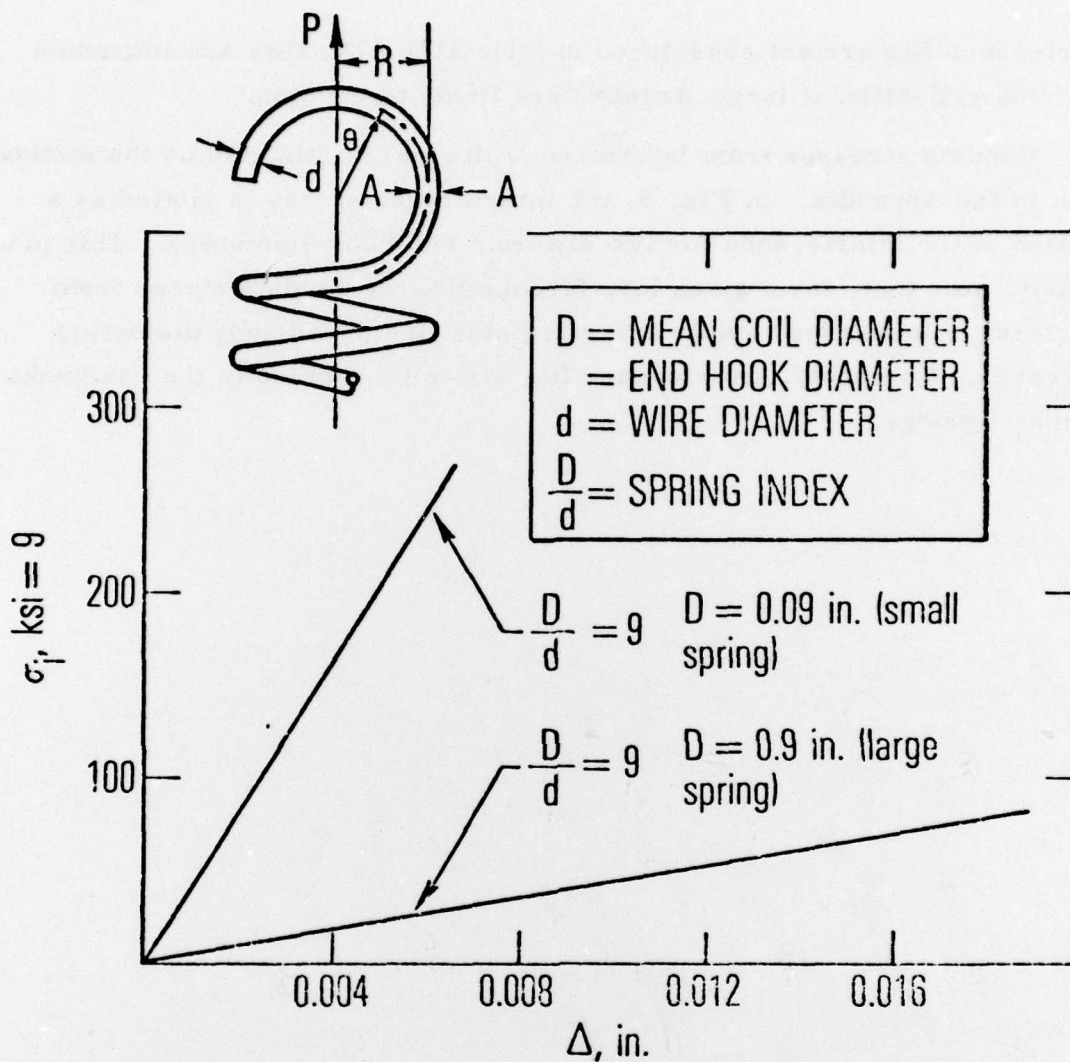
Figure 8. Interference Stress  $\sigma_i$  at Critical Section of End Hooks vs Interference Fit  $\Delta$ .  $\sigma_i$  determined from Eq. (A-2) in the Appendix.

Bending stresses from interference fits were estimated by the method given in the Appendix. In Fig. 8, the interference stress is plotted as a function of the interference for two different end hook diameters. This plot demonstrates that, for a given interference fit, the bending stress from interference increases rapidly as spring size (i. e., end hook diameter) decreases. Obviously, interference fits are to be avoided in the end hooks of small springs.

where  $M = PR \sin \theta$ , and  $\partial M / \partial P = R \sin \theta$  (Fig. 8).

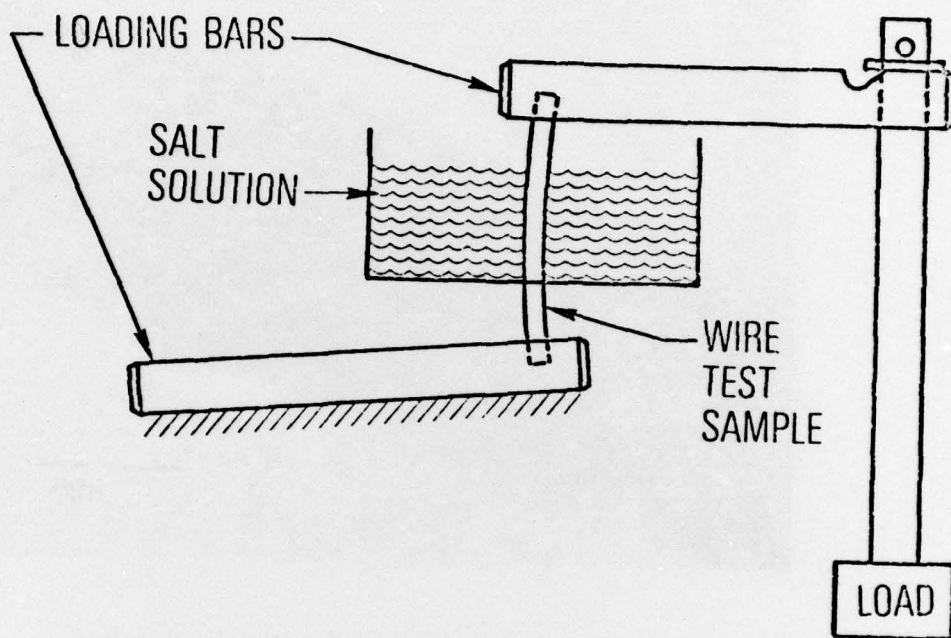
Figure 9. Fixture for Sustained Load Bending of Wire

From these results, neither material could be determined to be superior in terms of resistance to stress-corrosion cracking. There were, however, obvious differences in the direction of stress-corrosion paths between the two materials. In the 17-7PH spring wire (loaded in bending as shown in Fig. 9), cracking was confined to a longitudinal plane running parallel with the wire axis. This cracking path persisted even when a deeply notched sample was stress corroded (Fig. 10). In the Custom 455 spring wire (similarly loaded in bending), cracking developed across the wire at an angle of approximately 30 deg to the wire axis. The cracking paths on unnotched samples of the materials are compared in Fig. 11.

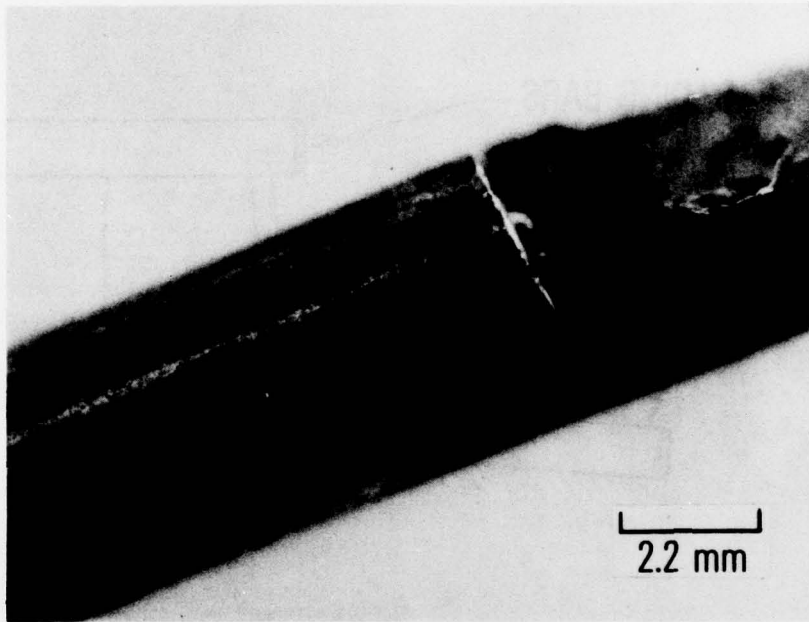
Figure 10. Stress Corrosion Cracks in Notched 17-7PH Spring Wire, Loaded in Bending. Cracks developed parallel to the wire axis on both sides of the notch

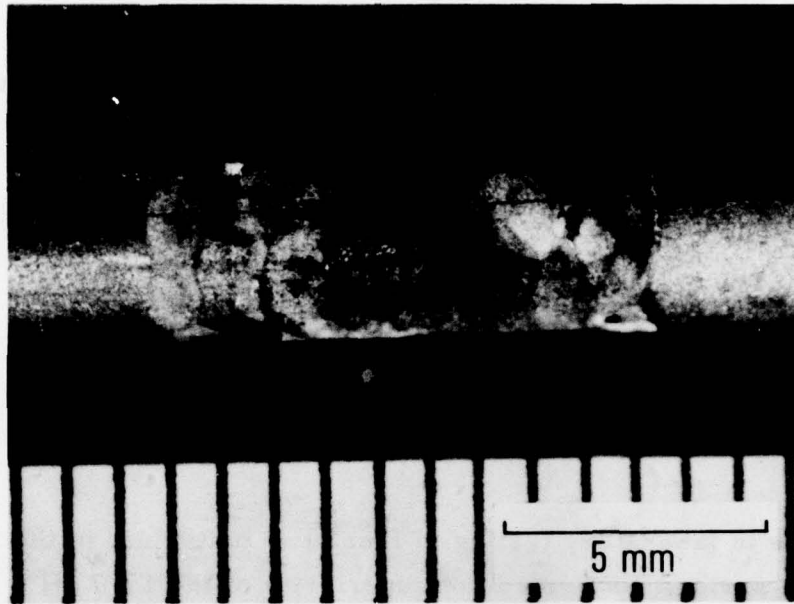
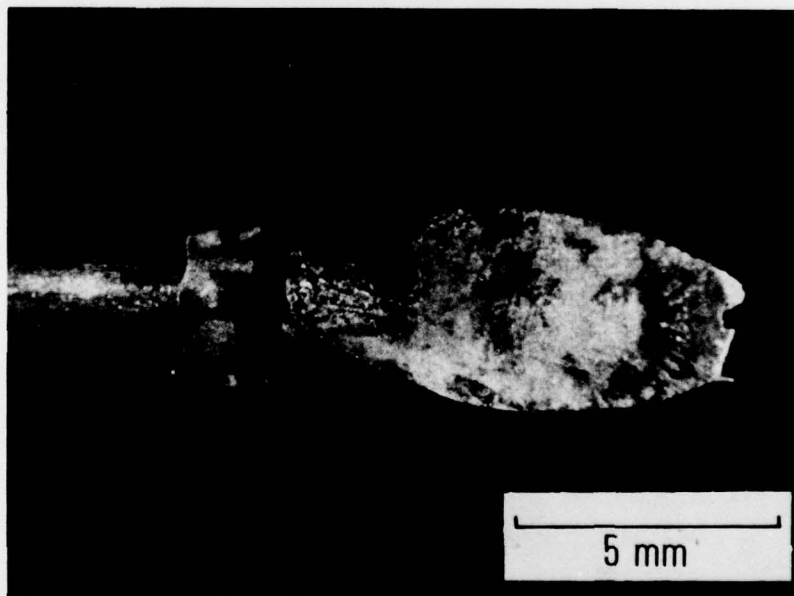
Figure 11. Stress Corrosion Crack Paths in 17-7PH, CH900 Wire (upper) and in Custom 455, CH850 wire (lower). Both samples were loaded in bending and are shown with the tensile side up.

Since the 17-7PH, CH900 spring material was susceptible to stress corrosion only along a longitudinal plane, and this plane is subject to little or no applied tensile stresses under torsional loads, the 17-7PH, CH900 wire would be expected to be resistant to stress corrosion when used in a coil compression spring. As stress-corrosion cracking in the Custom 455 wire tended to follow a path only a few degrees from the plane of maximum tensile stress under torsional loading, its resistance to stress corrosion would not be expected to vary significantly when incorporated into a coil spring.
