# TECHNICAL REPORT

Final Report  
F-C4708-01

STRESS CORROSION ENVIRONMENTAL EFFECTS ON AF 1410

Dr. Victor V. Damiano

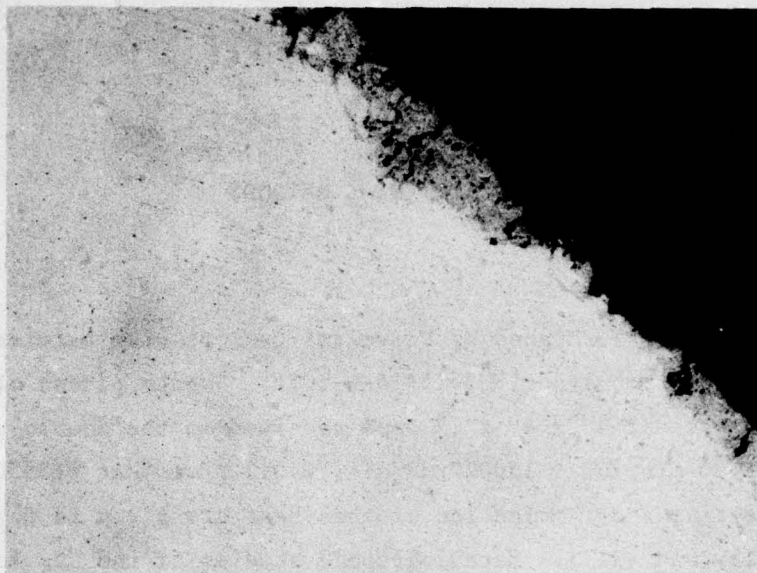
Figure 1. Metallographic Cross Sections of As-Received AF 1410 Sheet Showing the Oxide Layer (Top) and the Overall Cleanliness of the Steel.

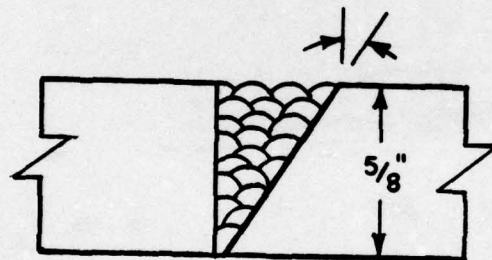
PRELIMINARY  
JOINT DESIGN

Table III. AF-1410-1 Test Weld

Welding Parameters

Amps - Root Pass 120-130, Filler Passes 130-140

Energy Input - 31.2 KJ

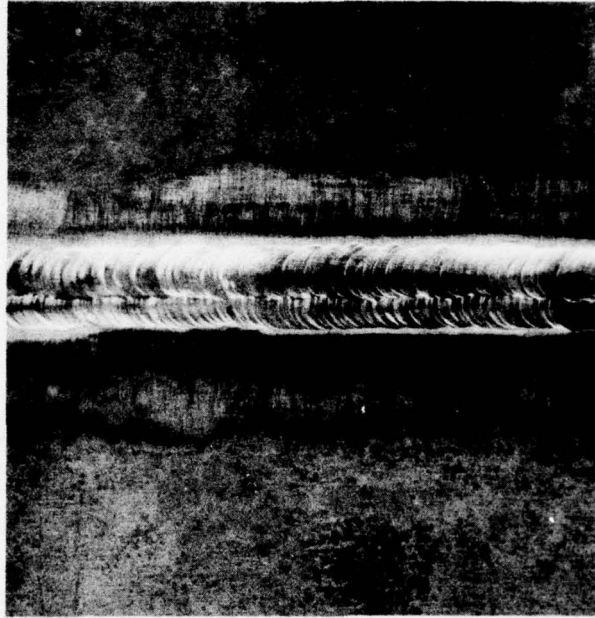
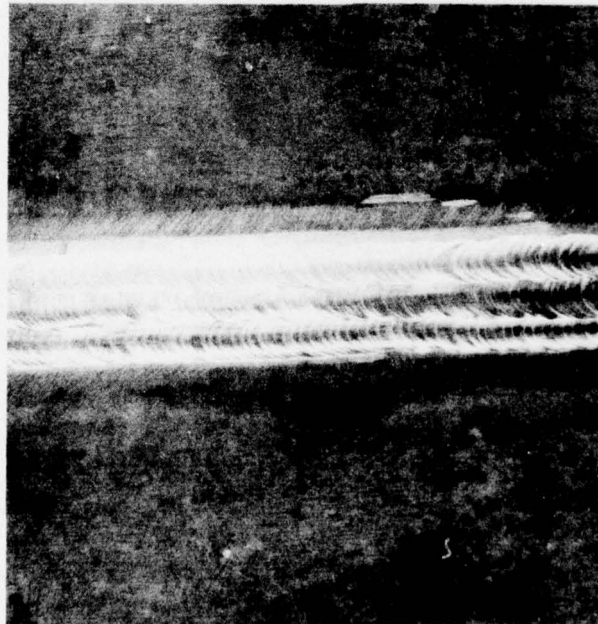
Top of Weld A

Bottom of Weld B

Figure 3. Completed Weld Using AF 1410 Sheet Material as Filler Wire

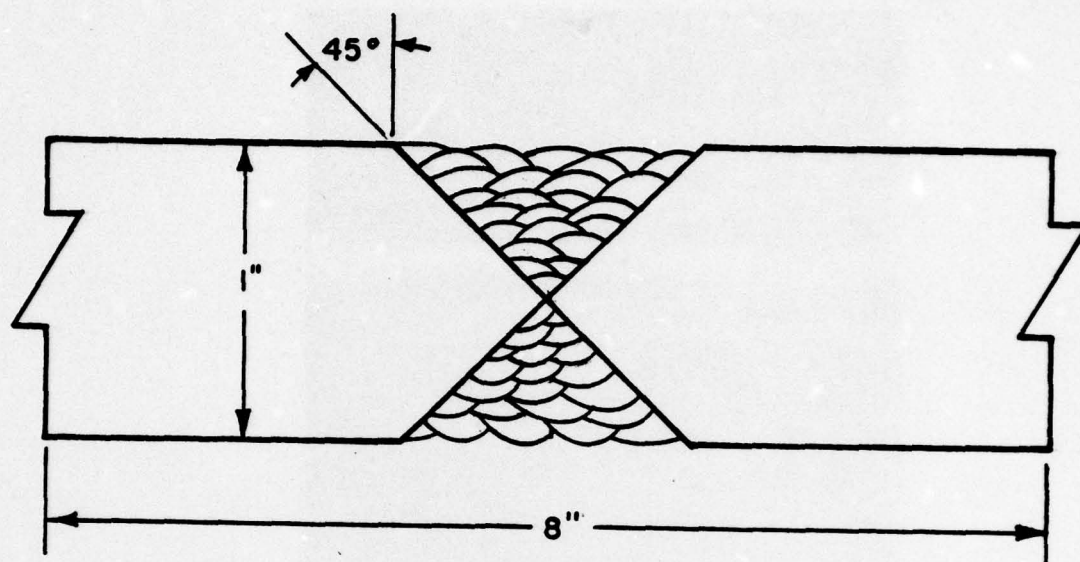
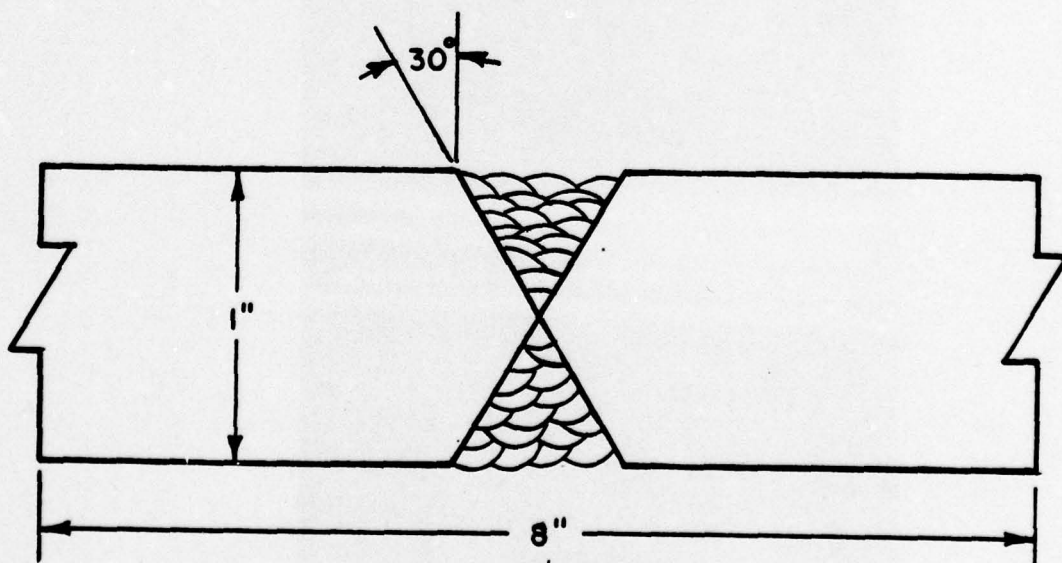
Figure 4. Joint Design AF-1410-2 and AF-1410-3

The welding parameters used are given in Table III. Two additional weld joints were made using the 1" thick plates after it was determined that AF-1410-1 was satisfactory. These plates, designated AF-1410-2 and AF-1410-3, were welded along the 8" edge of the plates. The joint design for these plates is shown in Figure 4. The double V design was selected for the Stress Corrosion Cracking test since it presented a more symmetrical design for crack propagation studies parallel to the weld beads.

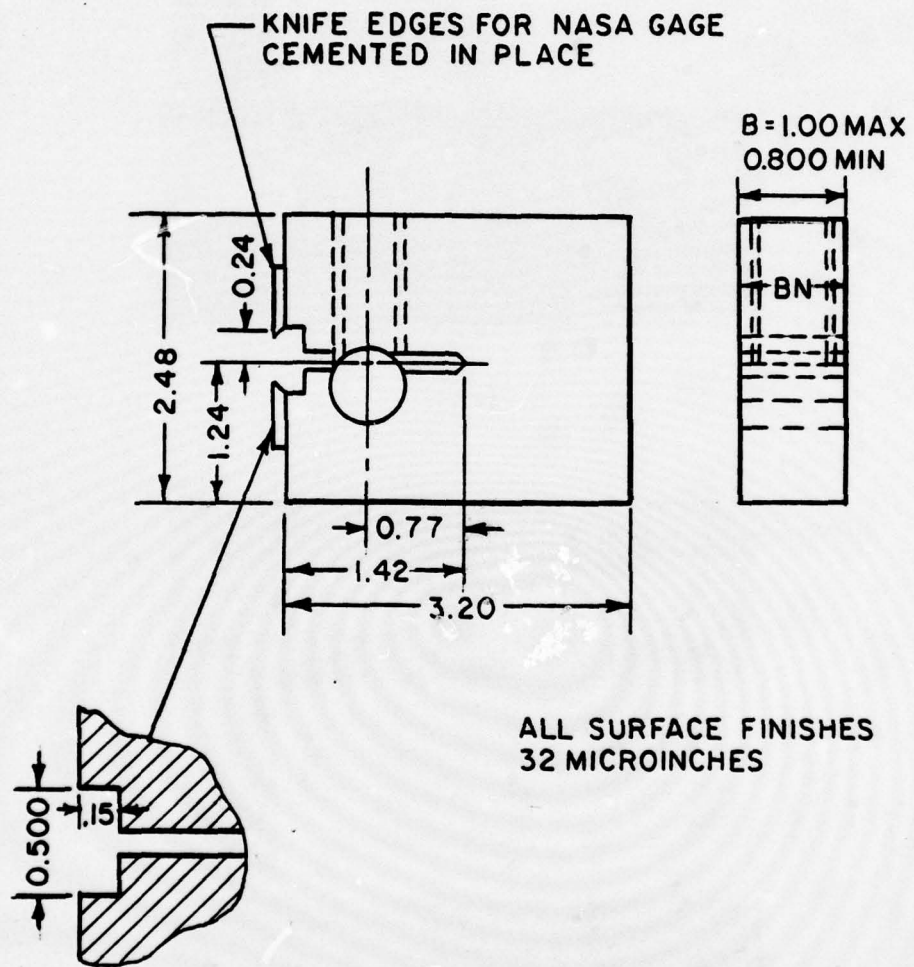
Figure 5. Detailed Drawing of Modified 1/T WOL Specimen  
Dimensions One Half Those Shown for 1/2-T  
Specimens

The samples were machined and fatigue cracked by Met Cut Research Associates following Novak and Rolfe's (2) modified WOL specimen design as shown in Figure 5. WOL samples machined from AF-1410-2 and AF-1410-3 are shown in Figures 6(a) and (b) respectively. Figure 6(a) shows one base plate and one weld WOL sample. The second (WOL) weld sample from this plate was tested by Met Cut Research Associates.

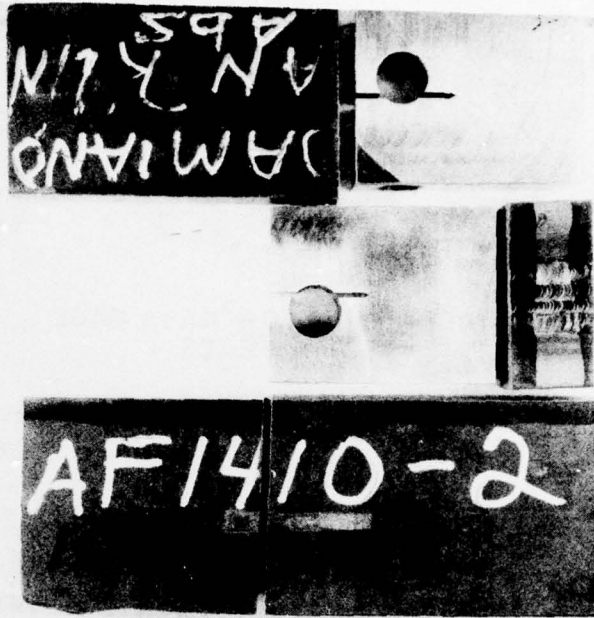
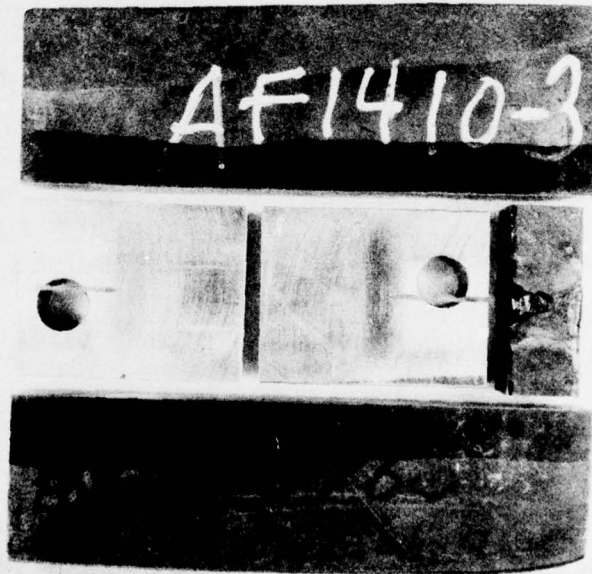
Figure 6. (a) - WOL Samples from Weld and Base Plate - AF-1410-2  
(b) - WOL Sample from Weld AF-1410-3

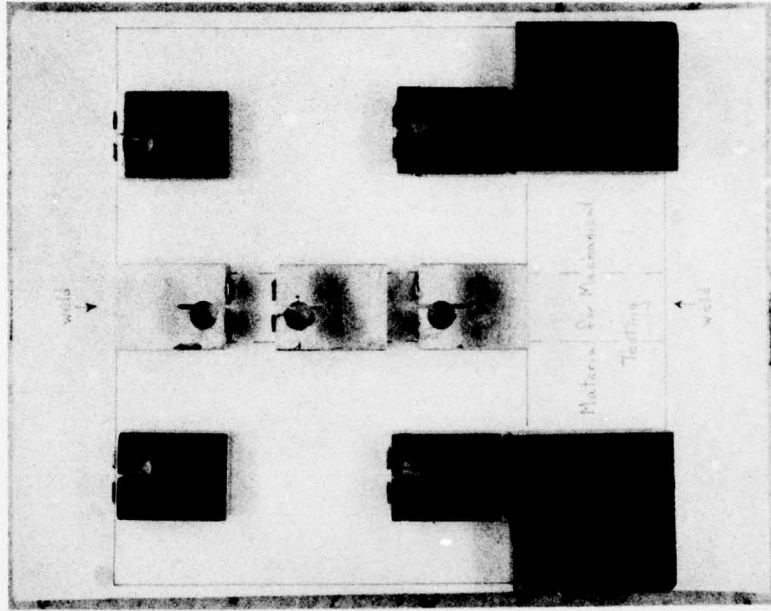
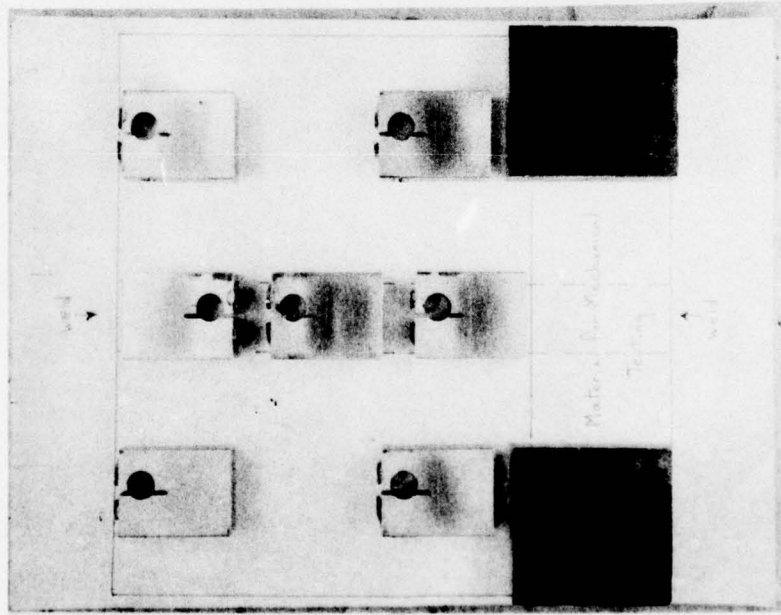
Figure 7. Arrangement of WOL Test Specimens Cut from AF-1410-5 and AF-1410-6 Weld Assemblies

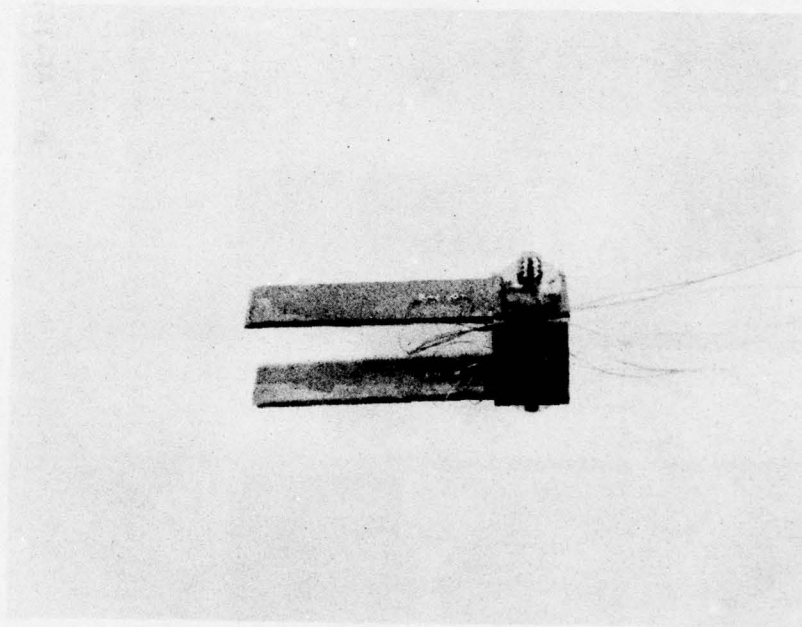
Figure 8. NASA Clip Gage with Strain Gages in Place

The gage consists of two cantilever beams and a spacer block which are clamped together with a single nut and bolt. The material used for the gage was 13V-11Cr-3Al titanium alloy in the solution treated condition because of its high yield strength to modulus ratio. Four 120 strain gages were mounted longitudinally on each side of the beams as close as possible to the beam-spacer block. The gage bonding conformed to the manufacturer's specification.

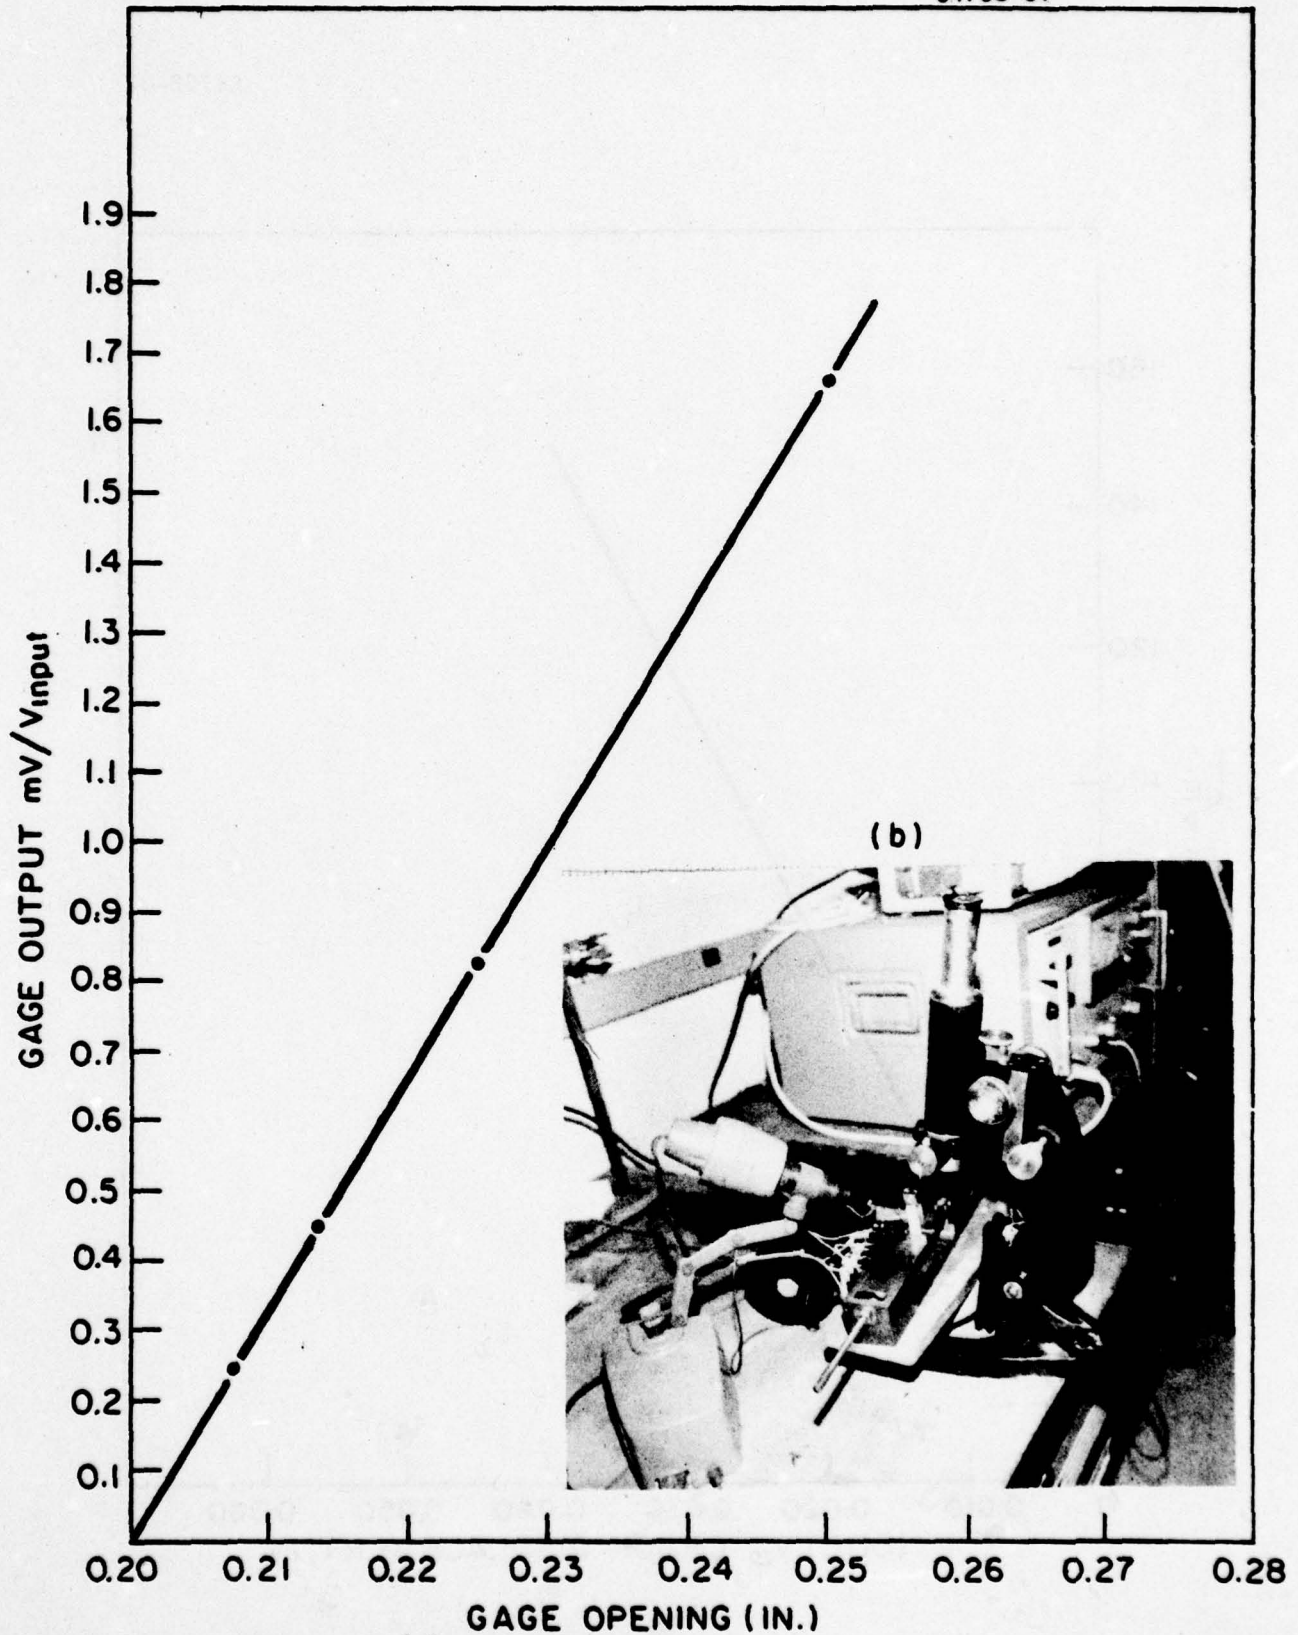
Figure 9. (a) Calibration of Gage Opening vs. Gage Output  
(b) Arrangement of Microscope Used to Calibrate Clip Gage.

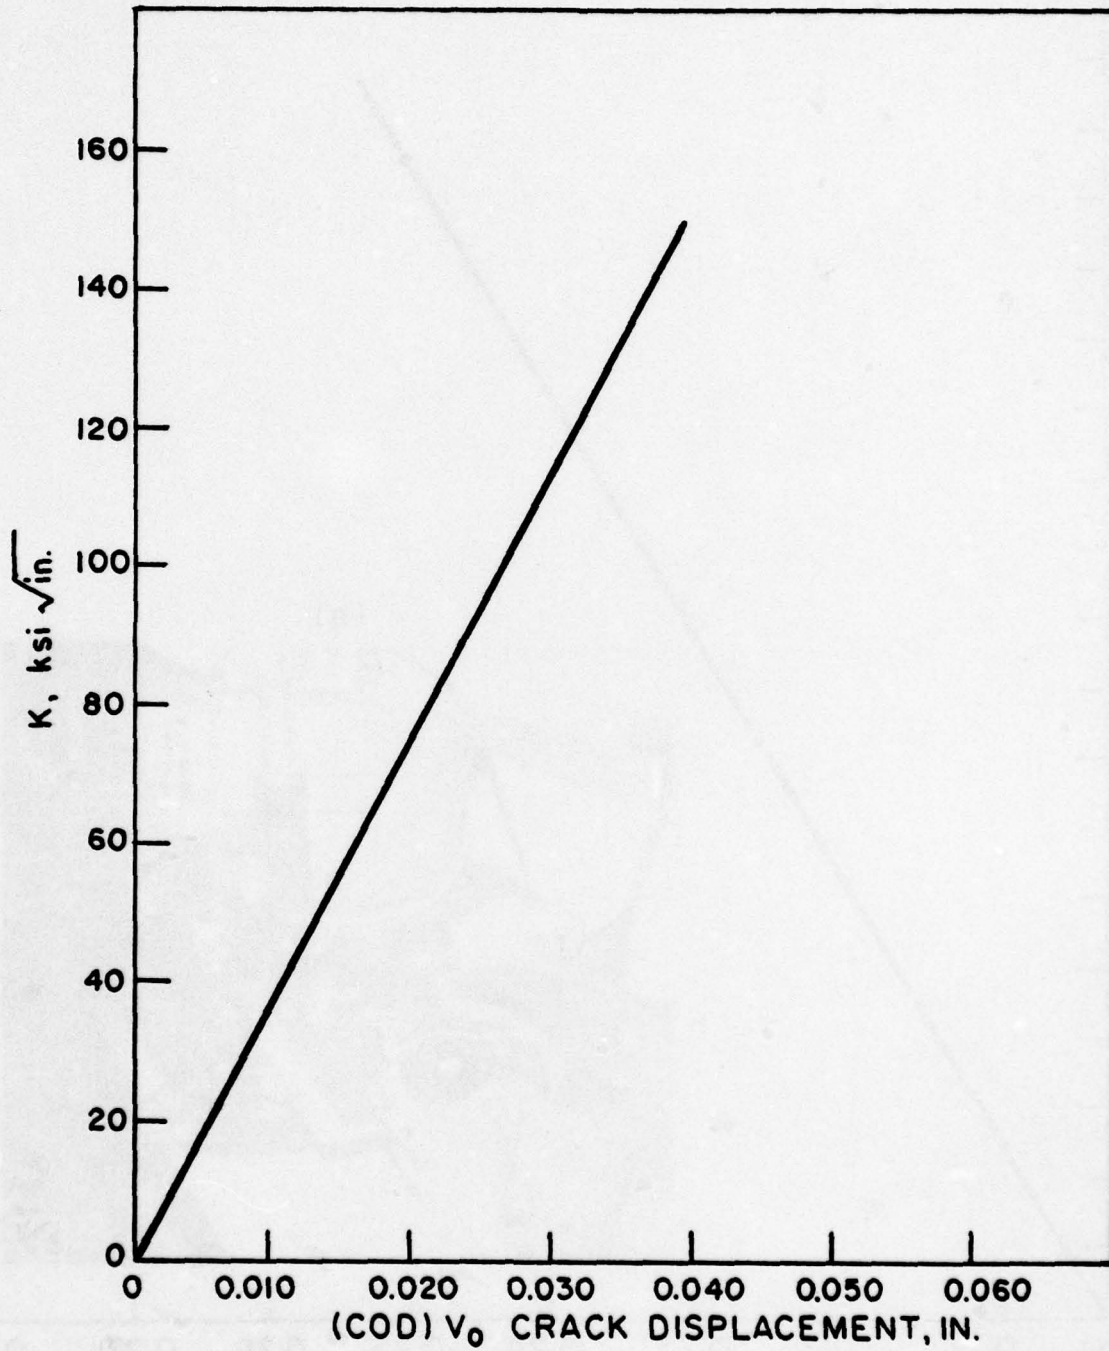
Figure 10. Correlation of  $K_1$  to  $V_0$

Nominal crack opening displacements  $V_0$  required to initially load 1-T modified WOL specimens of AF-1410 to a given  $P$  of  $K_{I0}$  value are plotted in Figure 10. These data were generated from the relationship

$$V_0 = \frac{K_{I0}}{E} \times \frac{A_0 B_n}{B} \frac{C_6}{C_3}$$

where  $E$  is the modulus =  $28 \times 10^6$   
 $A_0$  is the original crack length  
 $B_n$  is the specimen thickness  
 $B = 1"$  for 1-T,  $0.5"$  for 1/2-T  
 $C_6$  and  $C_3$  are a function of  
 as given in Appendix 1.

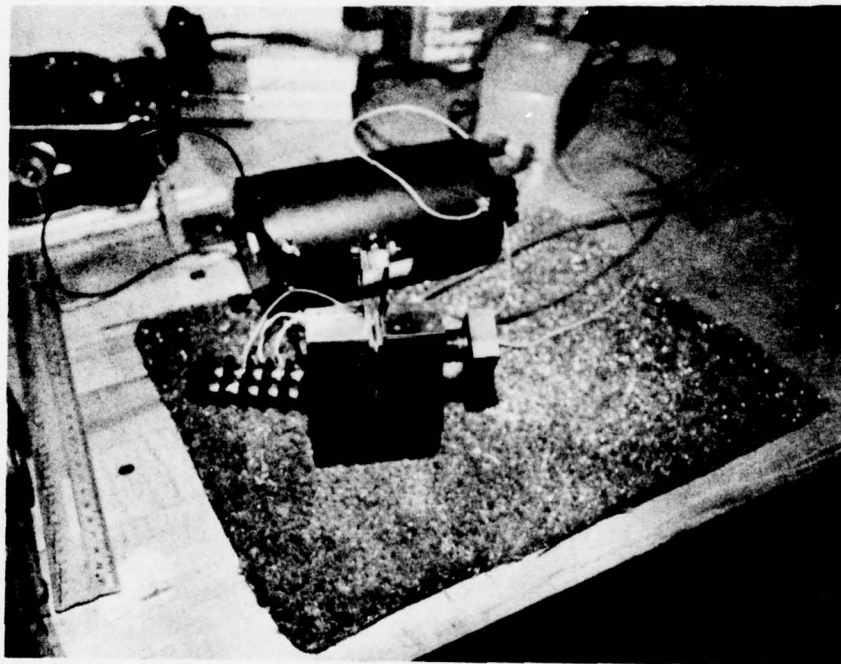
Figure 11. NASA Clip Gage Arranged on WOL Specimen  
Ready for Application of Load by Torquing Bolt

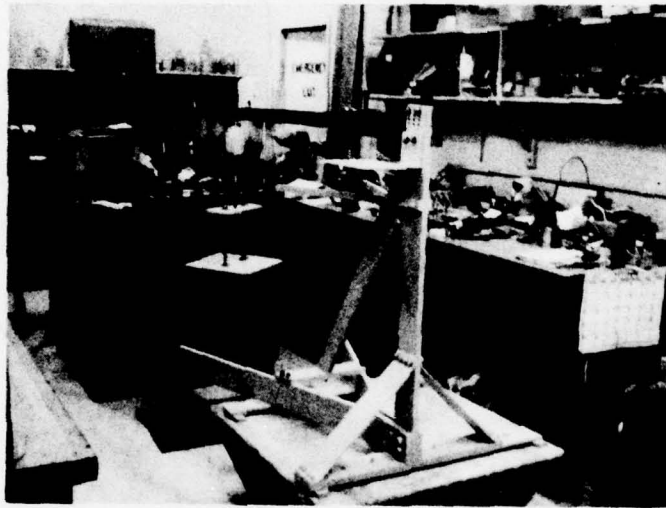
Figure 12. Cantilever Beam Test Ring for SCC Testing

4" x 8" x 5/8" plates welded along the 4" edge provided three test specimens measuring 1" x 1/2" x 16" for cantilever beam SCC tests by the method developed by Brown (4). The pre-notched and fatigue cracked bar was held horizontally and surrounded at the notch by 3.5% NaCl in water as seen in Figure 12. The specimen was dead-weight loaded for periods of time extending to 500 hours. The stress intensity factor  $K_{\sigma}$  was calculated for various loading conditions as described in Appendix 1. By incorporating a step loading procedure it was possible to minimize the number of samples required to establish a value of  $K_{ISCC}$ .

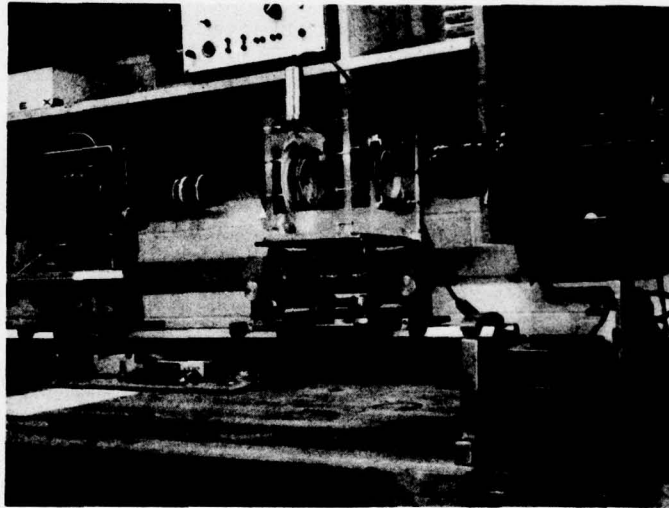
Figure 13. Cinematographic Apparatus Showing Dual 16mm Cameras - WOL Specimen and Corrosion Cell for the Continuous Monitoring of Crack Propagation

The apparatus for the continuous monitoring of crack path and crack growth rates utilizing cinematography is shown in Figure 13. The loaded WOL sample was placed in the corrosion cell and either single frame or short bursts of 6 to 10 frames were taken on a continuous basis without interruption of the tests. Crack growth rates and crack paths were documented on 16mm Ektachrome film.

The apparatus was also used to monitor crack growth rates by interrupting tests and periodically photographing the crack at predetermined intervals. Crack lengths were measured directly on the film at 20x magnification.

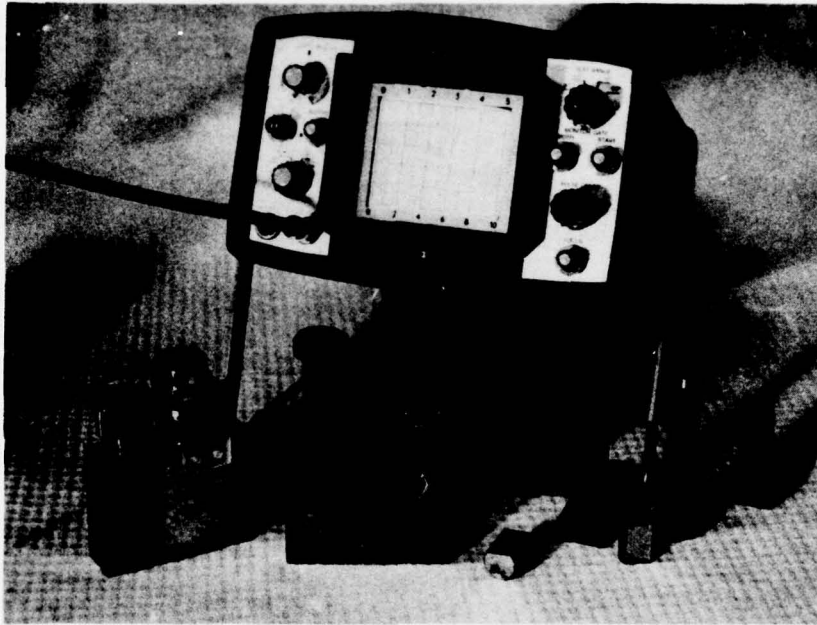
Figure 14. WOL Specimens with Transducer for Ultrasonic Evaluation of Crack Growth and the Krautkramer System

transducer pulse-echo technique utilizing longitudinal waves was investigated to determine whether crack movement at the center of the WOL specimen could be monitored in the SCC test. The transducer specimen arrangement and the Krautkramer system are shown in Figure 14. Glycerine was used as a coupling agent for transmitting ultrasonic energy. The transducer was clamped on the top of the specimen and positioned so that the transducer remained out of the corrodant. As the crack propagated, the reflected energy from the crack tip increased and the output voltage at the observed spike increased. The reflected signal was time gated and continuously monitored with a recorder. The rate of increase in the reflected signal from the crack tip was examined in terms of its ability to assess the crack growth rates at the center of the specimen.

Preliminary tests using ultrasonics as a means to monitor crack velocities at the center of the specimen were not successful, primarily because of the edge effects produced by interaction of the ultrasonic beam with the lateral surfaces of the specimen. Reduction of the specimen thickness from 1" to 1/2" in the present series of specimens decreased the ability of the detector to discriminate the center of the specimen from the edges and negated its use as a monitor of the crack velocity at the center of the specimen.

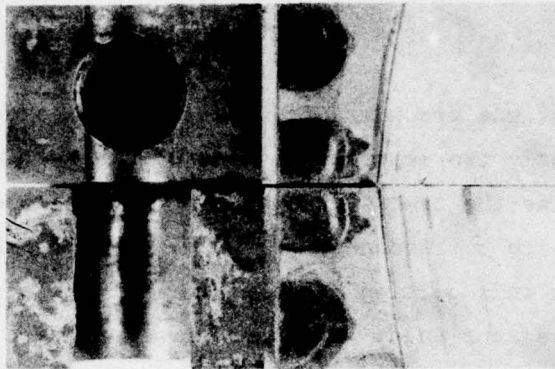
FATIGUE  
PRE CRACK

↑ ↑ ↑ SCC CRACK  
EXTENSION

Figure 16. (a) Fracture Surface of AF 1410-2 Weld Tested by MetCut  
(b) Fracture Surface of AF 1410-2 Weld Tested by FIRL  
(c) Fracture Surface of AF 1410 Base Plate Tested by FIRL

After the test, the samples were fractured by cooling the sample with liquid nitrogen. The fatigue and SCC crack fronts observed on the fractured surface are seen in Figures 16(a), (b) and (c) for the weld and base plate.

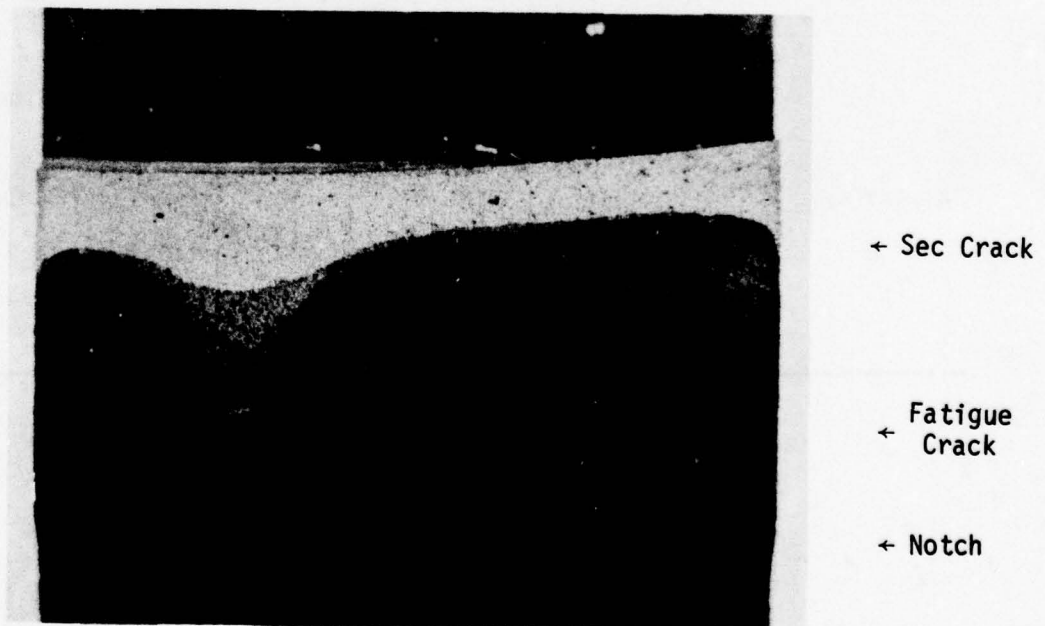
Figure 17. (a) Enlarged View of Figure 14(b) Showing Irregular Fatigue Crack Front  
 (b) Enlarged View of Figure 14(c) Showing Fatigue Crack and Sec Crack

Two non-connected fatigue crack fronts were found to be present, as seen in Figure 17(a). Apparently two separate fatigue cracks were nucleated at the notch which did not join as the cracks extended in the weld zone. The central region of the specimen which corresponded to the first weld passes did not propagate suggesting that this portion had a higher fatigue strength than the upper and lower portions of the weld. These observations were also made for AF-1410-3, and suggest that a nonhomogeneous micro-structure or the presence of residual stresses were the cause of the non uniform propagation of cracks in the weld. The crack shapes observed on the fracture surface were similar in both the Met Cut and the FRC tested samples and precluded any meaningful estimates of  $K_{ISCC}$  values for the AF-1410-2 or AF-1410-3 WOL Tests.

The fatigue crack front on the base plate WOL specimen seen in Figure 17(b), however, was uniform and  $K_{ISCC}$  and crack propagation rates could be determined from periodic measurements of the crack lengths measured on the test film. The branching effect observed on the lateral surface of this specimen was apparently associated with the development of a double shear lip at the surface. No evidence of crack branching was observed on the fracture surface.

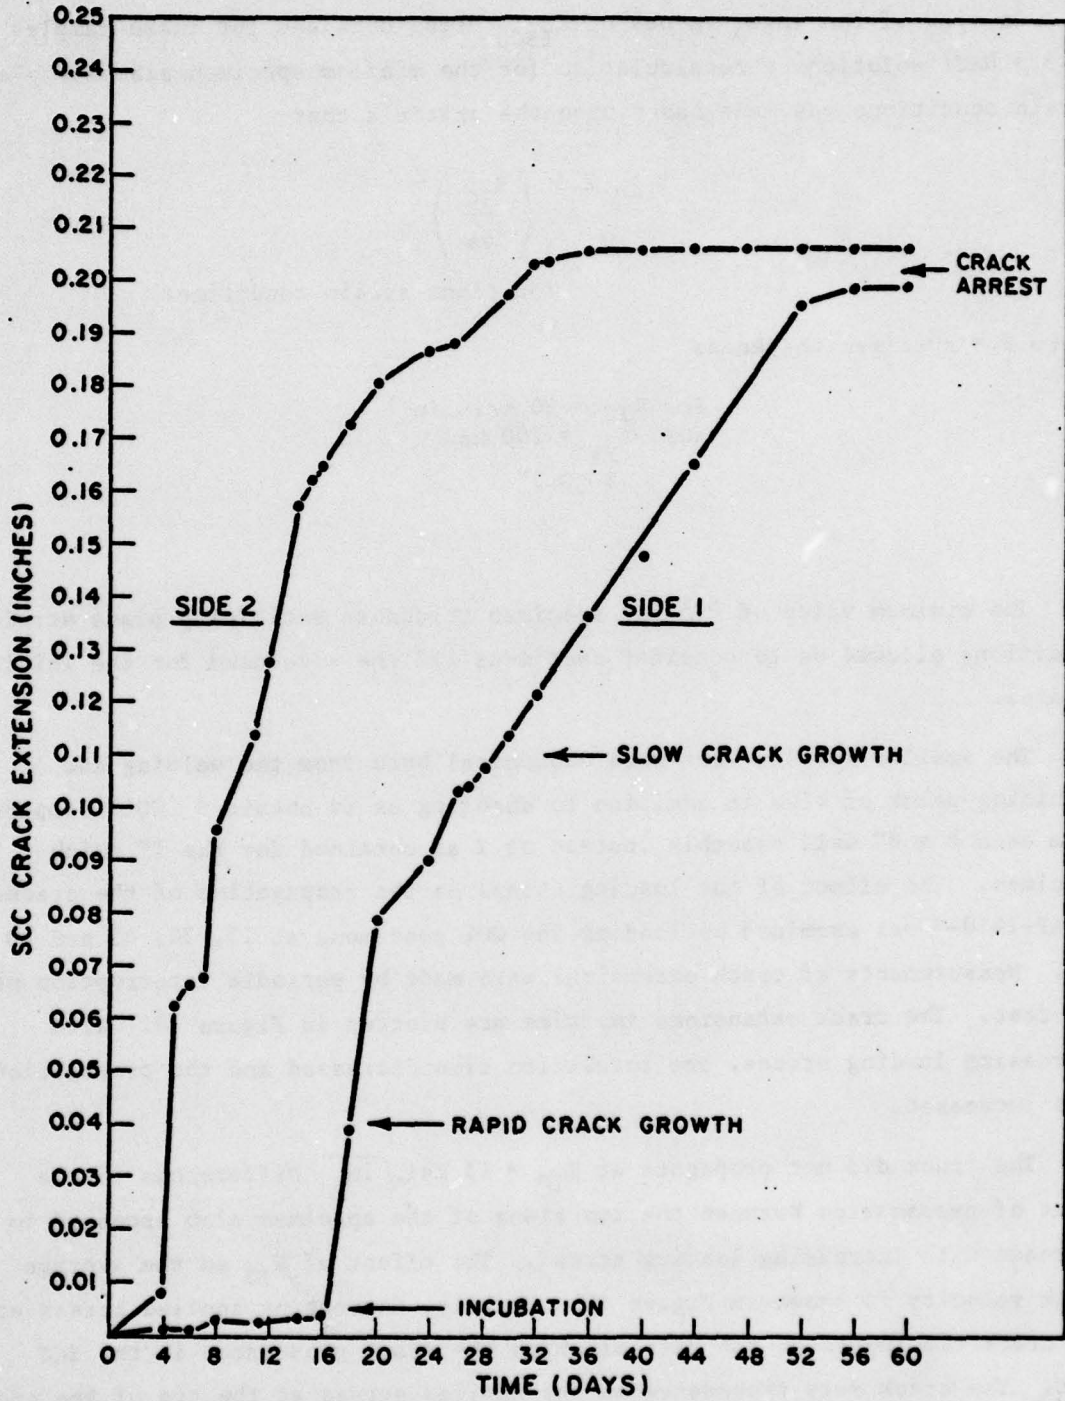
Figure 18. Crack Extension vs. Time WOL Test of AF-1410 Base Plate  $K_{10} = 40 \text{ ksi}\sqrt{\text{in.}}$

Crack growth extensions vs. time are plotted in Figure 18 for sides 1 and 2 of the 1" thick AF-1410 WOL base plate specimen. A lagging of the crack on side 1 was observed, due primarily to a longer incubation time which preceded the crack propagation. The crack propagation process consisted of an initial incubation stage followed by a rapid growth stage, and then a slow crack growth stage. The rates of crack growth estimated from the slopes of the curves was on the order of  $20 \times 10^{-4}$  in./hr for stage 1 and  $2 \times 10^{-4}$  for stage 2.

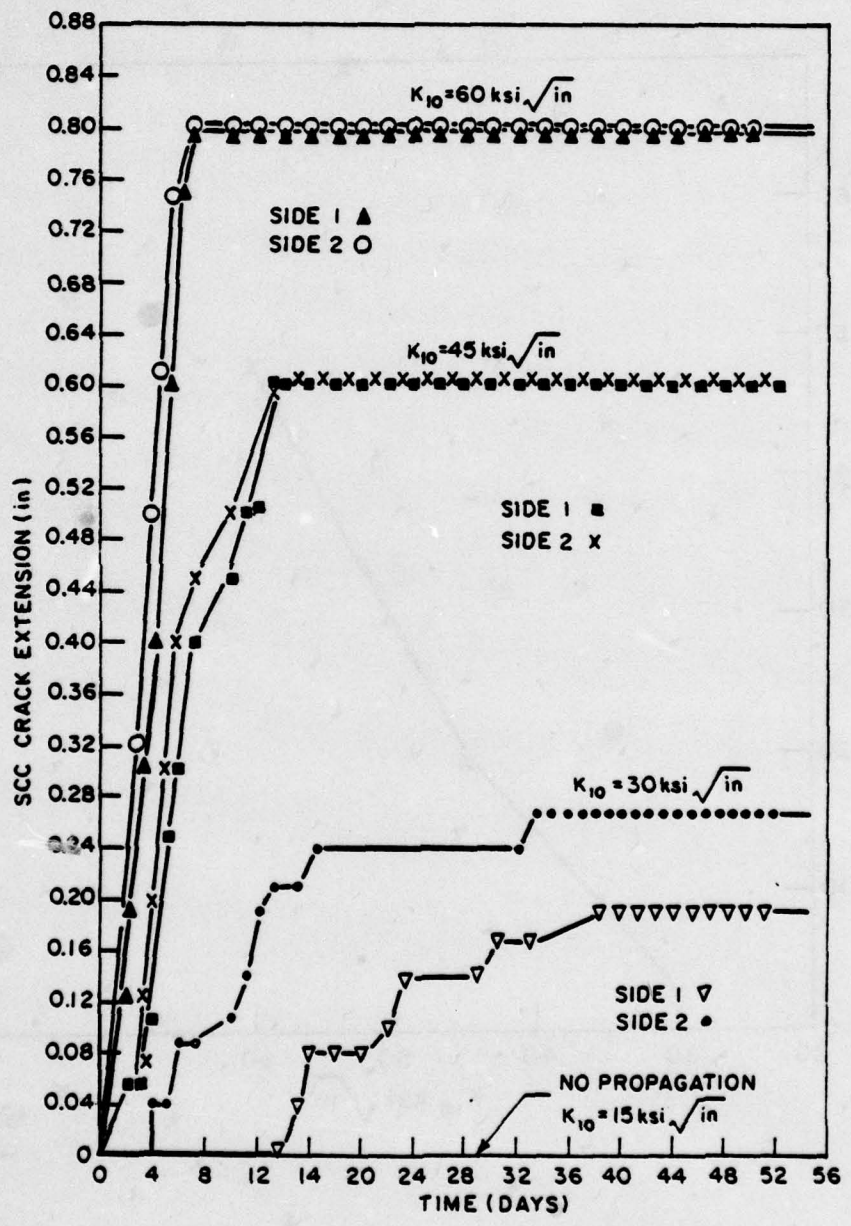
Figure 19. Crack Extension vs. Time WOL Test of AF-1410 Base Plate

The smaller samples were more economical both from the welding and machining point of view in addition to enabling us to obtain 3 (WOL) samples from each 8 x 8" weld assembly instead of 2 as obtained for the 1" thick specimen. The effect of the loading stress on the propagation of the cracks in AF-1410-5 was examined by loading the WOL specimens at 15, 30, 45 and 60 ksi. Measurements of crack extensions were made by periodic interruption of the test. The crack extensions vs. time are plotted in Figure 19. With increasing loading stress, the incubation time decreased and the propagation rate increased.

The crack did not propagate at  $K_{I0} = 15 \text{ ksi}\sqrt{\text{in.}}$ . Differences in the rates of propagation between the two sides of the specimen also appeared to decrease with increasing loading stress. The effect of  $K_{I0}$  on the average crack velocity is shown in Figure 20. Clearly, increasing applied stress at the crack tip increased the rate at which the crack propagated in the SCC test. The crack rate dependence on the applied stress at the tip of the crack may also explain the observed decrease in crack velocity with time.

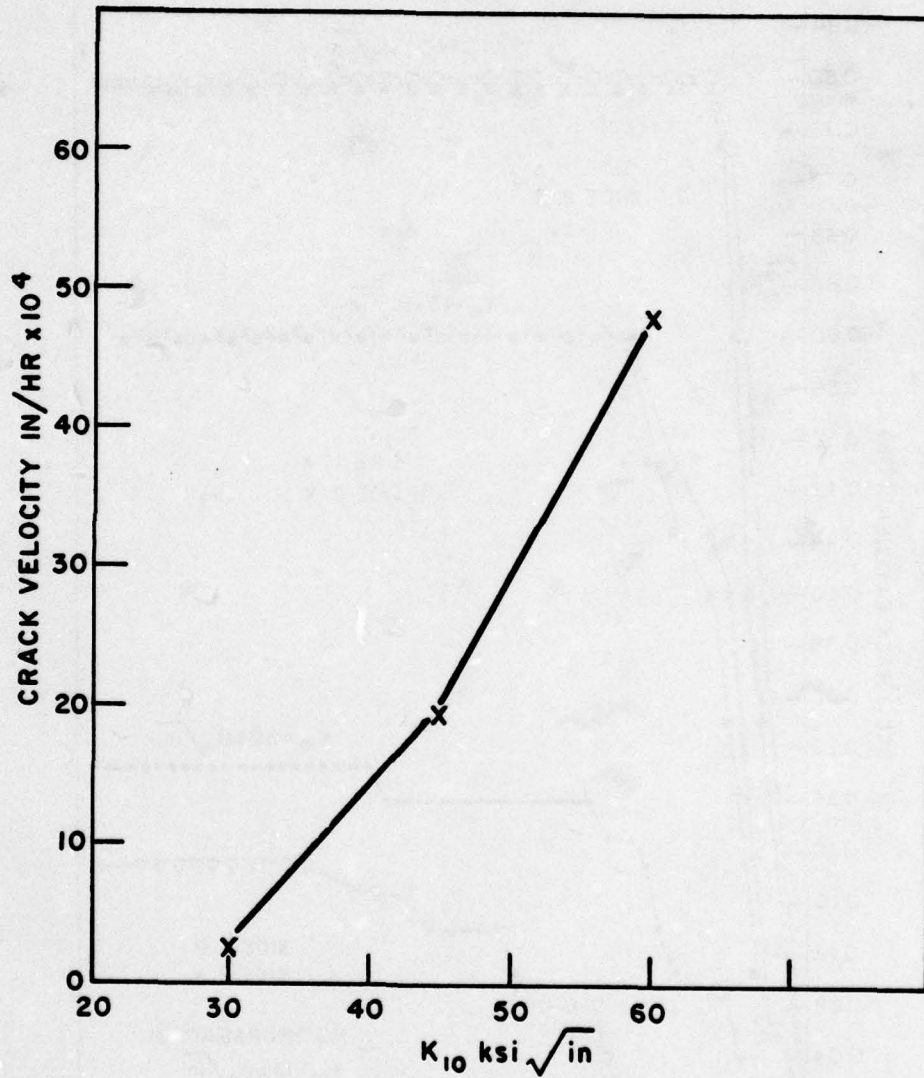
Figure 20. Effect of  $K_{10}$  on Average Crack Velocity AF-1410 Base Metal Aged ( $950^{\circ}\text{F}$  - 4 hrs.) from Figure 19

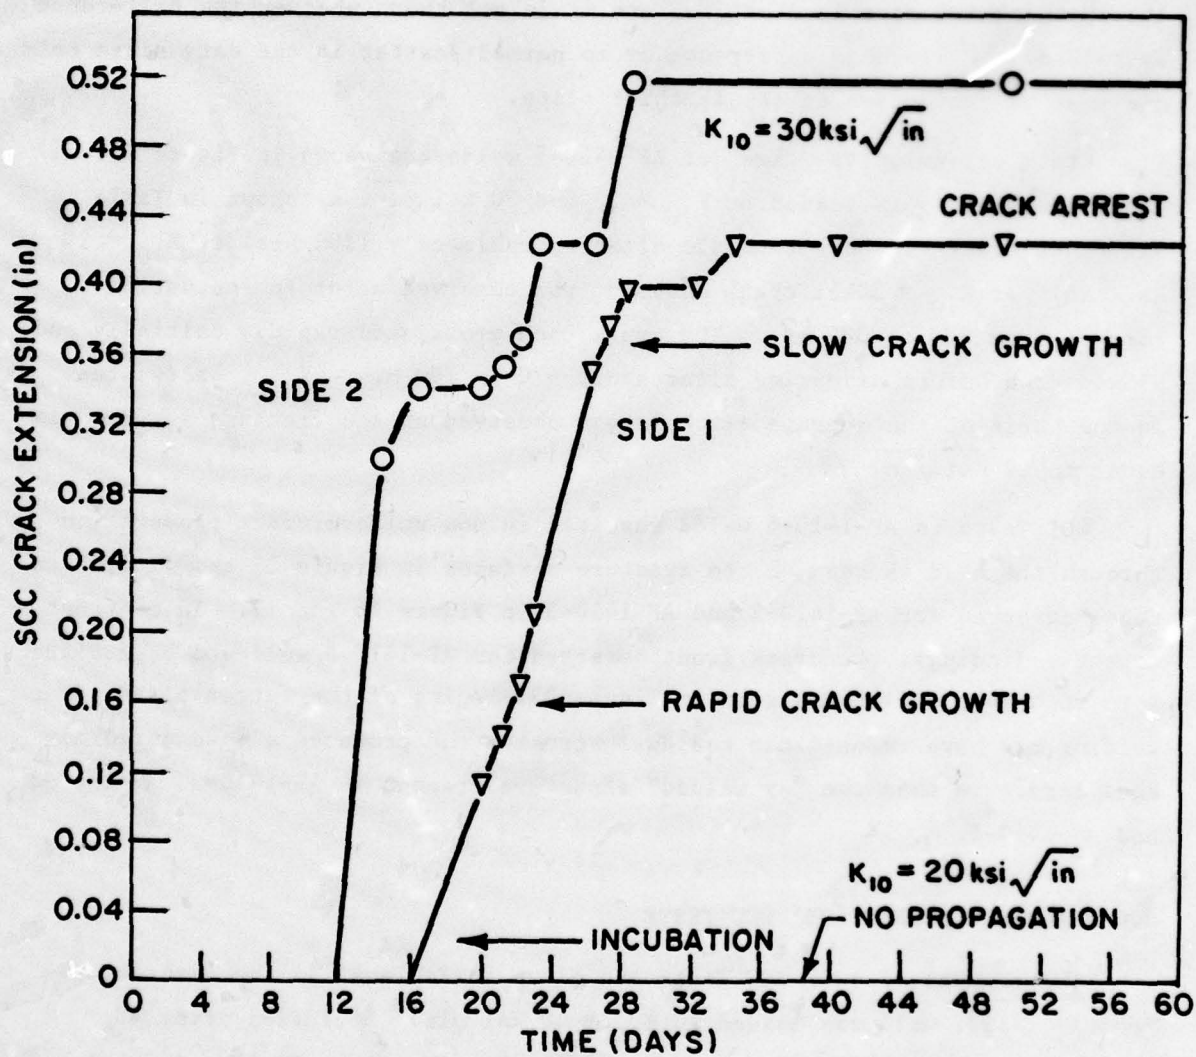
Figure 21. Crack Extension vs. Time WOL Test  
 AF-1410-5 (Weld)  $K_{10} = 30 \text{ ksi}\sqrt{\text{in.}}$

Crack extension vs. time for AF-1410-5 welds are shown in Figure 21. These specimens were loaded at  $K_{10} = 20$  and 30 ksi  $\sqrt{\text{in.}}$  as shown in Table VII. The crack did not propagate after approximately 1500 hrs. at  $K_{10} = 20$  ksi  $\sqrt{\text{in.}}$ . At  $K_{10} = 30$  ksi crack movement was observed after an incubation time of from 280 to 380 hrs. The crack then propagated rapidly initially and slowed down before arresting after about 670 to 790 hrs.  $K_{ISCC}$  calculated on the basis of the average crack length observed on the fracture surface was equal to 22 ksi  $\sqrt{\text{in.}}$ .

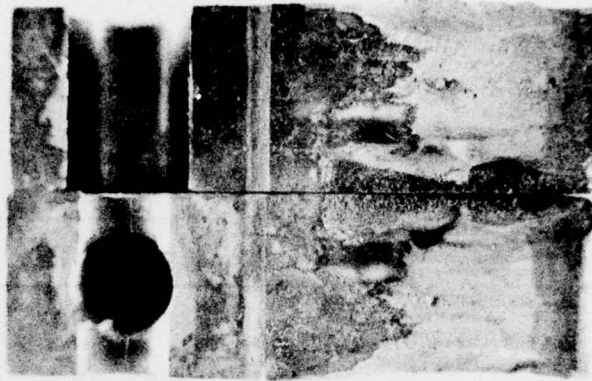
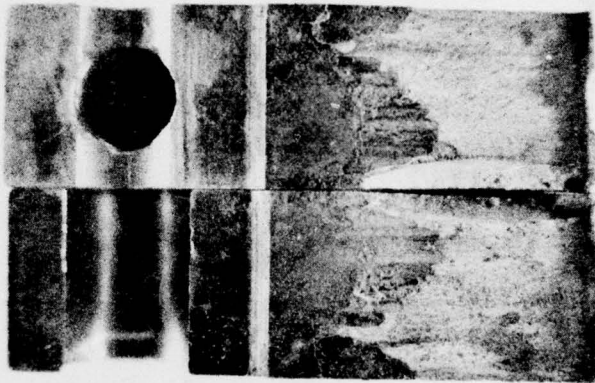
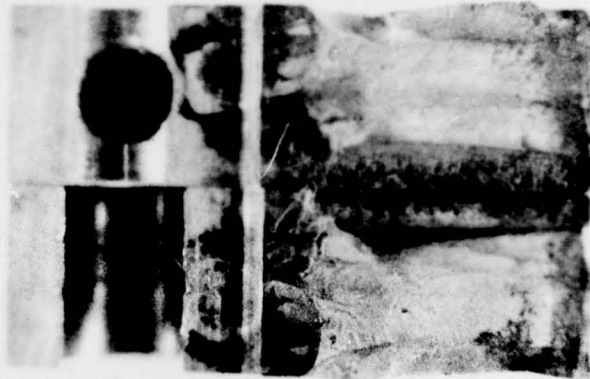
Figure 22. Fractured Surface of WOL Specimen AF-1410-6 at Weld. Irregular Fatigue and SCC Crack Fronts.

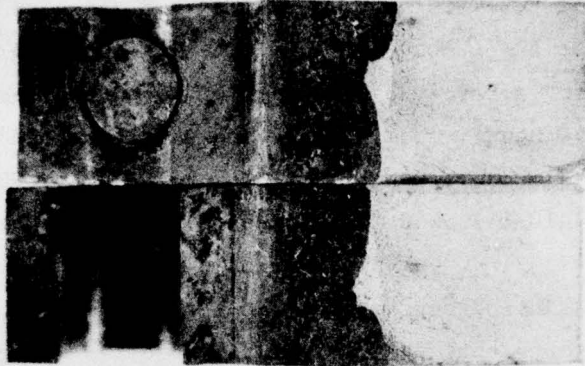
Figure 23. Fracture Surface of AF-1410-5 WOL (a) Base Plates and (b) Weld Specimens Showing Fatigue and SCC Crack Fronts

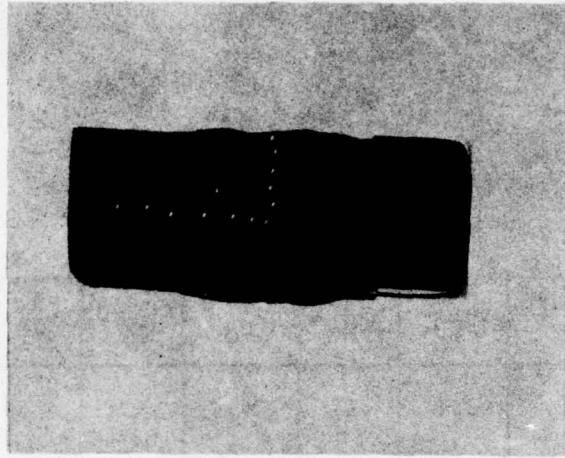
Figure 24. Weld Cross Sections with Hardness Impressions  
(a) AF 1410-2  
(b) AF 1410-3  
(c) AF 1410-4

The fusion zone of weld cross sections as seen in Figures 24(a), (b) and (c) were studied with the SEM for both metallurgical and chemical homogeneity. The compositional and hardness variation observed in the cross sections from top to bottom of the fusion zones are given in Tables VIII to XII for AF-1410-2, AF-1410-3, AF-1410-4, AF-1410-5, and AF-1410-6 respectively. The region designated top of weld represents the final passes of the weld.

The compositional variation of Cr, Mn, Fe, Co, Ni and Mo through the weld zone for each of the weld assemblies was found to be minimal. The Mo content for AF-1410-4 was lower than observed for the other welds at position 3 and 4 in the weld.

The hardness tended to be lower at the top position for all of the weld assemblies except for AF-1410-5, which appeared to show more uniformity in hardness than any of the other welds. The variation of hardness in the weld cross section may reflect nonuniformity in aging associated with the "as welded" condition.

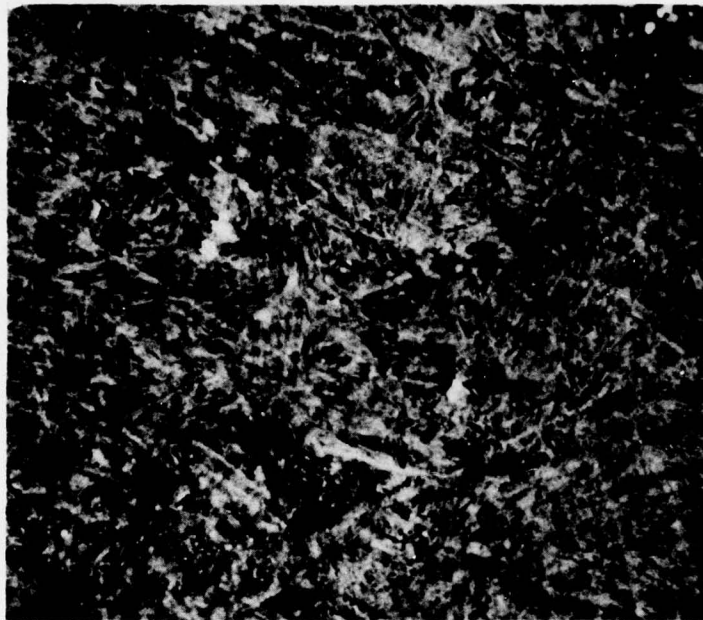
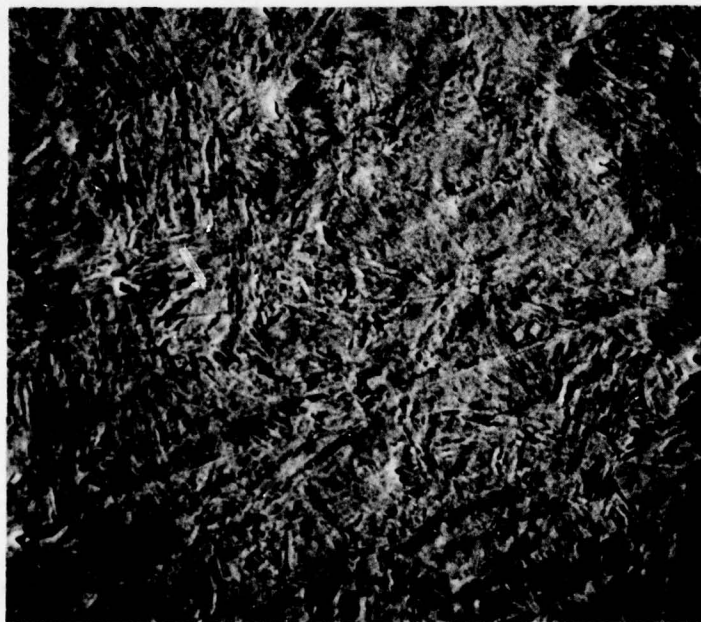
Figure 25. Back Scattered Electron Image of Weld AF-1410-2 at Positions 1 and 2 Shown in Table V. Mag. 500X

Back scattered SEM micrographs of the microstructures observed at the various locations at which hardnesses were taken from AF-1410-2 and AF-1410-5 shown in Table VIII are shown in Figures 25 to 30.

The microstructure of AF-1410-2 weld consisted of a coarser lath martensite with microporosity than observed for AF-1410-5 as noted in comparing Figures 25, 26 and 27 to Figures 28, 29 and 30. The refinement of the martensite and grain size was achieved by preheating the plates prior to welding. In addition to structure refinement the structure also appeared to be more uniform throughout the weld cross section. To minimize residual stresses, the direction of welding was reversed after each pass. It was not possible to assess the effectiveness of the latter procedure in minimizing residual stresses since the measurement of residual stresses in the cross section was beyond the scope of the program.
