# TECHNICAL REPORT

Final Report  
F-C4708-01

STRESS CORROSION ENVIRONMENTAL EFFECTS ON AF 1410

Dr. Victor V. Damiano

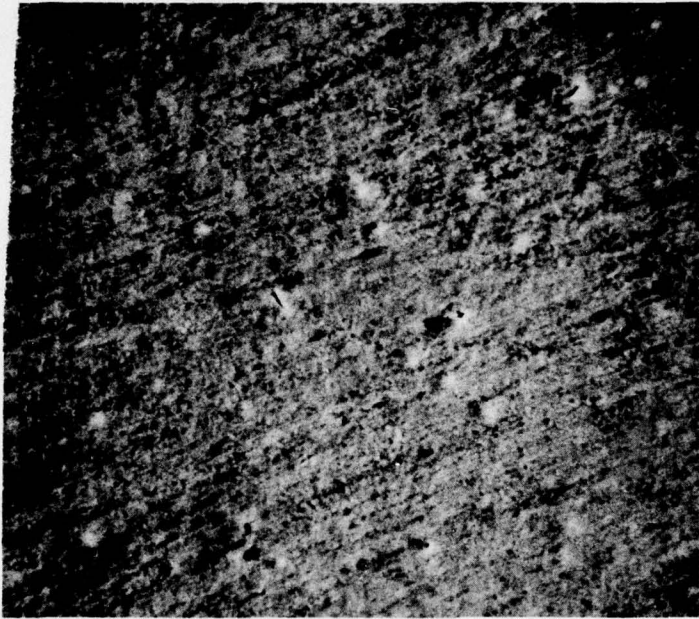
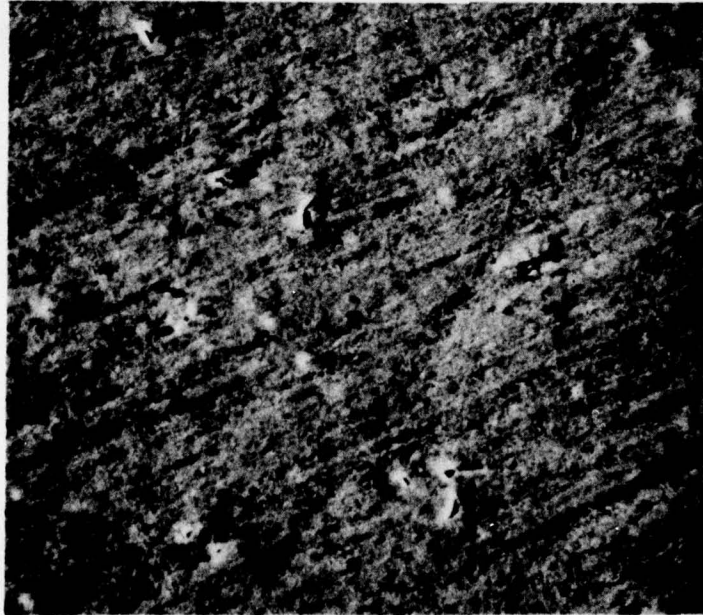
Figure 26. Back Scattered Electron Image of Weld AF-1410-2 at Positions 3 and 4 Shown in Table V. Mag. 500X

The microstructure of AF-1410-2 weld consisted of a coarser lath martensite with microporosity than observed for AF-1410-5 as noted in comparing Figures 25, 26 and 27 to Figures 28, 29 and 30. The refinement of the martensite and grain size was achieved by preheating the plates prior to welding. In addition to structure refinement the structure also appeared to be more uniform throughout the weld cross section. To minimize residual stresses, the direction of welding was reversed after each pass. It was not possible to assess the effectiveness of the latter procedure in minimizing residual stresses since the measurement of residual stresses in the cross section was beyond the scope of the program.

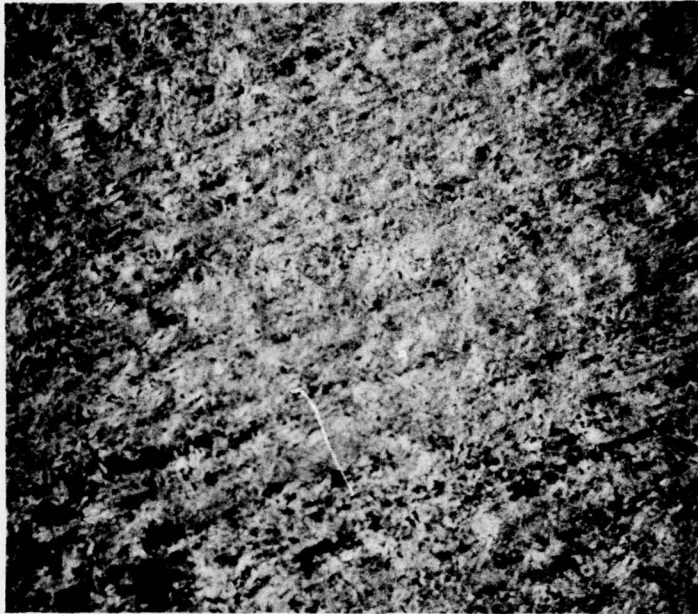
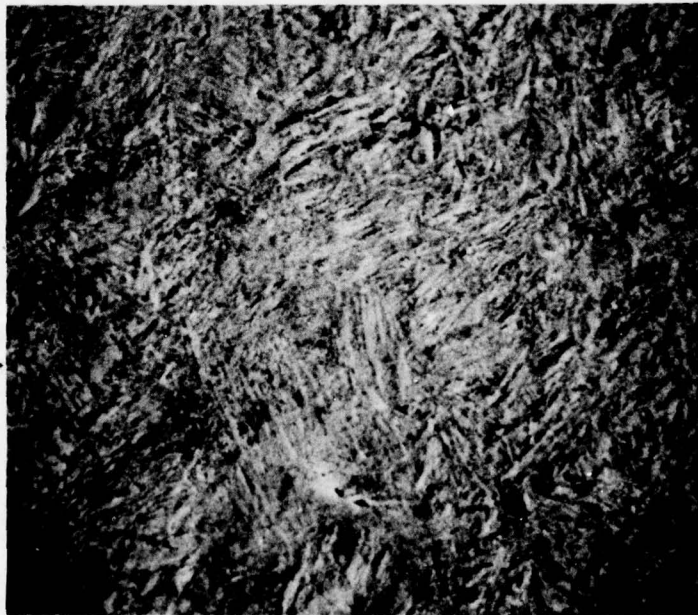
Figure 27. Back Scattered Electron Image of Weld AF-1410-2 at Positions 5 and 8 Shown in Table V. Mag. 500X

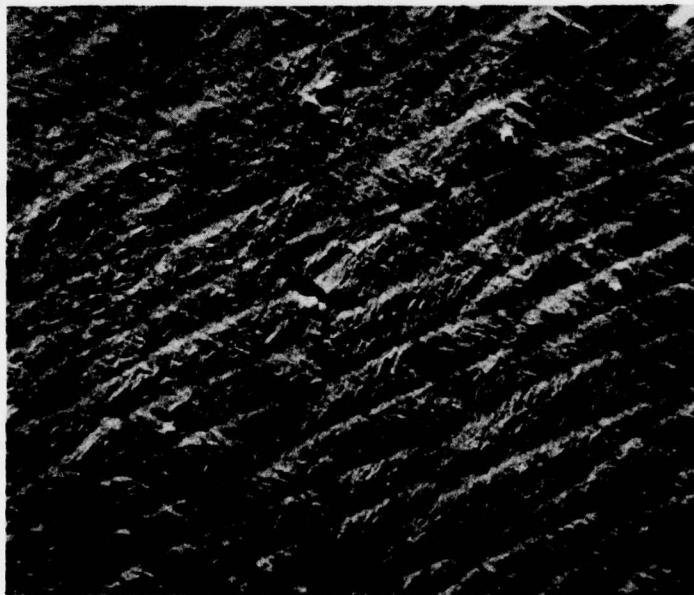
Figure 30. Back Scattered Electron Images of Weld AF-1410-5 at Positions 5 and 6 Shown in Table VI. Mag. 500X
