TECHNICAL REPORT 6L-79-31

UTILIZATION OF MARGINAL CONSTRUCTION MATERIALS FOR LOC

Geotechnical Laboratory
U. S. Army Engineer Waterways Experiment Station
P. O. Box 631, Vicksburg, Miss. 39180

November 1979

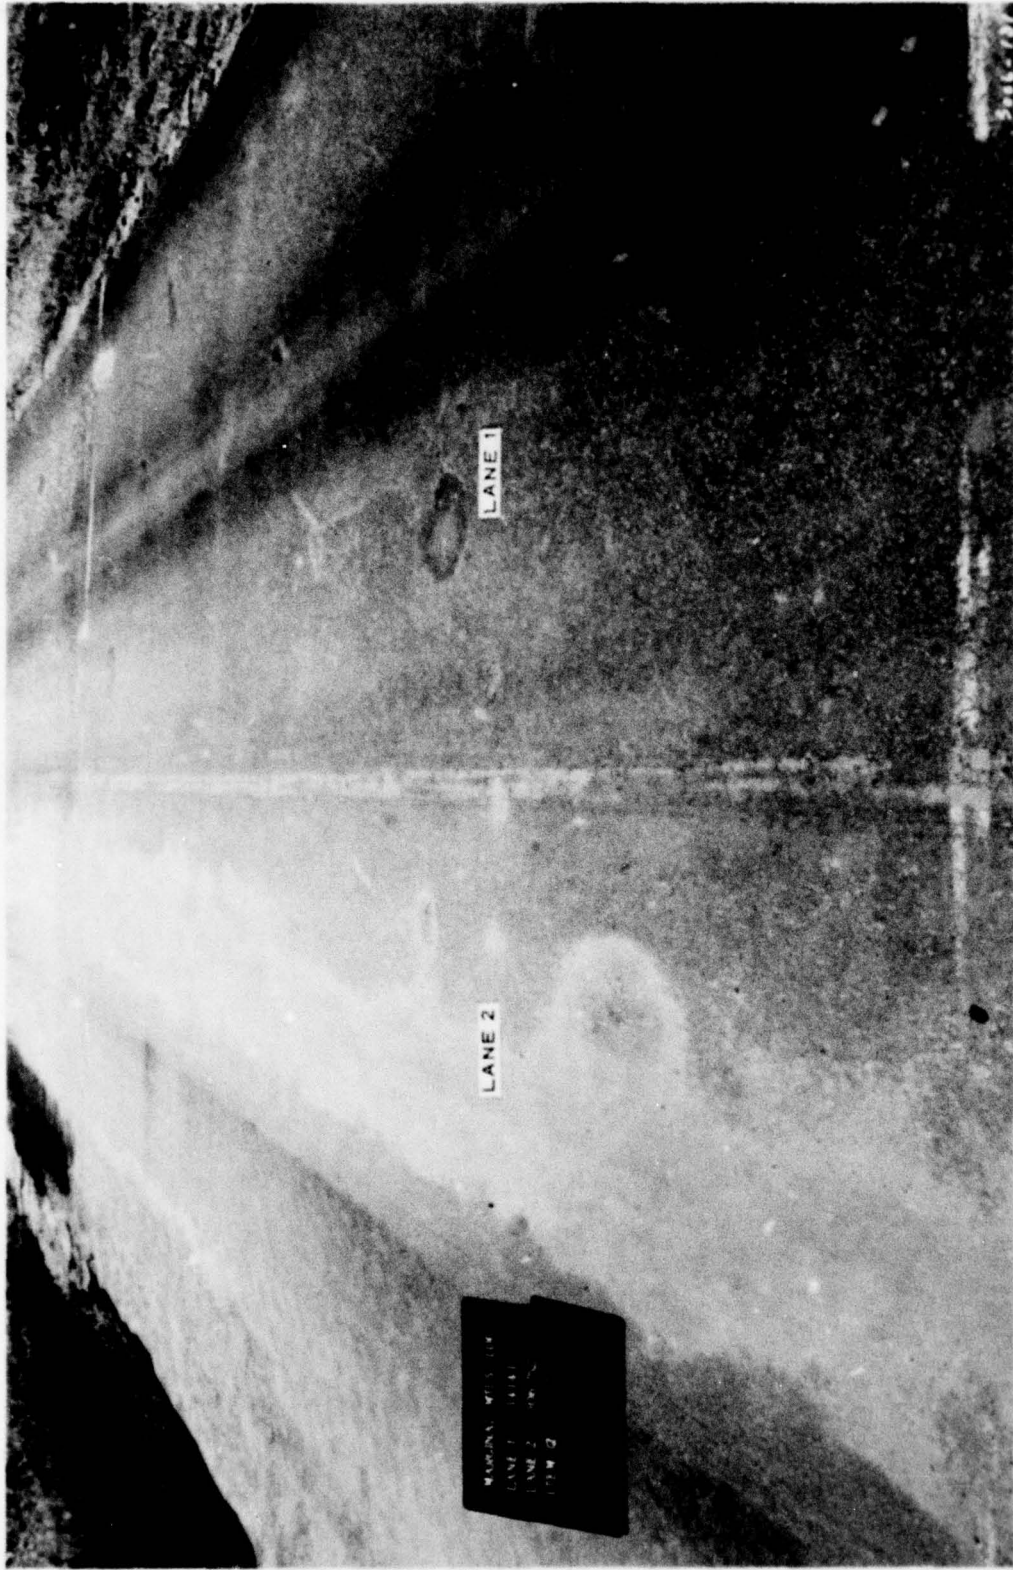
Photo 50. General view of item 12 after traffic (lane 1, 34,143 operations;
lane 2, 106,752 operations)

66. Items 11 and 12 performed very well during the entire traffic period. General views of these items before traffic are shown in Photos 47 and 48. Slight shoving was detected in both items at the beginning of traffic but seemed to stop after about 8,162 operations. After 8,162 operations, a shallow rut had formed in both test items. The maximum rut depth measured at this time was 1/4 in. in item 11 and 3/8 in. in item 12. Traffic was continued to 34,143 operations, with little or no change in the condition of the two pavements. Indications were that a large number of operations would be required to produce any appreciable distress; therefore, traffic was discontinued. Items 11 and 12 were rated in satisfactory condition at the end of traffic. Photos 49 and 50 show a general view after traffic of items 11 and 12, respectively.

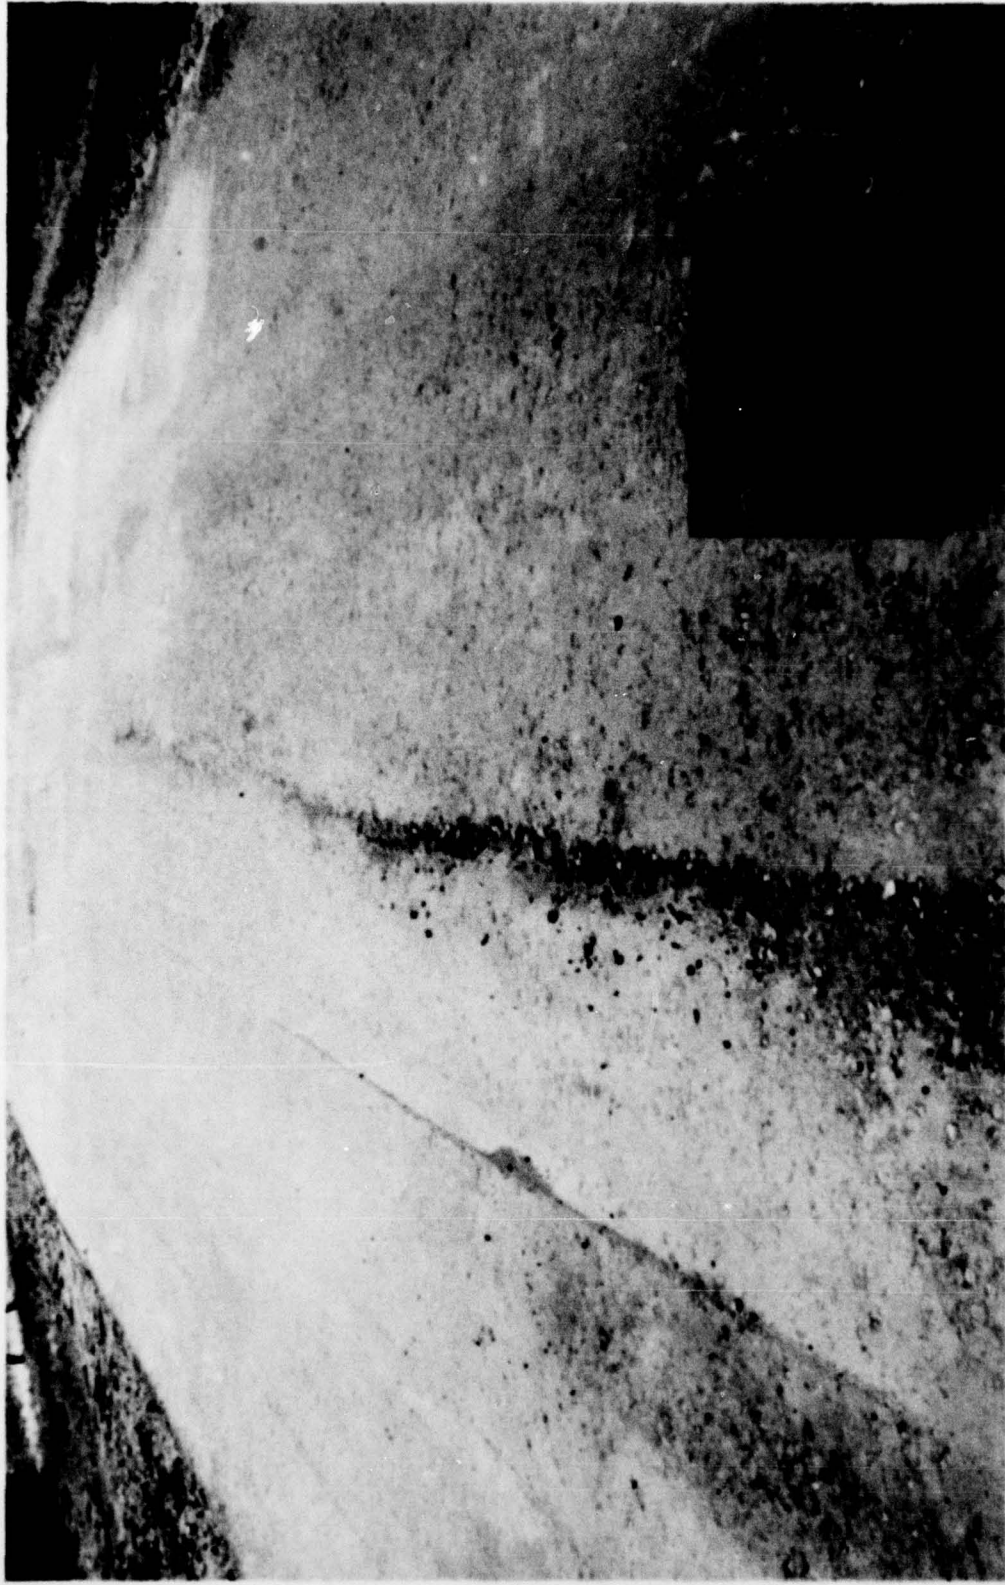
Photo 78. General view of item 6 (rigid pavement) prior to traffic

90. The condition of item 6 before the application of traffic is shown in Photo 78. Two transverse cracks extending across the width of the pavement were detected before traffic was commenced. Photo 79 is a closeup view of one of these cracks. The pavement in this item performed very well structurally during traffic testing. However, during wet weather traffic the surface became slippery. The first distress observed during traffic was several 2- to 3-ft-long hairline transverse cracks after 18,821 operations. No further cracks developed, and only slight spalling occurred during the remainder of traffic. Traffic was stopped after 125,000 operations because there were indications that a very large amount of traffic would be required to produce any significant distress. An overall view of item 6 at this time is shown in Photo 80. The performance of this item was rated good although the pavement performed excellently structurally during traffic. The good rating was assigned to this item because skid resistance decreased during wet weather.
