FINAL REPORT  
ON THE  
ESTABLISHMENT OF ENGINEERING DESIGN DATA FOR  
HYBRID STEEL/CERAMIC BALL BEARINGS

F. R. MORRISON  
J. PIRVICS  
R. YONUSHONIS

PREPARED BY: SKF TECHNOLOGY SERVICES  
1100 FIRST AVENUE  
KING OF PRUSSIA, PA. 19406

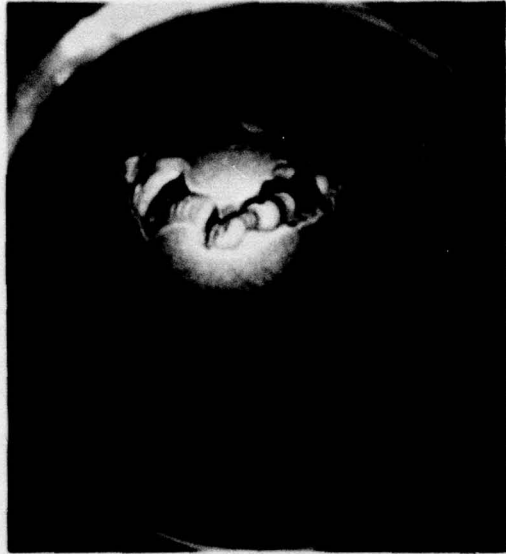
FIGURE 8

The ceramic balls which had undergone life testing were subjected to an intensive failure analysis using the capabilities of the scanning electron microscope. Failed and unfailed areas of the balls were viewed at magnifications up to 5000X in the secondary electron imaging mode. Additionally, the back scatter mode was employed to further detail the elemental structure of areas of interest and x-ray wavelength spectrometry was used to identify the elemental composition of observed defects. The specific balls which were examined are identified in Table 5 and the extent of the typical spalls are illustrated by the photographs of Figure 8.

Typical Spalls Encountered on Tested Silicon Nitride Balls

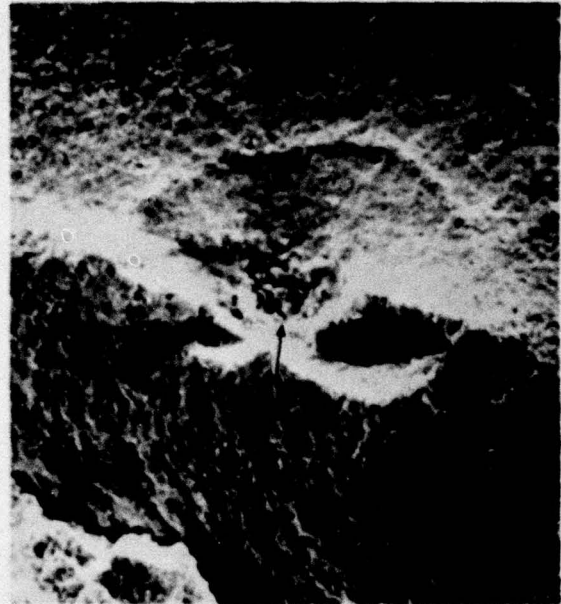
FIGURE 11

The spalled ball from bearing 104 which lived only slightly longer than 108, is shown in the photomicrographs of Figure 11. This failure appears to have initiated at a small void in the material. Since voids would normally be formed by the presence of a foreign substance in the powder which reacts with the silicon nitride at the pressing temperature, it would be expected that the microstructure in the area of the void would be atypical. As can be seen from photomicrograph 7780, this is indeed the case as the grains do not have the well defined edges and hexagonal shape seen in normal hot pressed silicon nitride.

Void Type Spall Origin Found in Silicon Nitride Ball From Bearing 104

7776 40X  
Arrows Depict Crack Propagation  
Direction

7777 400X  
Arrow Points to Suspected  
Fracture Origin

7780 5000X  
Microstructure at Fracture Origin

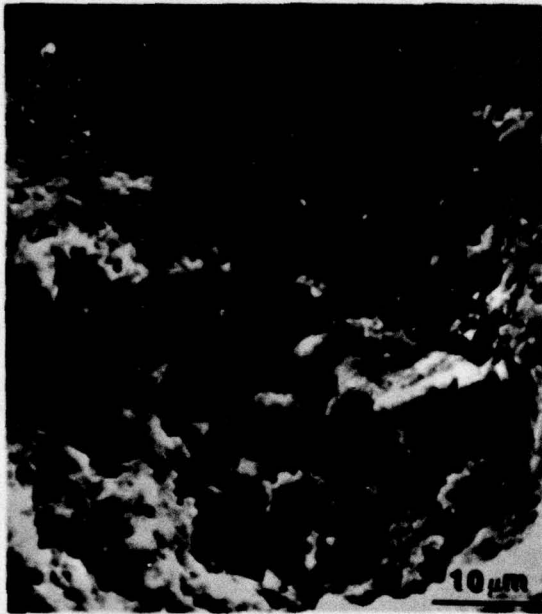
FIGURE 12

Elemental analysis with the x-ray spectrometer was conducted in an attempt to identify the material that produced the void. Although shadings are noted in the BSE image shown in Figure 12, it was not possible to detect any concentrations of boron, carbon, oxygen, aluminum or magnesium in this area. However, this lack of evidence is not necessarily definitive since the geometry of a void complicates the analysis technique. It is extremely difficult to orient the specimen in a way which will allow the x-rays to escape from the cavity and be detected. Thus it is possible that the elemental peak of the void originating material was masked by the edges of the void.

Secondary Electron Image and Back Scattered Electron Image of Spall  
Origin of Ball From Bearing 104

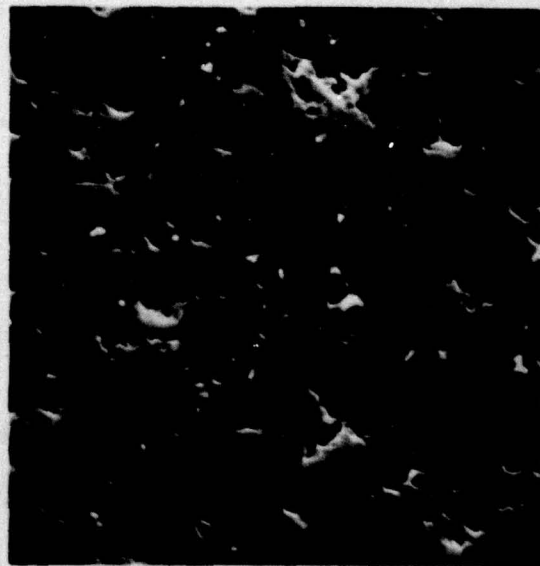
FIGURE 13

Bearing number 102 had accumulated  $64 \times 10^6$  revolutions i.e. more than 8X the lives of the previously examined failures, when it was terminated with an extensive spall on a ceramic ball. The examination of the primary failure was not instructive, but a small spall, shown in Figure 13, was located on a second ball. Unlike the previous two spalls, no evidence can be seen that an extraneous factor, eg. void, inclusion, surface defect, etc., influenced the formation of the flake. While this could very likely be an example of the standard silicon nitride fatigue process, it is also possible that all evidence of the failure initiator was removed as the original spall continued to grow under repeated stressing cycles. It can then only be positively said that no evidence of a material defect could be noted in the remaining ball structure and the cause of the failure is open to conjecture.

The surface in the immediate vicinity of the spall is quite rough and contains numerous metallic wear particles as can be seen in photomicrographs 7769 and 7768. Photomicrograph 7767 illustrates that this condition is not typical of the overall ball surface finish. It is likely that the damaged zone was created after the failure since this type of surface distress is often noted around discontinuities on metal bearing surfaces.

Spall Noted on Second Ball from Bearing 102

7765 32X  
Spall and Surrounding Damage Area

7769 2500X  
Surface Area Around Perimeter of Spall

7768 2500X  
BSE Image Showing Metal Contamination (Same Area as Photo #7769)

7767 2500X  
Typical Surface Finish of Ball  
Away From Spalled Region

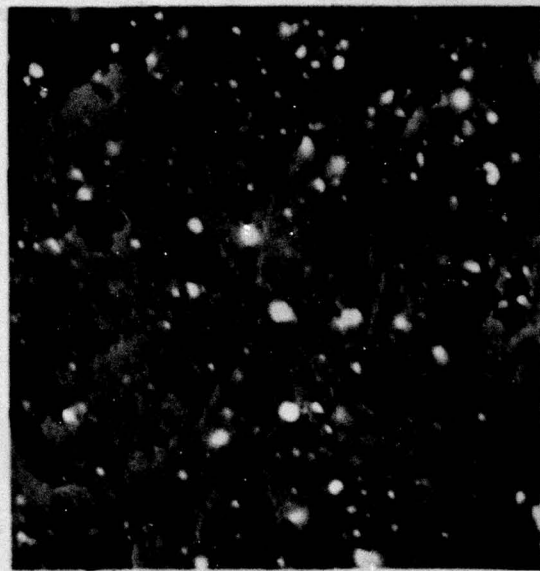
FIGURE 14

A ball from bearing 101 was also examined to provide a comparison with an element from a bearing which had successfully survived an extended operating period. As can be seen from Figure 14, the surface condition of the surviving ball is not significantly different than the typical surfaces noted on balls that failed prematurely. This implies that the failures can not be related to surface damage produced during the ball finishing operations.

Surface Finish of Ceramic Ball From Unfailed Bearing 101

Typical Surface Condition After Test

Worst Surface Area Noted After Test

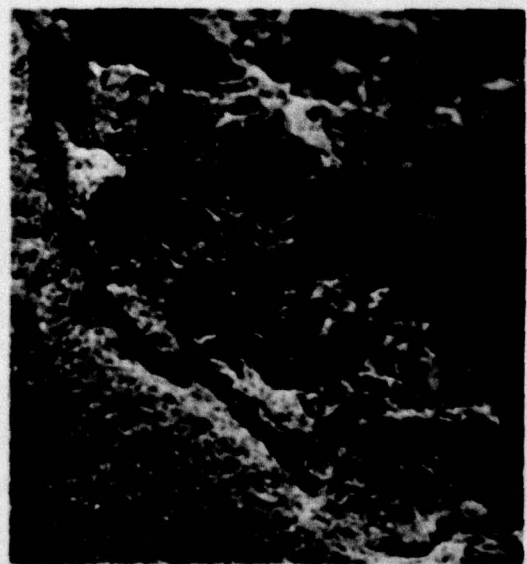
FIGURE 19

A spalled ball from bearing 126 which lived only slightly longer than 130, is shown in Figure 19. Some unusual particles were discovered at the failure origin as shown in photomicrograph 7805. Elemental analysis established that the particles were rich in carbon. This coupled with the particle morphology implied that the contaminant was graphite. Graphite is used as die material for the silicon nitride hot pressing operation so it is easy to envision that this contaminant could be introduced into the silicon nitride powder. Figure 20 shows a fracture surface of the specific graphite compound used in the mold. As can be seen, the morphology of the particle identified with the arrow is very similar to that seen on the foreign particles found in the ball material. Thus it would seem conclusive that the contaminant was graphite from the pressing mold.

Inclusion Type Spall Origin Found in Silicon Nitride Ball From Bearing 126

7802 50X  
Spall Origin Indicated by Arrow

7805 1000X  
Unusual Particles Noted At Spall  
Origin

Secondary and Back Scattered Imaging of Spall Origin

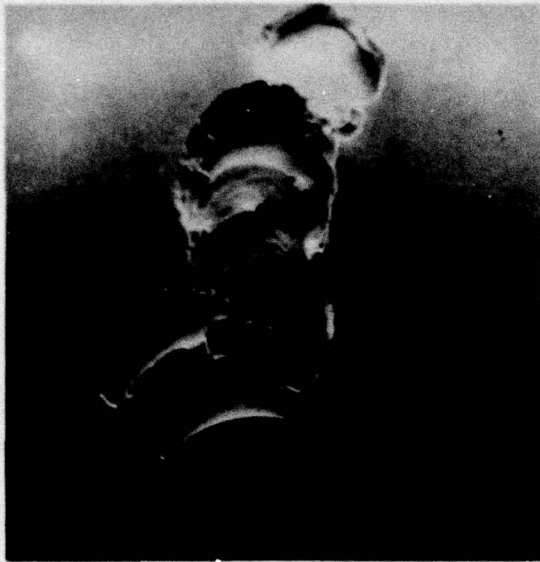
FIGURE 21

Figure 21 shows the spalled ball from bearing 127, one of the two longest lived failures in the low load test group. As was the case with the long lived failure from the high load test group, a specific failure origin could not be identified. Again the failure initiator could have been destroyed by the spalling process or this could be a valid fatigue spall.

Spall Found in Silicon Nitride Ball From Bearing 127

7823                      100X  
90° Clockwise Rotation
