REPORT NO. MT-053  
NOVEMBER 1979

EXPLOSIVELY JOINING  
DISSIMILAR METAL TUBES

A PROJECT OF THE  
MANUFACTURING TECHNOLOGY PROGRAM  
NAVAL SEA SYSTEMS COMMAND

FINAL REPORT

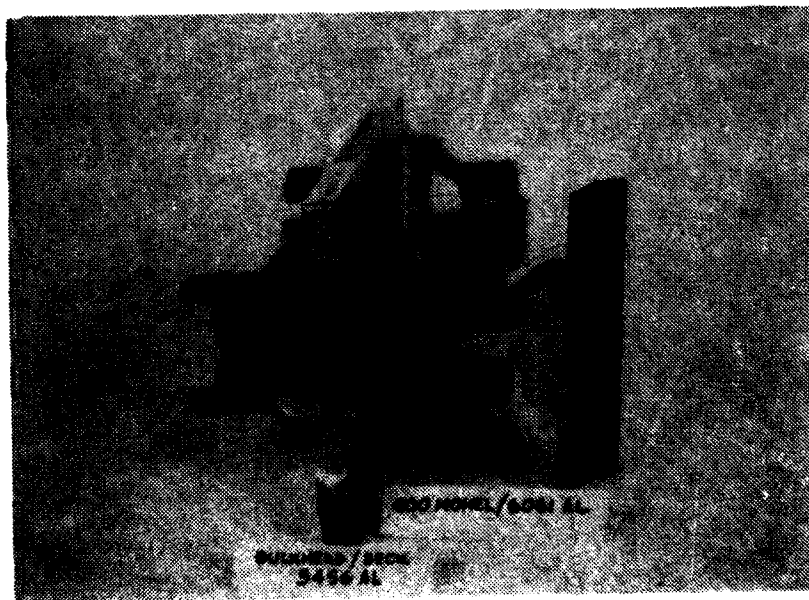
FIGURE 9

A - ALUMINUM/STAINLESS STEEL

B - ALUMINUM/400 MONEL

TYPICAL PENETRATION FITTINGS  
AS WELDED IN PLACE

Two parts from earlier trials were welded into a section of one-half inch thick plate to show how penetration fitting would look in place (Figures 9A and 9B). The materials of these parts were 304 stainless steel (9A) and 400 series monel (9B) pipe with collars of 6061-T6 aluminum. These were conventionally welded into 5456 aluminum plate that had been previously prepared by cutting 3 1/2" holes and machining 30° angles on both sides of the holes, leaving a one-eighth inch flat edge. Photomicrographs of this 6061 Al/304 SS interface (Figures 10A and 10B) show a wavy interface rather than the "sawtooth" effect seen in flat plate clads. This variation has no apparent effect on the strength of the cladding. Also worthy of note is the apparent "melt" or mixture of the parent metals trapped in the interface.

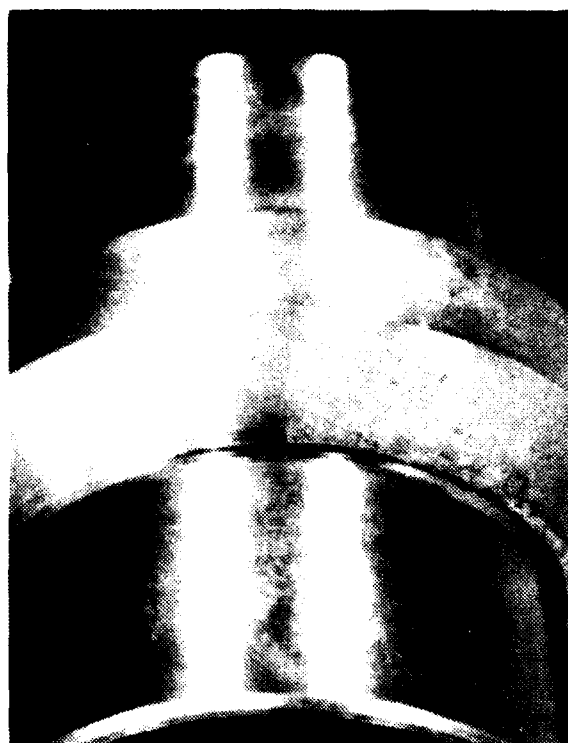
Fig. 10. Ni-Cu Specimen, unpainted and paint-removed regions.
