**THE EFFECT OF COMPRESSIVE LOADING  
ON THE FATIGUE LIFETIME OF  
GRAPHITE/EPOXY LAMINATES**

*LOCKHEED-CALIFORNIA COMPANY  
RYE CANYON RESEARCH LABORATORY  
BURBANK, CALIFORNIA, 91520*

OCTOBER 1979

TECHNICAL REPORT AFML-TR-79-4128  
Final Report May 1977 — August 1979

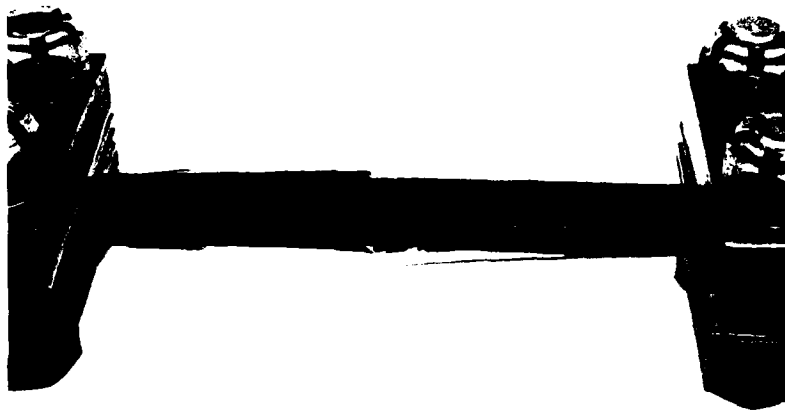
Figure 13. Tension-Tension Fatigue Test Showing Failed Laminate 1 Coupon
