NRL Report 8370

**Fractographic and Microstructural  
Analysis of SCC Specimens of HY-100, HY-130,  
and HY-180 Steel Weldments**

FRANCES W. FRASER AND EDWARD A. METZBOWER

January 10, 1980

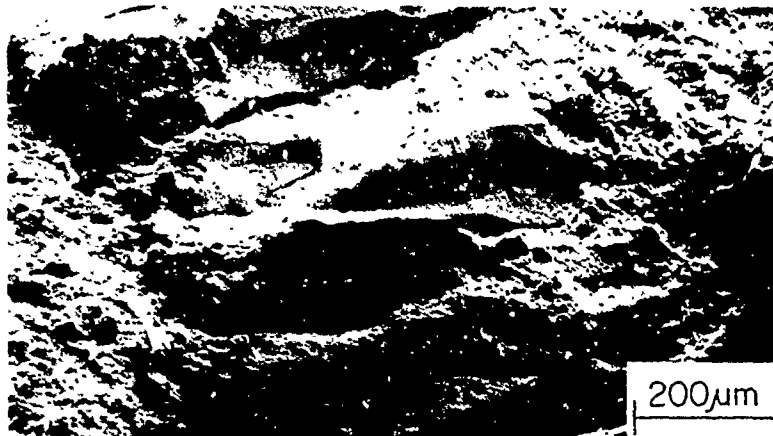
In specimen K, a heat-treated HY-130 specimen, fracture modes at the fatigue interface included IG separation, cleavage, and MVC. Some IG fracture occurred in columnar grain and adjacent equiaxed grain areas (Figs. 14a and 14b). Smooth, flat areas fractured by MVC, which was accompanied in some instances by stretching, whereas the coarser areas fractured by MVC and cleavage. Microcracks, corrosion products, and pitting were also noted.

Fig. 14a — Intergranular separation in columnar grains in specimen K
