INVESTIGATION OF THE MECHANICAL AND
CORROSION PROPERTIES OF MA 87 ALUMINUM POWDER ALLOY

Roy W. Brodie and Leon Bakow
- Structures and Materials
- LOCKHEED-CALIFORNIA COMPANY
Burbank, California

FINAL REPORT
Contract N62269-78-C-0446

Prepared for
NAVAL AIR DEVELOPMENT CENTER
Aircraft and Crew Systems Technology Directorate
Warminster, Pennsylvania 18974

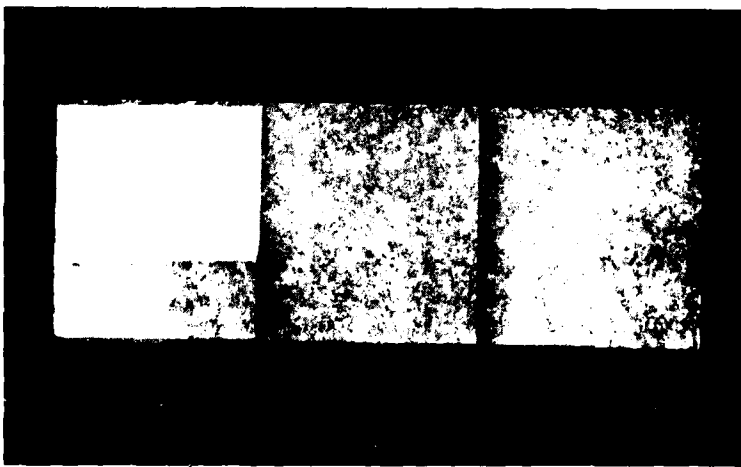
Figure 33. - Typical surface conditions of wing spar cap - cap, LS 9788 after excitation tests.

All the MA87 (CT91) specimens were resistant to exfoliation when tested in EXCO, salt spray or sea coast (8 months exposure) environments as shown in table 13. However, pitting corrosion was evident. The surface conditions of several specimens after exposure to the three environments are shown in figures 33 through 36. The pitting attacks encountered in the salt spray and EXCO tests are shown in figure 37. The resistance to exfoliation is attributed to the fine equiaxed grain structure and absence of elongated grain boundaries.

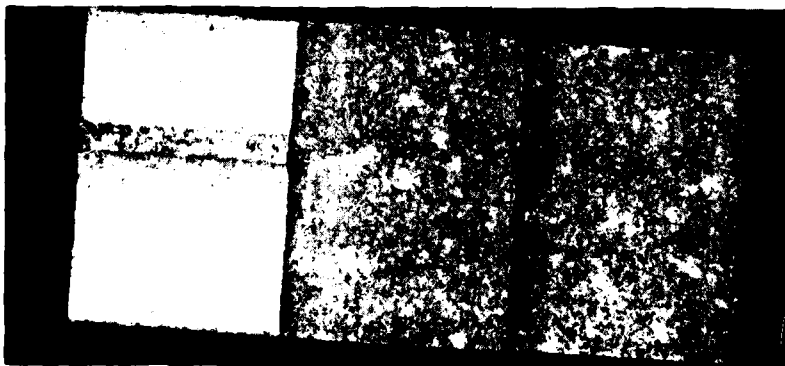
Figure 35. - Typical surface conditions of flanged cap - base, LS 13116 after exfoliation tests.

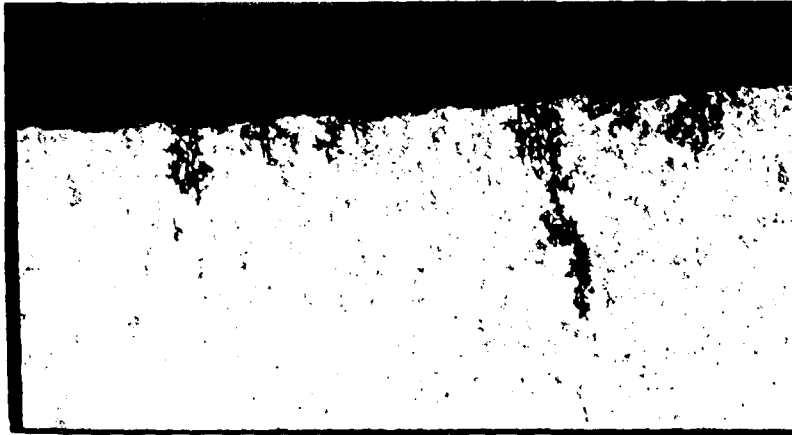
Stressed at 45 ksi
(310 MPa)

Stressed at 35 ksi
(241 MPa)

Stressed at 25 ksi
(172 MPa)

Figure 38. - Photomicrographs of pitted stress corrosion specimens,
mag. 200x.

The stress corrosion specimens failed to sustain the 45 ksi (310 MPa) target stress level in the 3.5 percent salt alternate immersion test, see table 14. Failures occurred at 35 ksi (241 MPa) within 16 days and at 25 ksi (172 MPa) within 19 days. Metallurgical examination of failed specimens showed severe pitting, but no intergranular attack, see figure 38. Therefore, MA87(CT91) must be protected from pitting corrosion to retain the load sustaining performance.

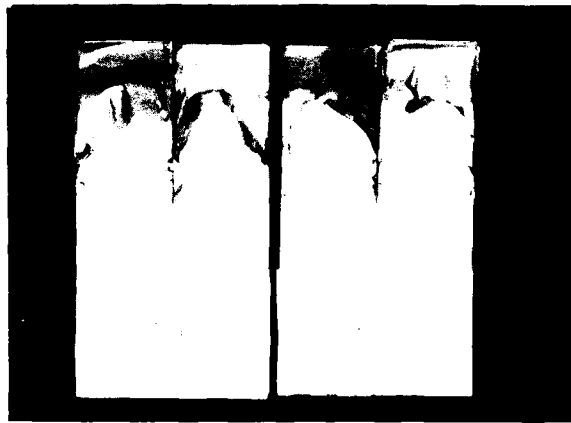
Figure 61. - Fatigue crack growth specimen fracture surfaces, tested in lab air.

Photographs of the fracture surfaces included as figures 61 and 62 show the fracture surfaces were generally smooth in appearance with irregular spaced bench marks caused by changes in the load levels. Extensive tunneling, shear lip formation and curving of the crack path occurred in the later stage of testing. The stain on the fracture surfaces of the 3.5 percent salt solution are due to oxidation. The observed fracture behavior is similar to that of L-T oriented compact 7075-T76511 extrusions evaluated by Lockheed-California Company in reference 3.
