COMBAT DAMAGE ASSESSMENT TEAM  
A-10/GAU-8 LOW ANGLE FIRINGS  
VERSUS  
SIMULATED SOVIET TANK COMPANY (ARRAY 17)  
(LAVP Lot Number AJD 79A121-001, AEROJET)  
(14 AUGUST 1979).

Ruben H.S. STOLFI  
R.R. McEACHIN  
APRIL 1980

Prepared for: A-10 System Program Office  
Wright Patterson Air Force Base  
Ohio 45433

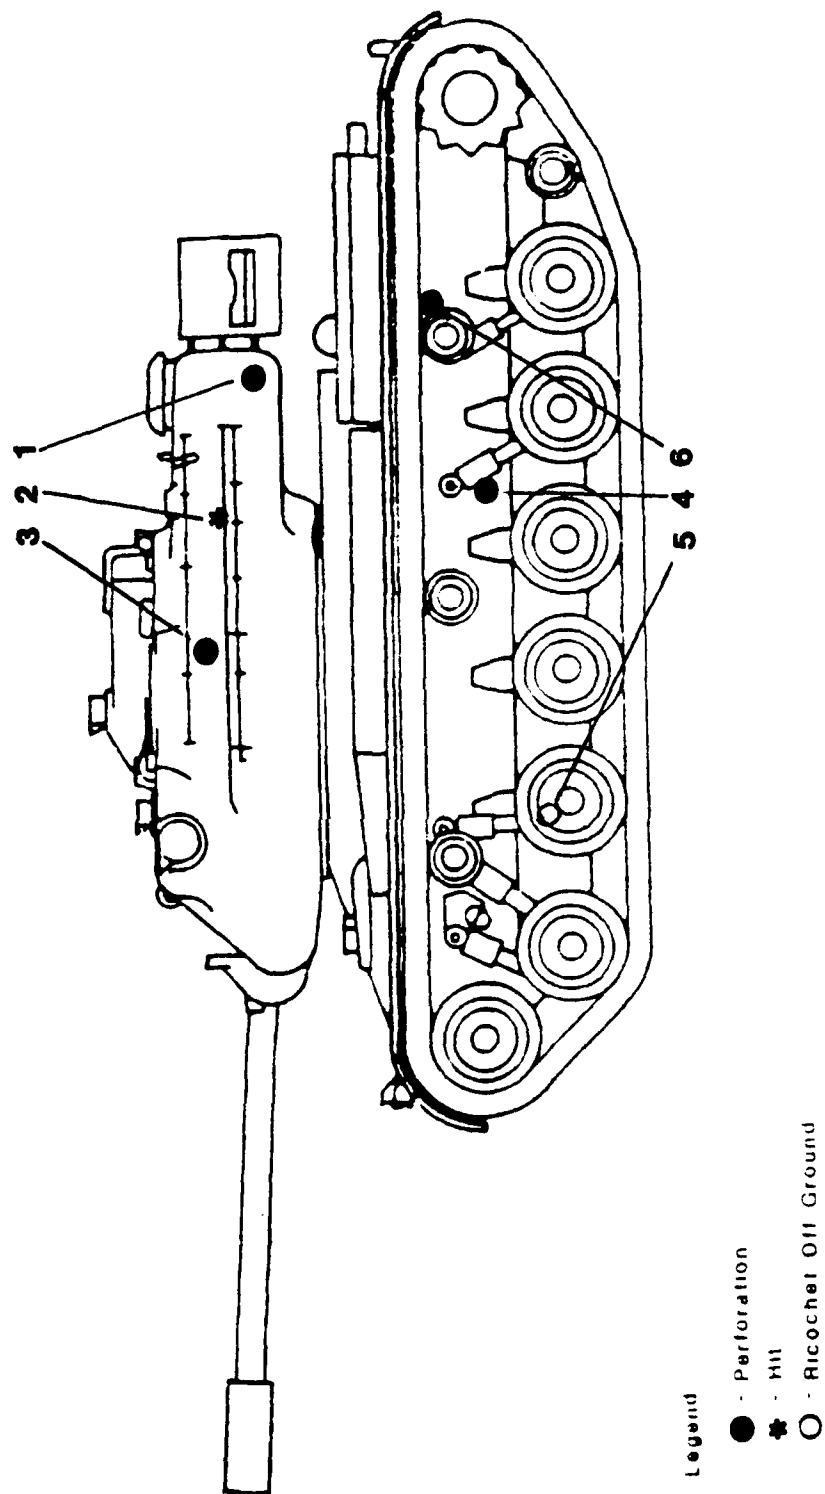
FIGURE 7. Impact Diagram, Tank 38.

100% M-Kill and 95% F-Kill resulting from the following observed effects (Figure 7):

a. M-Kill: The assessment of 100% M-Kill is based on perforation 3 (Figure 8) through the turret which caused 3 crew casualties, perforation 4 through the left fuel cell near the bottom, and perforation 6 (Figure 9) through the left side of the engine compartment with damage to major engine components, e.g., oil cooler and carburetor.

b. F-Kill: The assessment of 95% F-Kill is based on perforation 3 which caused fragment and spall impacts on crew manikins. Examination of manikin damage supports a view that the tank commander (Figure 10 and 11) and loader (Figure 12) were killed and the gunner (Figure 13) seriously wounded.

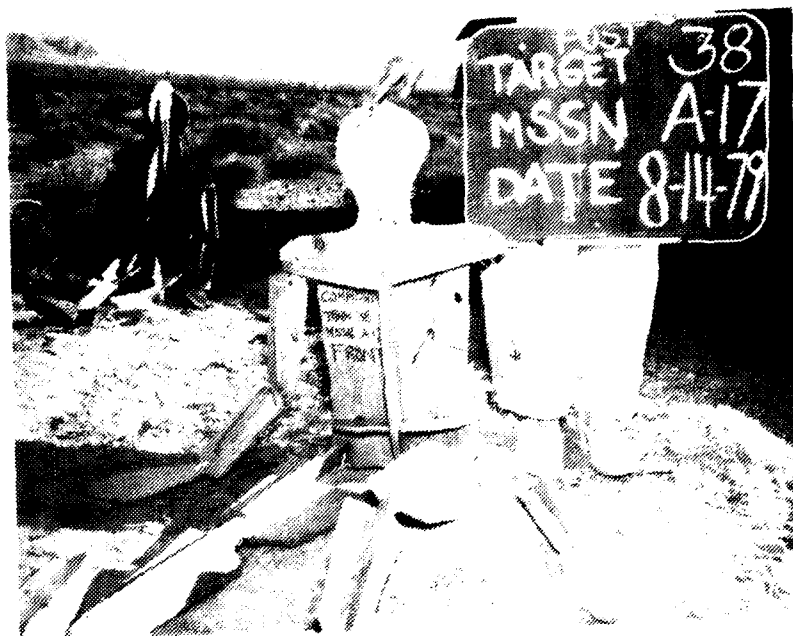
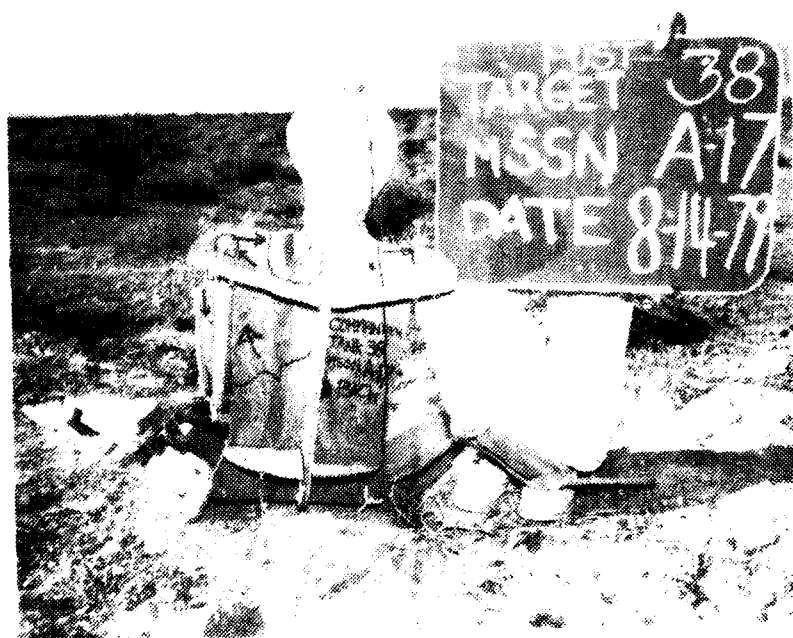
FIGURE 10. Tank 38 Commander - Front.

FIGURE 11. Tank 38 Commander - Back.

FIGURE 12. Tank 38 Loader.

FIGURE 13. Tank 38 Gunner.

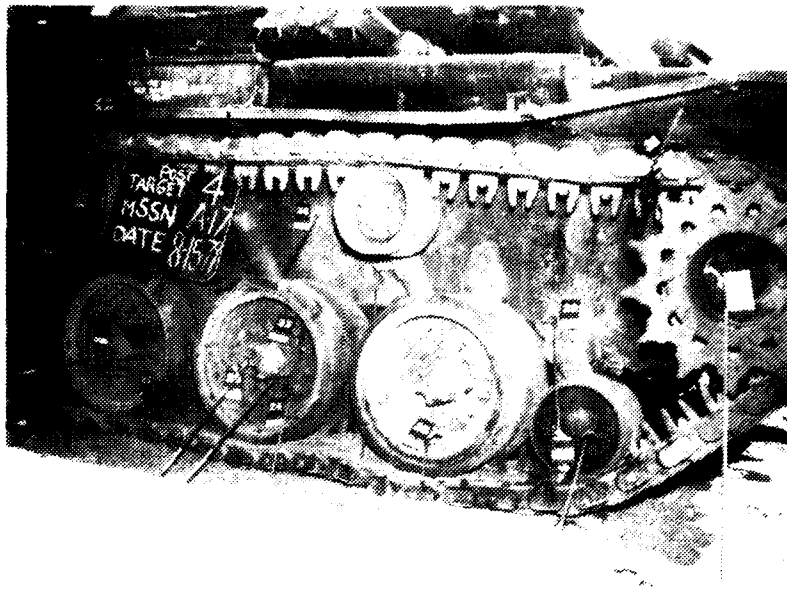
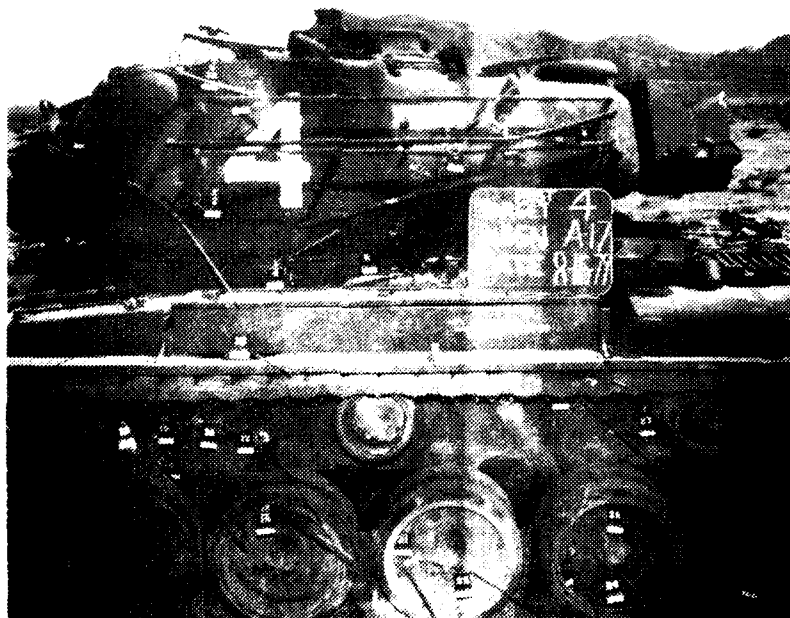
- a. M-Kill: The assessment of 90% M-Kill is based on impacts 6 and 7, which incapacitated the tank commander, gunner, and loader, and impacts 13, 20, 22, 24, 25, 30, and 31, which caused significant cumulative damage to the track and suspension system (Figures 20 and 21).
- b. F-Kill: The assessment of 100% F-Kill is based on impact 4, which jammed the turret and impacts 6 and 7, which perforated the left side of the turret killing the tank commander (Figure 22) and wounding the gunner and loader, as assessed from fragment damage to crew manikins.

FIGURE 20. Tank 4 Rear/Side Damage.

FIGURE 21. Tank 4 Left/Center Damage.

FIGURE 22. Impact 4, Tank 4 Tank Commander.

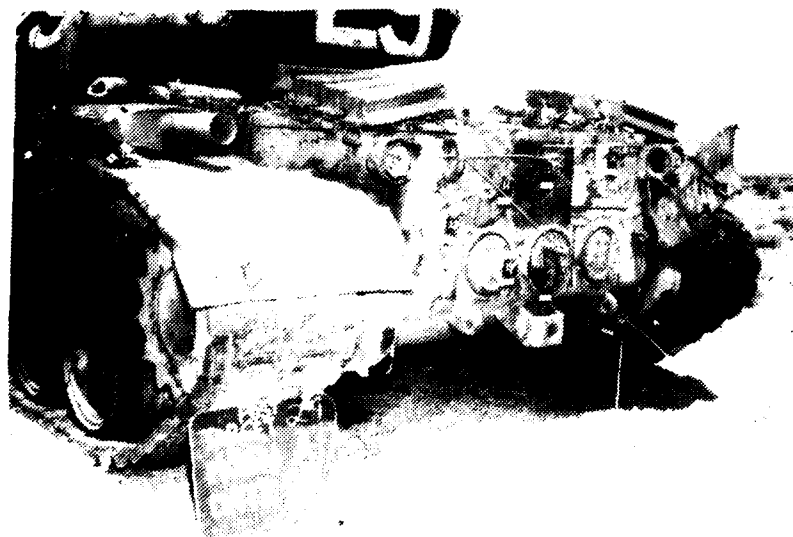
The assessment of 100% M-Kill is based on impacts 13 and 19 (Figures 33 and 34) which perforated the rear of the hull and penetrated into the transmission case. The resulting effects on the transmission, i.e., loss of transmission oil and fragment and spall damage to gears, would result in complete loss of function of the transmission and immobilization of the tank.

FIGURE 33. Close-in View of Impacts 13 and 19, Tank 29.

FIGURE 34. Reference View of Impacts 13 and 19, Tank 29.
