*Analysis of the performance of a 140-foot Great Lakes icebreaker: USCGC Katmai Bay*

CRREL Report 80-8

George P. Vance

February 1980

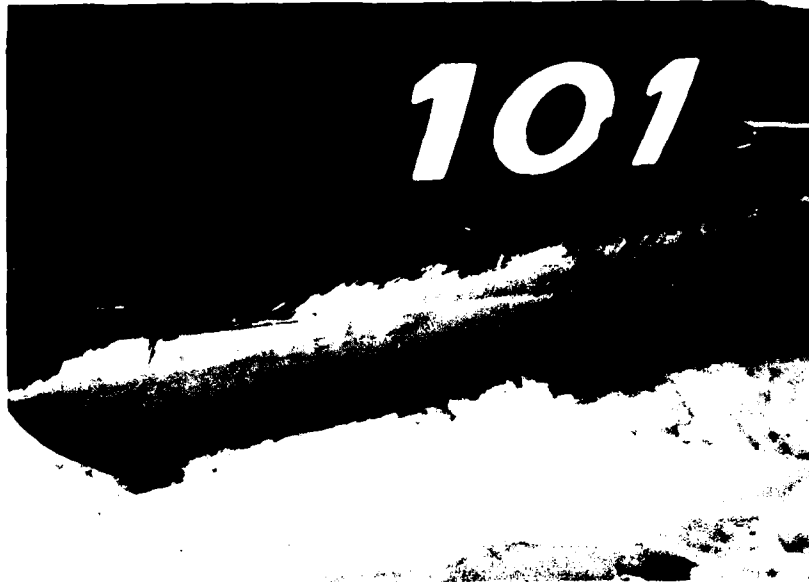
*Figure 1. Hull plating condition on port bow of Katmai Bay.*

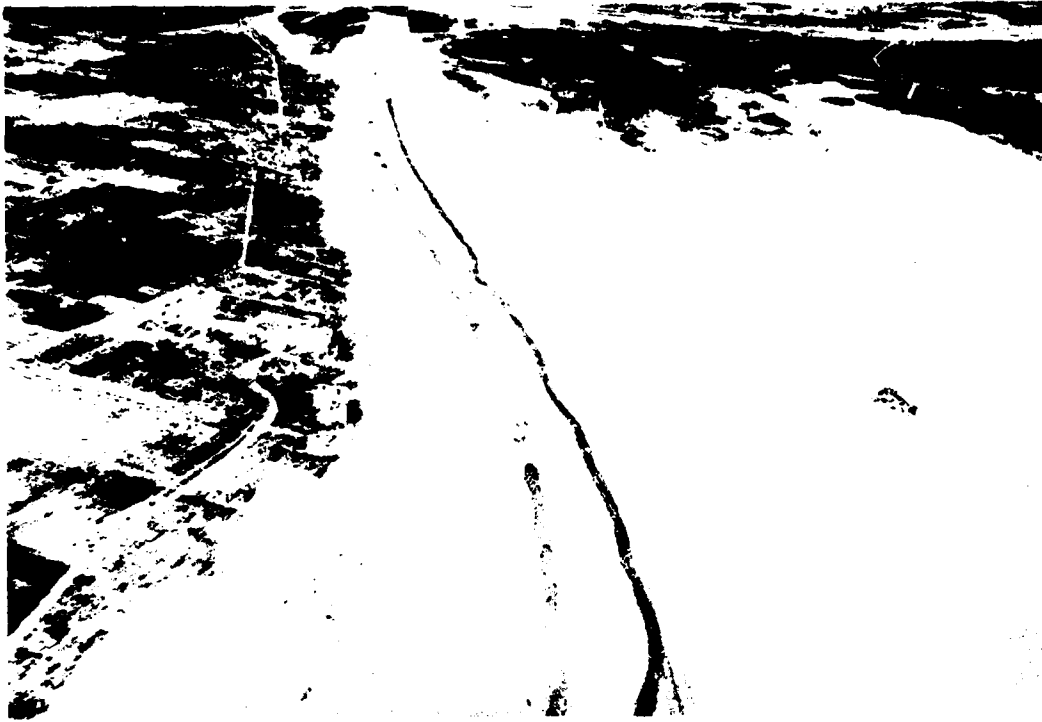
*Figure 5. Aerial view looking upstream showing ice conditions and steamer track in courses 3 and 4 of Little Rapids Channel—Six Mile Point, left foreground, 18 January 1979, 1200 to 1400 hr.*

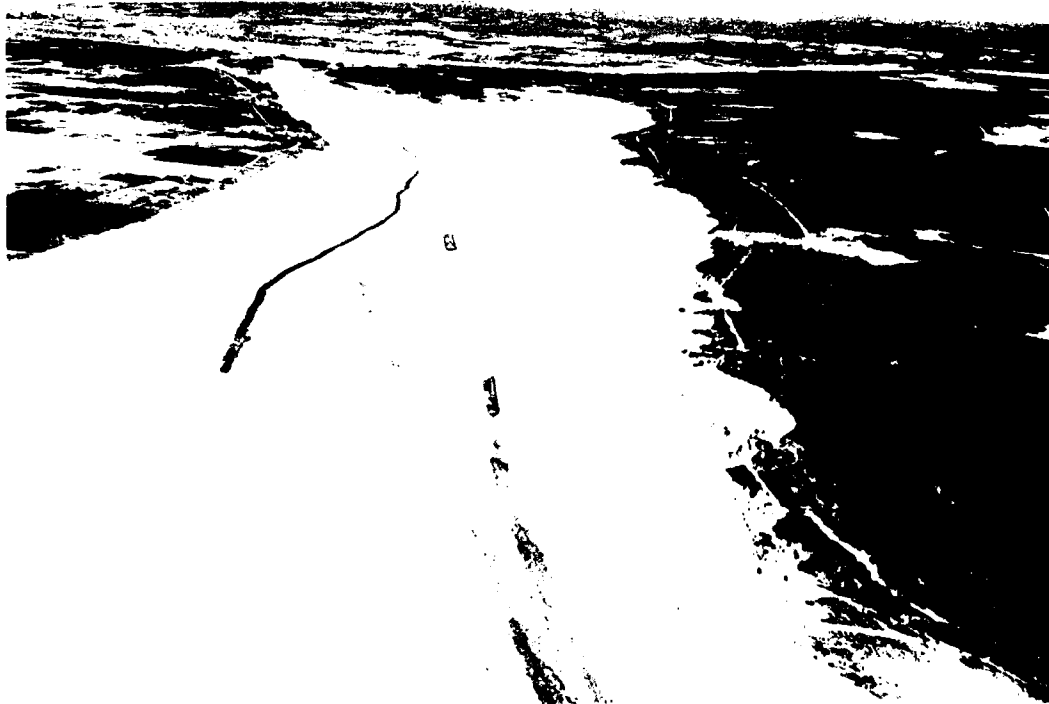
*Figure 6. Aerial view looking upstream showing ice conditions and steamer track in Lake Nicolet—Nine Mile Point in right foreground, 18 January 1979, 1200 to 1400 hr.*

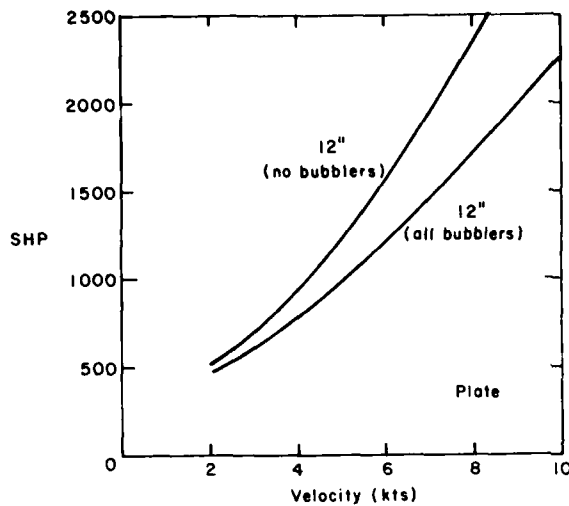
Figure 9. Shaft horsepower vs velocity in plate ice with 3 to 5 in. of snow cover, with aft bubblebers or no bubblebers in operation.

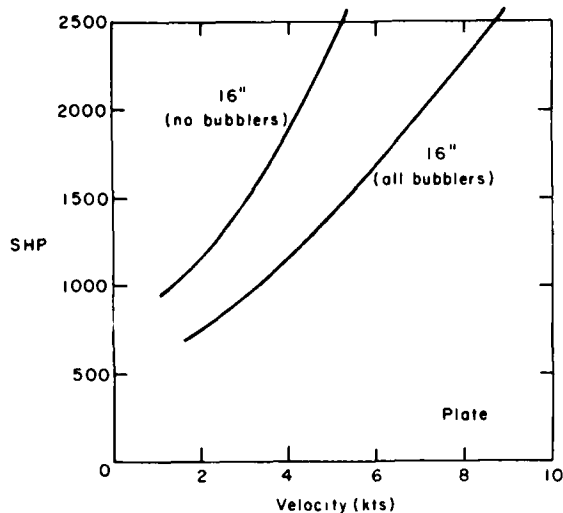
Figure 11. Shaft horsepower vs velocity in plate ice and 3 to 5 in. of snow cover—comparison of performance with all bubblers operating or no bubblers.

The comparisons in Figure 11 and Table 5 for 16 in. of ice indicate the most impressive power savings, an average of 35%. This is primarily due to the weather conditions on the day these tests were conducted. There was a prevailing wind that created a significant ice pressure force. Although no quantitative measurements were made, this was the only day that the track closed

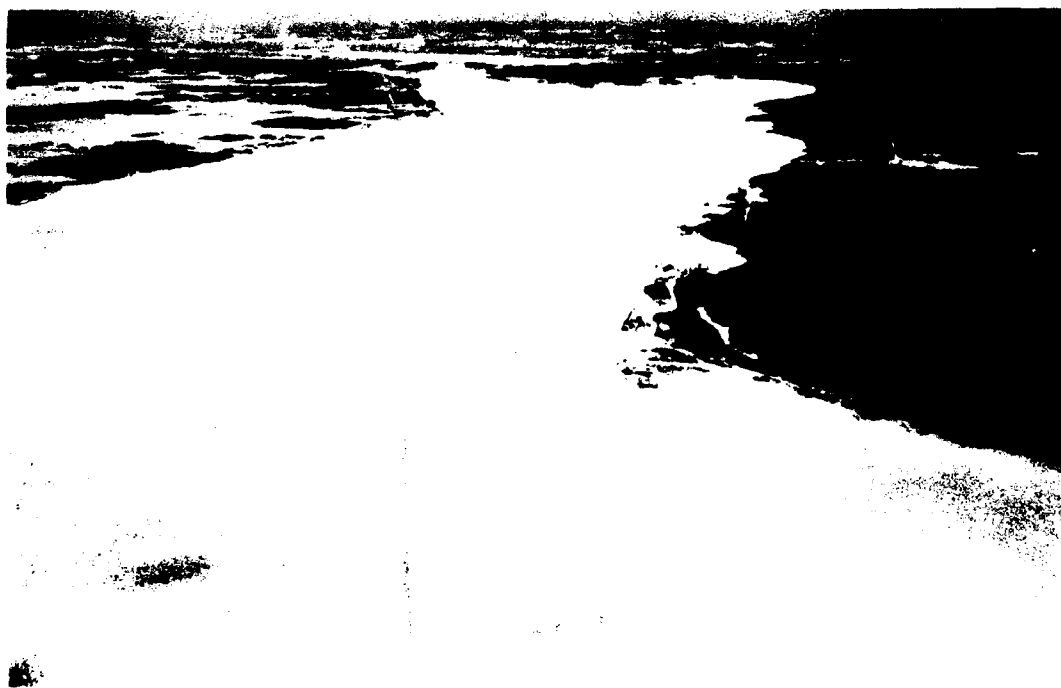
*Figure 15. Aerial view looking upstream showing ice conditions and steamer track through Lake Nicolet with Nine Mile Point in right foreground, 9 February 1979, 1200 to 1400 hr.*

Figures 14 and 15 are views of the ship track in Middle Neebish Channel and Lake Nicolet. The consistency of the brash can be seen in Figure 16. Figures 16 and 17 indicate that the brash ice in the channel during tests on 8 and 10 February was packed so tightly one could walk out and measure the thickness immediately after the passage of the vessel. This was not the case for the tests on 13 March, where the channel was completely filled but was not packed to the point where one could walk on it after passage of the vessel.

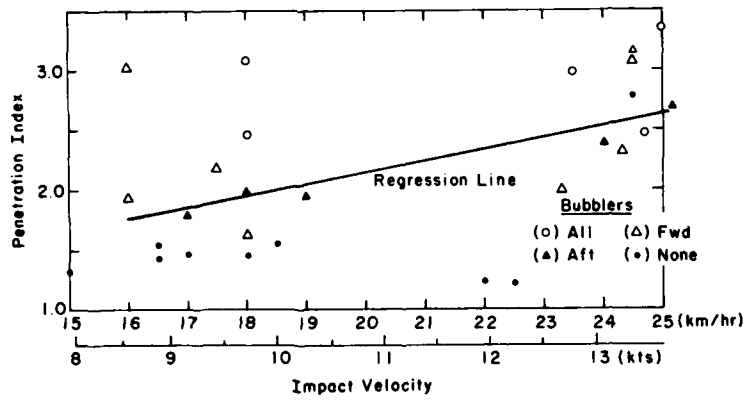
Figure 25. Penetration index vs impact velocity, 17 March 1979.

It should be noted that all tests were conducted at full power and impact velocity was varied by changing impact distance. Broken ice was always present in the channel.

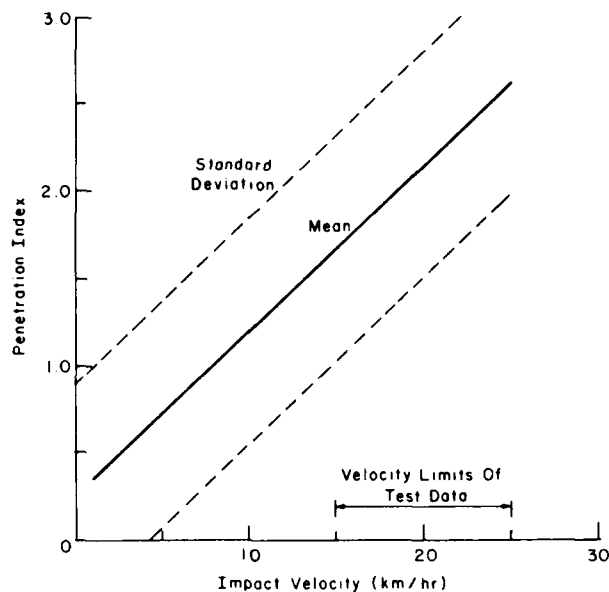
Figure 26. Computed penetration index vs impact velocity in 22 to 30 in. of ice and 2 to 3 in. of snow where  $PI = 0.095 (IMVEL) + 0.255$ ,  $R = 0.505$ ,  $\sigma = 0.65$  and  $PI_{AVG} = 2.17$ .

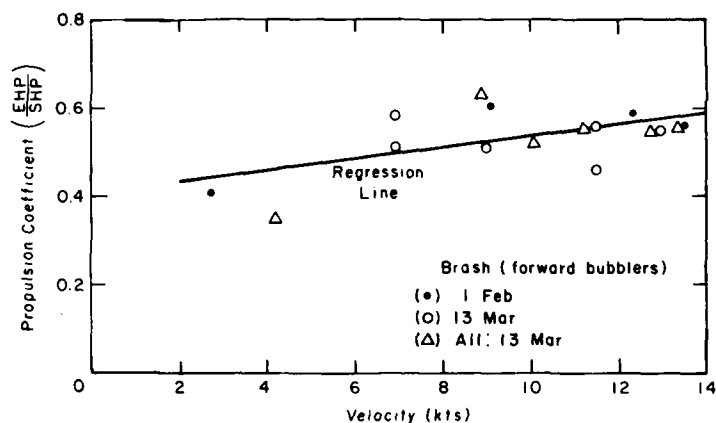
Figure 34. PC vs velocity in brash ice with only forward bubblers operating.

value of  $t$ . Computations of the  $PC$  using various values of  $t$  were made and are presented in Internal Report 621. The plots in Figures 31 to 34 were derived using a value of 0.2 for  $t$ .

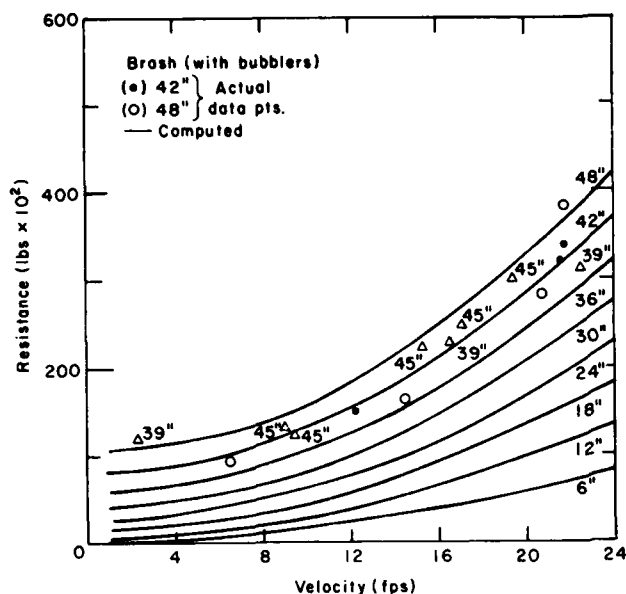
Figure 40. Ice resistance in 40 to 50 in. of brush ice with all bubblers operating.
