# **Development and Evaluation of Processes for Deposition of Ni/Co-Cr-AlY (MCrAlY) Coatings for Gas Turbine Components**

**Solar Turbines International  
P.O. Box 80966  
San Diego, California 92138**

TECHNICAL REPORT AFML-TR-79-4097

Final Report for Period 1 November 1976 to 1 September 1978

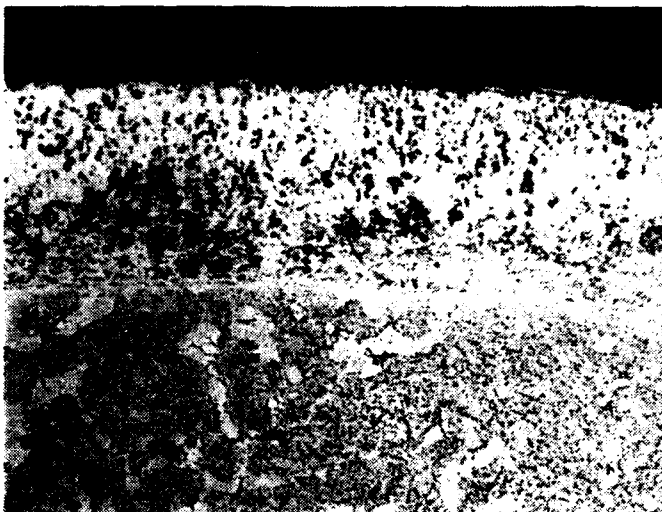
Figure 36. Microstructures of BC32 Coated Rene' 125 Specimens  
After 239 Hours of Hot Corrosion Rig Testing

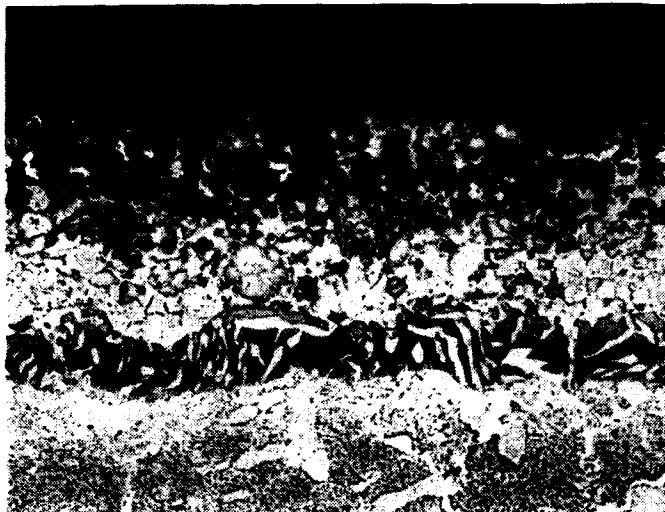
Figure 38. Microstructure of CCRS Lot 8864 Coated Rene' 125 Specimen After 239 Hours of Hot Corrosion Rig Testing

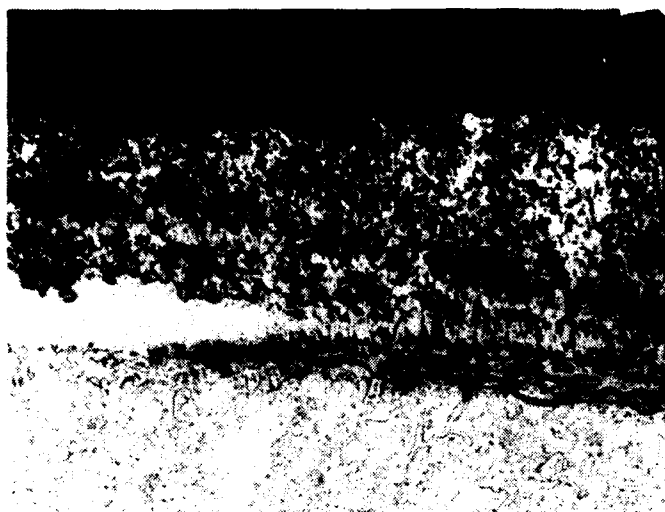
Figure 43. Microstructures of PVD NiCrAlY Coated X-40 Specimens  
After 174 Hours of 871°C Hot Corrosion Burner Rig  
Testing
