GAI CONSULTANTS INC MONROEVILLE PA  
NATIONAL DAM INSPECTION PROGRAM. PENELEC RETENTION DAM. (NDI I.--ETC(U)  
MAR 80 B M MHALCIN

PHASE I INSPECTION REPORT  
NATIONAL DAM INSPECTION PROGRAM

Penelec Retention Dam: NDI I.D. No. PA-00809

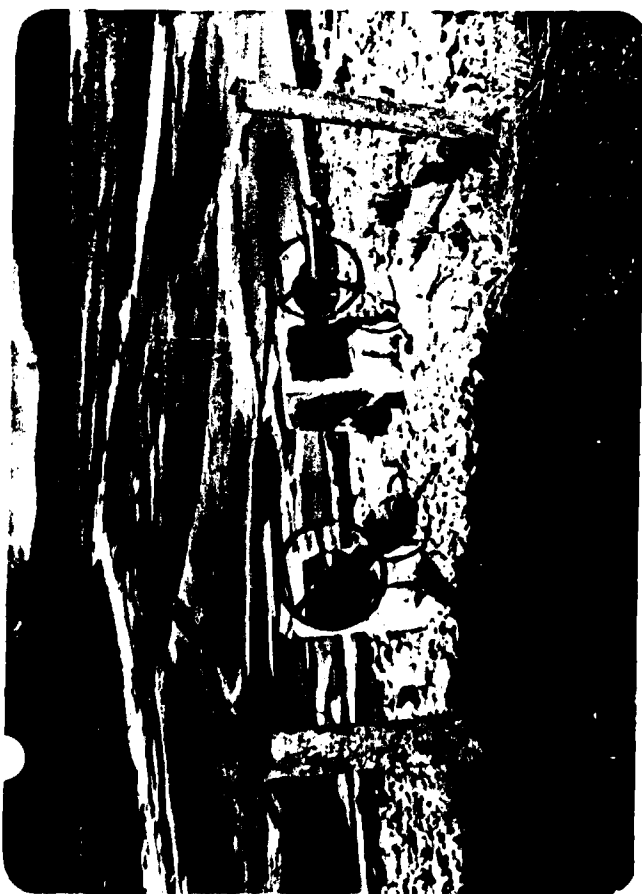
2. Outlet Works. Both 24-inch diameter conduits that comprise the outlet works are reportedly functional; however, neither was operated in the presence of the inspection team. All exposed valve mechanisms appear to be well maintained and in good condition as does the outlet headwall (see Photographs 1, 3, 5 and 6).

PHOTOGRAPH 1 View of the reservoir and upstream gate operators as seen from embankment crest.

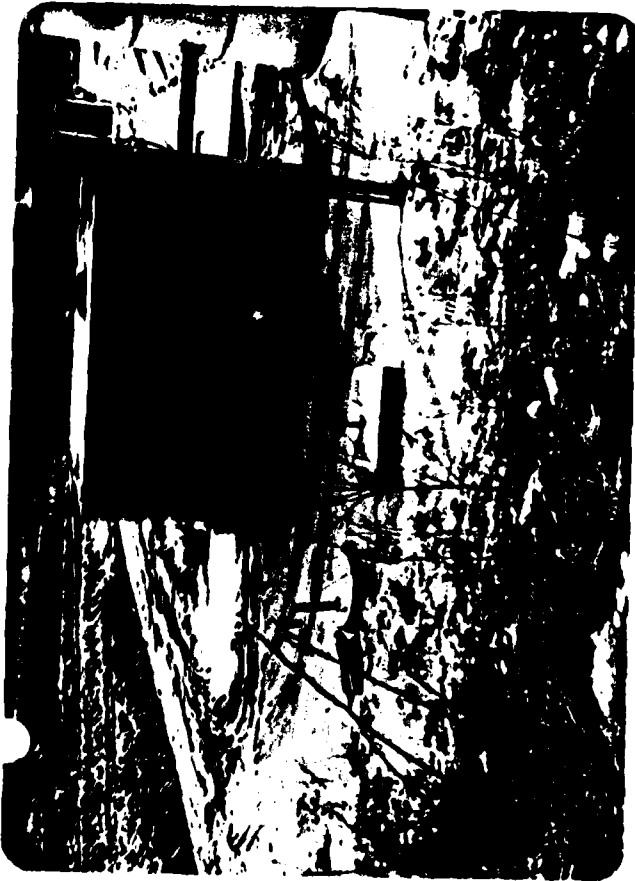
PHOTOGRAPH 7 View of the rectangular, concrete spillway channel and trapezoidal-shaped, gabion-lined discharge channel.
