# NAVAL POSTGRADUATE SCHOOL

**COMBAT DAMAGE ASSESSMENT TEAM**  
**A-10/GAU-8 LOW ANGLE FIRINGS**  
**VERSUS**  
**SIMULATED SOVIET TANK COMPANY (ARRAY 18)**  
**(AEROJET LOT NUMBER AJD79A181-001)**  
**(30 AUGUST 1979)**

R.H.S. STOLFI  
R.R. McEACHIN

MAY 1980

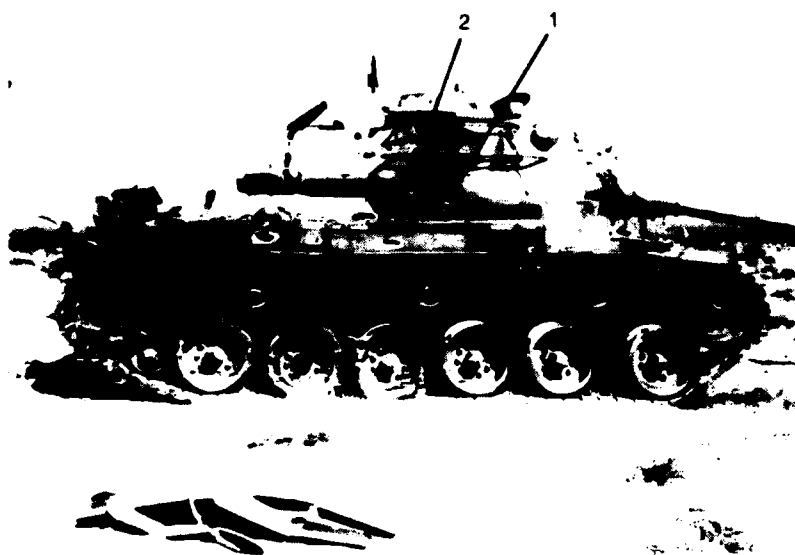
FIGURE 25. Tank 7, Photo, Right Side.

- a. M-Kill: The assessment of a 100% M-Kill is based on impacts 12 and 13 which perforated the rear of the hull penetrating into the transmission case, and on cumulative damage to the track and suspension system caused by impacts 14, 17, 18, 19, and 24.
- b. F-Kill: The assessment of a 100% F-Kill is based on impact 1, which perforated the right side of the turret killing the gunner and damaging the commander's main armament controls, and impact 2 which jammed the turret so that it could not be traversed (Figure 25).

Note impacts 1  
(perforation) and  
2 (hit, which  
jammed turret).
