STRUCTURES REPORT 375

THE STRENGTH OF OCCUPANT RESTRAINT
SYSTEMS IN LIGHT AIRCRAFT
- AN EXPERIMENTAL EVALUATION

by
S. R. SARRAILHE

FEBRUARY 1979

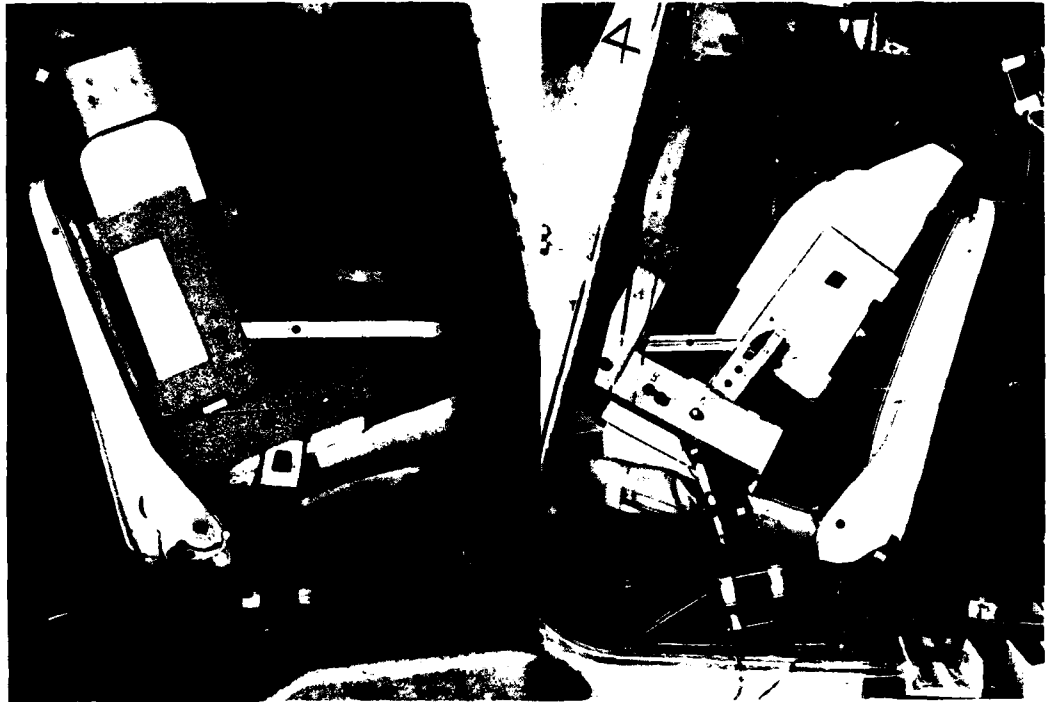
FIG. 1. PIVOTED BODY BLOCK INSTALLED AND UNDER LOAD IN A LAP SASH RESTRAINT.

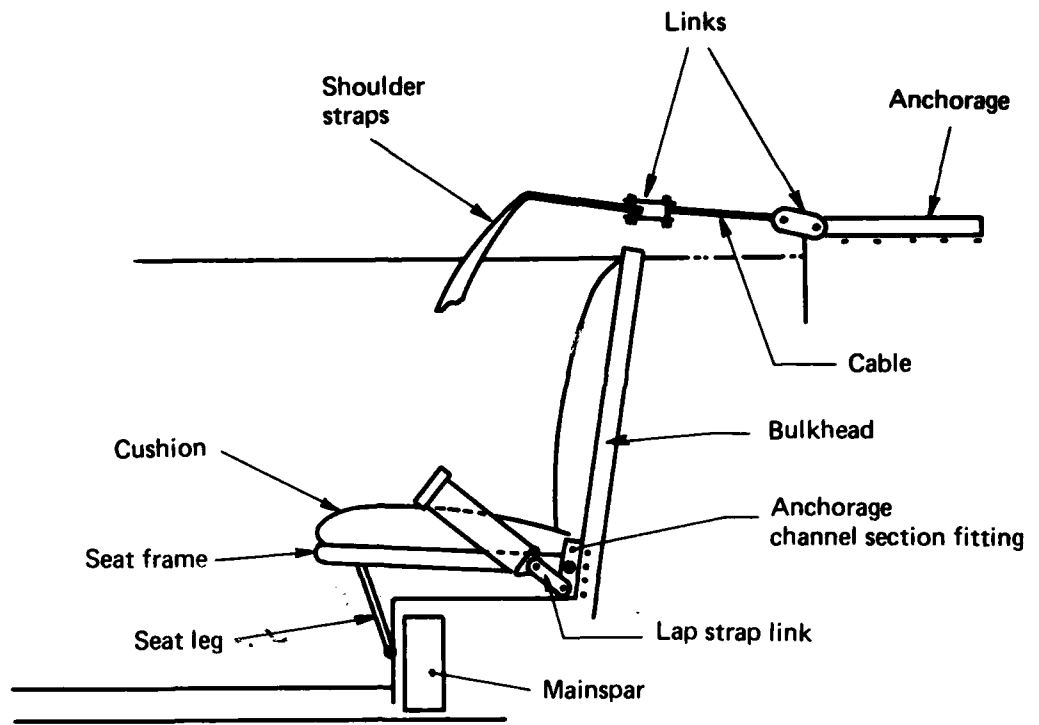
FIG. 3. LAYOUT OF SEAT AND HARNESS – AIRCRAFT "A"

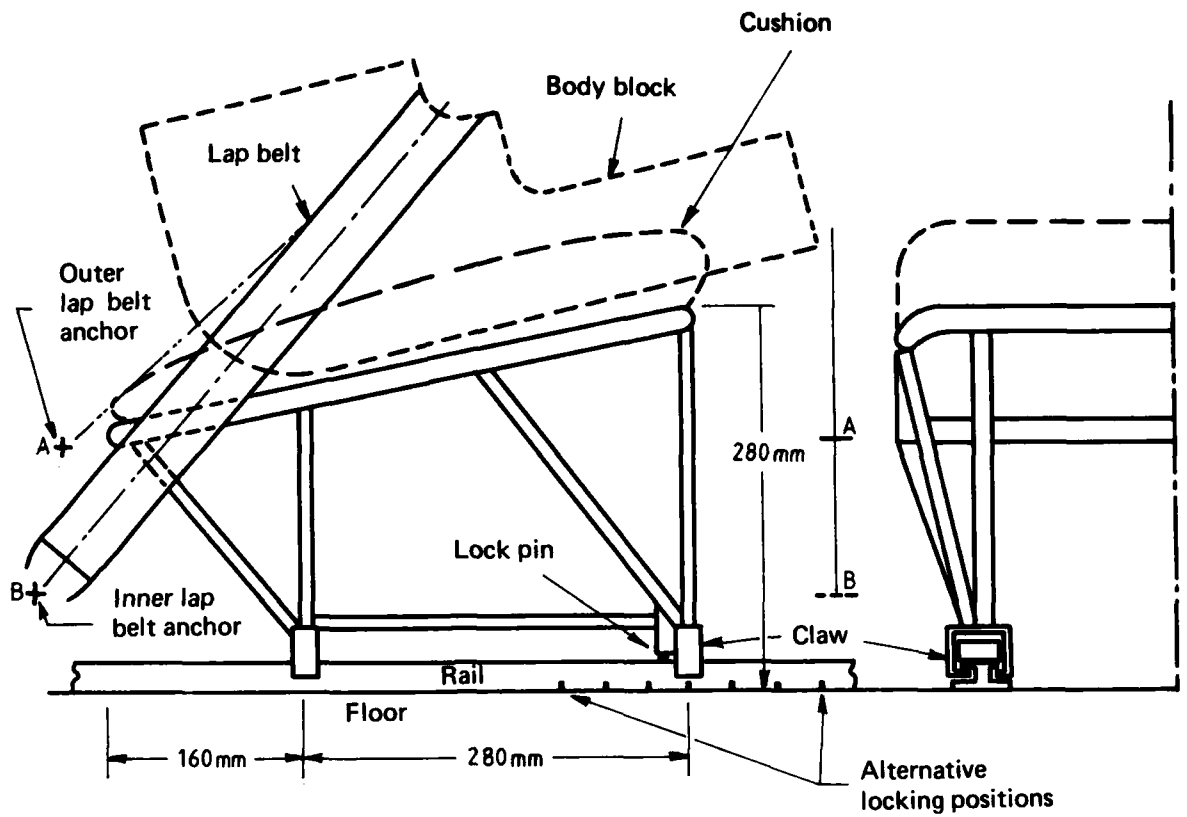
FIG. 5. LAYOUT OF FRONT SEAT AND LAP BELT - AIRCRAFT "B"

The left front seat was locked in the mid position of its fore and aft adjustment. The body block was positioned on the seat and a webbing strap fitted to represent the lap belt. Transducers were used to measure the total applied load and the tensions in the strap. Load was applied in a forwards direction and incrementally increased to a value of 7.5 kN. Although no failures had occurred, there was considerable deflection which resulted in the transducers contacting the seat frame. As further loading could have damaged the transducers, the test was discontinued and the webbing strap replaced by steel links incorporating more compact transducers. The links reproduced the geometry previously measured at the load of 7.5 kN. Loading was continued until the applied load reached 24.5 kN. The test was terminated to allow inspection of the structure and again no damage was found. Strap tensions at the anchorages were each approximately 40% of the applied load.

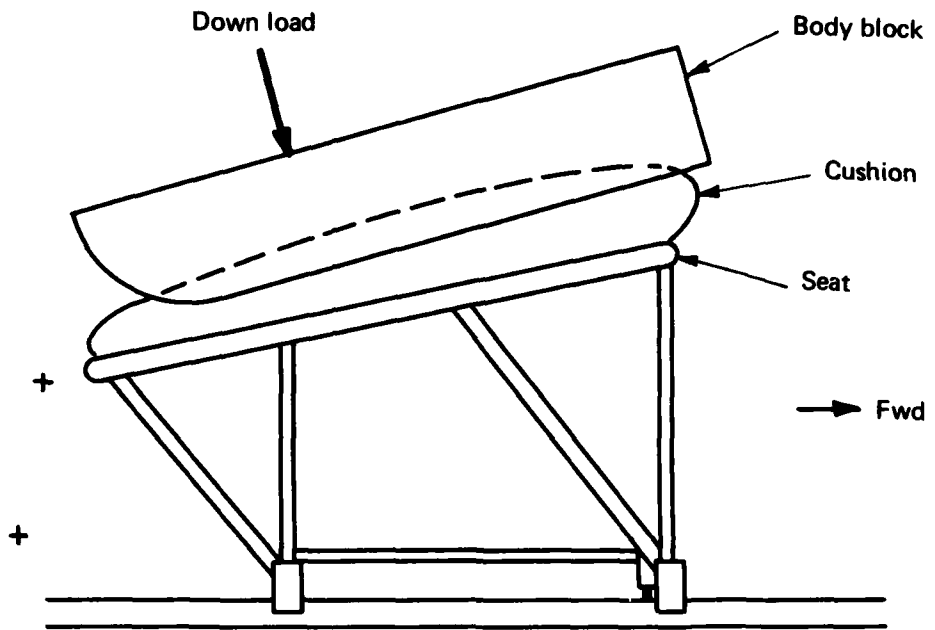
FIG. 11. THE FRONT SEAT UNDER "VERTICAL" LOADING

The maximum load that the seat could react was 10 kN. The deflection at this load was 50 to 70 mm from the "static position" (e.g. the position with a weight of 750 N on the seat resulting from the mass of the man). After the test it was found that all the longitudinal webbing straps and the rear transverse strap had broken.

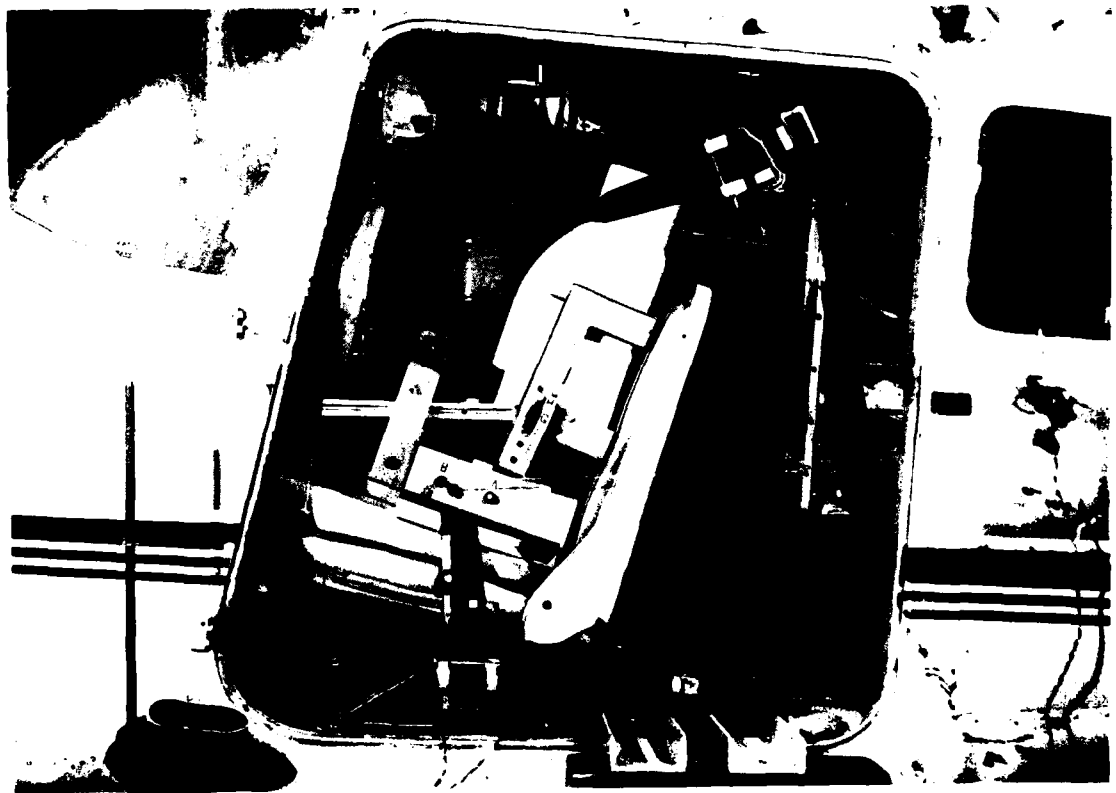
FIG. 12. LAP SASH RESTRAINT SYSTEM TEST IN THE CABIN OF AIRCRAFT "C"

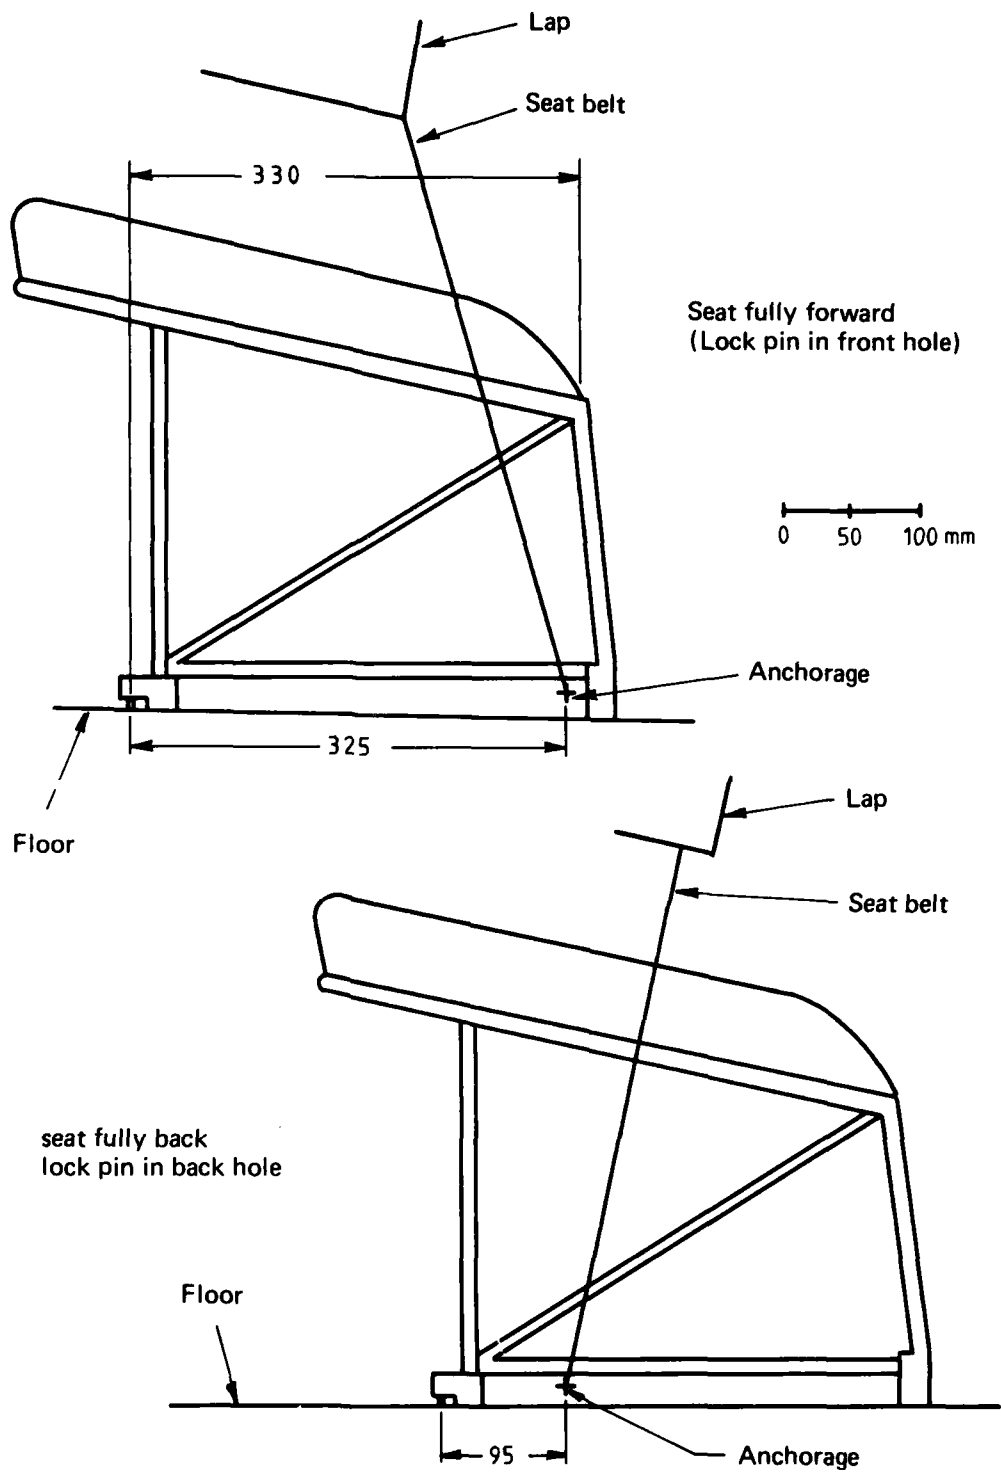
FIG. 13. LAP BELT SLOPE WITH SEAT IN FORWARD AND FULLY BACK SEATING POSITIONS FOR AIRCRAFT "C"

Note: Seat can slide further forward or backwards for ease of access.

- (iii) Aircraft C had a very strong cabin and aircraft of this type had been overturned with negligible damage to the cabin structure. The lap strap anchorages were too far forward relative to the seat, and in consequence the slope of the lap strap was too steep. This allowed the hips to move forwards excessively under forwards loading, and also resulted in greater strap and seat loads than would have occurred with a more moderate seat belt slope.

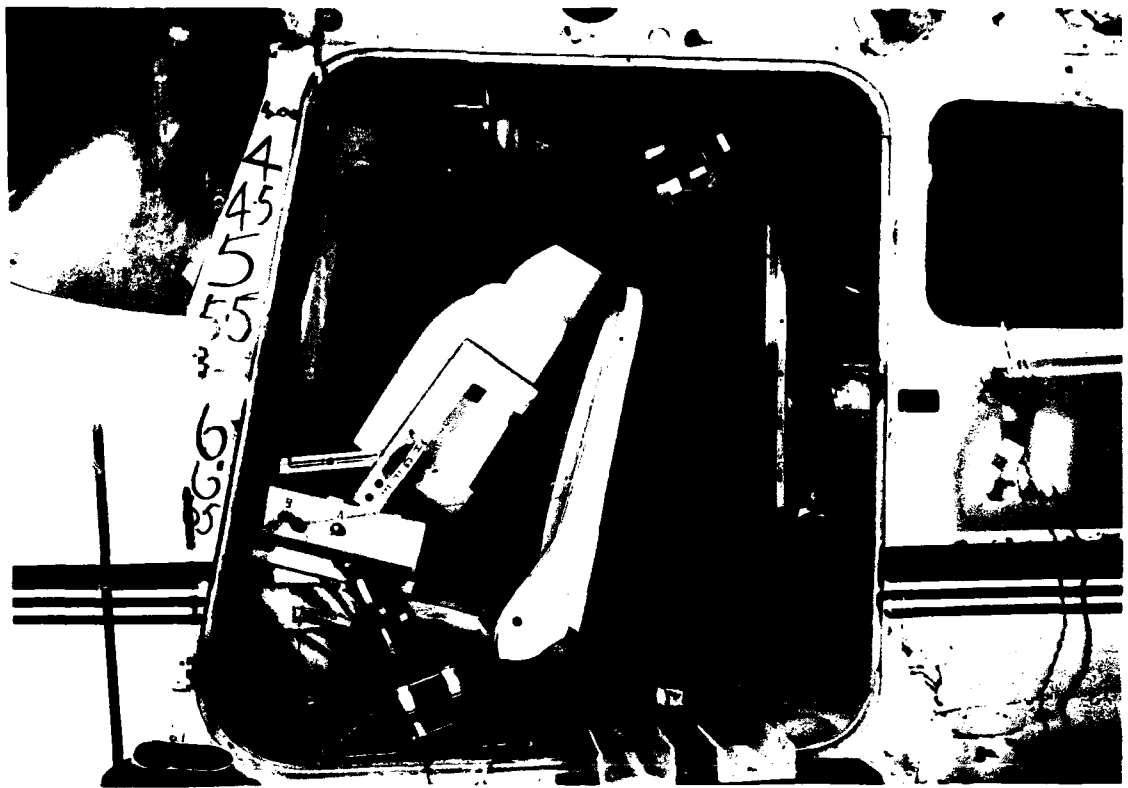
FIG. 14. RESTRAINT SYSTEM UNDER LOAD OF 8kN IN AIRCRAFT 'C'

The condition just before this happened is shown on Figure 14. Body block load was 8 kN and the tensions in the inner and outer lap straps were 3 kN and 1.8 kN, respectively. Resolution of the applied load and strap tensions indicated a reaction between the dummy and seat of about 4 kN. The position and directions are indicated on Figure 15, where it is seen that most of the load would have been applied to the seat front cross bar.

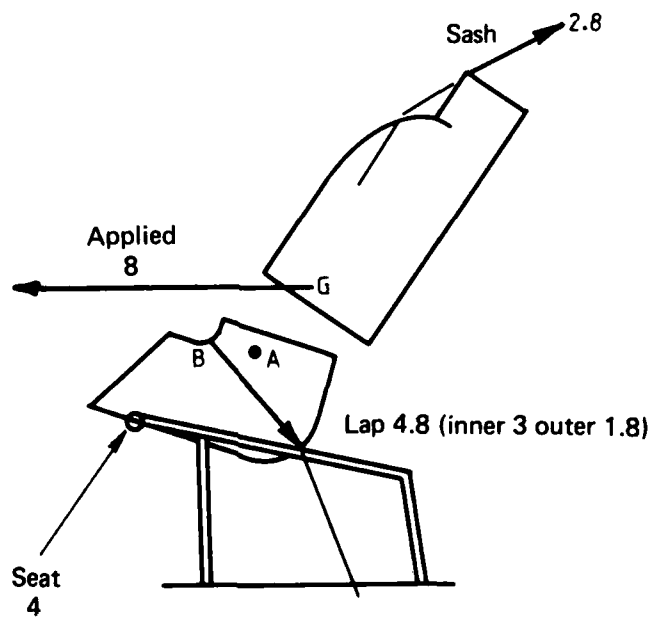
FIG. 15. RESOLUTION OF FORCES ONTO THE BODY BLOCK IN AIRCRAFT 'C'

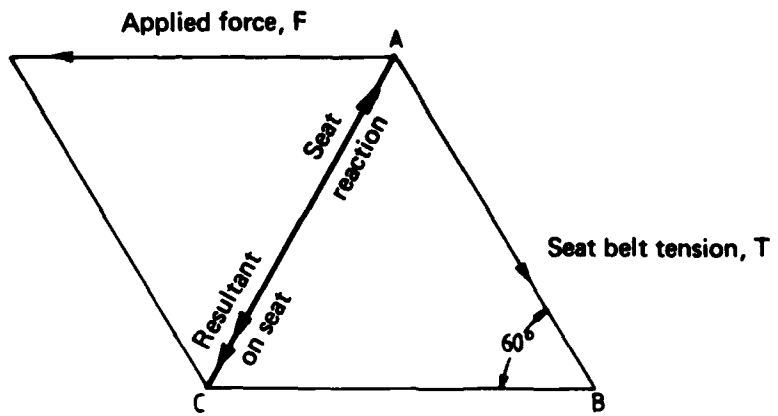
FIG. 17. RESOLUTION OF FORCES IN THE SEAT AND SEAT BELT. As F and T are equal (measured in test) and seat belt slope was 60° , triangle of forces ABC is equilateral, thus the seat reaction is also equal to F .

In all the tests with a lap belt, the tension in each strap was approximately half the forward load, thus the loop load from both straps was about equal to the forwards load. The lap strap slope varied during the test from the nearly vertical condition, shown on Figure 16a, to about 45° as shown on Figure 14c; however, at the design load (6.7 kN) the slope of the belt was approximately 60°. It follows that the resultant load on to the seat would also be approximately equal to the forward load, as shown on Figure 17.

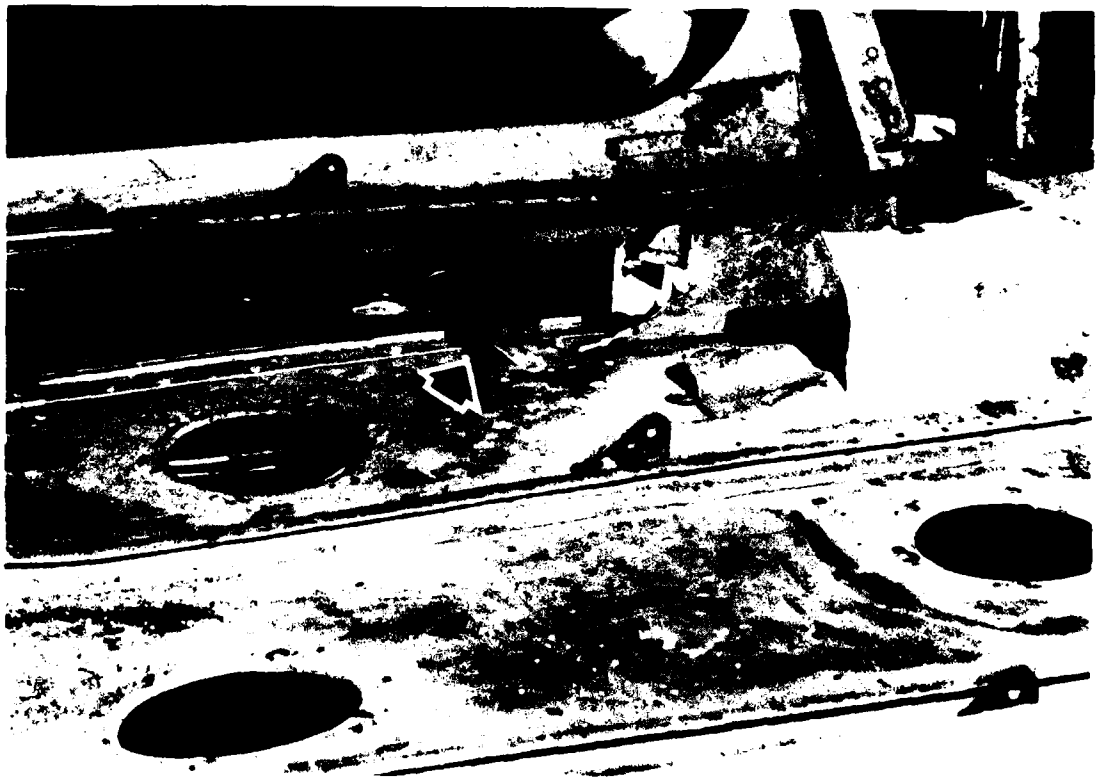
FIG. 18. FAILURE OF THE INNER LAP STRAP ANCHORAGE (9.2kN) – AIRCRAFT 'C'

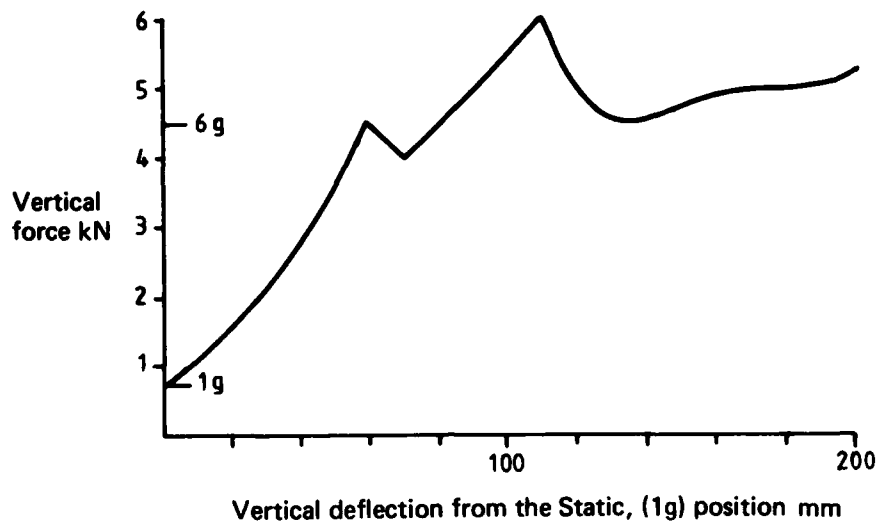
FIG. 20. VERTICAL FORCE DEFLECTION – AIRCRAFT 'C' – SEAT BACK AS SUBSTITUTE SEAT BASE.

The body block was pressed on to the seat cushion and the load and deflection were measured as it was forced through the seat frame until an occupant would have reached the floor of the aircraft. The fabric of the upholstery started to tear at a load of about 3 kN. The load reached 5 to 6 kN before the fabric failed completely. Loading was continued and the springs, acting as tension links or straps, reacted a force of about 5 kN as the body block was pressed through the seat. The force deflection characteristics are shown on Figure 20.

A seat back modified to represent the seat base withstood vertical loads of 5 to 6 kN (6-8 g). This force was reached after a downwards compression of the seat into the frame of approximately 100 mm. The fabric seat cover tore round the seat perimeter at that stage and as the body block was thrust further into the seat the springs resisted with a force of about 5 kN.

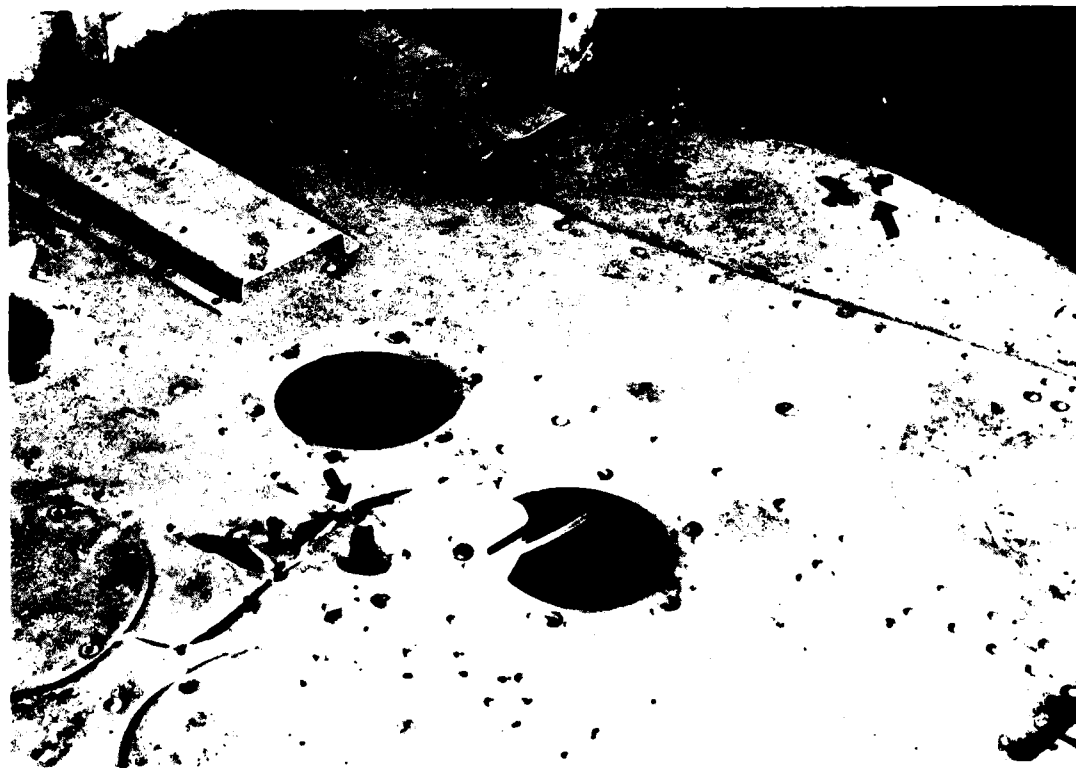
FIG. 21. FAILURE OF THE FLOOR AND THE PAIR OF INNER LAP STRAP ANCHORAGES (23kN) AND FAILURE OF THE OUTER ANCHORAGE (10kN) – BACK SEAT AIRCRAFT 'C'

The seat was removed and the inner anchorages tested by applying load directly to the two bolts. The load was applied in a forwards and upwards direction approximately 30° to the horizontal. The bolts withstood 21 kN with negligible deflection, but at 23 kN the floor panel split and resistance fell as the structure failed. The split is shown on Figure 21.
