CONTRACTOR REPORT ARLCD-CR-80013

**EVALUATION OF SMALL ARMS PROPELLANTS IN LOADING HOPPER**

**SOUTHWEST RESEARCH INSTITUTE**

**AUGUST 1980**

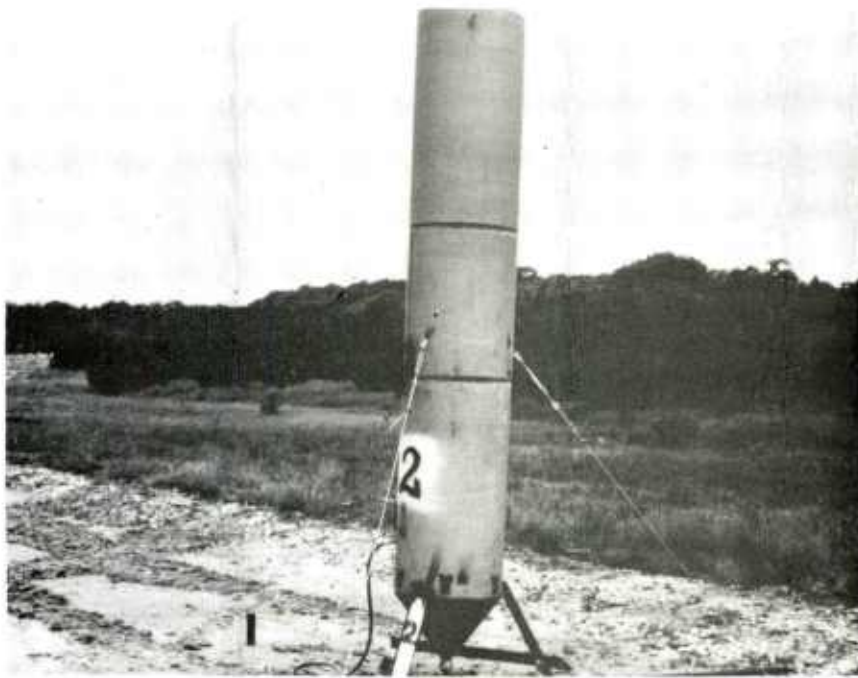
Figure 3. Emplaced conventional hopper

conical section to provide better structural integrity; 2) the conical section thickness, for the conventional hopper, was increased from 28 gauge to 6.3 mm to increase the hopper strength; and 3) loading ports were added immediately above the hopper section, on each type, to facilitate propellant loading. The ports were made from the same material as the hopper stack and were held in place by four 16-mm bolts. The door size for the conventional hopper was 470-mm across by 406-mm high. The SCAMP hopper port was 508-mm square. Figure 3 shows the emplaced conventional hopper and figure 4 shows the emplaced SCAMP hopper.

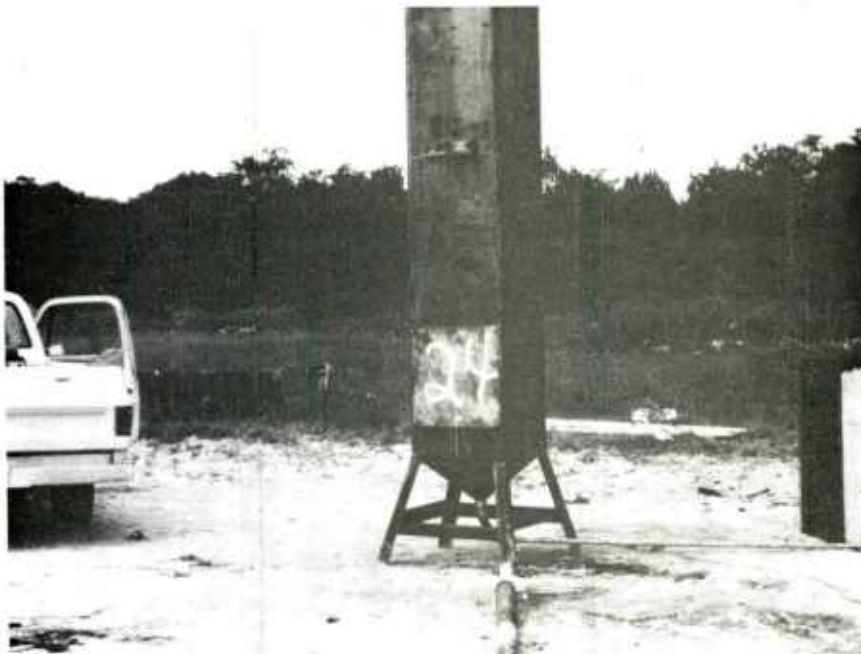
Figure 4. Emplaced SCAMP hopper

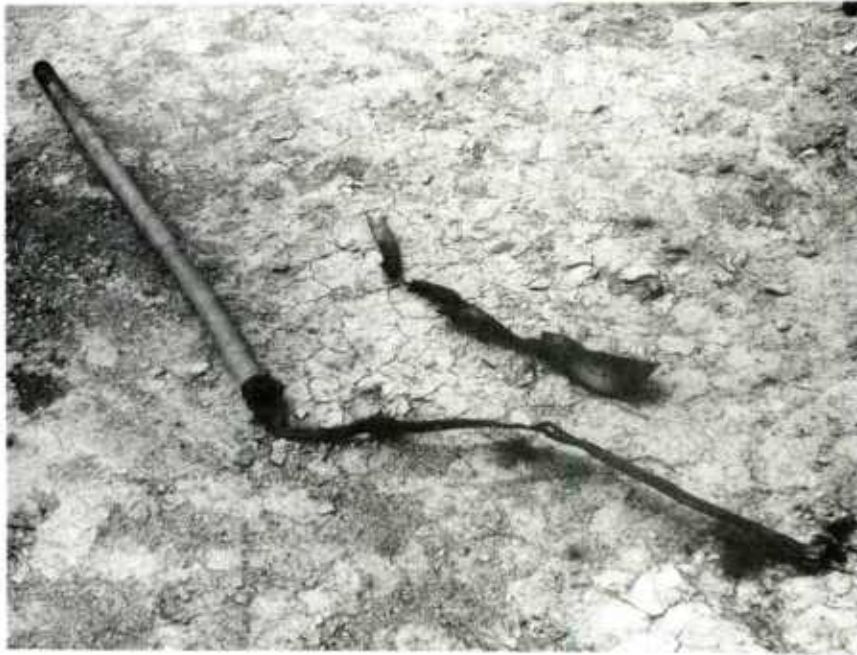
Figure 12. Steel feed pipe and fragments after explosion reaction of IMR 8208 propellant within the pipe

The burning reaction was not a problem in the hopper, but was in the feed pipe. On the second test of the IMR 8208 series, an explosion (or detonation) took place in the steel feed pipe about 1 m from the discharge end between 60 and 90 seconds after the initiation of the propellant in the hopper. Pipe fragments were found about 150 m from the test site. Figure 12 shows the feed pipe after the test. The large fragment which was recovered is also shown in the figure.

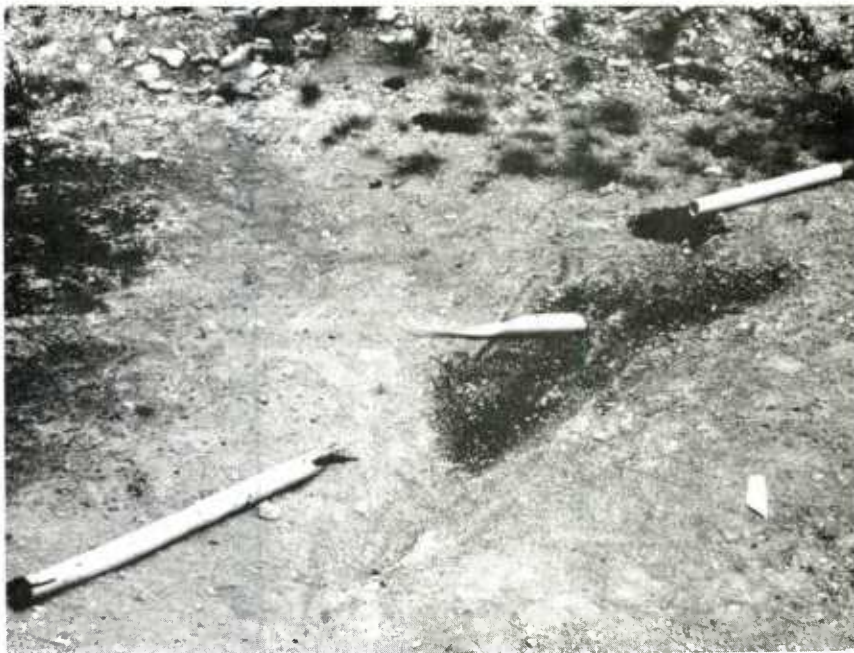
Figure 13. Typical PVC feed pipe fragments, IMR 8208 propellant test series

To reduce the confinement of the feed pipe and the hazard potential to equipment and material stored within 200 m of the test, PVC pipe was substituted for the steel pipe. The PVC pipe appeared to reduce the explosion frequency; however, two out of five feed pipes did explode. The reduction in frequency from 50% to 40% in the change of feed pipe material is not considered to be significant. The severity of the explosion, however, was reduced significantly in that PVC pipe fragments were usually found within 10 m of the test site. Typical PVC pipe fragments from this test series, are shown in Figure 13.

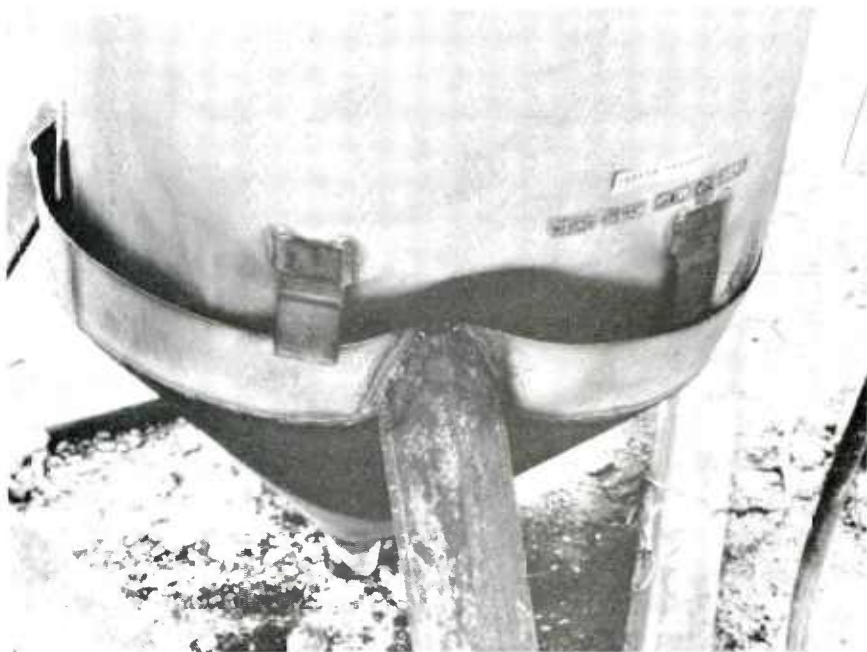
Figure 15. Initial conventional hopper after test with WC 818 propellant

The test series with WC 818 propellant was expected to produce higher reactions within the hopper than the IMR propellant. Indeed, in the initial exploratory tests, a test with WC 818 damaged the hopper so severely that a new hopper had to be made. The initial hopper configuration (before the test) is shown in figure 14. The hopper damage (fig. 15) was confined, primarily, to the hopper-stack junction. This damage was caused by the two-body action of the hopper and the sack during the propellant burning process which was compounded by the constraints placed by the guy wires used to support the hopper.

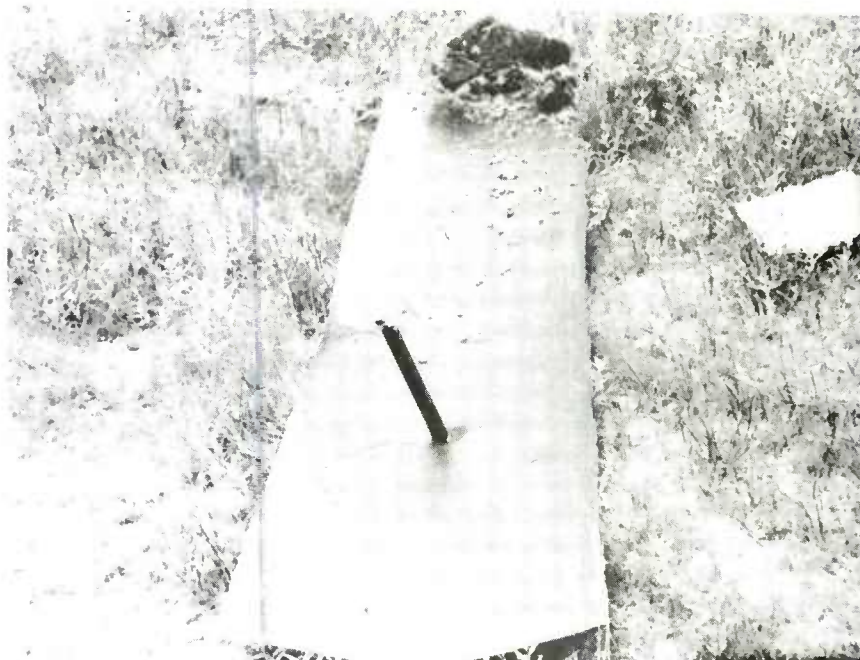
Figure 21. Second stack panel from SCAMP hopper after 91 kg of WC 844 propellant were initiated

The SCAMP hopper propellant load was initially specified at 91 kg. That charge was placed into the hopper and initiated (figs. 19 through 23). Side panels of the hopper were separated from the hopper and blown a distance of about 9 m. The damage necessitated the fabrication of another hopper. The shape of the side panel (fig. 22) indicated that a secondary reaction, located about half-way up the stack, may have caused the hopper explosion.

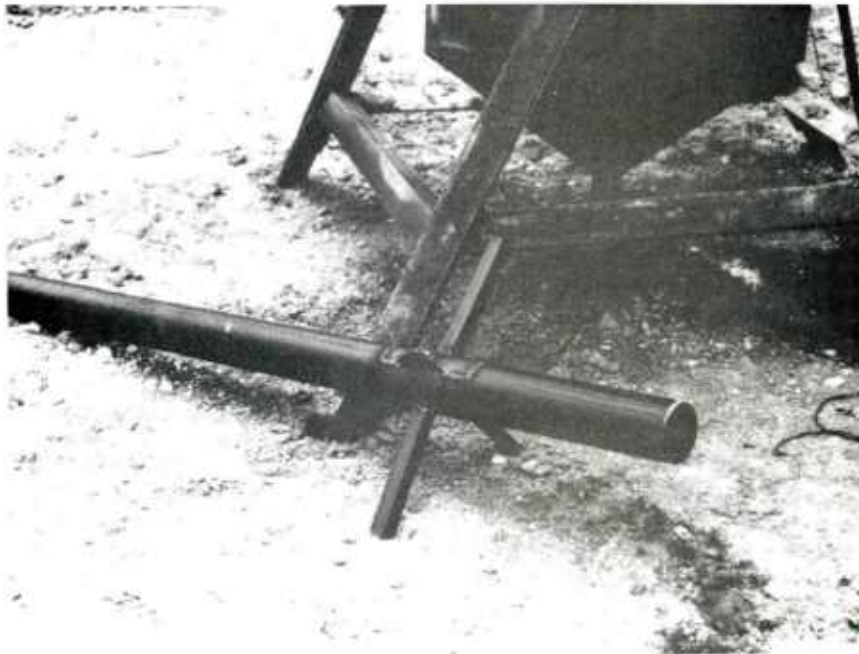
Figure 23. "Vent pipe" of SCAMP hopper after 91 kg of WC 844 propellant were initiated in hopper

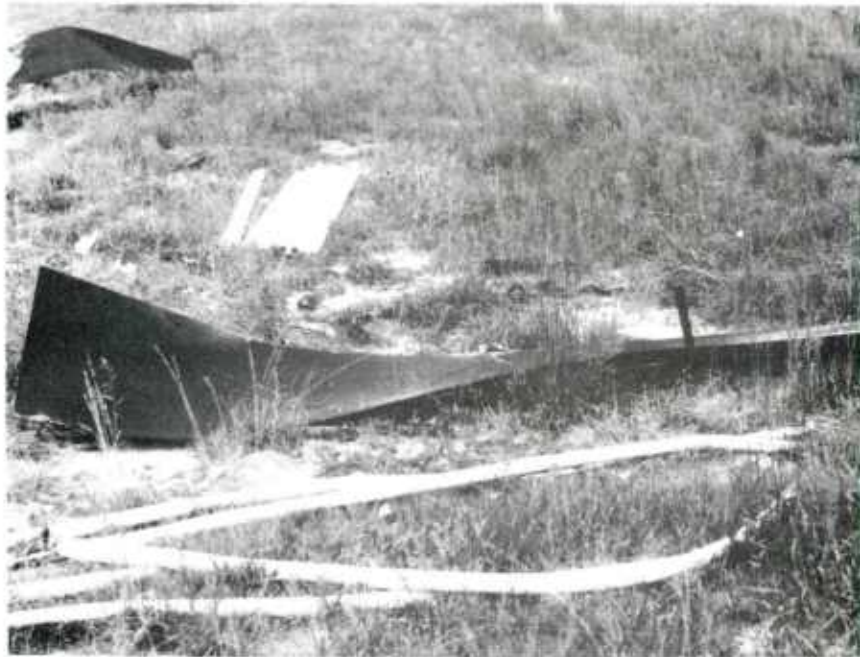
Figure 29. SCAMP hopper stack panel no. 2 after initiaon of 68 kg of WC 844 propellant

The SCAMP hopper propellant load was reduced to 68 kg as the "minimum acceptable" for process operations. To that end, the 68 kg propellant charge was placed in the hopper and initiated. Figure 24 illustrates the distribution of segments of the hopper following the explosion. Figures 25 through 30 are photographs of the hopper segments after the test. The pressure trace for this test is shown in figure 31. The "peak pressure" is in the order of 37.2 kPa. The trace shows a fairly rapid pressure excursion during the primary impulse followed by several smaller pulsations. Each vertical division represents 11.07 kPa and each horizontal division is 500 ms. Following this, test portions of the hopper were salvaged,

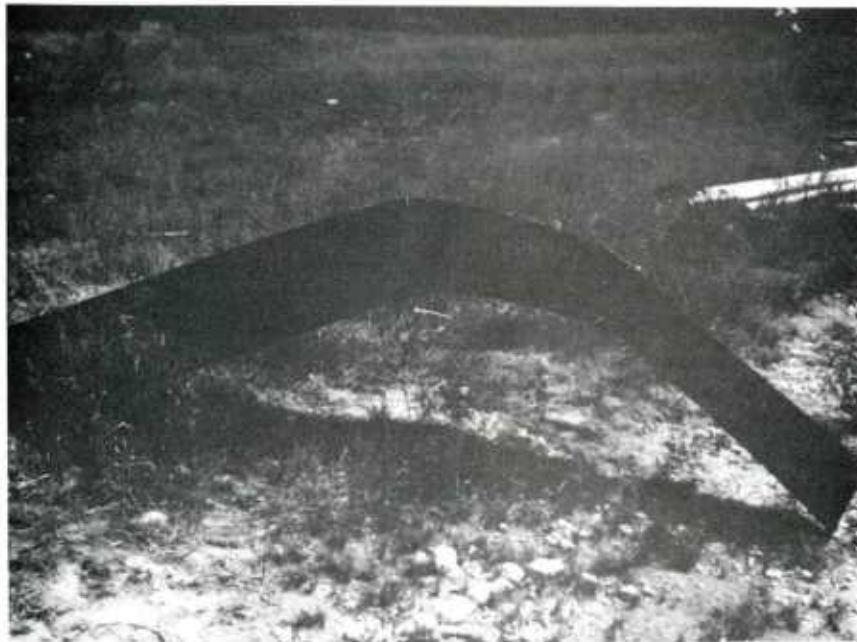
Figure 30. SCAMP hopper stack panel no. 3 after initiation of 68 kg of WC 844 propellant

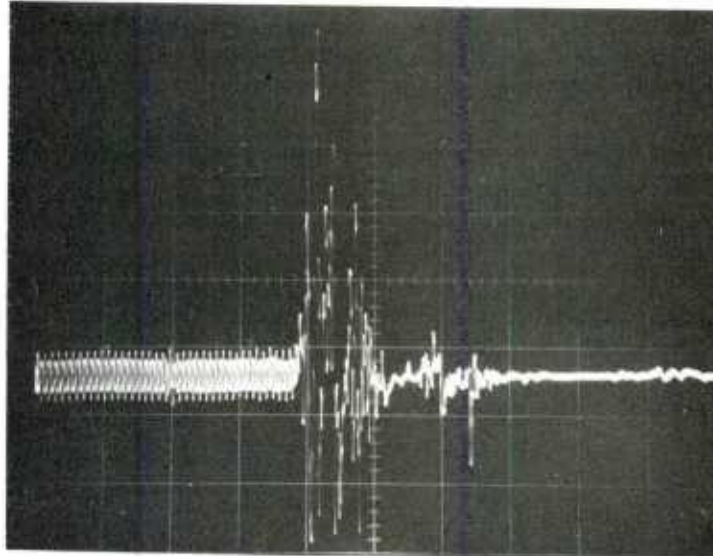
Figure 31. Pressure trace from SCAMP hopper with 68 kg of WC 844 propellant
