**EFFECTS OF MULTIPLE SHOT PEENING/CADMIUM  
PLATING ON HIGH STRENGTH STEEL**

*METCUT RESEARCH ASSOCIATES INC.  
3980 ROSSLYN DRIVE  
CINCINNATI, OH 45209*

TECHNICAL REPORT AFWAL-TR-80-4005  
Final Report for period 15 September 1978 — 15 December 1979

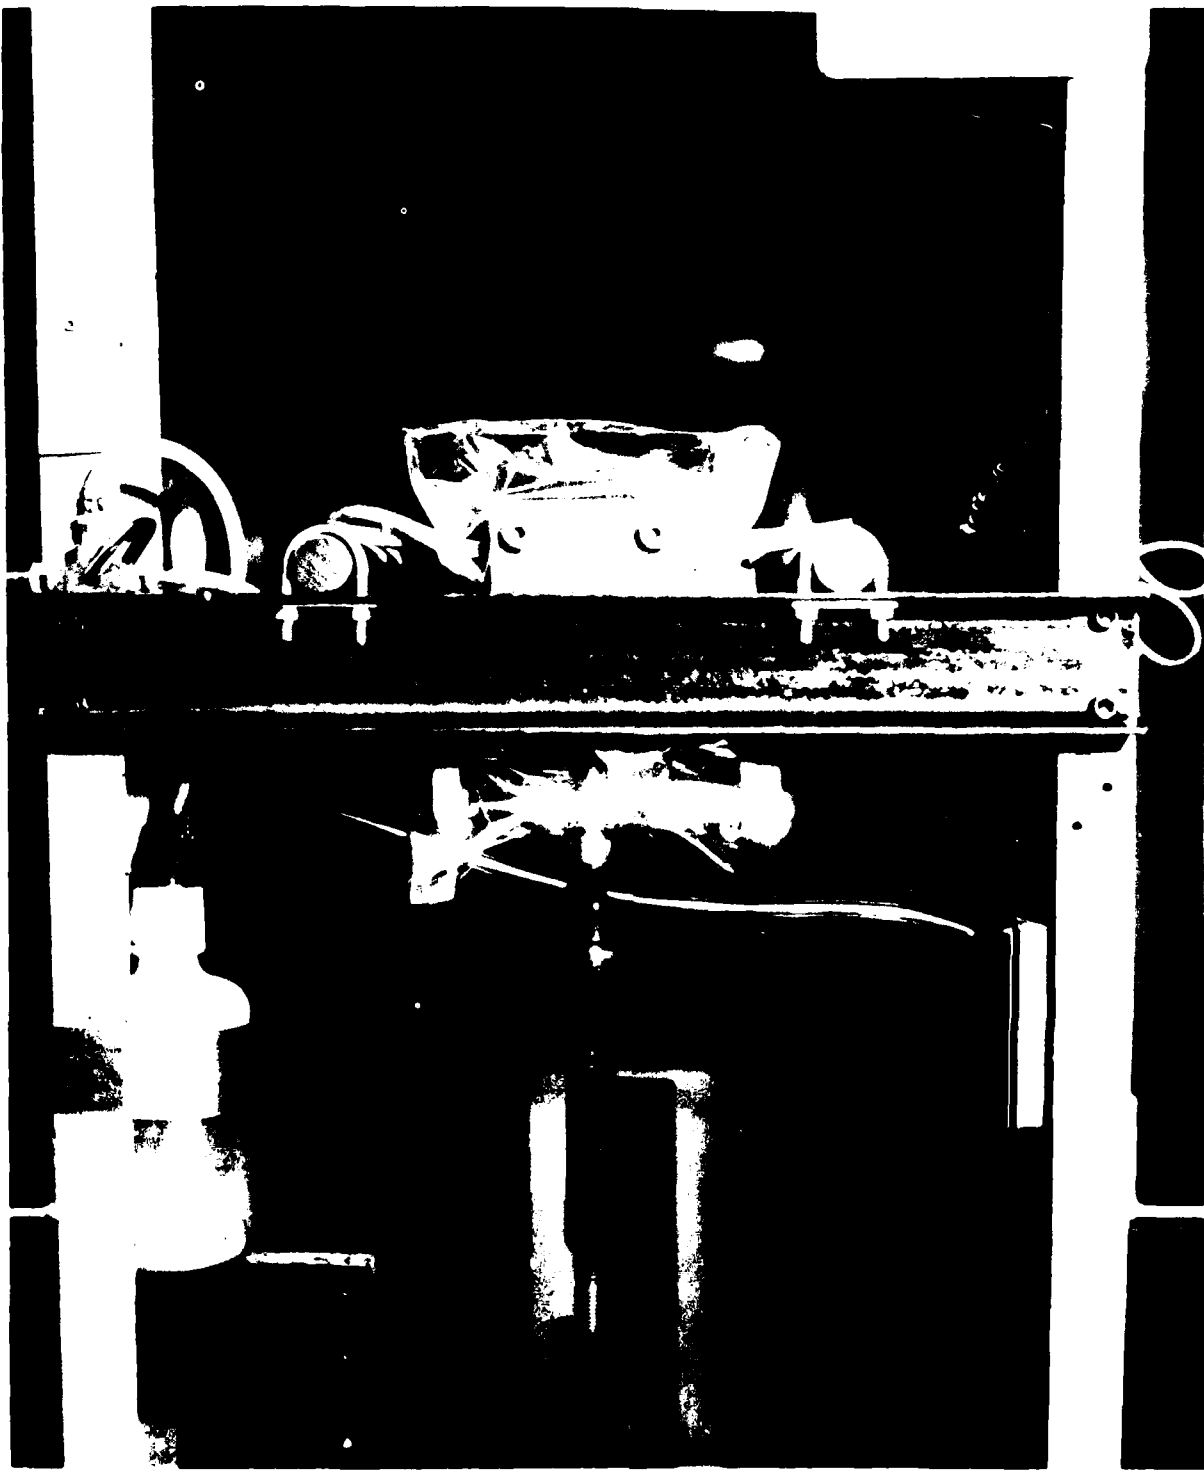
Figure 21 - Stress Corrosion Test Stand

Stress corrosion testing was conducted per ASTM G39-73, "Standard Method for Preparation and Use of Bent-Beam Stress-Corrosion Specimens" with one exception. Tests were conducted via a constant load, four-point bending technique rather than the constant displacement, four-point bending procedure outlined in the ASTM method. Specimens were nominally 3/8 in. thick by 1 in. wide by 12 in. long (9.5 x 15.4 x 305 mm). Loading fixtures were constructed such that the distance between end supports was 11 in. (279.4 mm) and the bending moment arm was 4 in. (101.6 mm). Therefore the constant bending moment test section of the specimen was the central 3 in. (76.2 mm) of its length. A schematic diagram of the loading fixture is shown in Figure 20. The loading fixture was mounted on a creep-rupture testing machine such that the dead-weight load could be applied using the 20:1 mechanical advantage of the equipment's lever system. Three such testing machines were outfitted and employed for testing in this program. A photograph of a test machine with specimen and loading fixture in place is shown in Figure 21.

The test environment was air at 80-100% relative humidity. This atmosphere was produced by bubbling compressed air through tap water and passing it into a plastic bag surrounding the test section.
