EXPERIMENTAL INSTALLATION OF MAST MOUNTED SIGHT  
ON AN OH-58C HELICOPTER

James A. Rule, Horace W. Hanson, Harry K. Harr, John P. Norvell,  
David A. Popelka

Bell Helicopter Textron  
P. O. Box 482  
Fort Worth, Texas 76101

Final Report for Period March 1978 - January 1980

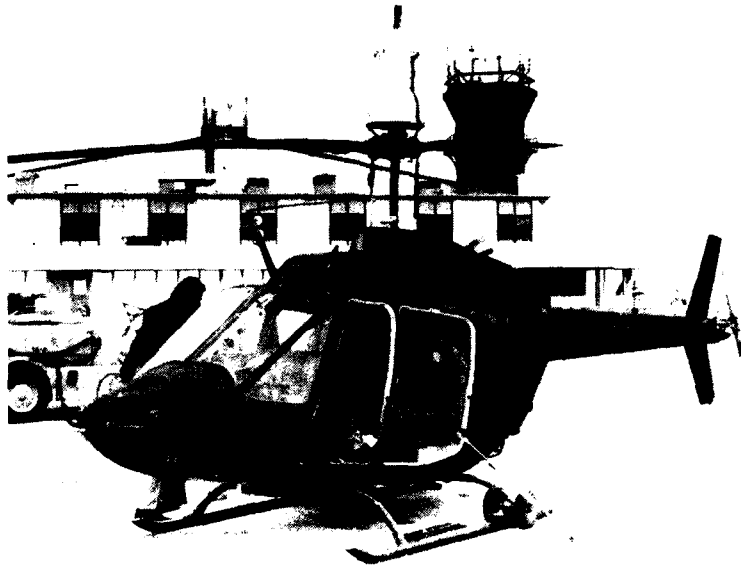
Figure 1. OH-58C with dummy sight installed.

The helicopter, shown in Figure 1, was a bailed U.S. Army OH-58C, Army Serial No. 69-16214. The dummy sight is shown installed on a focal mount on top of the mast. A BHT commercial Model 206 SCAS kit and hydraulically boosted tail rotor controls were installed in the helicopter to improve handling qualities and provide a stable platform for sight operation. The airframe was strengthened and a stiffer main rotor pylon isolation mount was installed.

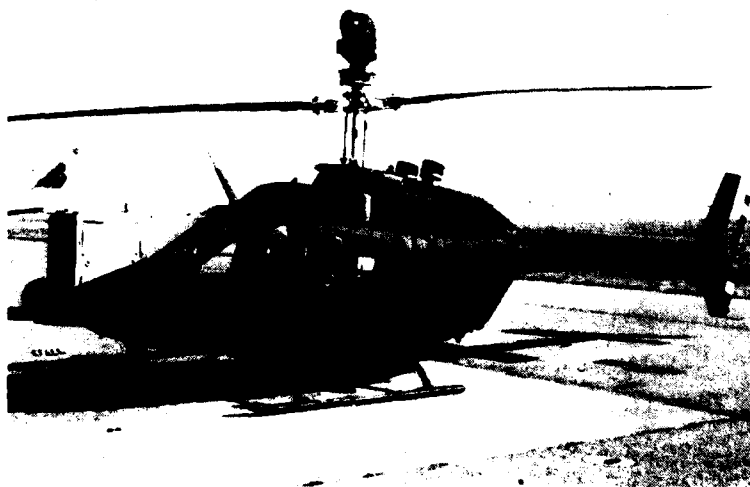
Figure 2. OH-58C with Rockwell sight installed.

Figure 2 shows the OH-58C with the Rockwell mast mounted sight installed on the focal mount. In addition to the sight, the Rockwell system included a number of electronic boxes and instrumentation equipment.

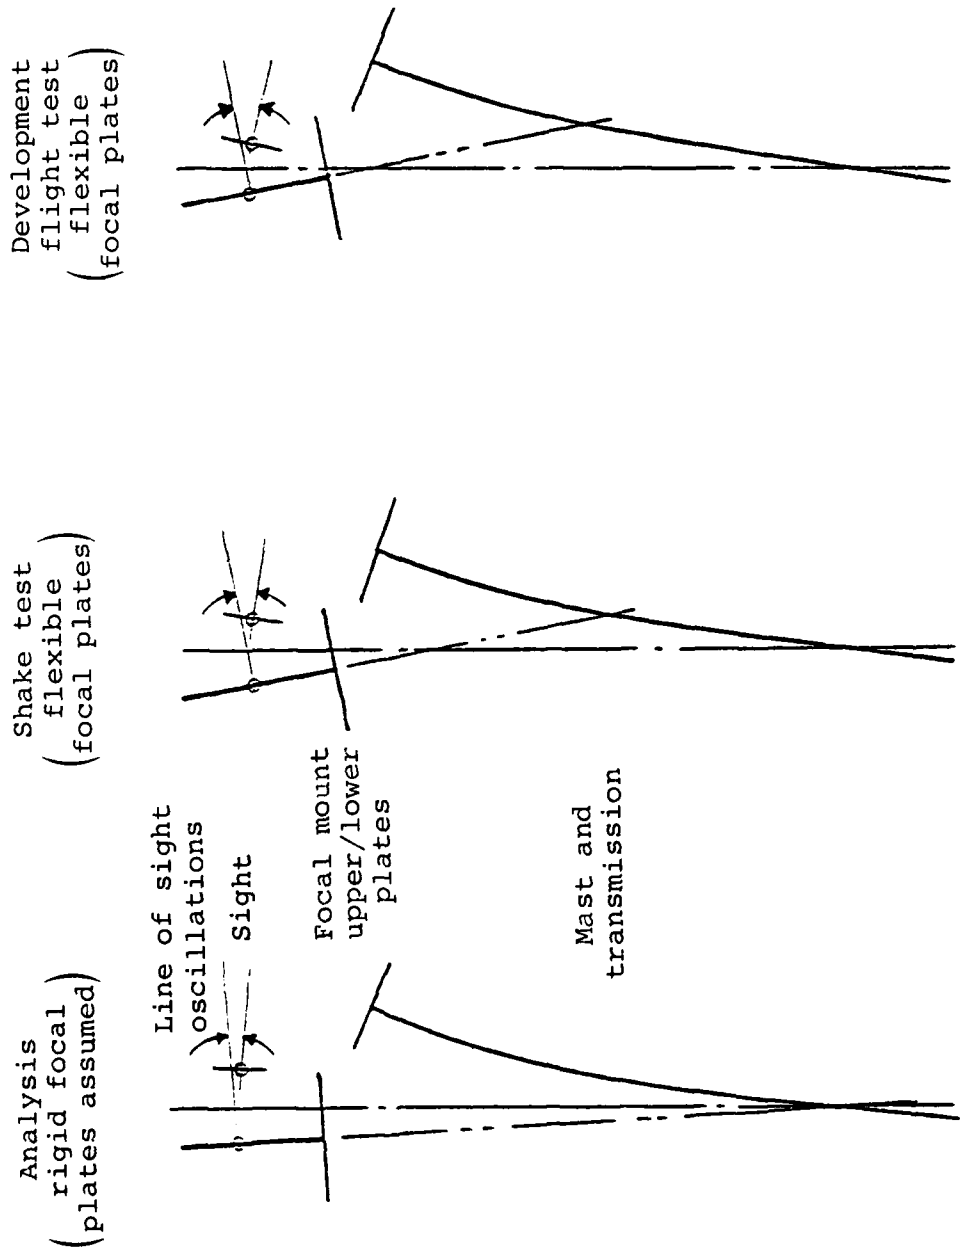
Figure 7. Comparison of MMS focal mount 2/rev pitch response deflection shapes.

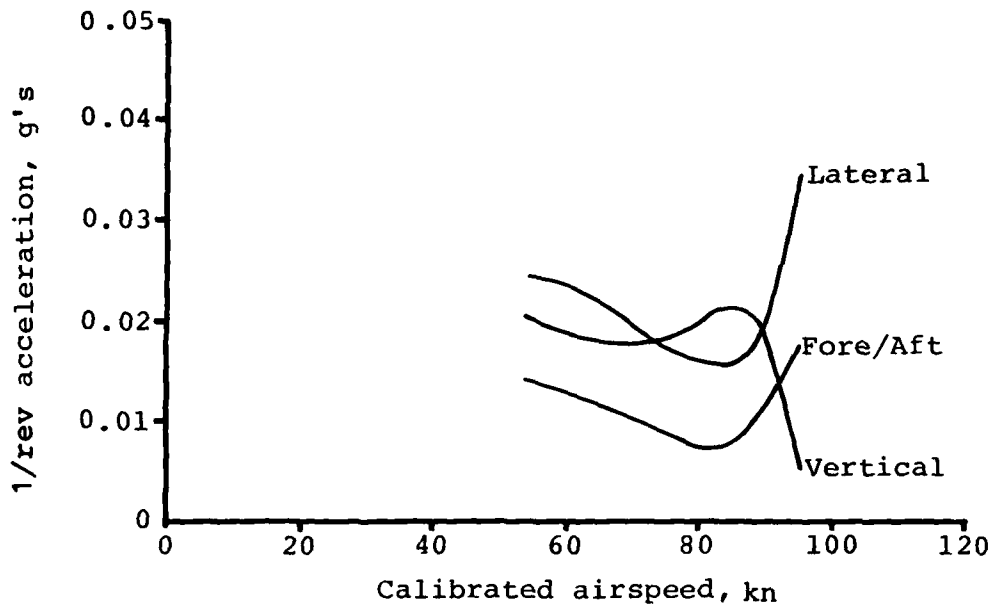
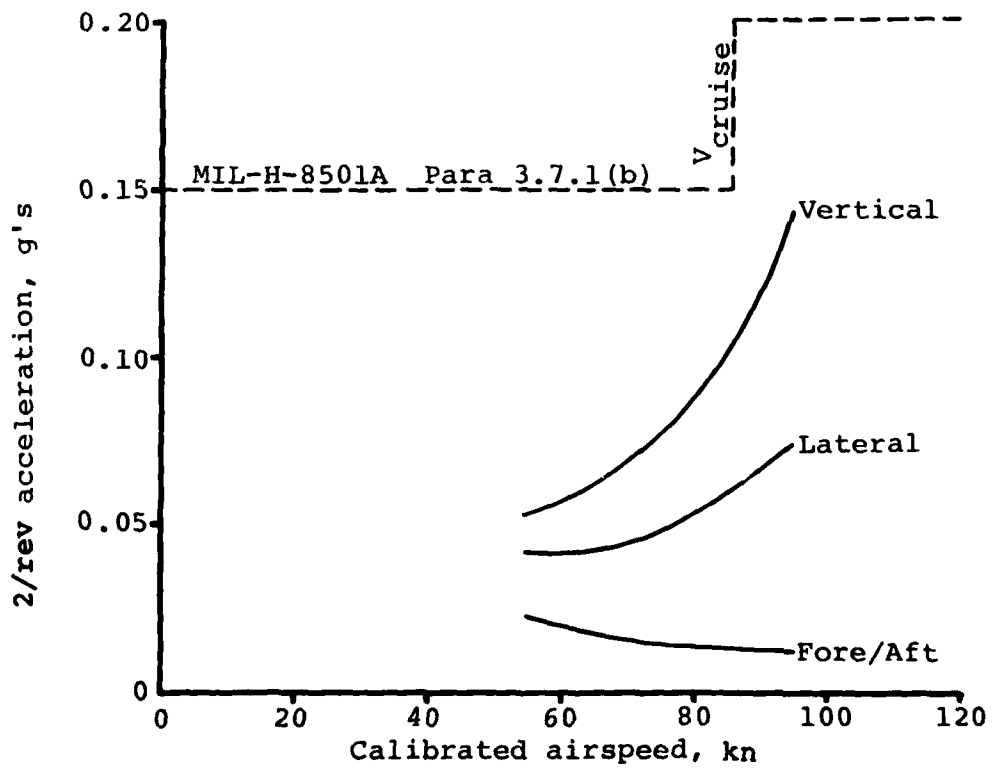
Figure 9. Pilot's seat vibration versus level flight airspeed - dummy MMS development flight test.

For a 72-pound MMS configuration and a compromise main rotor balance providing marginally acceptable pilot's seat one-per-rev vibration, representative level flight vibration data for the MMS cg and the pilot's seat are shown in Figures 8 and 9, respectively. MMS translational response did not exceed 1.85g's, including maneuver and moderate gust conditions; pitch rotational response did reach the Rockwell limit during severe gusts at 85 KCAS. With the MMS installed, maximum continuous torque at level flight resulted in 96 KCAS, and  $V_{cruise}$  was estimated 86 KCAS. Pilot's seat one-per-rev vibration levels were significantly higher than on the baseline OH-58C aircraft, especially during hover and at the higher airspeeds. No adverse loads or handling qualities problems were encountered.

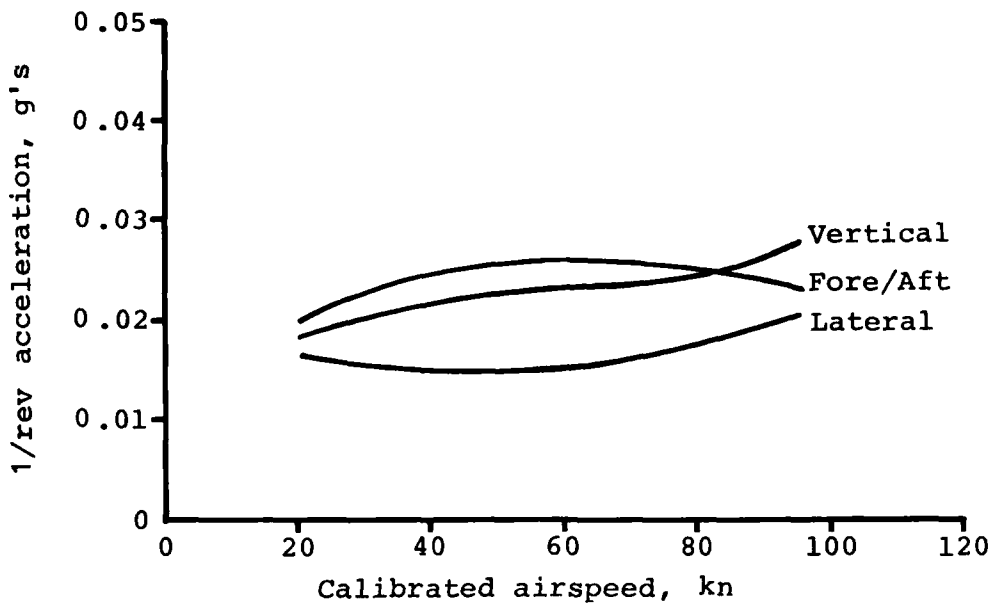
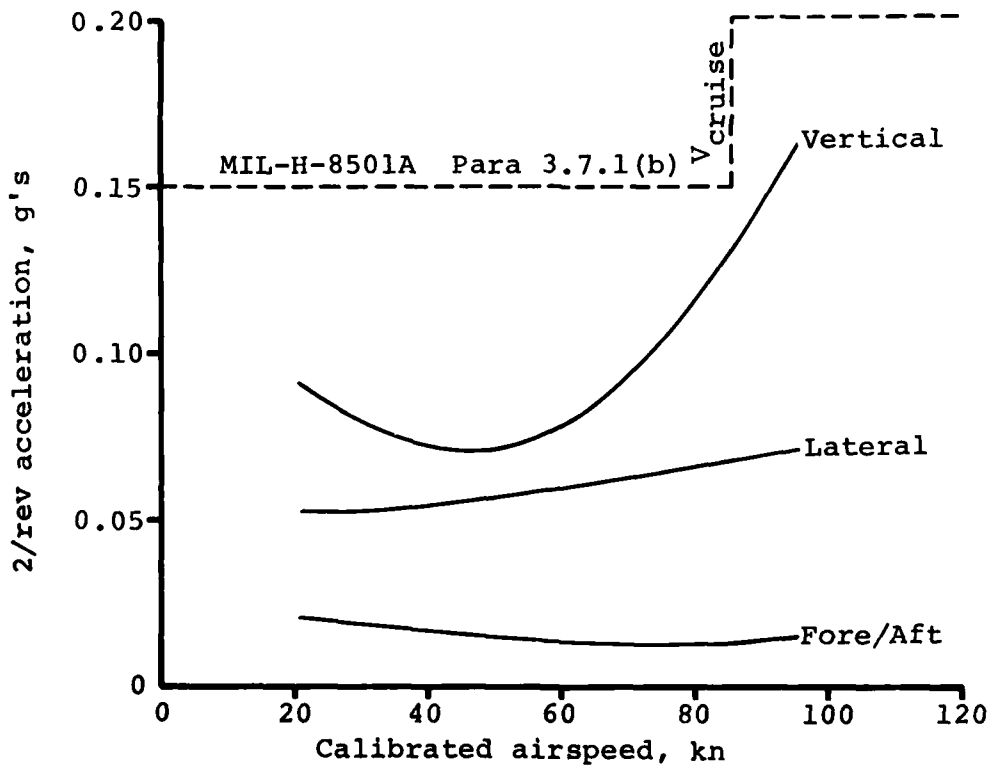
Figure 14. Pilot's seat vibration versus level flight airspeed - dummy MMS load level and vibration survey.

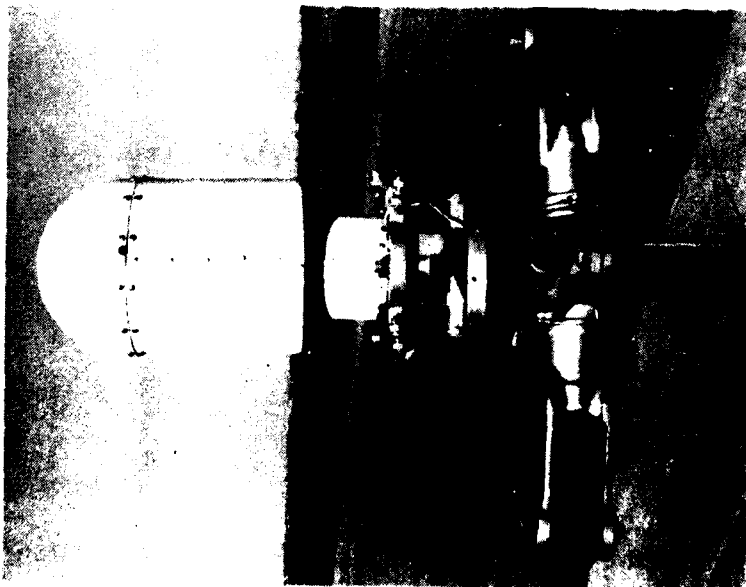
Figure 15. Nonrotating dummy sight on OH-58C.

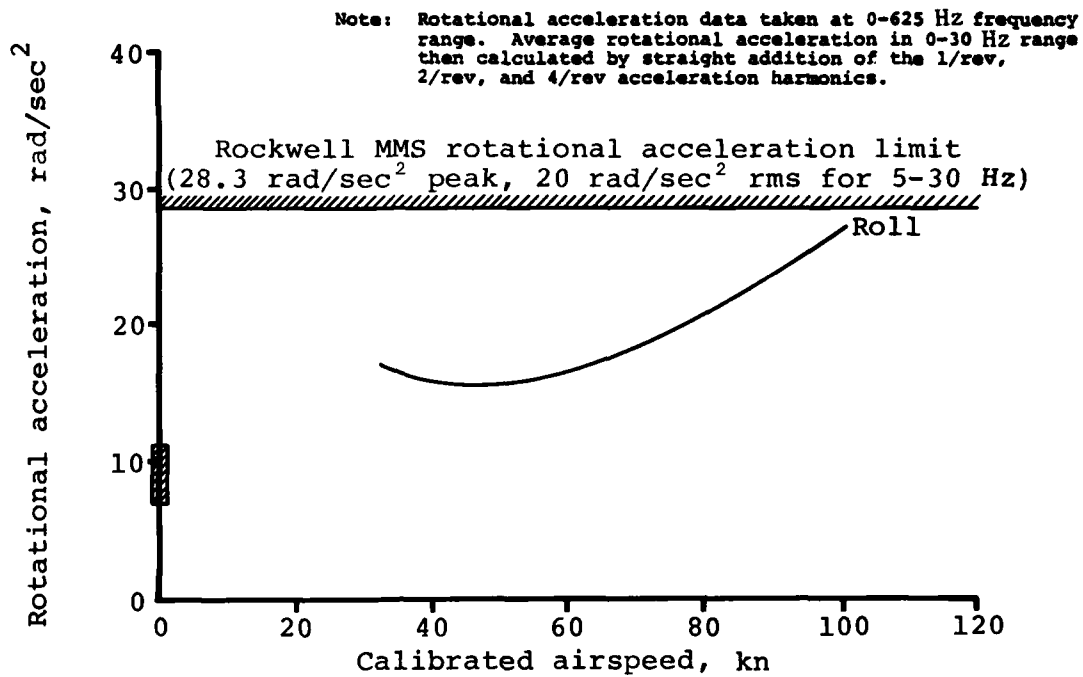
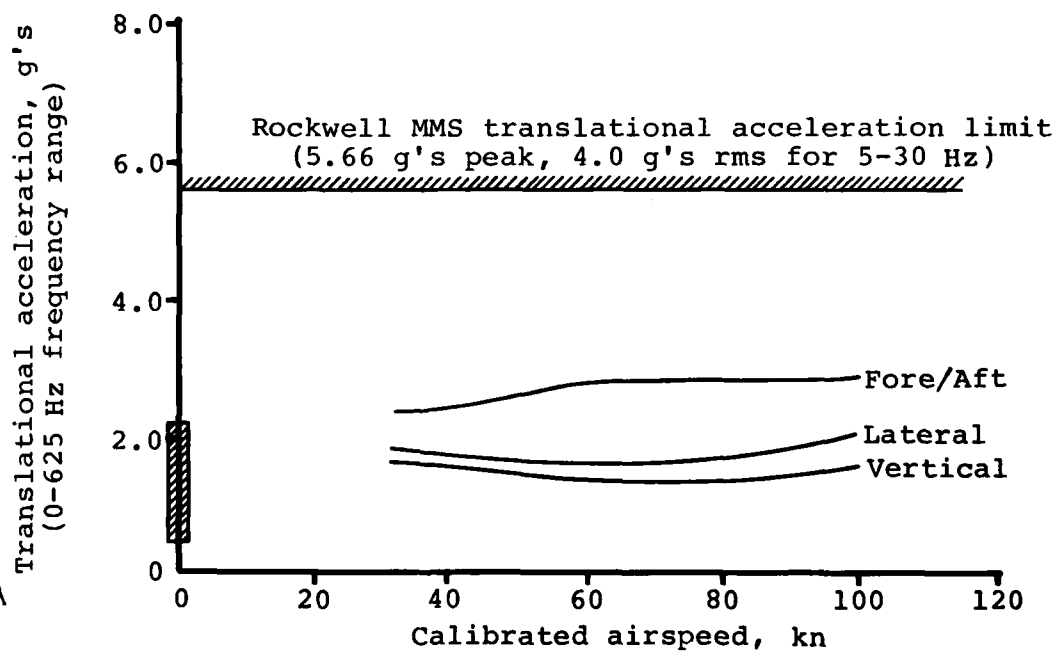
Figure 17. Rockwell MMS average vibration versus level flight airspeed - vibration survey.

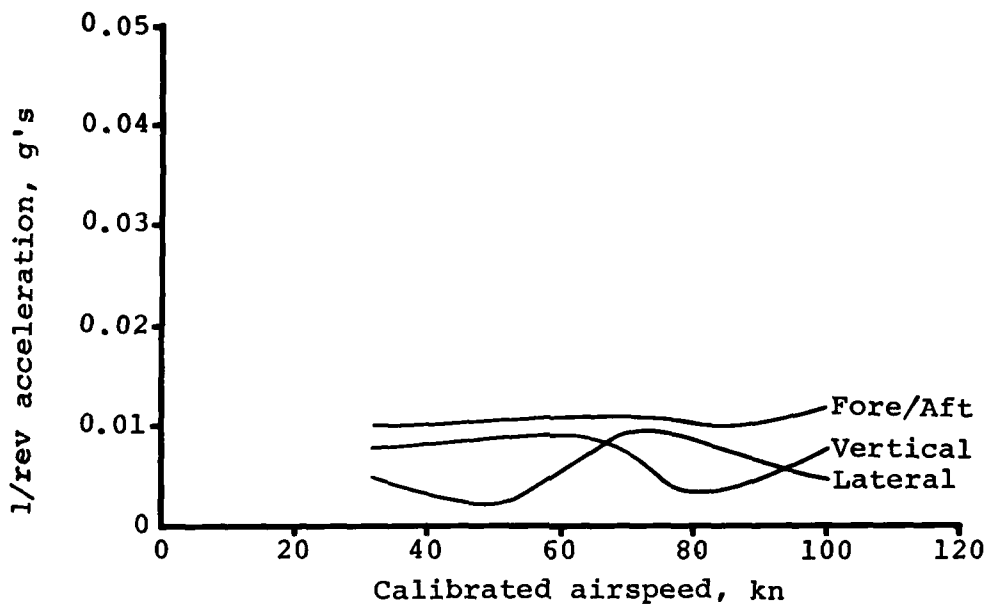
Figure 18. Pilot's seat vibration versus level flight airspeed - Rockwell MMS vibration survey.
