**Experimental Dune Restoration and  
Stabilization, Nauset Beach,  
Cape Cod, Massachusetts**

TECHNICAL PAPER NO. 80-5

**U.S. ARMY, CORPS OF ENGINEERS  
COASTAL ENGINEERING  
RESEARCH CENTER**

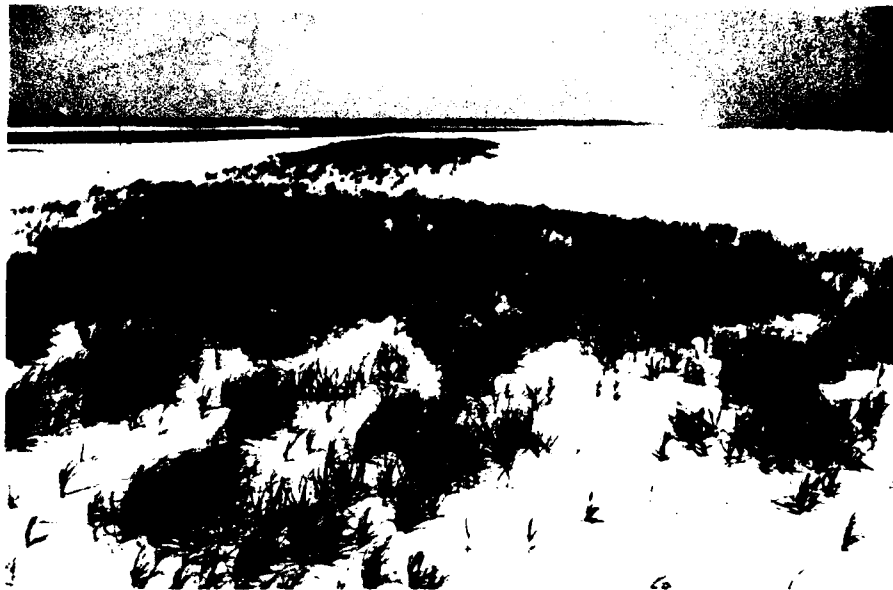
Figure 19. Plot 5 (American beachgrass on 90-centimeter spacing), May 1973.

b. Short-Term Dune Growth. Sand accumulation was negligible at the end of the first growing season. After two growing seasons 10 cubic meters per meter had accumulated and the crest elevation was 2.9 meters, 0.9 meter above the initial planting surface (Fig. 19).
