AD-A092 245 PRATT AND WHITNEY AIRCRAFT GROUP WEST PALM BEACH FL 8--ETC F/G 11/6  
SCALE-UP OF A TITANIUM CARBONITRIDE COATING SYSTEM FOR TITANIUM--ETC(U)  
JUL 80 L S SOKOL, C C MCCOMAS DAA646-77-C-0057  
UNCLASSIFIED PWA-FR-1897 AMRC-TR-80-39 NL

PWA-FR-11897

**ANMRC-TR-80-39**

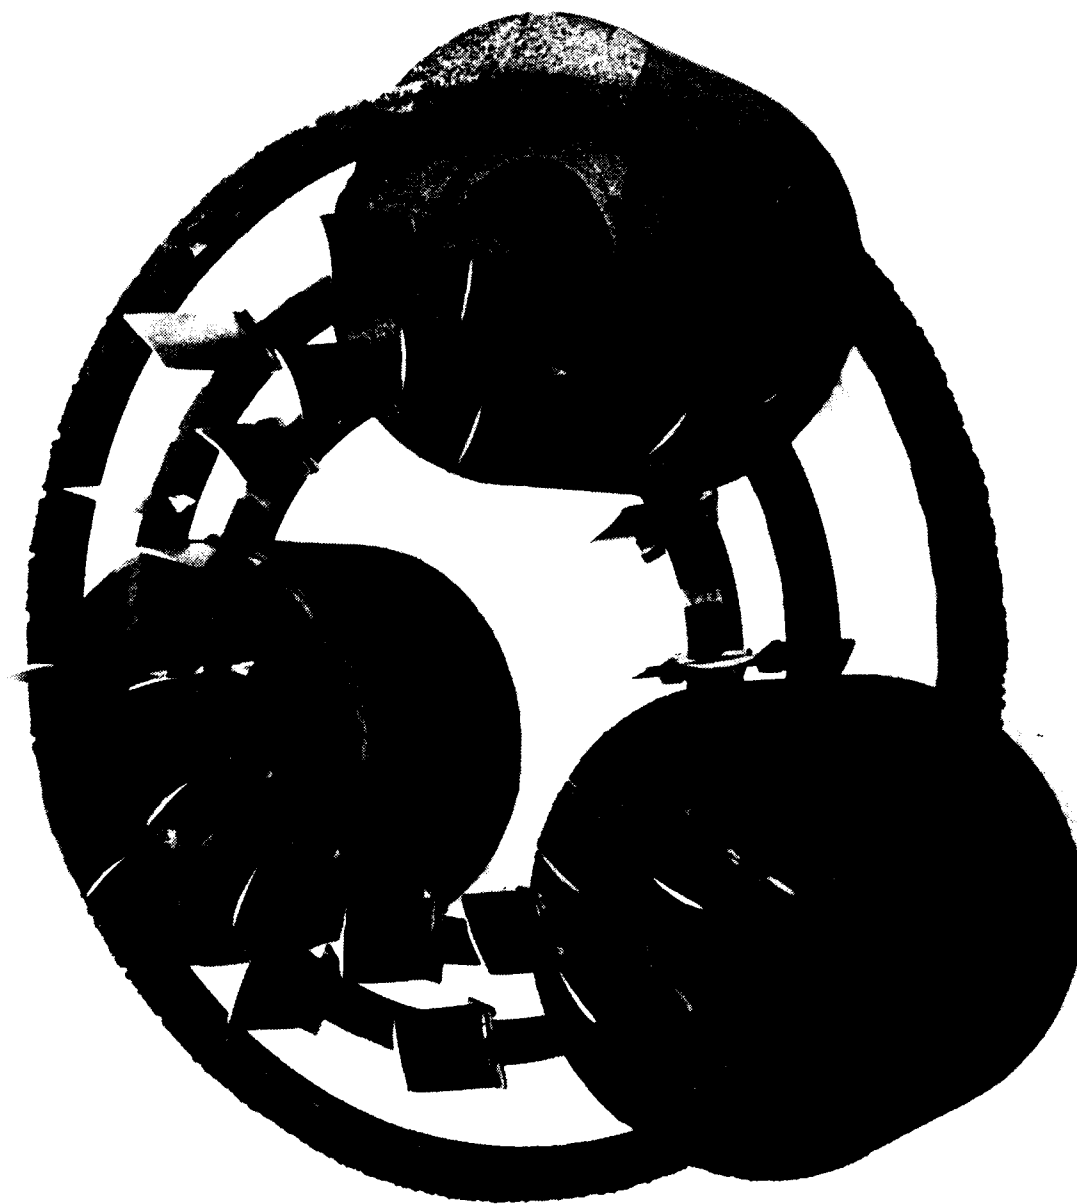
*Figure 24. Graphite Rings Used as Blade Holders*

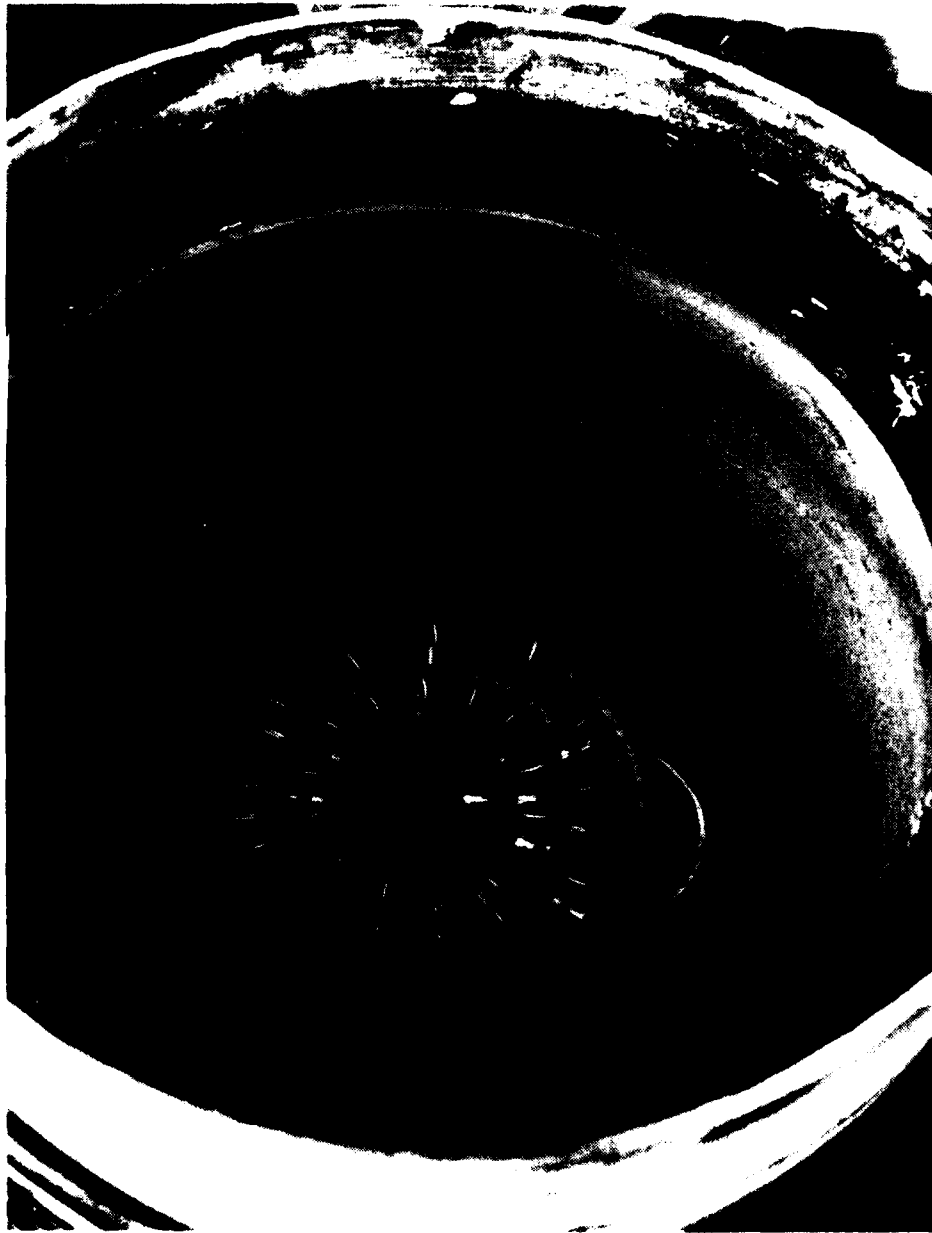
*Figure 25 - Blades Positioned in Furnace Chamber*

4. Distribution of gas flows and gas inlet temperatures was found to be a key variable in this process. Insulation at the top of the furnace was changed to increase or decrease the gas temperature as it entered the furnace chamber. Different types of baffle plates were tried to distribute the gas evenly, and the parts to be coated were positioned at different levels in the chamber. The conditions that gave the best results were an inlet temperature of 650°C, an inlet baffle plate 2 in. in diameter 1 1/2 in. below the inlet to the chamber and the parts positioned 4 to 5 in. below the baffle plate.
