LOAD TESTS OF A WOOD FLOOR OVER A BASEMENT

FINAL REPORT

FEMA Contract DCPA01-78-C-0223

A. Longinow  
R. P. Joyce

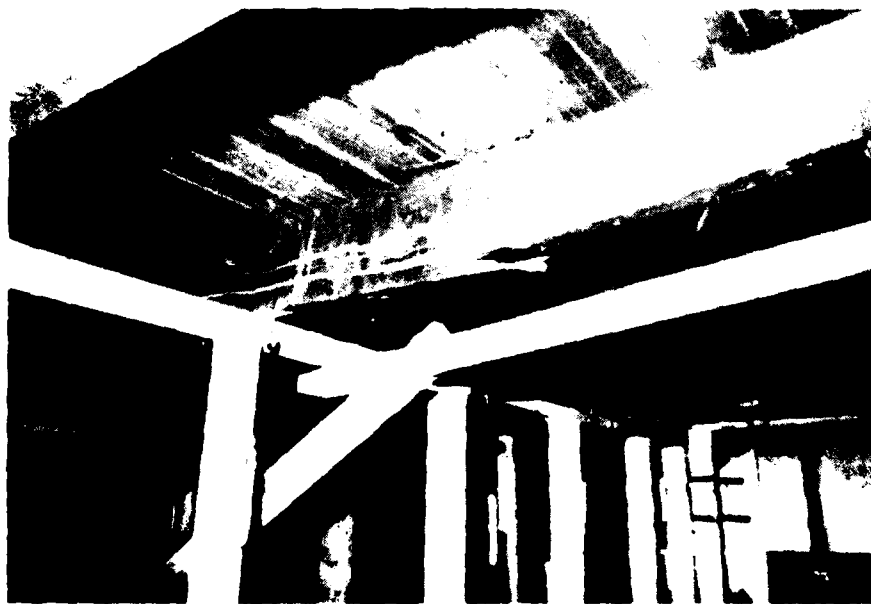
Figure 13. Failure of Joist 14E

Figure 13, joist 14E had no visible flaw aside from the initial failure cracks shown in Figure 10.

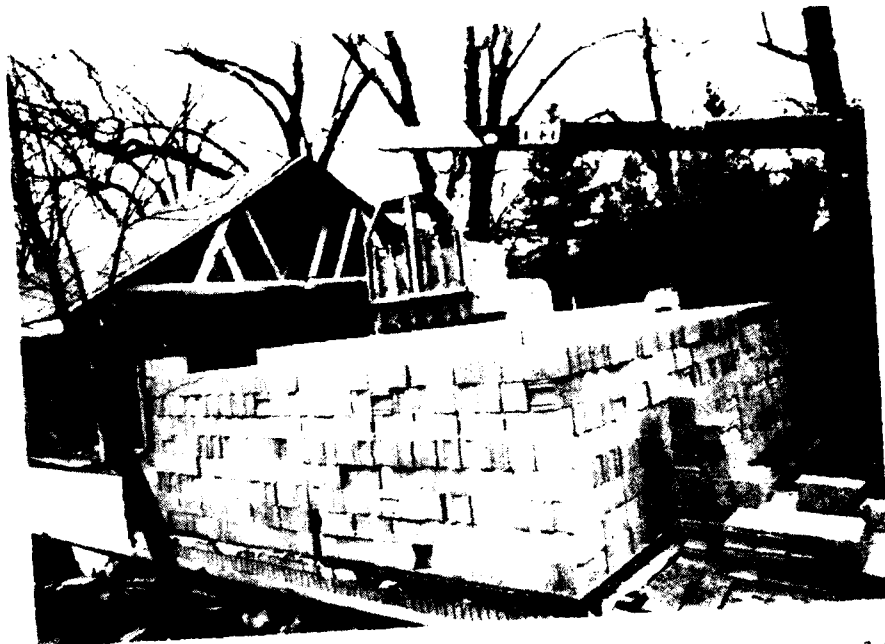
Figure 24. Start of Loading, Second Load Test

The loading sequence of the test structure is shown in Figures 24, 25, 26, and 27. Figure 24 shows the initial loading with the random distribution of the block and the method for conveying the block to the test structure.

Figure 25. Load at 12 Pallets of Block, 43,200 lb

Figure 26. Load at 42 Pallets of Block, 141,200 lb

Figure 27. Final Load at 47 Pallets of Block, 169,600 lb
