MISCELLANEOUS PAPER SL-80-18

# MONITORING DEFLECTION AT LOCKPORT AND AT BRANDON ROAD LOCKS CHICAGO DISTRICT

MONITORING DEFLECTION AT LOCKPORT AND AT  
BRANDON ROAD LOCKS, CHICAGO DISTRICT

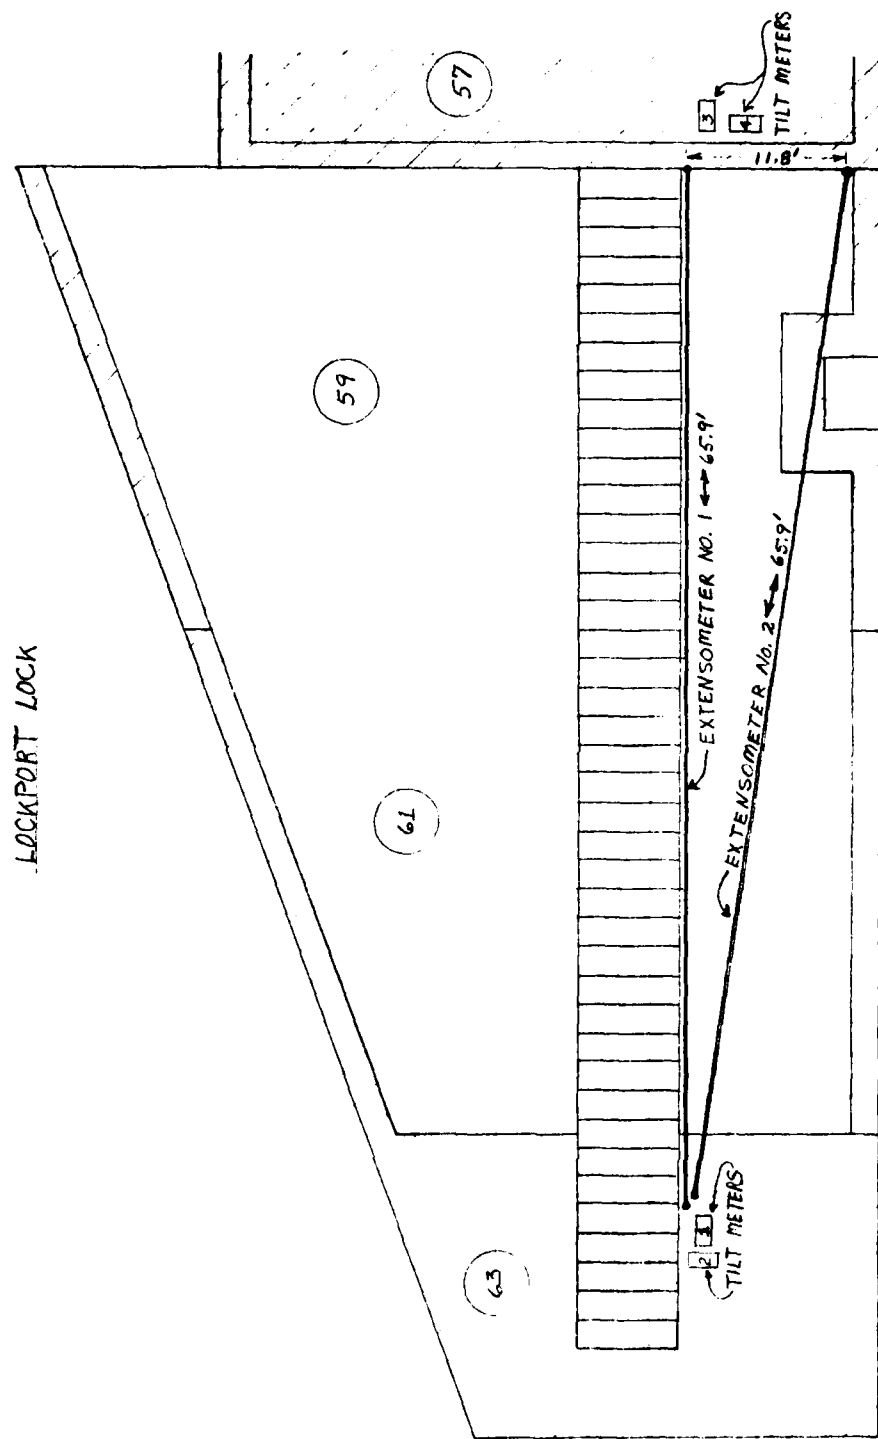
- a. Three extensometers were installed between monoliths 57 and 63 for the purpose of monitoring the movement of 63 with respect to 57. The movement of monolith 63 was referenced to the downstream vertical face of monolith 57. Figure 1 shows the extensometers to monitor downstream (gage No. 1) and lateral (gage No. 2) movements. Figure 2 shows an extensometer to monitor vertical (gage No. 3) movements. The extensometer rods are connected to built-in linear potentiometer for remote electrical read-out.

- b. Two inclinometers (tilt meters) capable of measuring  $\pm 14.5$ -deg tilt were installed on monolith 63. One inclinometer was installed with its sensitive axis parallel to the lock wall (meter No. 1) and the other perpendicular to the lock wall (meter No. 2). These meters are fully self-contained and designed to operate from a standard DC power source. Its output is an analog DC signal directly proportional to the sine of the angle of tilt. These meters are shown in Figure 1.

- c. Two inclinometers (meters No. 3 and 4) were also installed on monolith 57 in the same manner as described in b above and are also shown in Figure 1.

EXTENSOMETER NO'S 1 & 2 BETWEEN MONOLITHS 57 & 63  
 FOR MEASURING SEPARATION & LATERAL MOVEMENTS  
 & INCLINOMETER NO'S 1, 2, 3, 4 FOR MEASURING TILT  
 FIGURE 1

8. All gages were monitored for a minimum period of six months. The data has been reduced to plots as shown in the figures. Figure 1 shows the location of extensometers 1 and 2 which measured the axial upstream-downstream movement (No. 1) and lateral movement (No. 2). Figure 1 also shows the locations of tilt meters 1 through 4. Figure 2 shows the location of extensometer 3 mounted along the stairway and anchored at the base of monolith 63 and near the top of monolith 57 to detect any vertical movement.

11. The results from four tilt meters located as shown on Figure 1 are shown on Plates 8 through 11. No significant movement is indicated on either monolith 57 or 63. A shift occurred on monolith 57 axial tilt meter and on both axial and lateral tilt meters on monolith 63 at 118 days. This amounts to 0.1 degree of tilt. The reason for this is not known and is probably an electronic shift since the extensometer did not confirm such a change at 118 days.

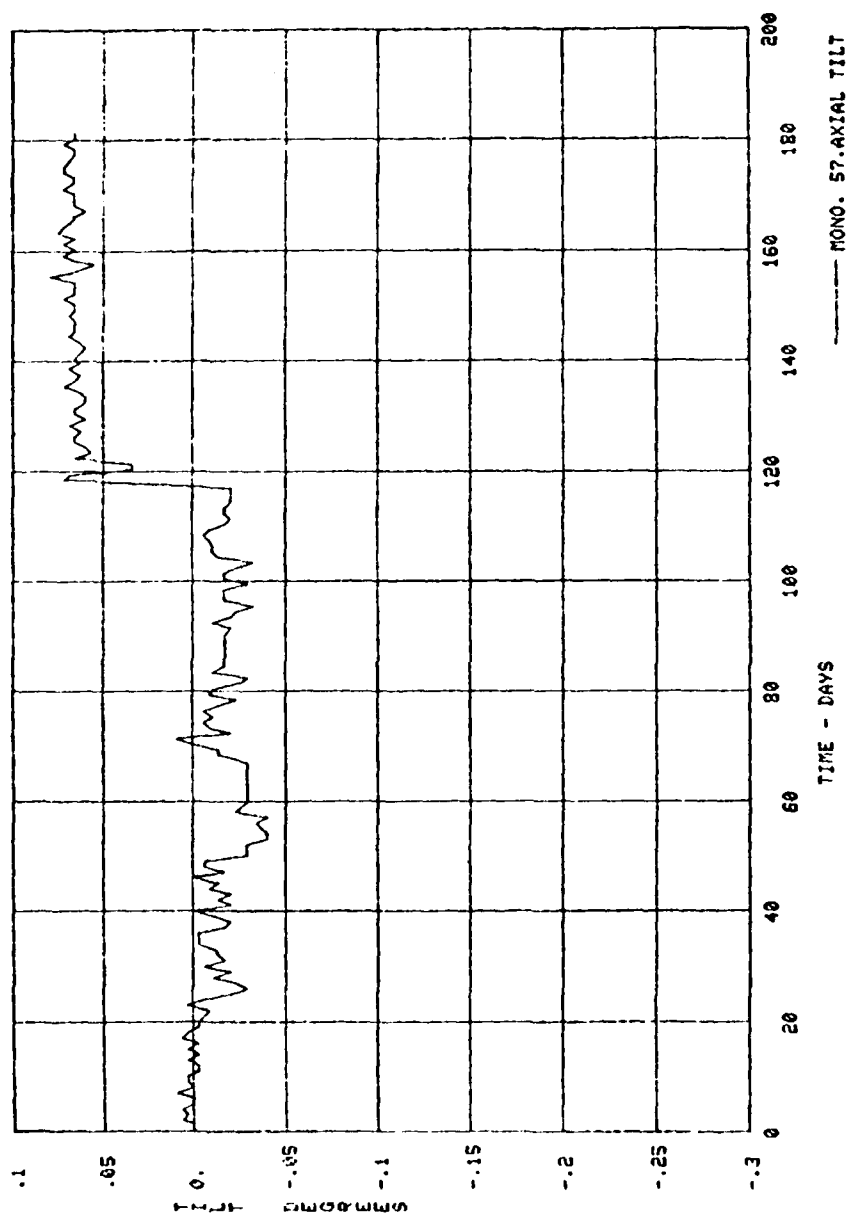
FIGURE 9 LOCKPORT L & D, MONOLITH NO. 57

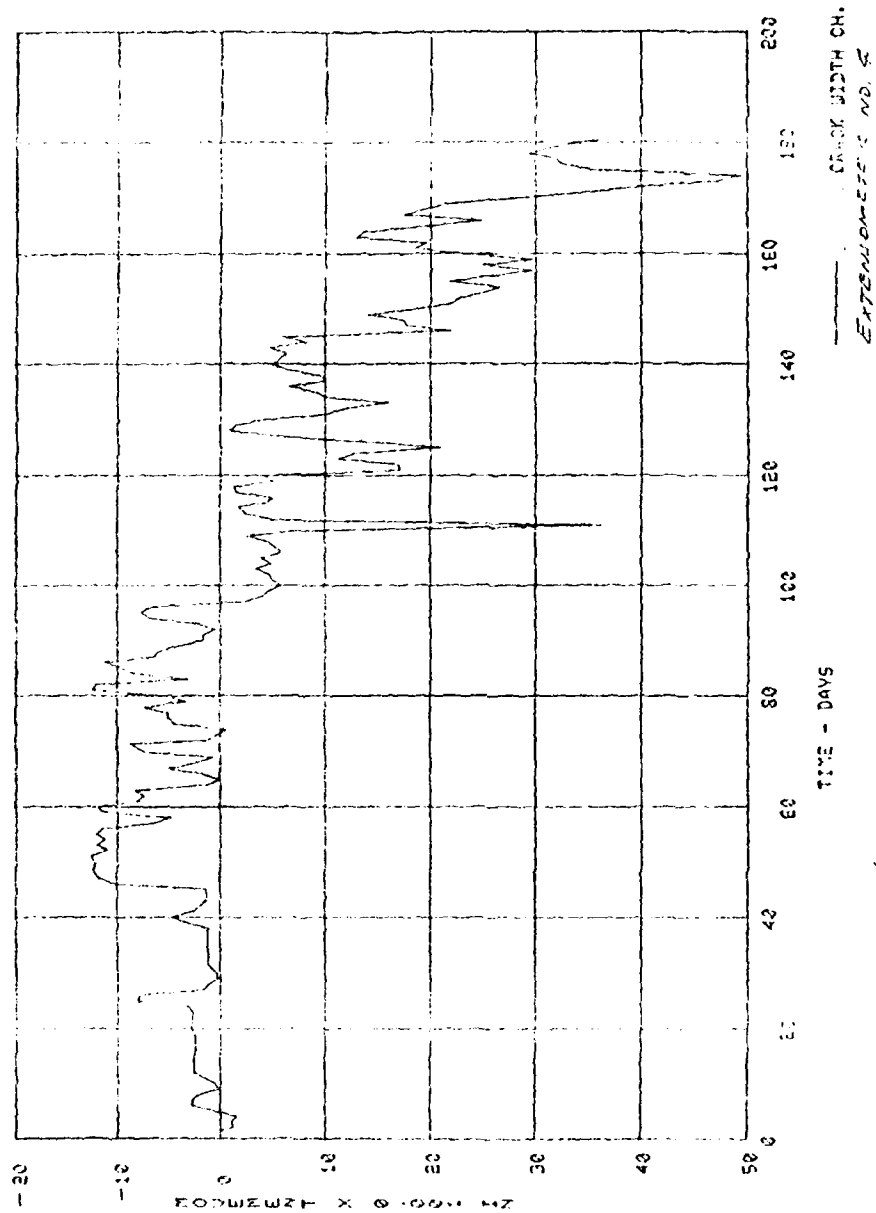
12. Extensometers 4, 5, and 6 were located across existing cracks in a gallery as shown in Figure 3. These extensometers were mounted perpendicular to the direction of flow; two in a horizontal plane, and extensometer 5 in a vertical plane to monitor crack opening caused by a portion of the land-side lock wall moving toward the lock chamber. Results are shown on Figures 12, 13, and 14. Extensometer 4 shows a movement of 0.030 in. corresponding to the existing crack

Figure 12: LOCKPORT L 2 D, MONO 50 GALLERY

increasing in width. Extensometer 5 shows up to 0.10 in. and Extensometer 6 shows a movement of 0.30 in. similar to Extensometer 4. Figure 15 shows a plot of the gallery temperature used to correct the gage for temperature effects. Extensometer 5 shows less daily variation due to temperature movement and emptying and filling loads since it was mounted in a vertical plane.

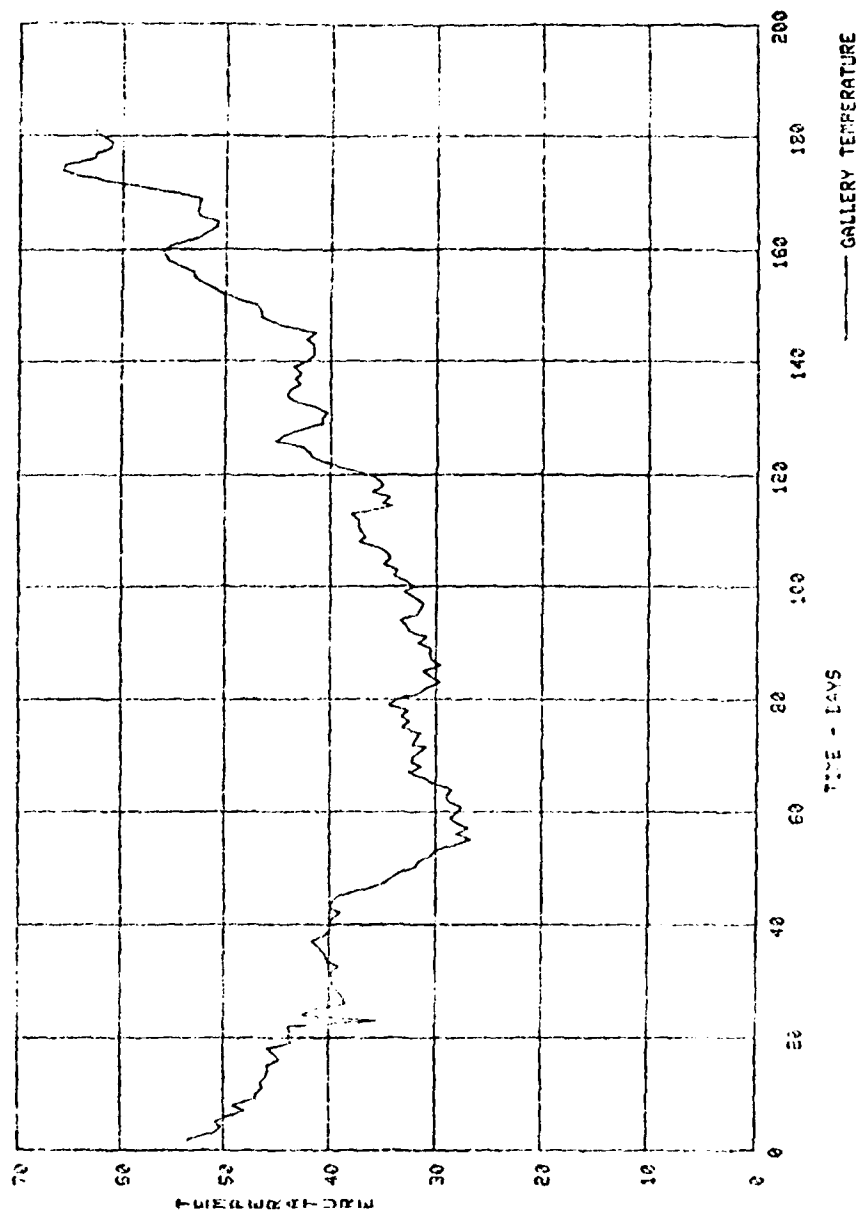
— GALLERY TEMPERATURE

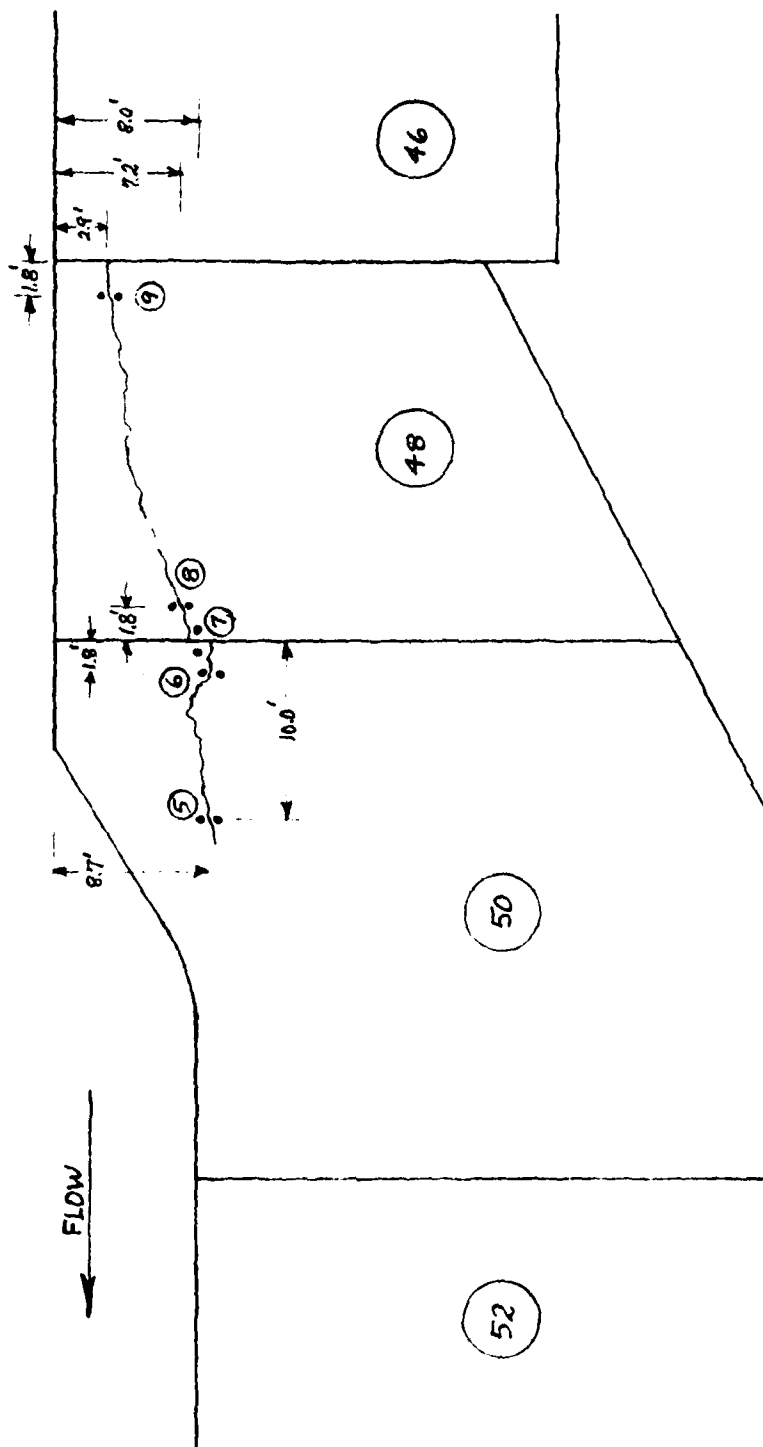
FIGURE 17

13. The fixed gage points installed at Brandon Road Lock located as shown in Figures 16, 17, and 18, were monitored for a period of eight months. These Whittemore gages were placed in 3/8-in. diameter drilled holes in the concrete. Gage inserts were fitted and driven in place. The results of periodic readings are shown in Figures 19 through 30. Points were lost on gage No. 1 after five weeks and were reset at the 27th week. Gage No. 2 shows a crack opening of 0.040 in. and Gage No. 3 shows as much as 0.060 in. A similar trend is indicated for all gages through gage No. 9 except for gage No. 7 which was installed across a monolith joint between monoliths 48 and 50. Gage Nos. 10, 11 and 12 were located across cracks in the ice house as shown in Figure 18 and showed little movement.

LOCATION OF WHITTEMORE GAGE POINTS 5, 6, 7, 8, & 9  
FOR MEASURING CRACK WIDTHS

- a. The fixed point data showed all the cracks to be widening a maximum of 0.060 in. and this occurred as the temperature increased during the later half of the monitoring period.
- b. Gage points 10, 11, and 12 located across cracks in the ice house at Brandon Road showed very little movement during this monitoring period.
