FAA-CT-80-35

THE BRAKING PERFORMANCE OF AN AIRCRAFT TIRE ON GROOVED PORTLAND CEMENT CONCRETE SURFACES

Satish K. Agrawal
Hector Daiutolo

INTERIM REPORT

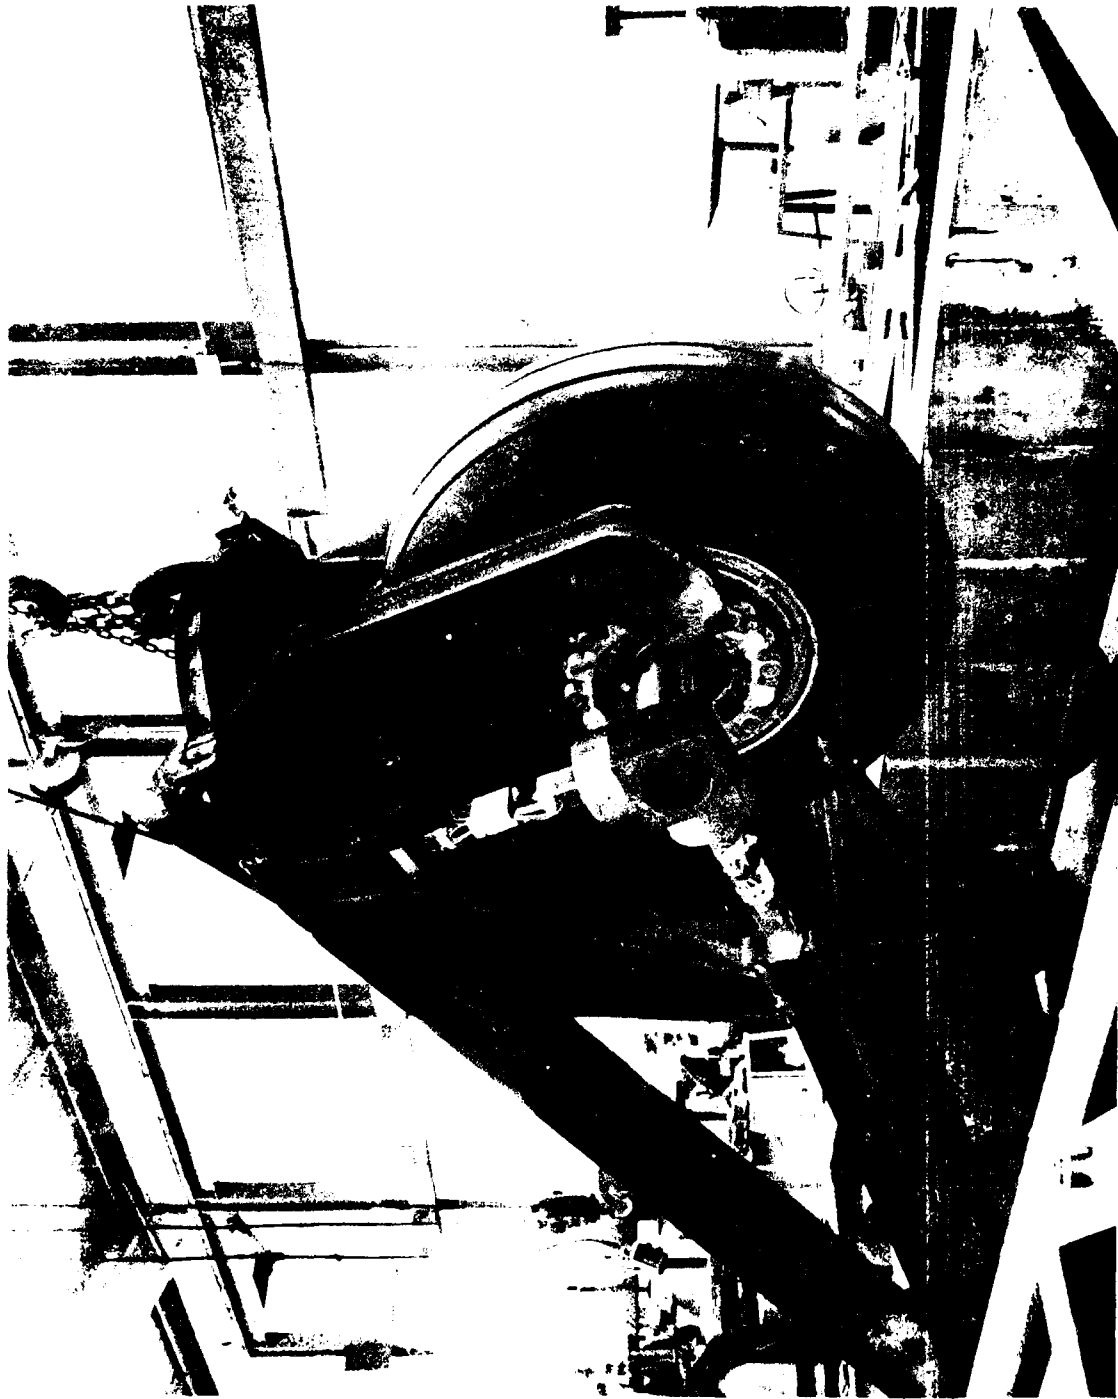
FIGURE 5. DYNAMOMETER AND WHEEL ASSEMBLY SHOWING VERTICAL AND HORIZONTAL LOAD LINKS

(reference 10). Figure 5 shows the dynamometer and wheel assembly and the details of the instrumentation for measuring vertical and horizontal loads at the axle. The assembly is pivoted about an axis contained in the dead-load carriage. The carriage weighs 60,000 pounds. Figure 6 shows the hydraulic system for applying vertical load on the test tire. The hydraulic fluid in this system is forced into the cylinders by pressurized nitrogen; the braking system is also activated by pressurized nitrogen. In each system, pressurized nitrogen is released by the action of a solenoid.

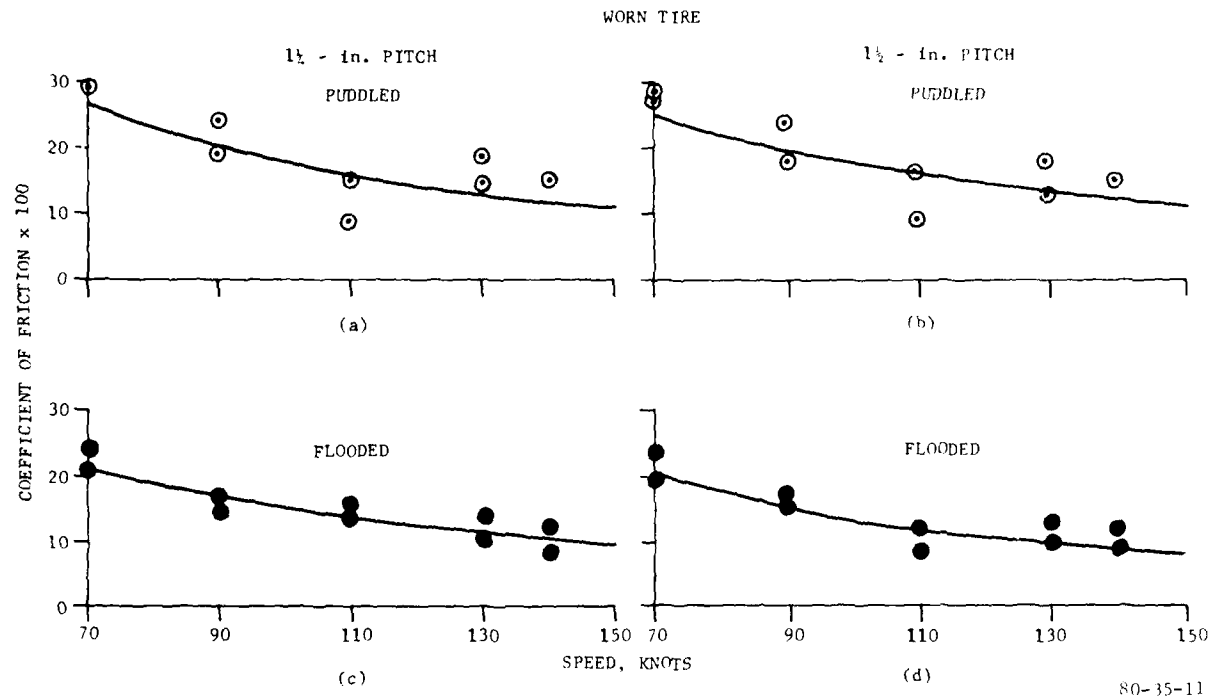
FIGURE 11. COEFFICIENT OF FRICTION AS A FUNCTION OF SPEED UNDER VARIOUS TEST CONDITIONS ON SAW-CUT GROOVES AND NONGROOVED CONCRETE (Sheet 1 of 4)

FIGURE 11. COEFFICIENT OF FRICTION AS A FUNCTION OF SPEED UNDER VARIOUS TEST CONDITIONS ON SAW-CUT GROOVES AND NONGROOVED CONCRETE (Sheet 2 of 4)

FIGURE 11. COEFFICIENT OF FRICTION AS A FUNCTION OF SPEED UNDER VARIOUS TEST CONDITIONS ON SAW-CUT GROOVES AND NONGROOVED CONCRETE (Sheet 3 of 4)

FIGURE 11. COEFFICIENT OF FRICTION AS A FUNCTION OF SPEED UNDER VARIOUS TEST CONDITIONS ON SAW-CUT GROOVES AND NONGROOVED CONCRETE (Sheet 4 of 4)

Figure 11 shows the coefficient of friction as a function of speed for the puddles and the flooded conditions on saw-cut grooves and on nongrooved surfaces, and figure 12 shows similar relationships for tests on V-grooves. Figure 13 shows results on wet surfaces. Data from figures 11 and 12 are replotted in figure 14 to show the relative performance of the saw-cut grooves and the V-grooves. Limited data on nongrooved surfaces are also included in this figure.
