FINAL REPORT  
DRY LUBRICATION OF HIGH TEMPERATURE  
SILICON NITRIDE ROLLING CONTACTS  
N00019-79-C-0612

T. M. YONUSHONIS

NOVEMBER 17, 1980

U.S. DEPARTMENT OF THE NAVY  
NAVAL AIR SYSTEMS COMMAND (AIR-5163D4)  
WASHINGTON, D.C. 20361

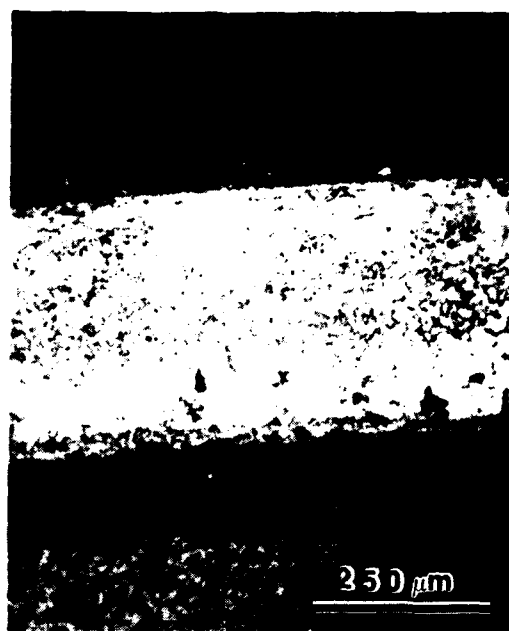
Figure 10 Optical micrographs of  $\text{Si}_3\text{N}_4$  spindle ball wear track from Test 9. A Pure Carbon Co. P2003 graphite cage was used as the solid lubricant source. Test conditions:  $1000^\circ\text{F}$  ( $538^\circ\text{C}$ ) for 60.9 hours (82 million stress cycles).

Overall view of wear track 100x

Edge of wear track 500x

Center of wear track 500x

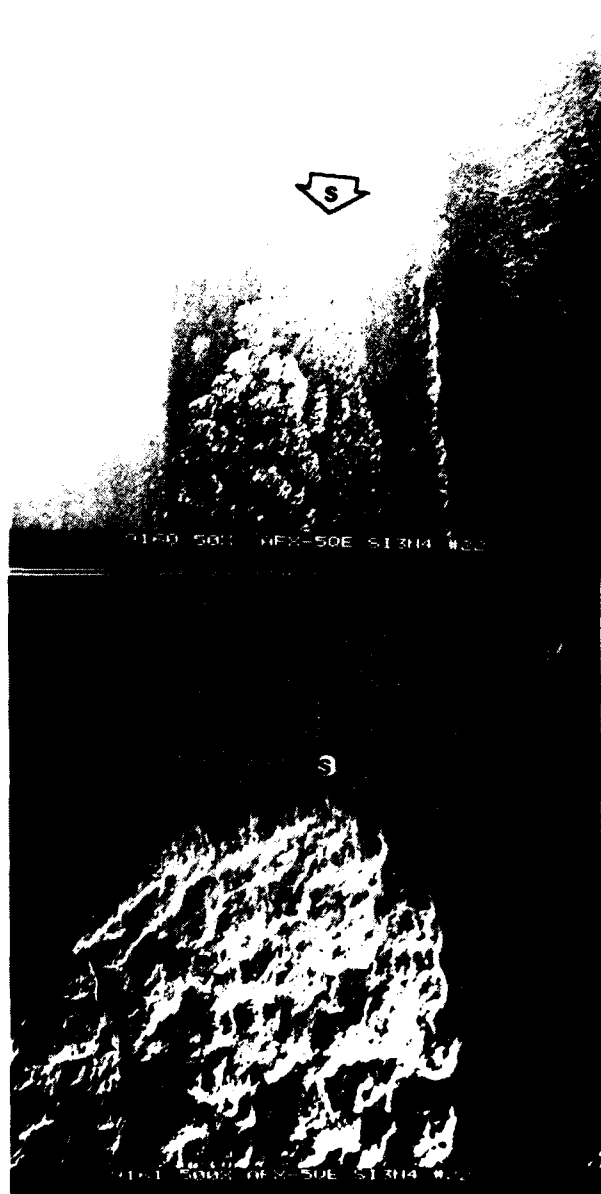
Figure 20

SEM photomicrograph of silicon nitride plastic flow and microspalling observed during high temperature test with 5000 Graphite AFX-5QE Cage. Test Conditions: 1200°F (649°C) for 29.8 hours (40 million stress cycles).
