TRW-3866

# FATIGUE ENDURANCE TESTING OF ION IMPLANTED ROLLER BEARING

TRW BEARINGS DIVISION  
RESEARCH AND DEVELOPMENT LABORATORIES  
JAMESTOWN, NEW YORK 14701

NAVAL AIR PROPULSION CENTER  
1440 PARKWAY AVENUE  
TRENTON, NEW JERSEY 08628

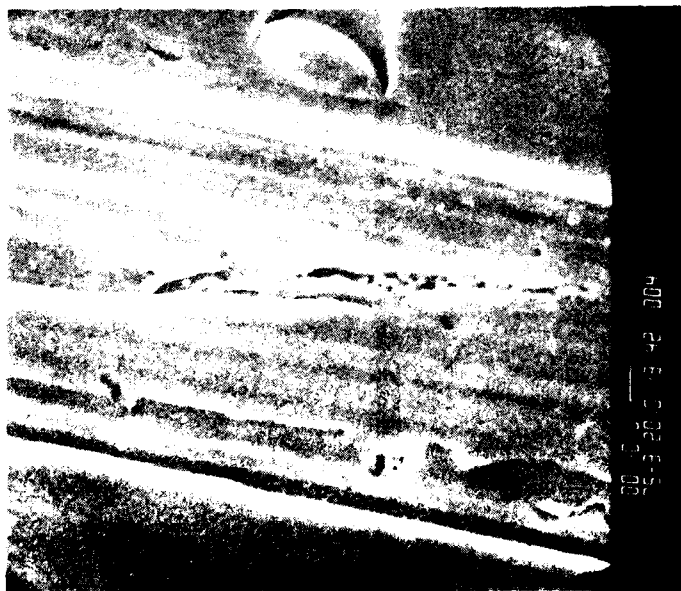
FIGURE 11 - SEM PHOTOS OF INNER RACE OF S/N R18.  
RACEWAY WAS IMPLANTED WITH CHROMIUM IONS  
MAGNIFICATION 4700X
