# NAVAL POSTGRADUATE SCHOOL

COMBAT DAMAGE ASSESSMENT TEAM,  
A-10/GAU-8 LOW ANGLE FIRINGS  
VERSUS  
SIMULATED SOVIET TANK COMPANY (ARRAY 20)  
(AEROJET LOT NUMBER AJD 79A181-001)  
(19 SEPTEMBER 1979)

11 MAY 1980

Prepared for: A-10 System Program Office  
Wright Patterson Air Force Base  
Ohio 45433

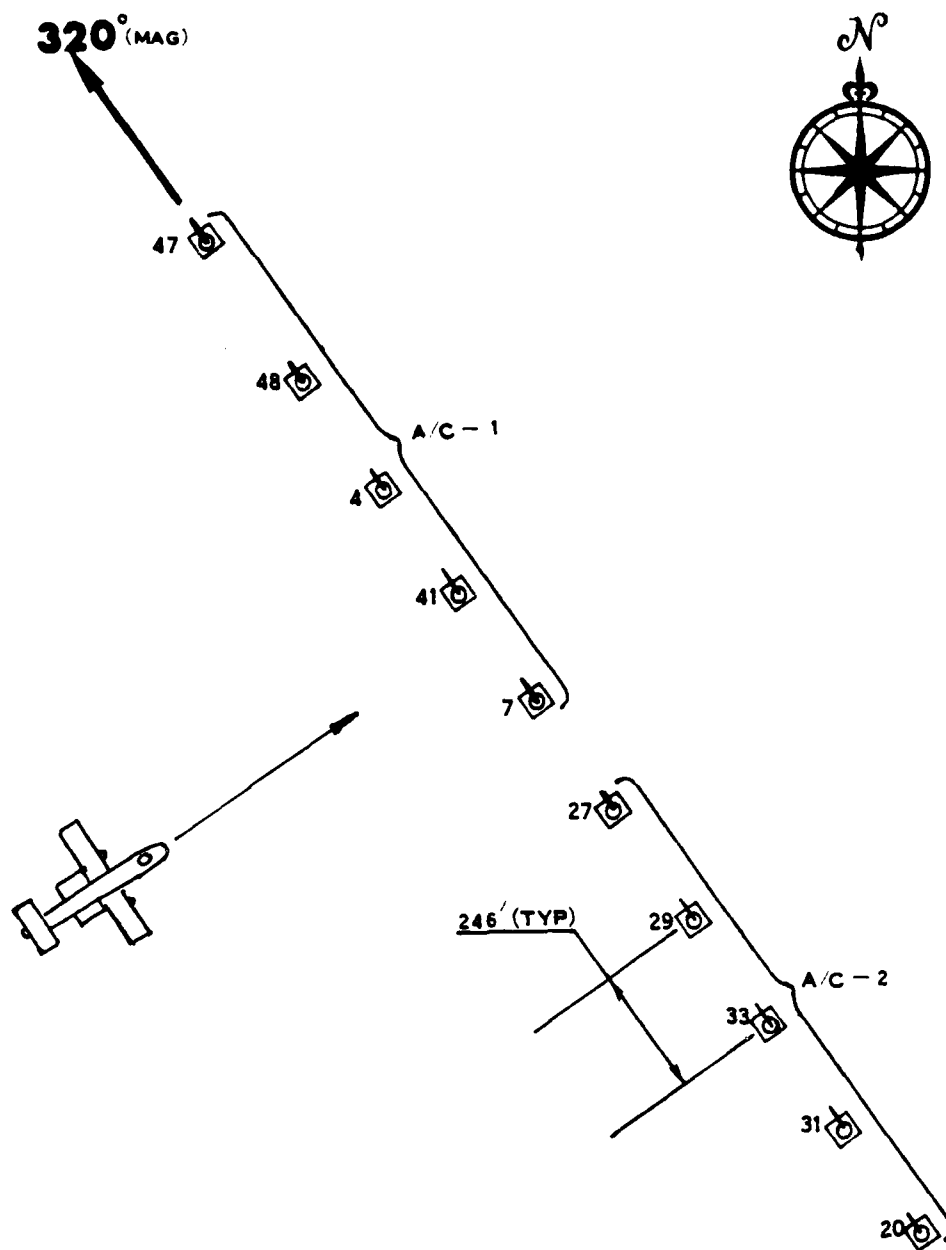
FIGURE 6. Approximate Target Layout.

The data noted immediately above were collected through the combined efforts of the CDAT and range support personnel at Nellis AFB, working together and using TSPI equipment, motion picture and still cameras, the industrial efforts required to repair, refurbish, and field the tank targets, and various systematic research techniques used to describe weapon effects and combat damage. The most basic materiel used in the test; i.e., the aircraft, gun, and projectile are illustrated in Figures 2, 3, 4, and 5. The tanks were arrayed in the tactical formation of a column of Soviet tanks as shown in Figure 6.

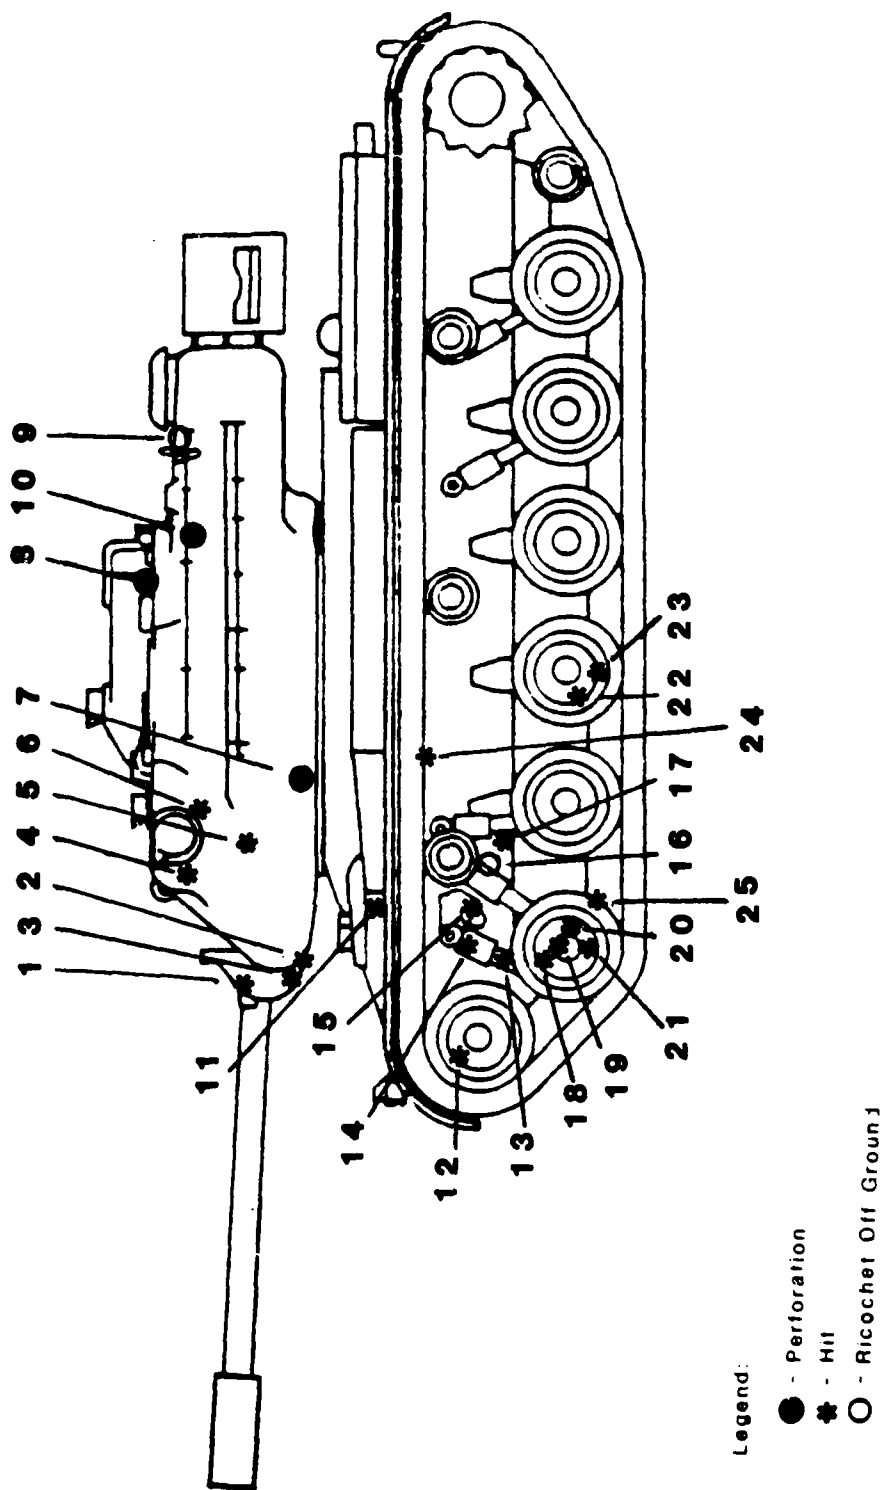
FIGURE 7. Impact Diagram, Tank 47.

100% M-Kill and 100% F-Kill resulting from the following observed projectile effects (Figure 7):

- a. M-Kill: The assessment of 100% M-Kill was based on impacts 7, 8, and 10 which perforated the left side of the turret killing the commander (Figure 8) and gunner and wounding the loader, driver, and bow gunner (Figure 9), impact 19 which destroyed the left number 1 road wheel hub, and impacts 13, 14, 15, 24, and 25 (Figure 10) which cumulatively damaged the track and suspension system.
- b. F-Kill: The assessment of 100% F-Kill is based on crew casualties to all five crew members.

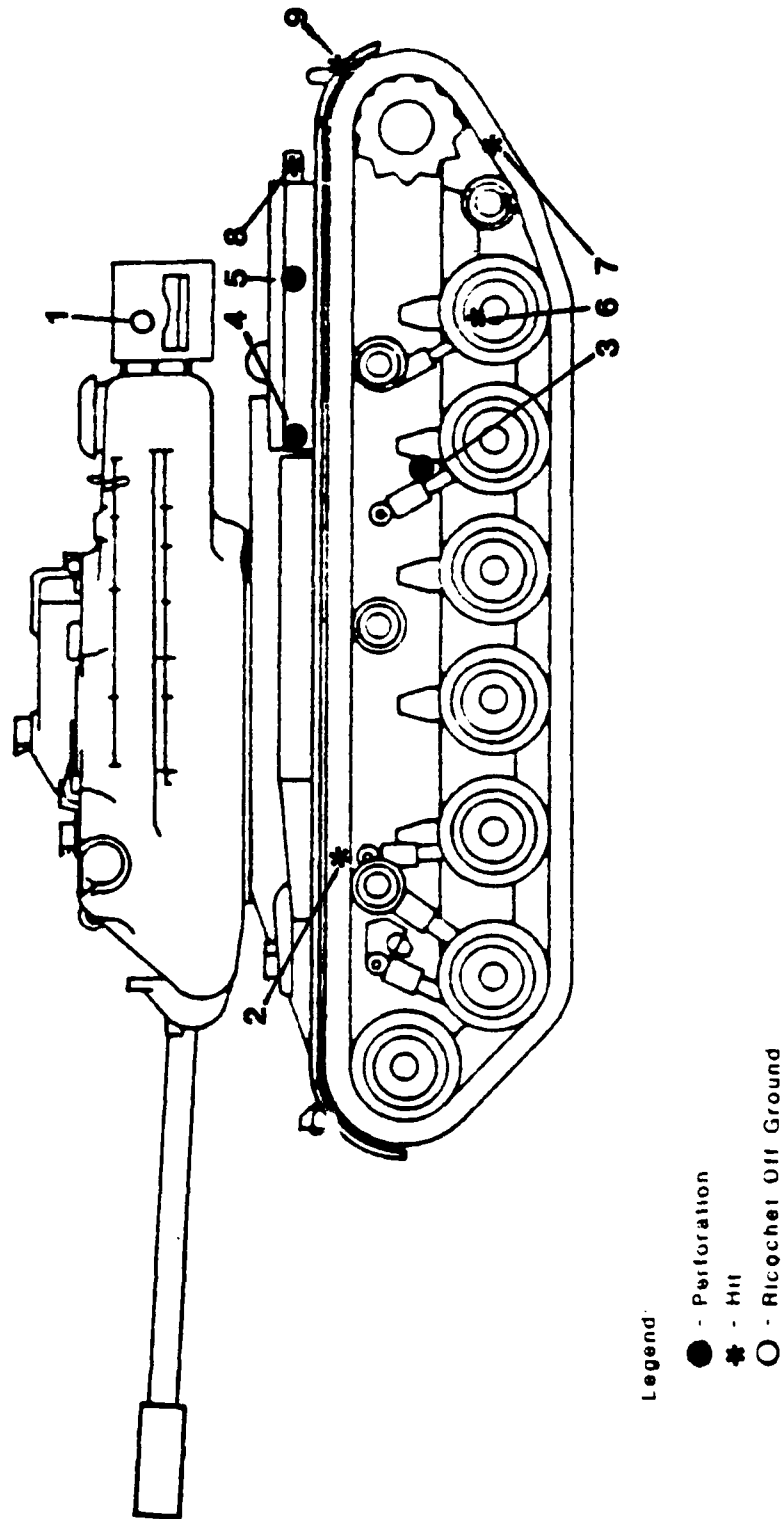
FIGURE 11. Impact Diagram, Tank 48.

100% M-Kill based on the following observed effects (Figure 11):

The assessment of 100% M-Kill is based on impact 3, which perforated the left hull and penetrated into the left fuel cell, and impact 5, which perforated the left hull into the engine compartment destroying the coupling on the oil cooler inlet line from the transmission (Figure 12).

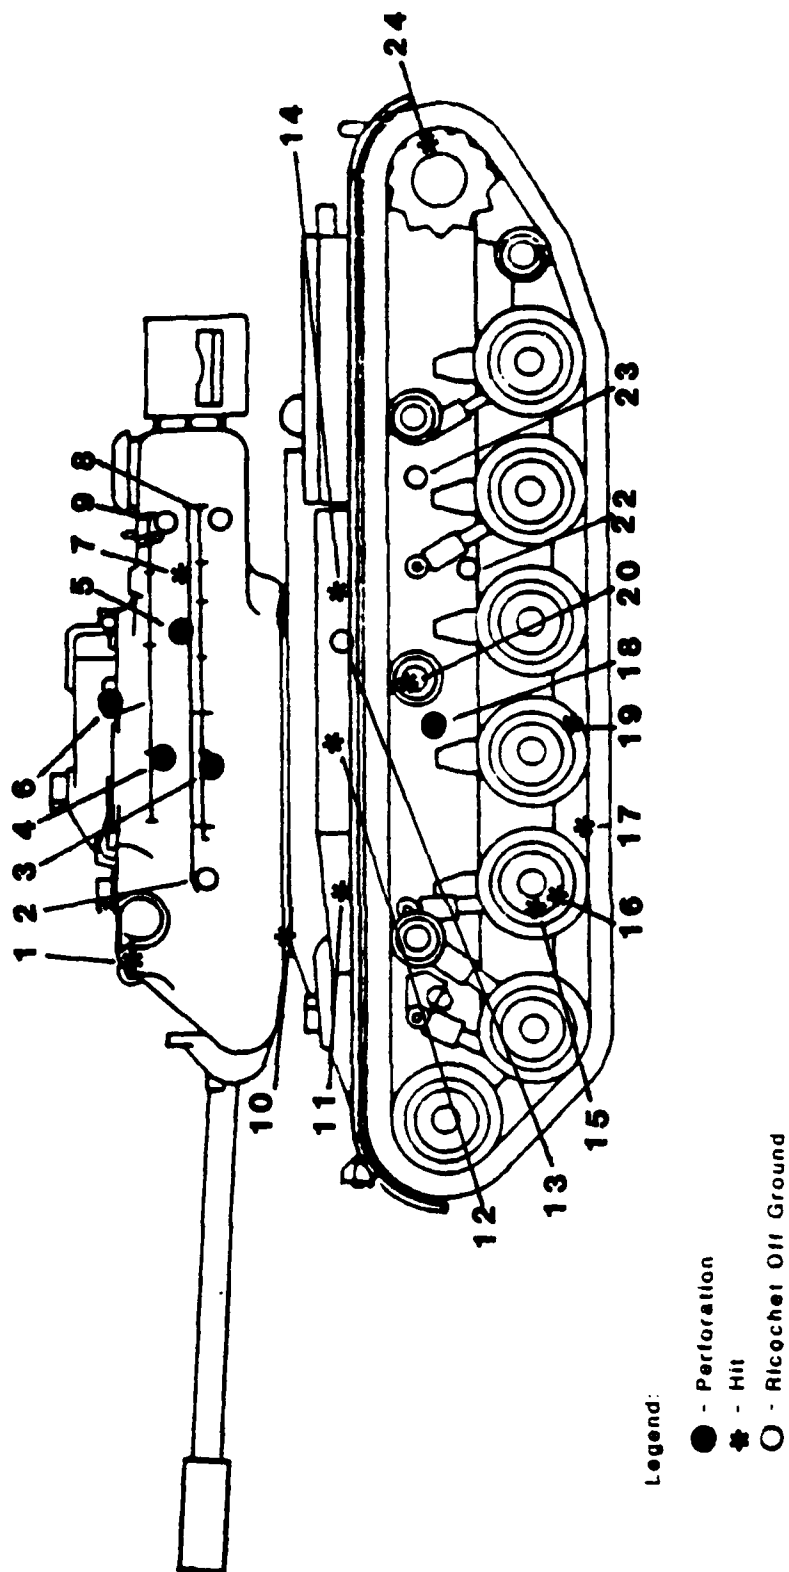
FIGURE 13. Impact Diagram, Tank 4.

90% M-Kill and 95% F-Kill resulting from the following observed effects (Figures 13):

NOTE: Number 21 not depicted.

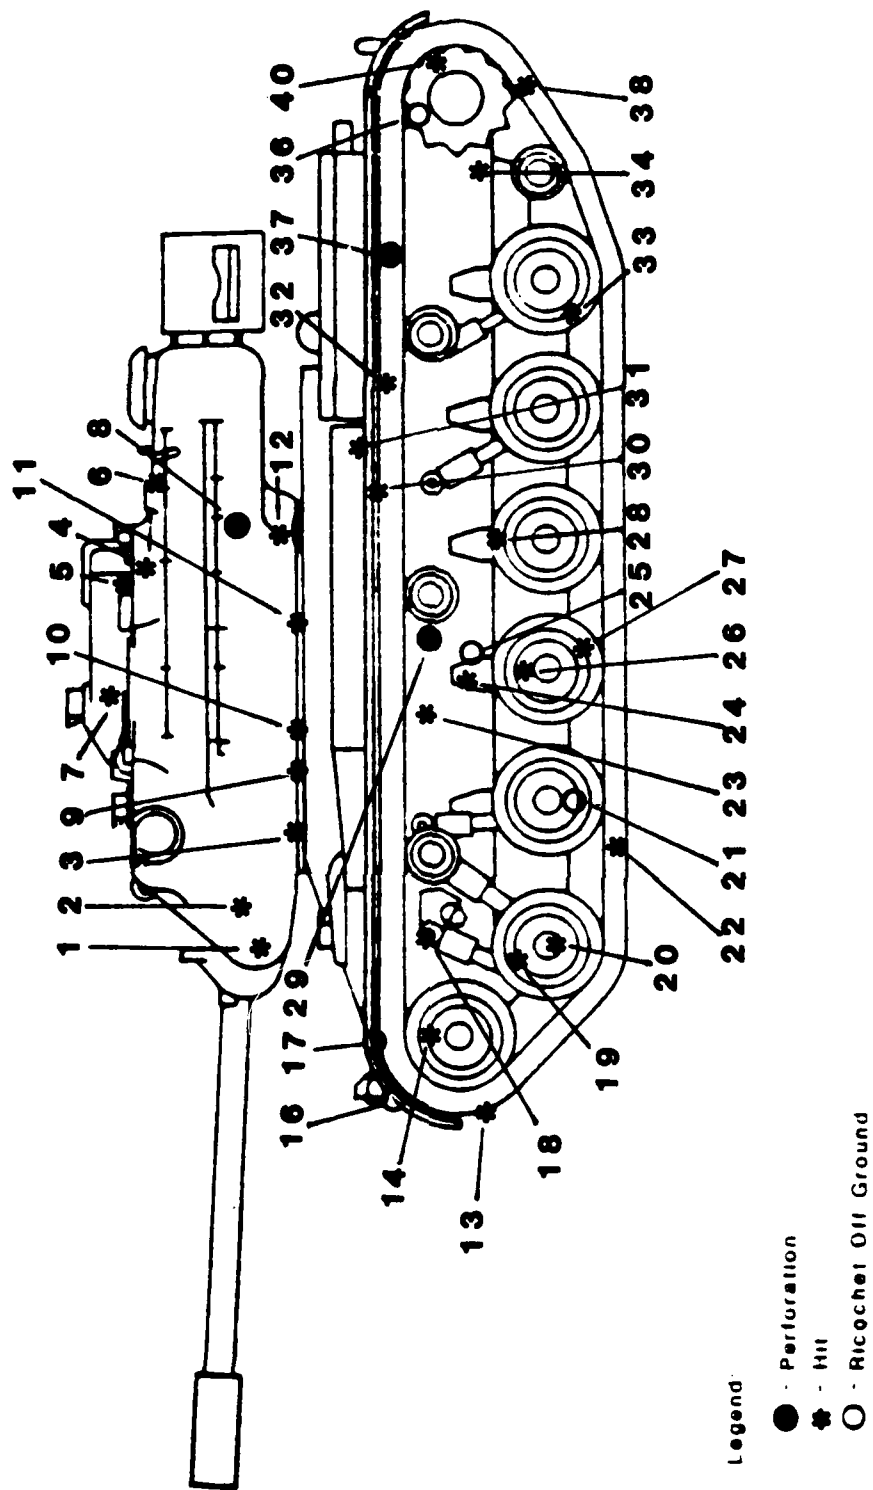
FIGURE 15. Impact Diagram, Tank 41, Left Side.

100% M-Kill and 100% F-Kill resulting from the following observed effects (Figures 15 and 16):

NOTE: Number 35 is a ricochet which is not depicted.

- a. M-Kill: The assessment of a 100% M-Kill is based on impact 29 which perforated the left hull armor and penetrated the fuel tank; to impact 8 (Figure 17) which wounded all personnel in the fighting compartment; and to cumulative damage to the track and suspension system resulting from impacts 13, 15, 20, 22, and 33 (see Figure 18 for impacts 13, 20, and 22).
- b. F-Kill: The assessment of 100% F-Kill is based on impacts 9, 10, and 11, which jammed the turret and prevented it from traversing (Figure 19); and impact 8 which incapacitated the tank commander, gunner and loader.

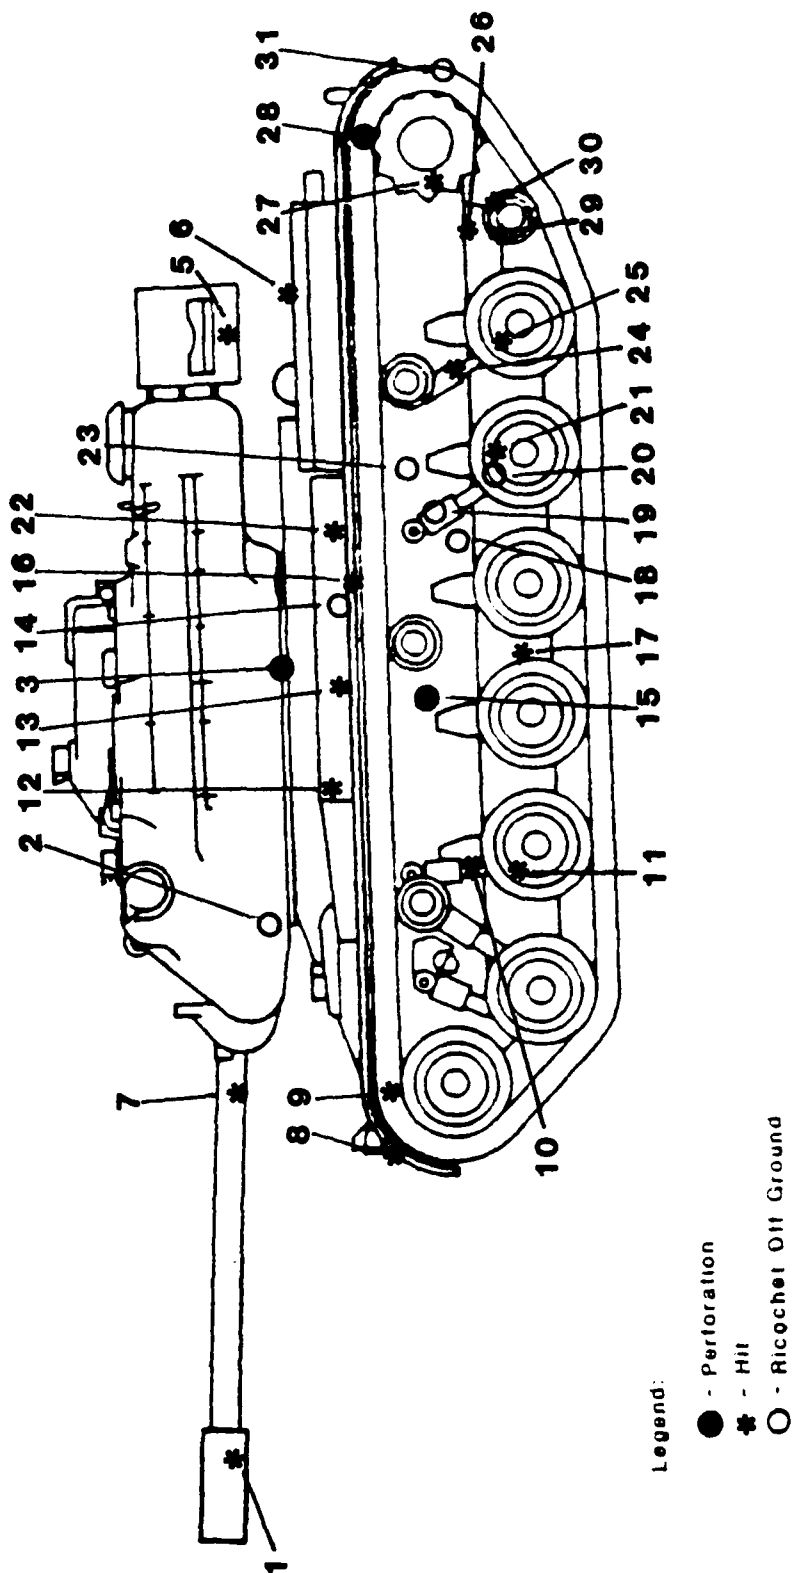
FIGURE 20. Impact Diagram, Tank 7.

100% (interdiction type) M-Kill and 20% F-Kill resulting from the following observed effects (Figure 20):

NOTE: Impact number 4 did insignificant damage to the storage box, and is not depicted.

- a. M-Kill: The assessment of a 100% interdiction type M-Kill after 500 meters movement was attributed to impact 9 (Figure 21) which destroyed one end connector and one track center guide on the same pair of track links, and to cumulative damage to the track and suspension system caused by impacts 25, 26, 27, 29, (Figure 22) and six other impacts.
- b. F-Kill: A 20% F-Kill was assessed due to damage caused by impact 1, (Figure 20 and 21), which penetrated the bore evacuator and gun tube.

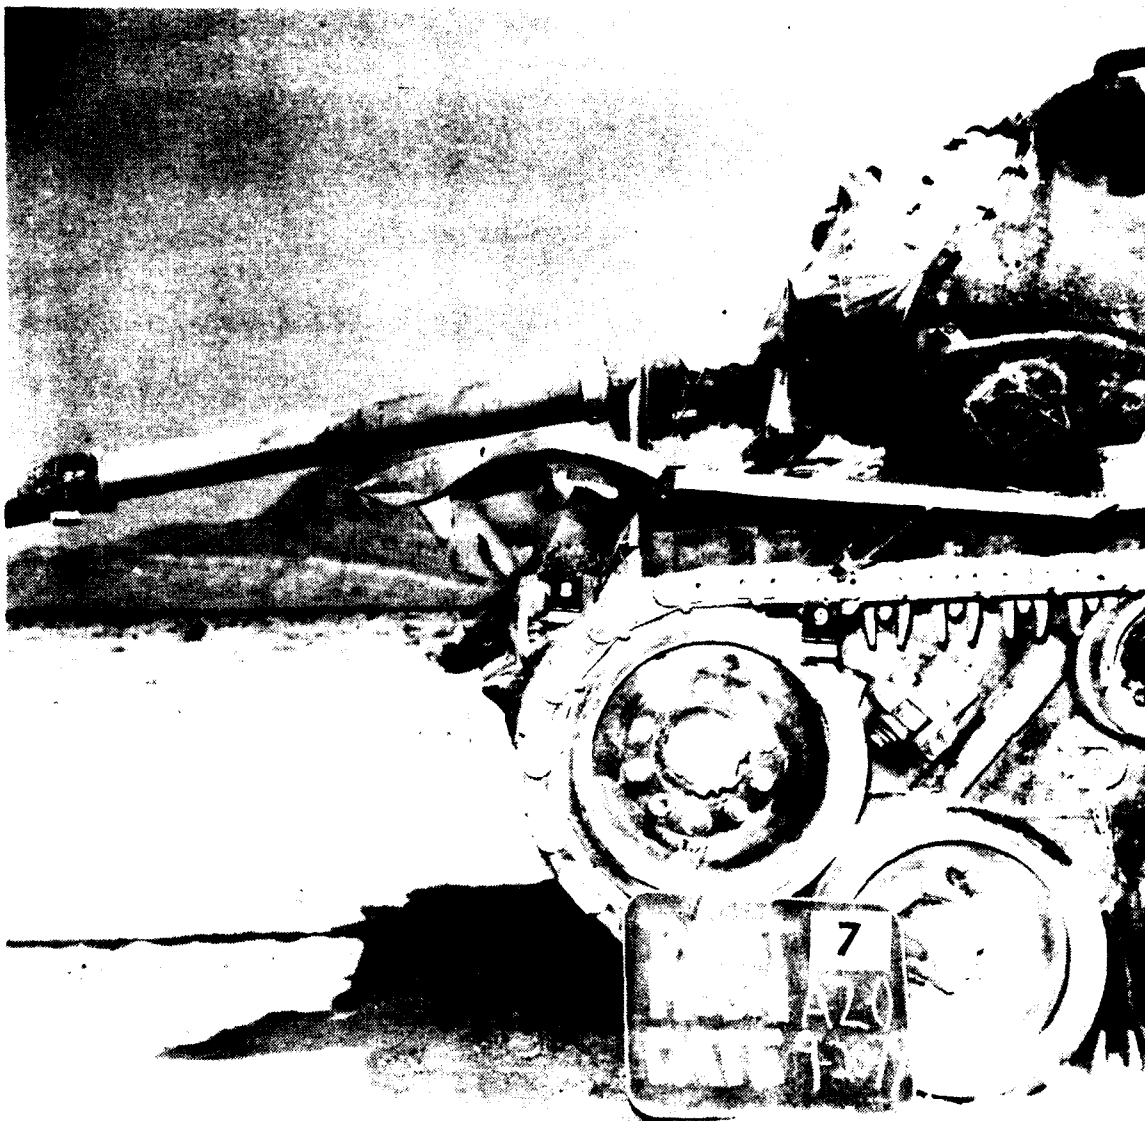
FIGURE 21. Damage to Track Connector and Center Guide  
Caused by Impact 9; Tank 7.

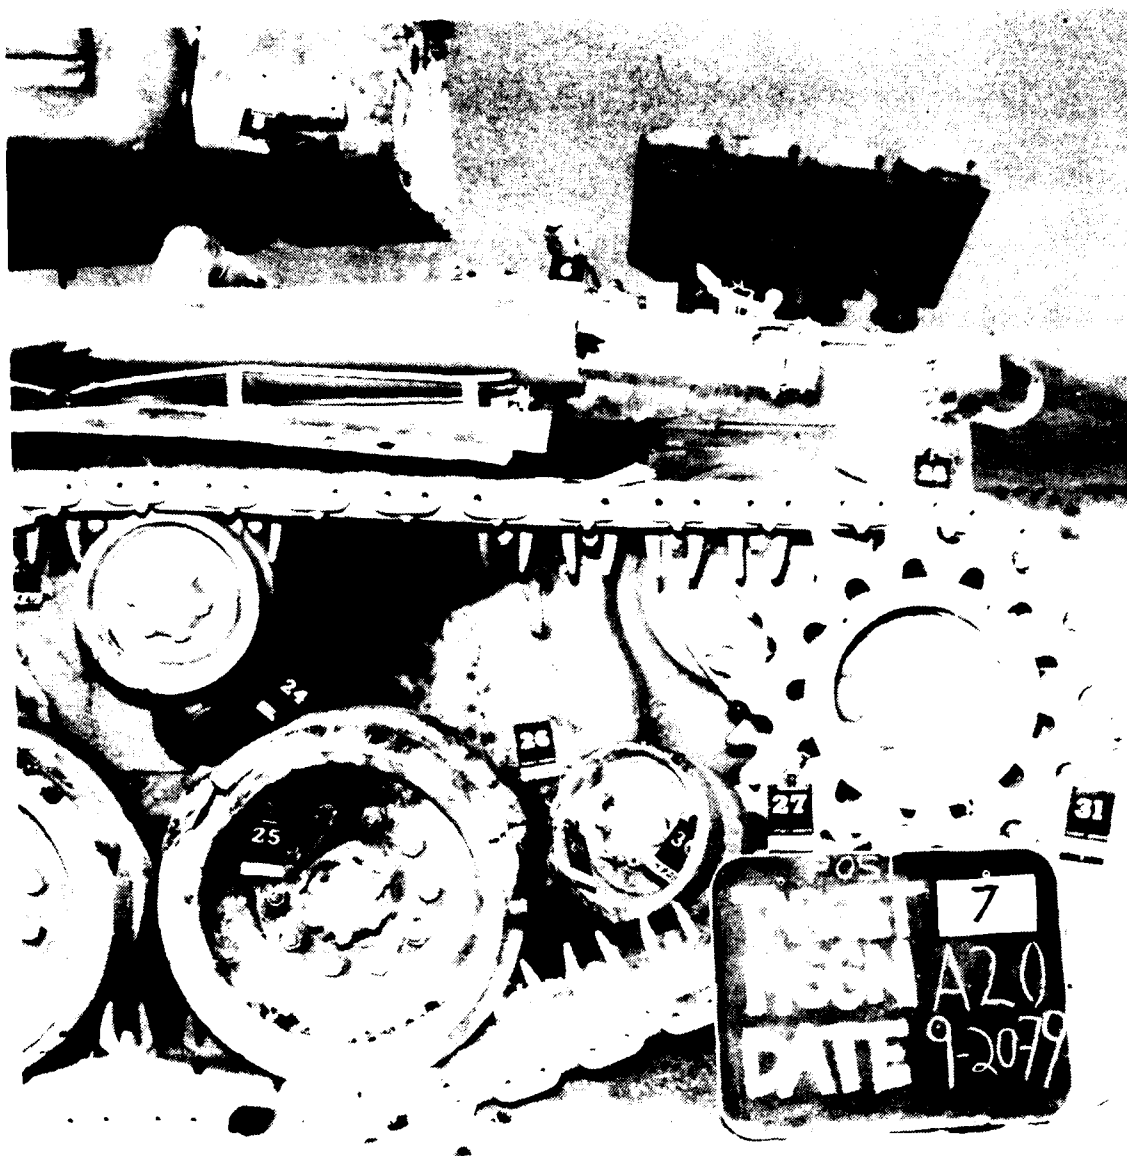
FIGURE 22. Extensive Damage to Track and Suspension System caused by Impacts 25, 26, 27, and 29; Tank 7.

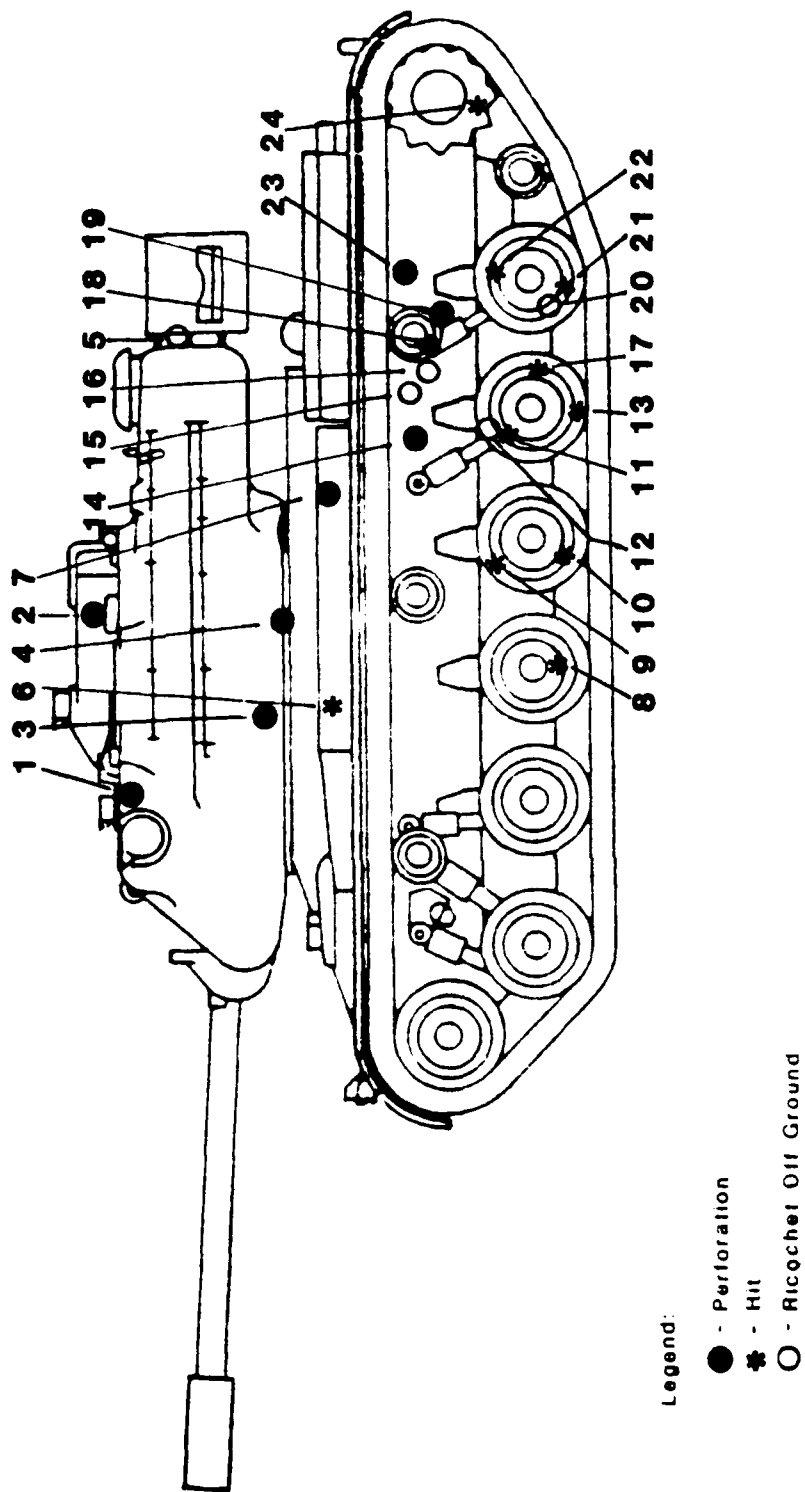
FIGURE 23. Impact Diagram, Tank 27.

100% K-Kill resulting from the following observed effects (Figure 23):

100% K-Kill due to a fuel fire resulting from impact 14 (Figure 24) which perforated the left hull armor and penetrated the fuel tank and impacts 1, 2, and 3, which perforated the turret causing crew casualties to all personnel in the fighting compartment. Impacts 7 (Figure 24), 19, and 23 (Figure 25) which penetrated into the engine compartment were also capable of igniting oil fed fuel fires.

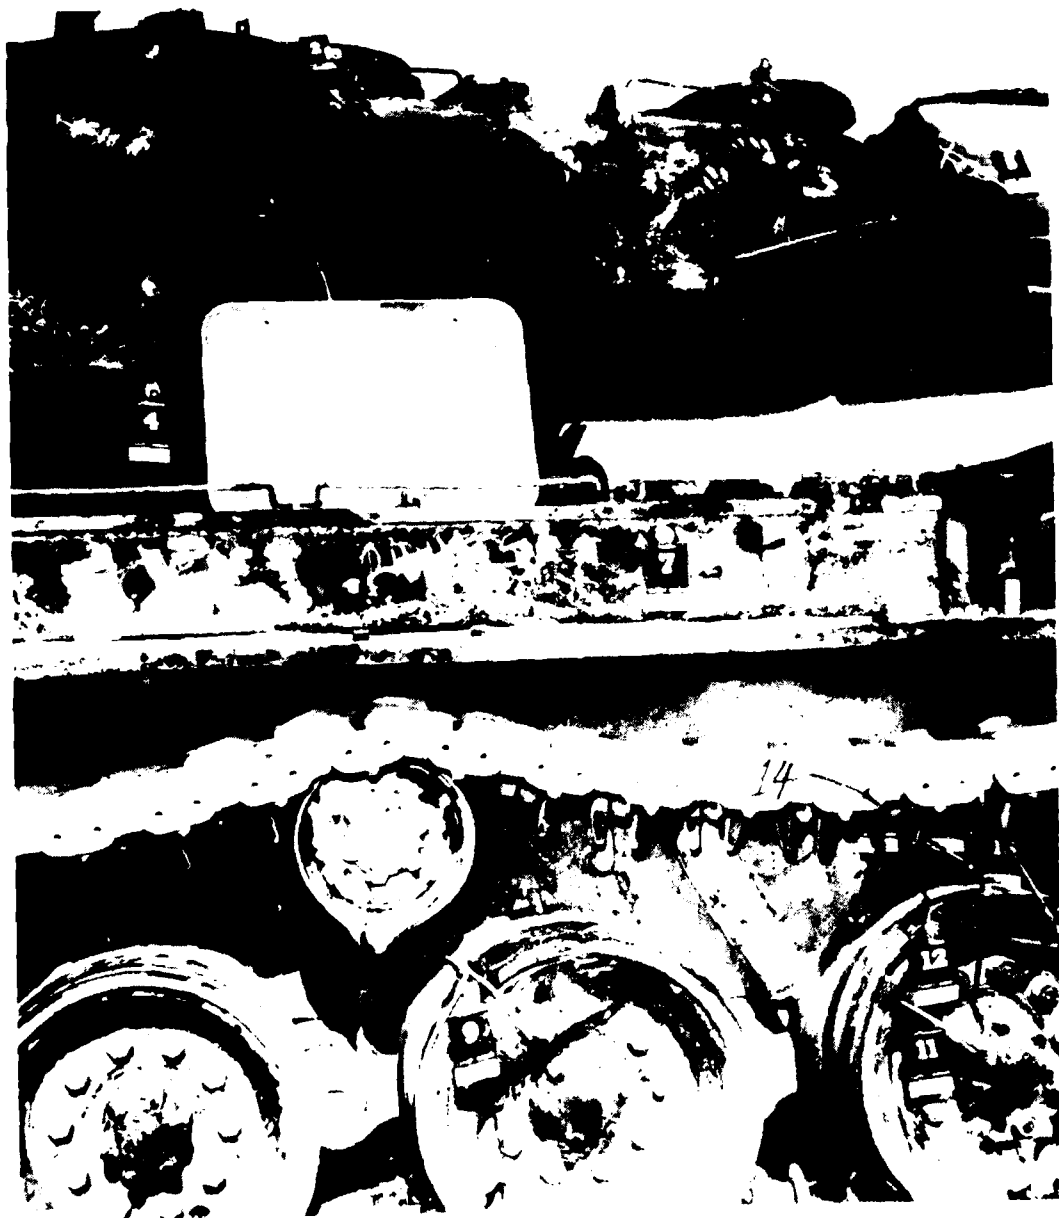
FIGURE 24. Impacts 7 and 14, Penetration of 100 lb. Hell Armor.

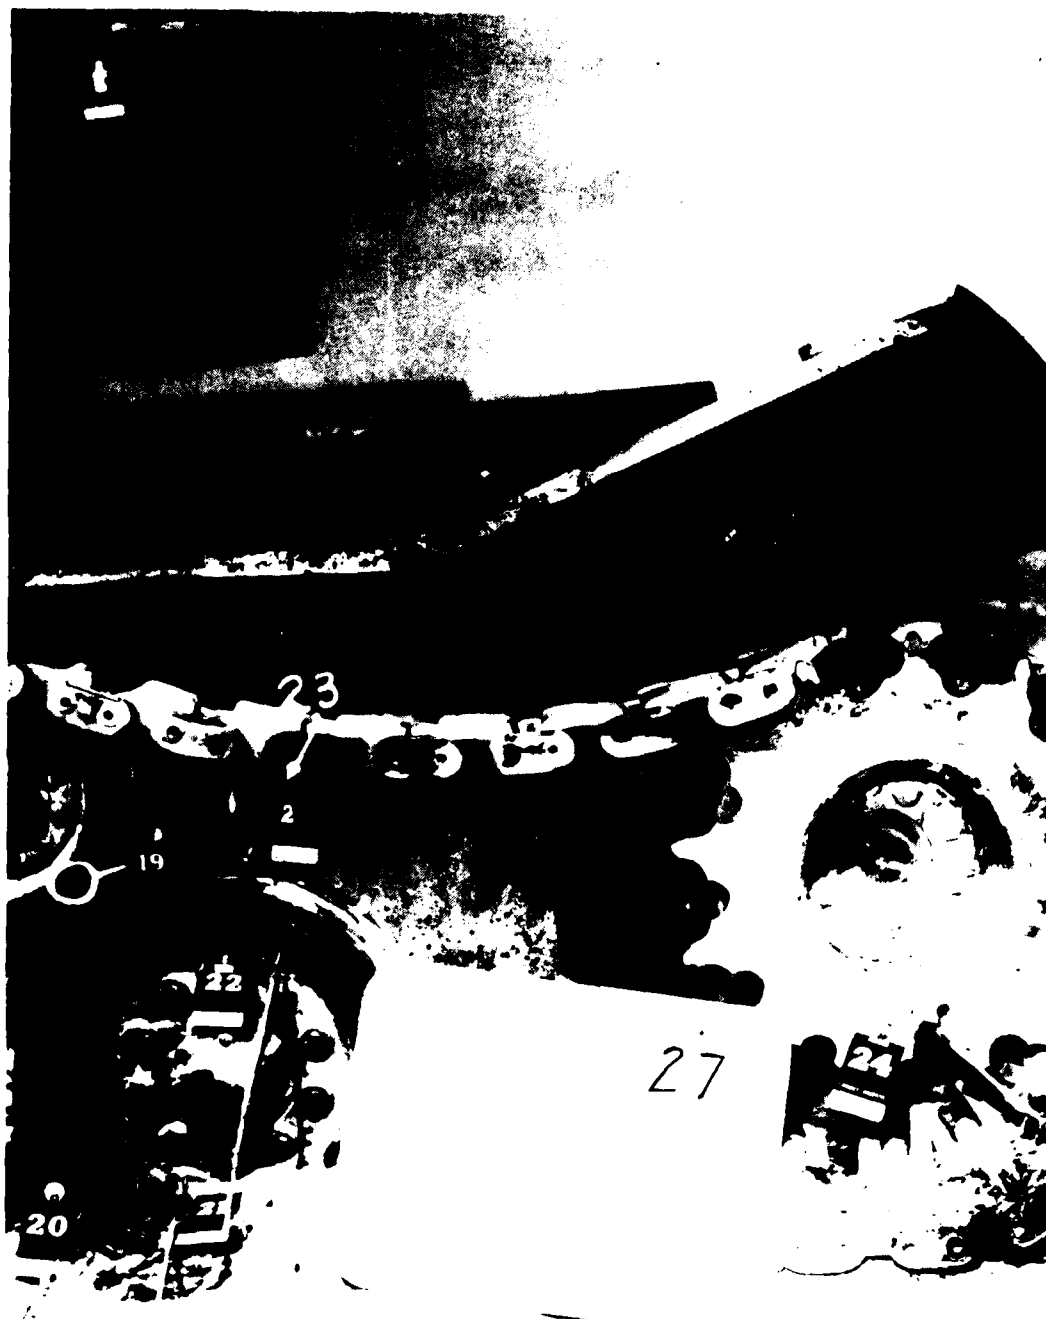
FIGURE 25. Impacts 19 and 23, Perforations in the Engine Compartment, Tank 27.

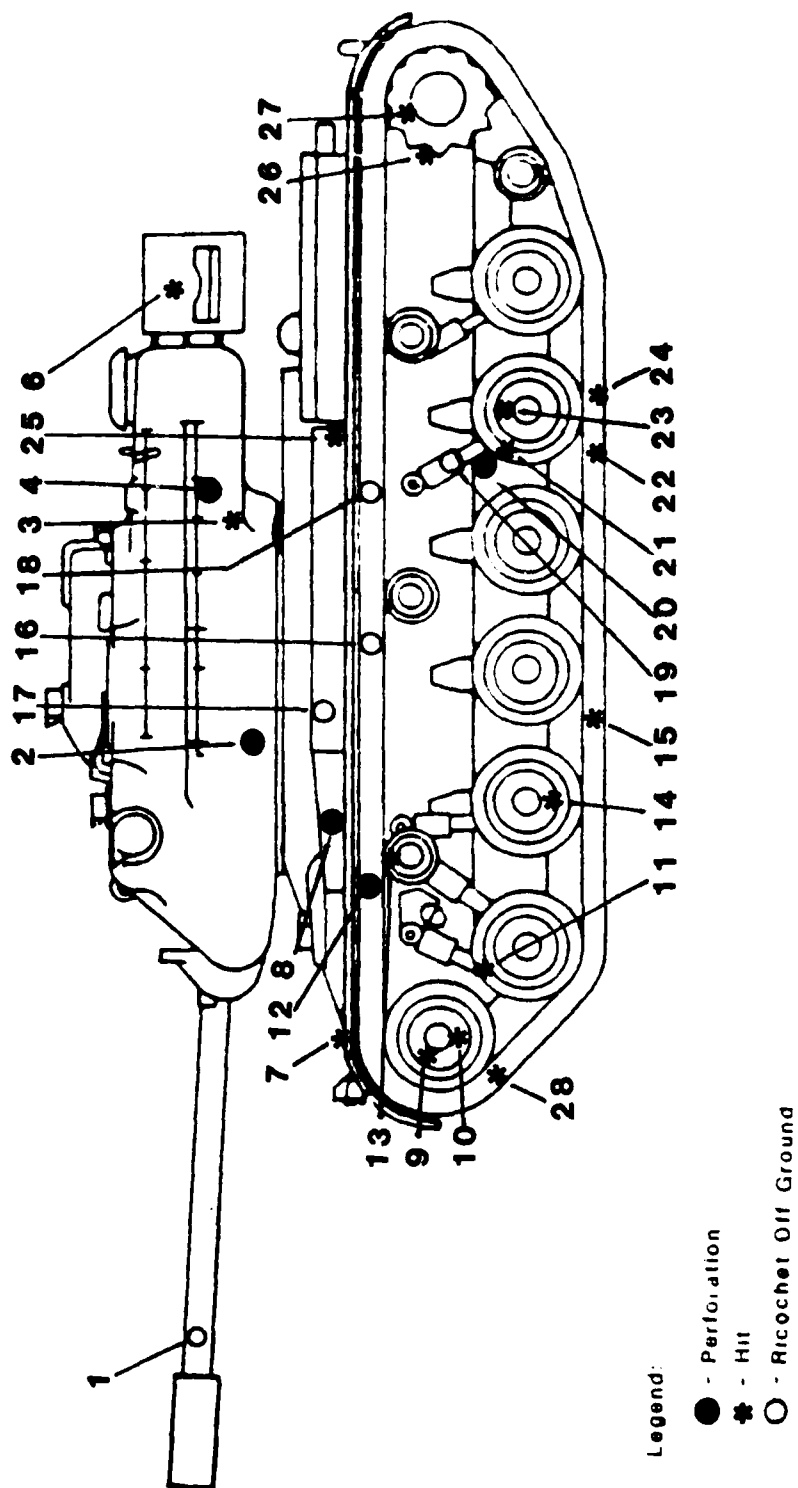
FIGURE 26. Impact Diagram, Tank 29.

100% K-Kill resulting from the following observed effects (Figure 26):

NOTE: Impact number 5 was a ricochet hit on left turret, not shown.

100% K-Kill due to a fuel fire resulting from impact 20 (Figure 27) which perforated the left hull armor and penetrated the fuel tank and from impacts 2, 4, 8, and 12 (Figure 28) which perforated the turret and hull armor causing crew casualties to all personnel in the fighting and driver's compartment.

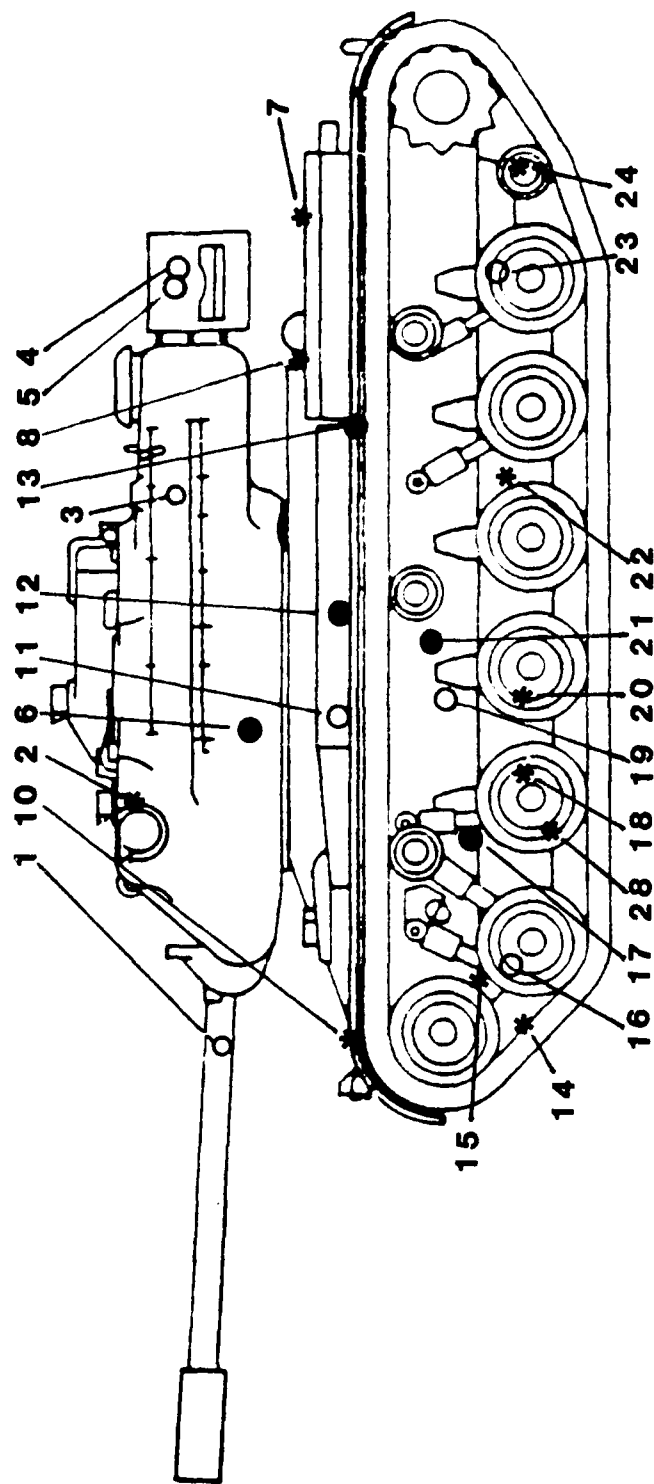
FIGURE 29. Impact Diagram, Tank 33, Left Side.

10% M-Kill and 30% F-Kill from the following observed effects (Figures 29 and 30):

NOTE: Impact number 9 was a simple hit which is not depicted.

- a. M-Kill: A mobility degradation of 10% was assessed due to minor track and suspension damage caused by impacts 14 and 22
- b. F-Kill: A firepower degradation of 30% was assessed due to loader casualty (Figure 31) caused by impact 6 (Figure 32).

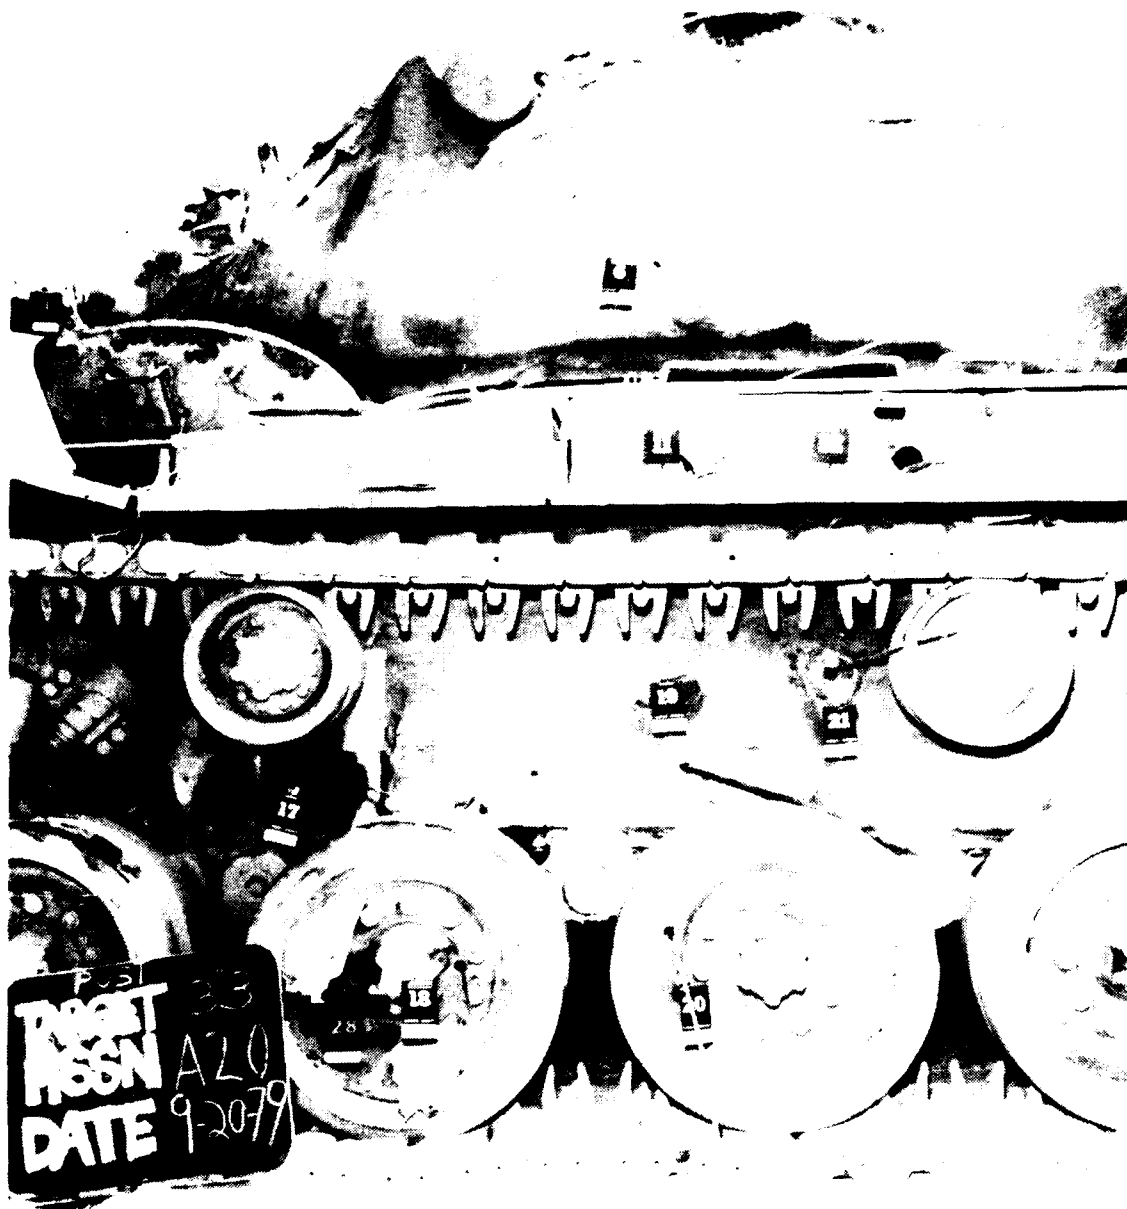
FIGURE 31. Impact 6 which Perforated the Turret and caused Loader Casualty, Tank 33.

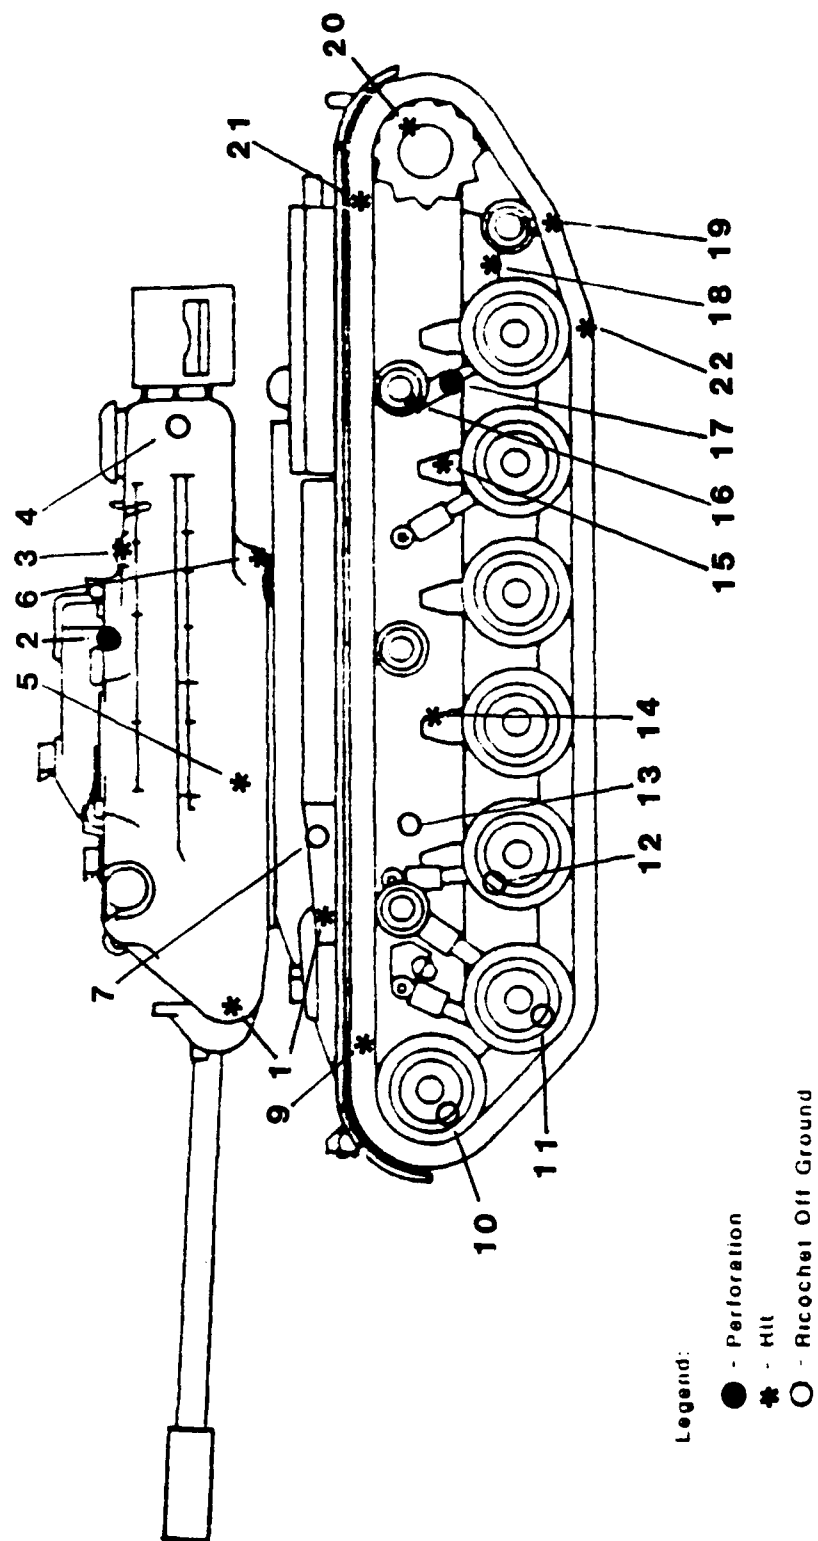
FIGURE 33. Impact Diagram, Tank 31.

100% M-Kill and 95% F-Kill resulting from the following observed effects (Figure 33):

- a. M-Kill: The assessment of a 100% M-Kill is based on impact 17 (Figure 34) which perforated the left hull and penetrated the fuel tank, and on track and suspension damage resulting from impacts 16, 19, and 22.
- b. F-Kill: The assessment of a 95% F-Kill is based on assessed casualties to crew members in the fighting compartment (Figures 35, 36, and 37) caused by impact 2.

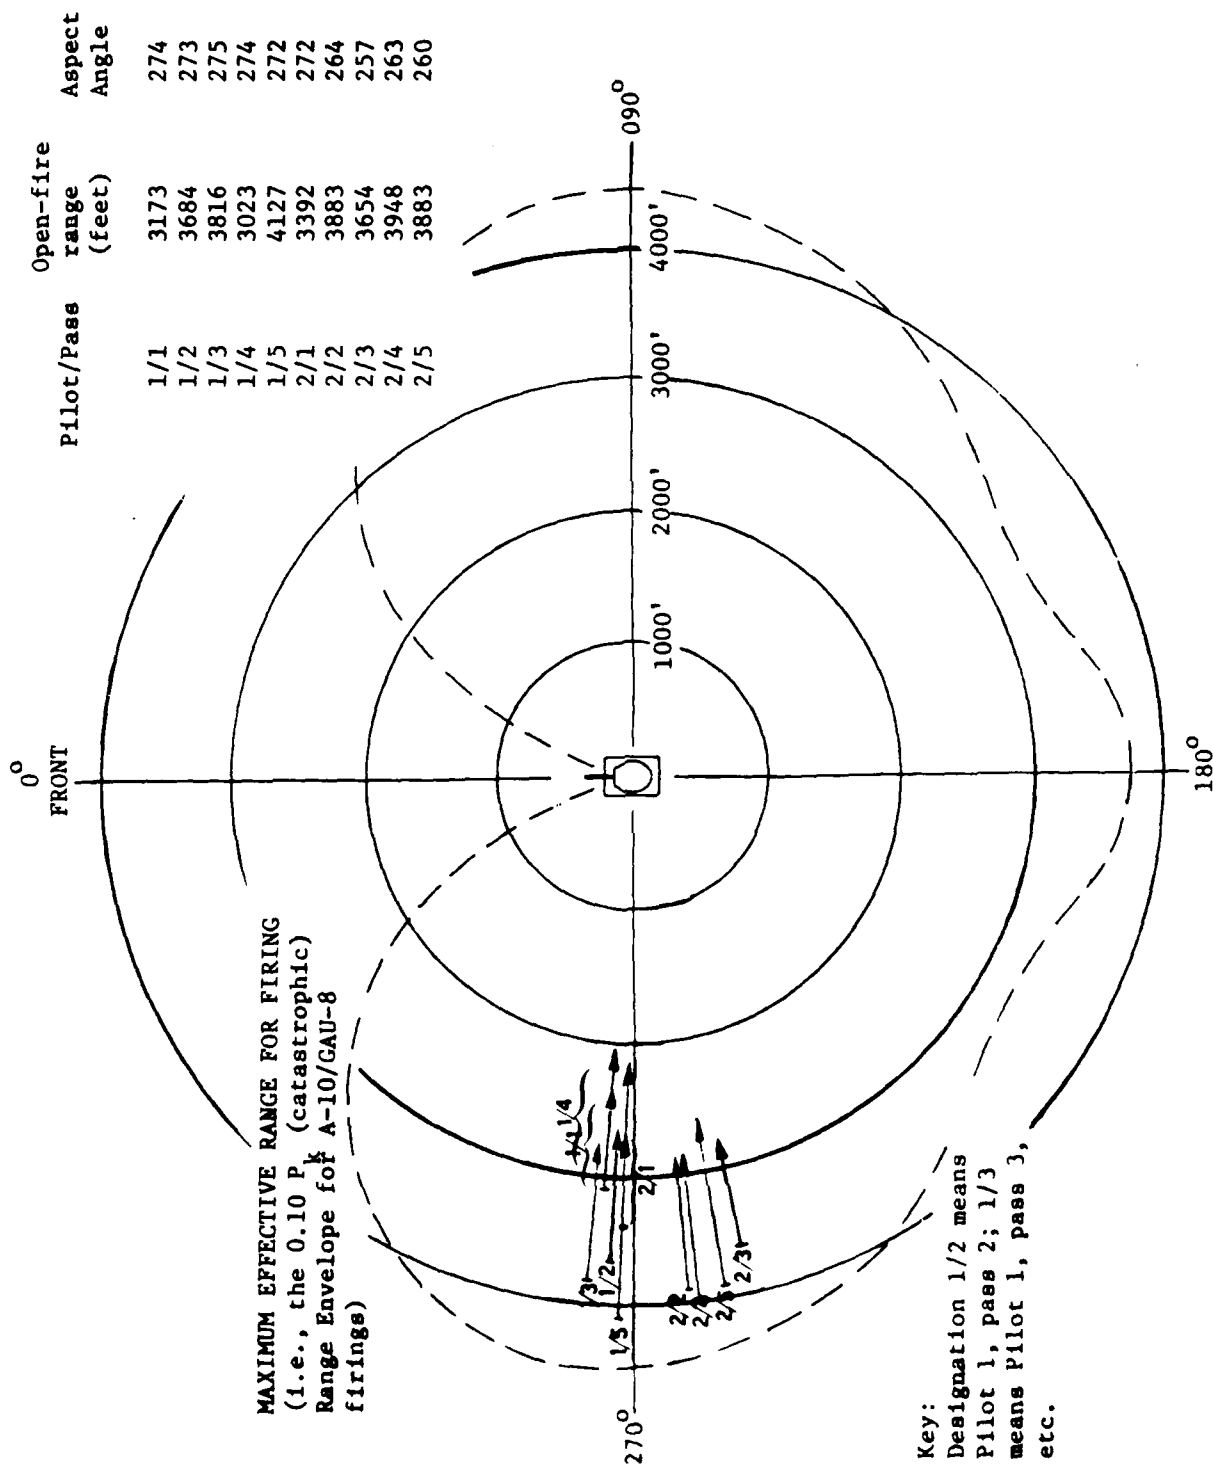
FIGURE A-1. Aircraft Attack Aspect.

Table A-I contains a summary of the results of Mission 20 of 19 September, 1979. Table A-II contains a summary of damage assessment based on perforation locations. Table A-III contains a summary of aircraft attack parameters. Figure A-1 depicts aircraft attack aspect by pilot as a function of open-fire range.
