EFFECT OF THERMAL RADIATION ON THE INTEGRITY OF PRESSURIZED AIRCRAFT EVACUATION SLIDES AND SLIDE MATERIALS

FINAL REPORT

MARCH 1981

Prepared for
U. S. DEPARTMENT OF TRANSPORTATION
FEDERAL AVIATION ADMINISTRATION
TECHNICAL CENTER

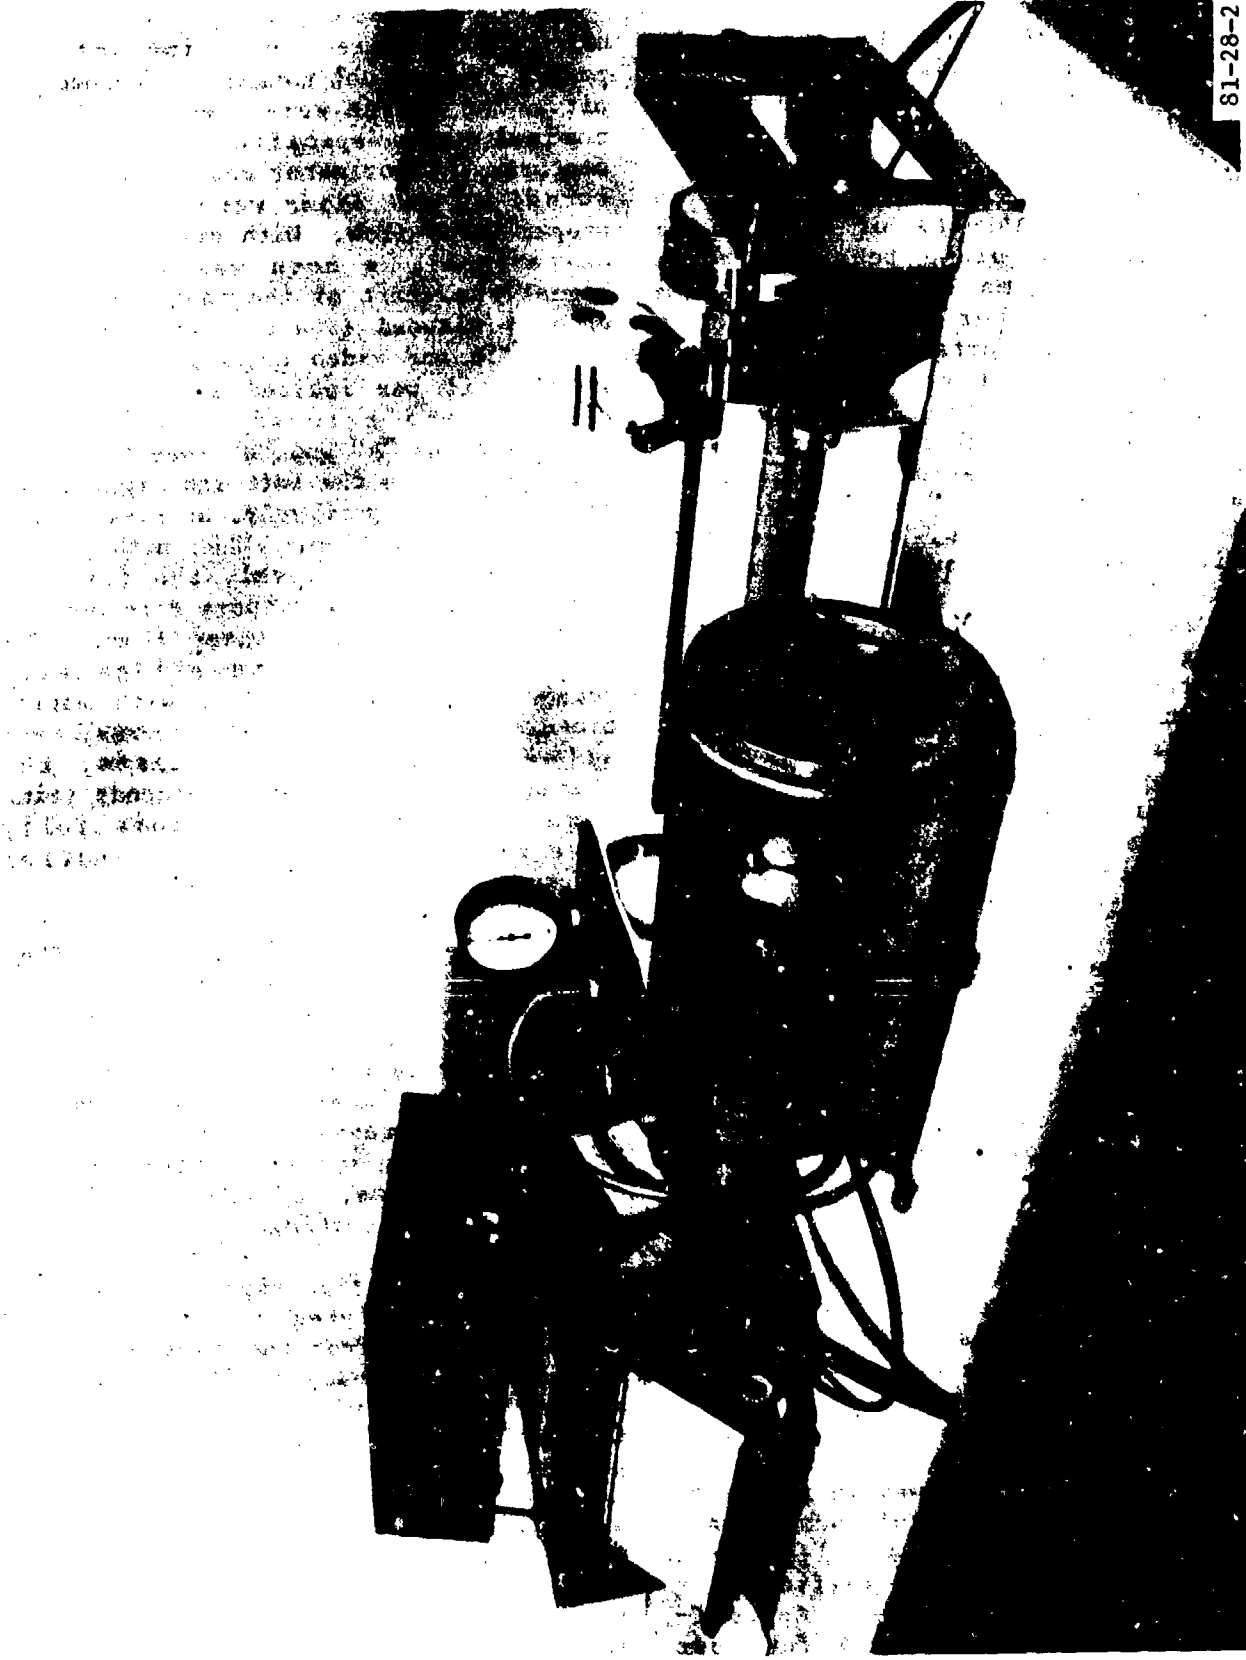
FIGURE 3. EVACUATION SLIDE MATERIAL LABORATORY TESTING APPARATUS

Measurements from the laboratory test apparatus included incident thermal radiation on the test sample, temperature of the unexposed surface (back side) of the sample, and time to initial pressure loss (time when a decrease in the cylinder pressure is first noted). Test materials included samples with and without seams, and with and without heat reflective coatings.

The desired heat flux exposure condition was set, by varying the distance of the calorimeter from the opening of the radiant heat furnace until the desired setting was achieved, and then setting the surface of the test specimen (after pressurization) to that same distance.

Back side surface temperature was measured with a 22-gauge iron constantan thermocouple attached to the inside of the pressure cylinder, adjusted so that the thermocouple bead touched (without

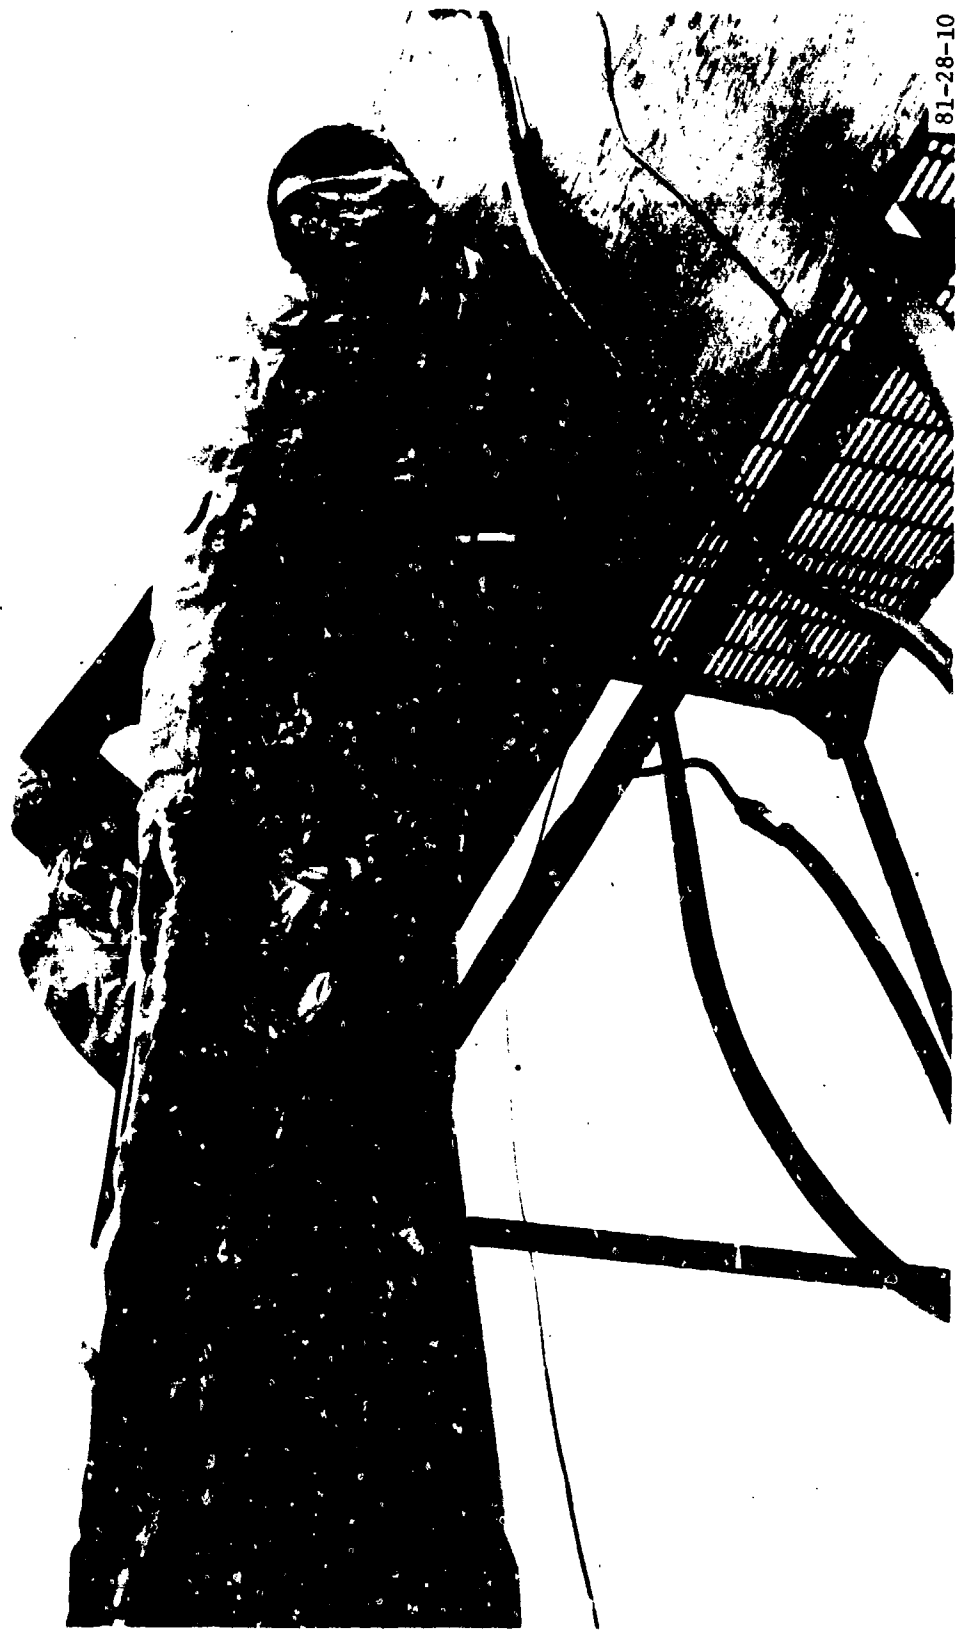
FIGURE 11. URETHANE NYLON NONSEAM FAILURE; TEST 16A

middle of the tube facing the fire. By 64 seconds, at a pressure of 0.5 psig, the uncoated slide blew out in a nonseam area approximately 3 feet below the aspirator on the tube facing the fire (see figure 11). The measured radiative heat flux levels are shown in figure B-12. Although the heat flux values are slightly less than in test 3, which also exposed a double-lane urethane nylon slide at 15 feet from the fire, the onset of failure from this test is consistent with test 3.

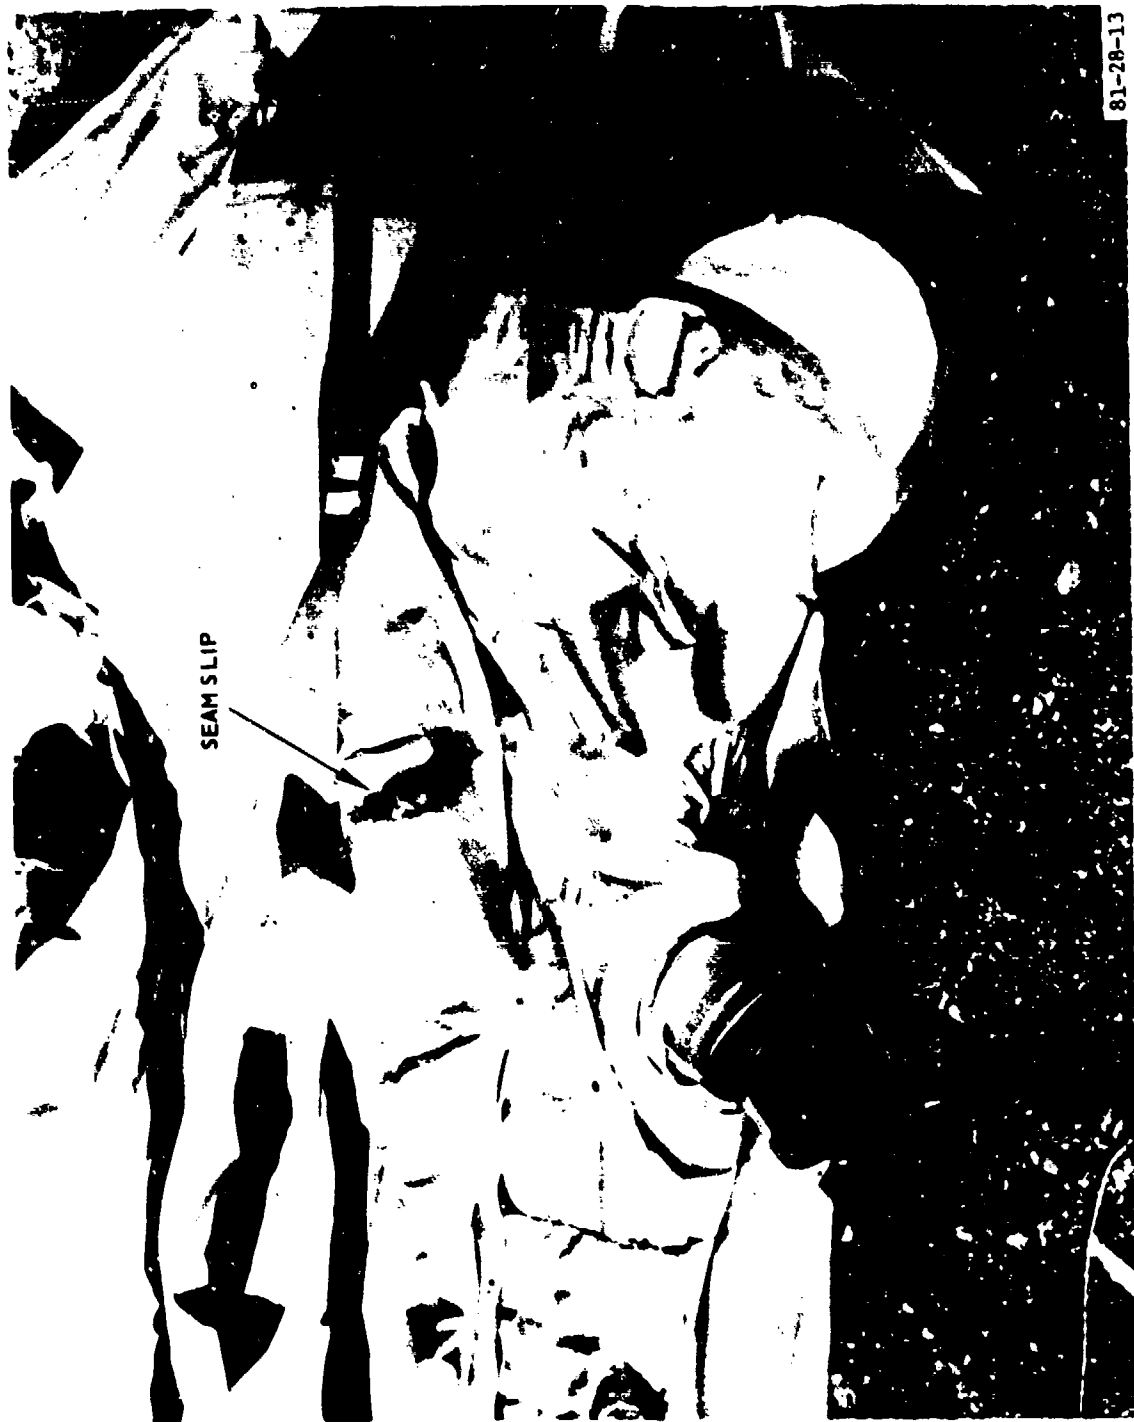
FIGURE 14. ALUMINIZED URETHANE NYLON SEAM SLIPPAGE; TEST 19

At 58 seconds into the test, seam slippage occurred near the top of the slide on a rounded corner of the upper retaining tube ("armrest") (see figure 14). The slide visually began to collapse at 85 seconds. The peak heat fluxes for the low, medium, and high calorimeters were 1.75 Btu/ft²-sec, 1.65 Btu/ft²-sec, and 1.25 Btu/ft²-sec, respectively (figure B-15). The average heat fluxes for the low, medium, and high calorimeters were 1.2 Btu/ft²-sec, 1.22 Btu/ft²-sec, and 0.85 Btu/ft²-sec, respectively (refer to appendix B-15). This test indicated that seam failure limited the potential heat resistance improvements provided by an aluminized coating applied to a

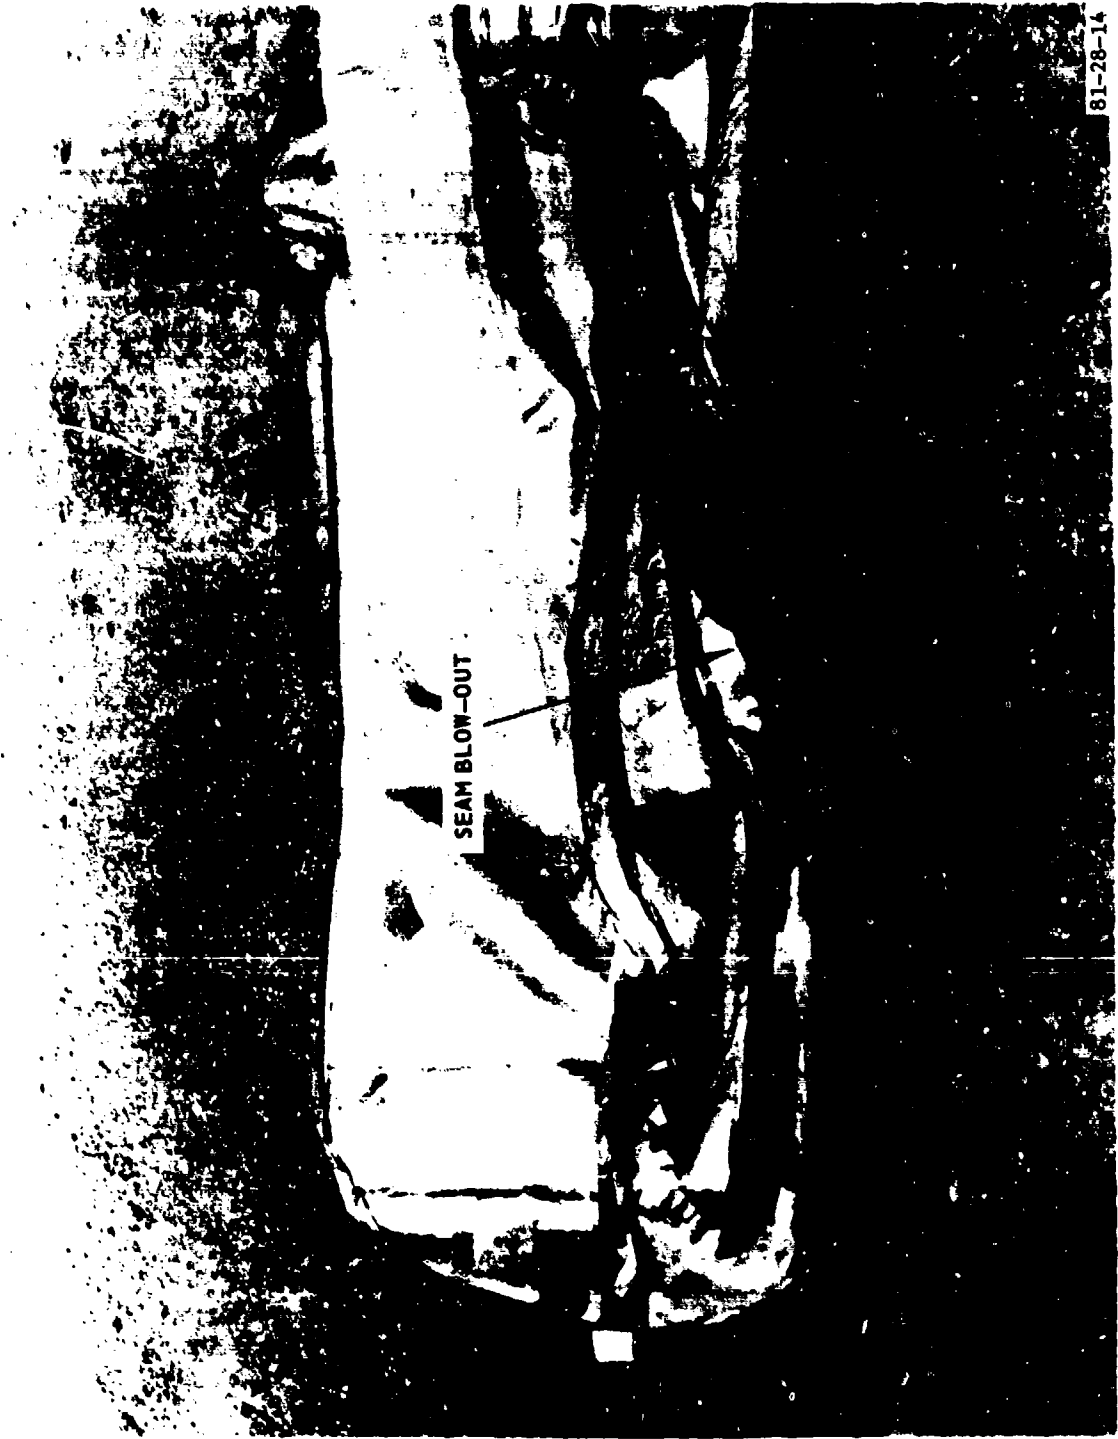
FIGURE 15. ALUMINIZED NEOPRENE NYLON SEAM FAILURE; TEST 20

At 49 seconds into the test, the slide reached a peak pressure of 4.1 psig and blew out catastrophically on a seam near the base of the tube facing the fire (see figure 15). The peak heat fluxes for the low, medium, and high calorimeters were 0.9 Btu/ft²-sec, 0.8 Btu/ft²-sec, and 1.1 Btu/ft²-sec, respectively, all recorded at 45 seconds (figure B-16). At these heat flux levels, it was expected that the aluminized neoprene nylon slide would have resisted the fire for a longer period of time. No visible radiant heat damage was noted in the middle and top areas of the slide, in spite of the highest heat flux levels at the top of the slide. Other seam areas near the base of the slide also showed no visible radiant heat damage. It was therefore concluded that the seam in the failure area contained some sort of flaw. The temperature rise for the top side of the sliding surface was 47° F by 49 seconds.

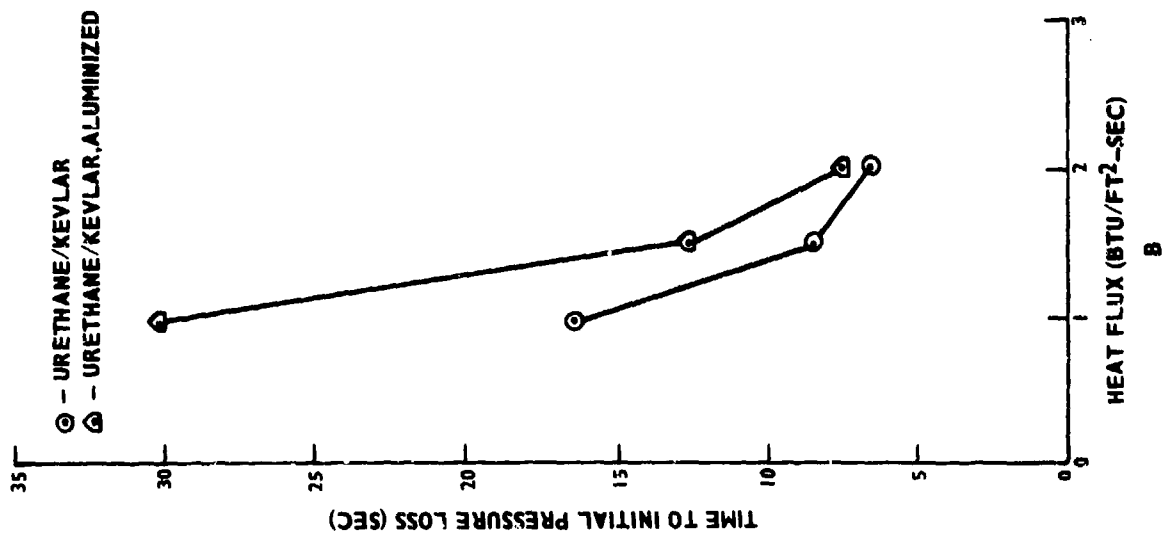
FIGURE 19. HEAT FLUX VERSUS TIME TO INITIAL PRESSURE LOSS

Figure 19 shows the effect of heat flux, base fabric and aluminization, on the time to initial pressure loss. For urethane nylon at 1.5 Btu/ft²-sec, the time-to-failure was increased from 26 seconds for the noncoated material to over 600 seconds for a new material with a reflective coating. This reflective coating was applied by the manufacturer in the finished fabric. At the same heat flux, the improvement provided by aluminization was much less significant for the Kevlar fabric, as shown

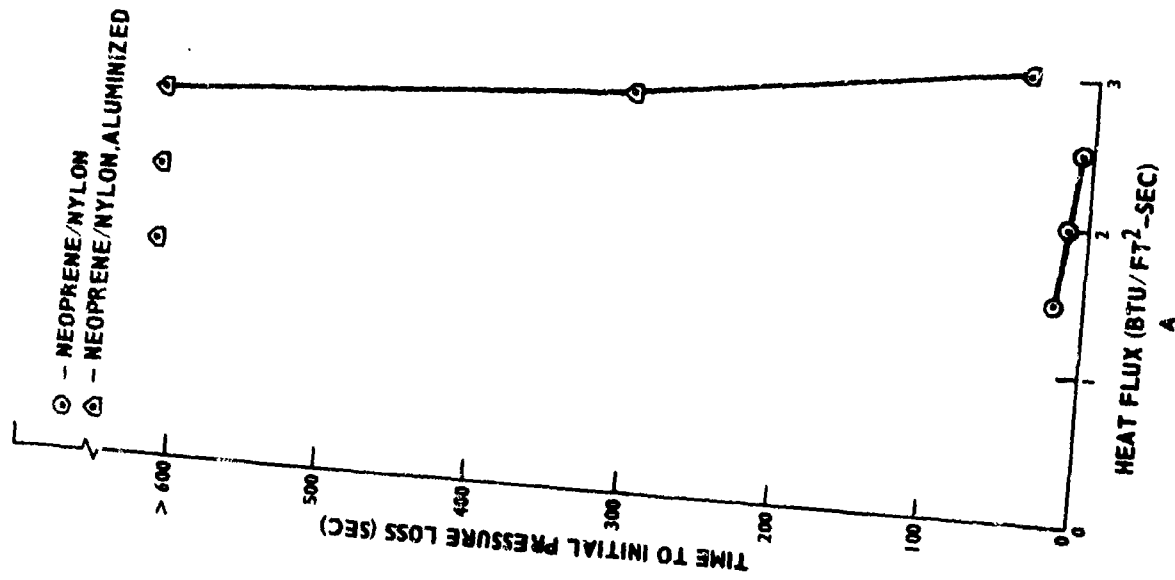
FIGURE 20. HEAT FLUX VERSUS TIME TO INITIAL PRESSURE LOSS
